Inventory and Assessment of Culverts, Bridges, and Stormwater Outfalls

Oak Creek Watershed Restoration Plan

Instream Survey Progress Update-Fall 2017

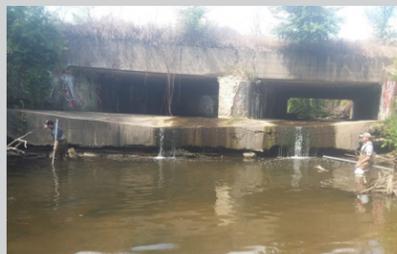
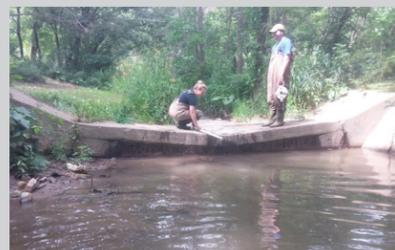
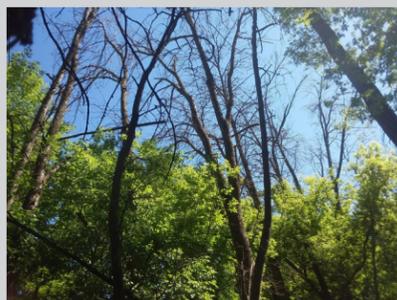
SEWRPC staff has completed an inventory and assessment of all stream crossings on the mainstem of Oak Creek, the North Branch of Oak Creek, and the Mitchell

Field Drainage Ditch. In total, 48 culverts and 34 bridges were assessed for general physical condition and for potential fish passage barriers. Locations of other potential fish passage impediments were also recorded—93 large woody debris jams, 13 weirs or drop structures, and the Mill Pond dam all potentially impact fish migration to varying degrees. In addition, general conditions have been assessed for 137 stormwater outfalls that discharge directly to the three main streams in the watershed.

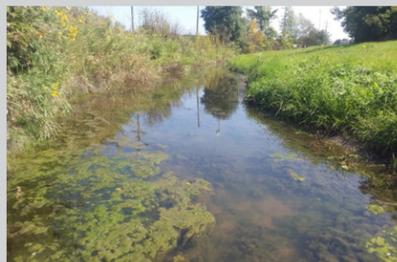
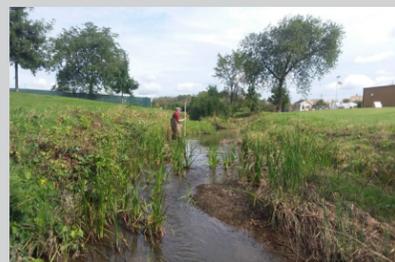
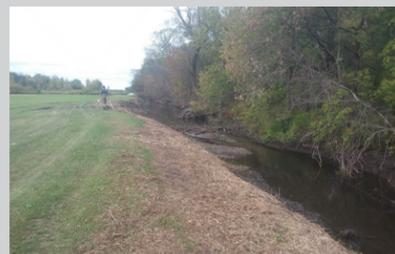
Insufficient Riparian Buffer, Channelization, and Disconnected Floodplain

Much of the mainstem of the Oak Creek was found to have relatively intact riparian buffer corridors, thanks in most part to the Milwaukee County parkway system. Survey of the North Branch of Oak Creek and the Mitchell Field Drainage Ditch encountered more frequent stretches of stream with little or no riparian buffer protection (see upper right for North Branch and lower right for Mitchell Field Drainage Ditch). Riparian buffers help to filter nutrients and other pollutants carried by stormwater runoff before they reach waterways. This nutrient rich runoff can lead to excessive algal growth (see North Branch of Oak Creek, upper left). Riparian buffers also provide vital habitat for aquatic and terrestrial organisms. Channelization can lead to disconnected floodplains through incision, as shown above. Streams that are disconnected from their floodplain are more vulnerable to streambed and bank erosion and habitat degradation.

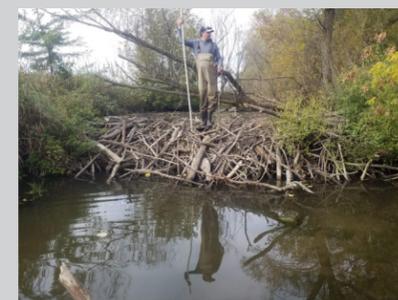
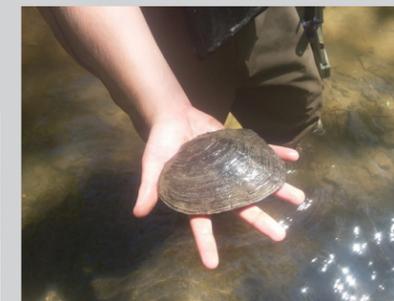
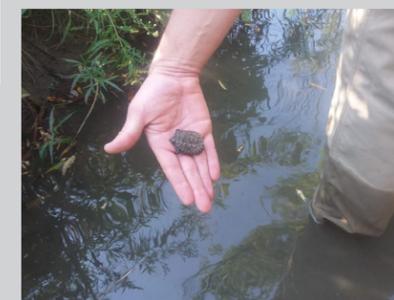
Important Biological, Hydrologic, and Geomorphic Features

The locations of notable features including groundwater seepages, tributary streams, drain tiles, trash, freshwater mussels, and other aquatic organisms were recorded and photographed. In the photo above SEWRPC staff stand on a beaver dam impounding a large amount of water on the Mitchell Field Drainage Ditch. The photo in the upper right shows a large native freshwater mussel found in Oak Creek's mainstem, downstream of the confluence with the North Branch. The photo in the lower right shows a juvenile snapping turtle encountered on the North Branch of Oak Creek near the MATC campus.

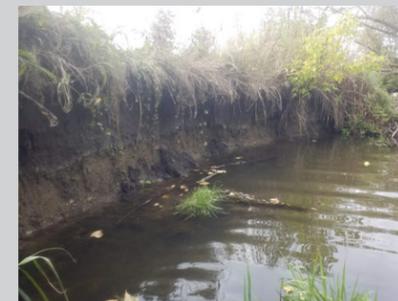
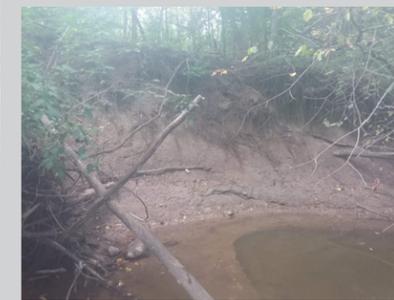
Streambank Erosion

Some streambank and bed erosion is normal and healthy in a stream system. However, channelization and altered hydrology can lead to excessive bank and bed erosion. Sediment loads resulting from excessive bank erosion can destroy aquatic habitat and spawning and feeding areas for fish, contribute to downstream water quality degradation, and contribute to the filling of the Mill Pond in Grant Park. Altogether, SEWRPC staff recorded 135 streambank erosion sites totaling over 3,600 feet of eroding bank on the Oak Creek mainstem, the North Branch of Oak Creek, and the Mitchell Field Drainage Ditch. Above are photos of severe bank erosion sites on the Mitchell Field Drainage Ditch (left) and the North Branch of Oak Creek (right).
