SEWRPC Staff Memorandum

**EVALUATION OF THE POTENTIAL IMPACT OF THE
REMOVAL OF THE MONTEREY DAM
ON WATER QUALITY AND WATER QUANTITY IN ASHIPUN LAKE**

January 26, 2012

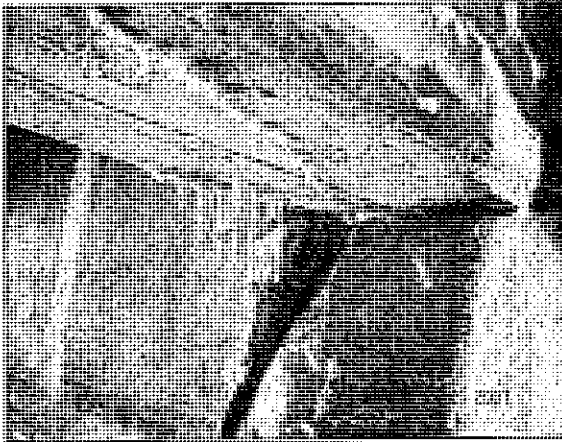
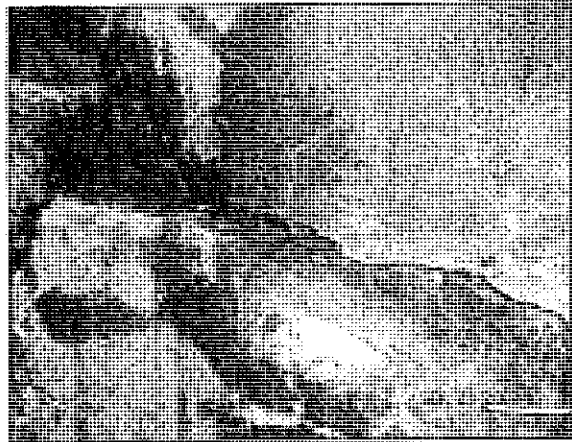
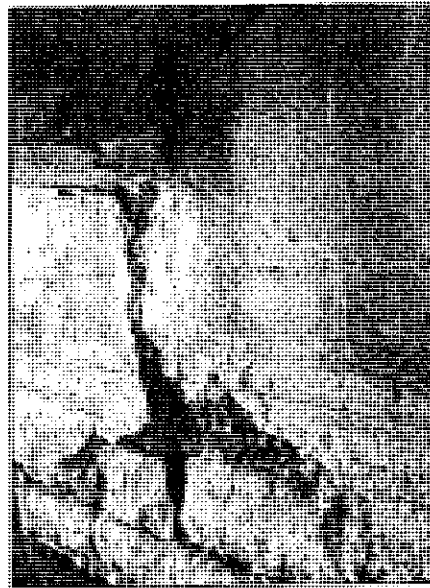
- There are major cracks with large chunks of concrete missing from the concrete sill abutments, especially on the south abutment. There is also evidence of some movement and rotation of the west and east ends of the south abutment.

This bridge should be replaced as soon as possible. The noted deficiencies have been present for considerable time; however, after review of the 1996 photos, it appears that they are progressing.

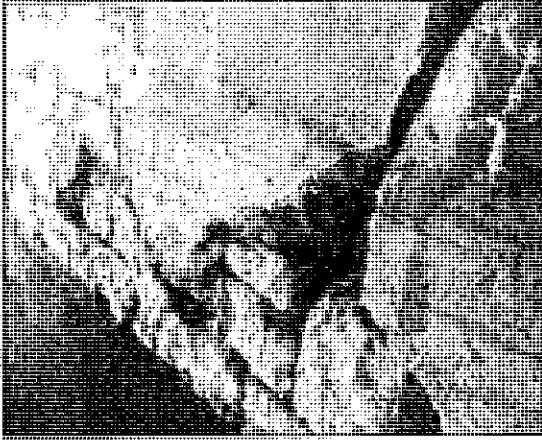
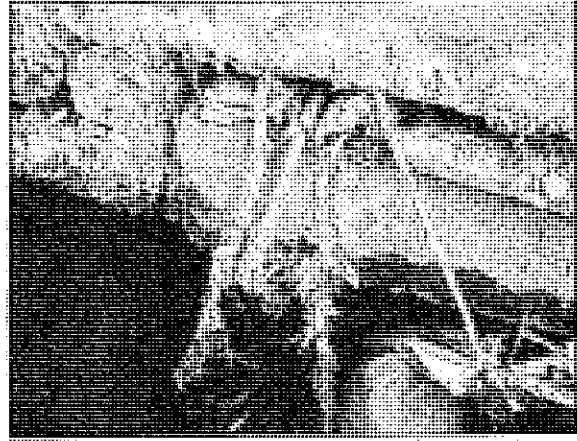
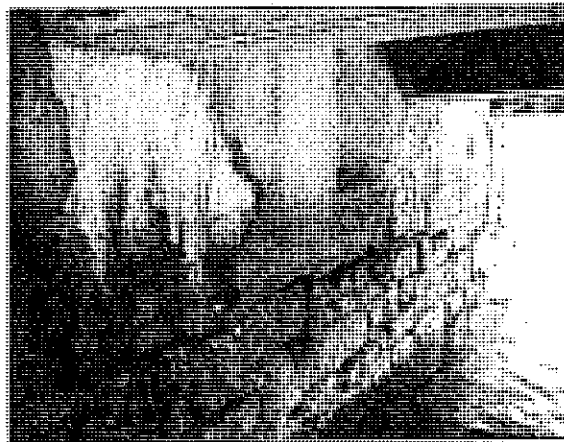
- The joints of the older stone masonry abutment foundations lack mortar and allow water to pass through them. This is most likely the reason for the water leakage at the sides of the dam (pictured below). There are roots and debris lodged in these joints.

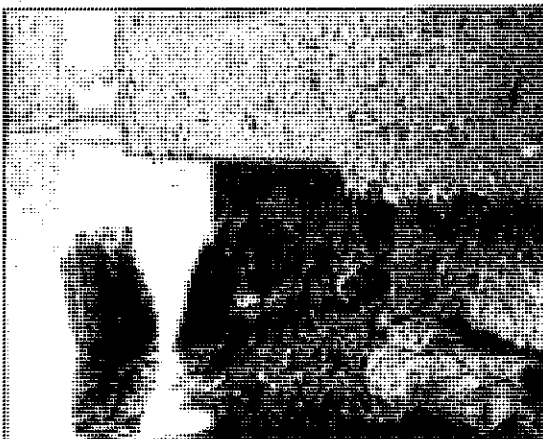
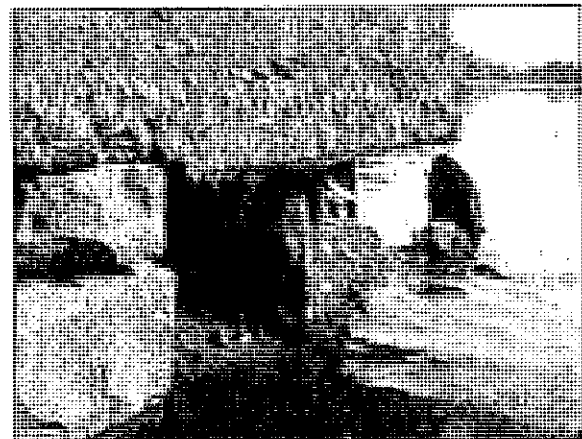
- The stone masonry abutment foundation at the west ends of the north and south abutments have been washed out and are missing. The remnants of timber piles, likely from a previous wingwall, are present on the east ends of the abutments.

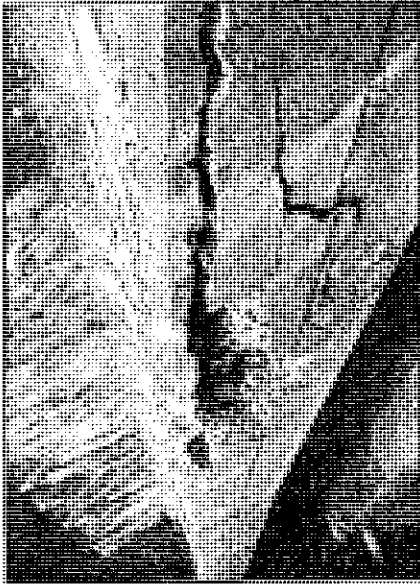
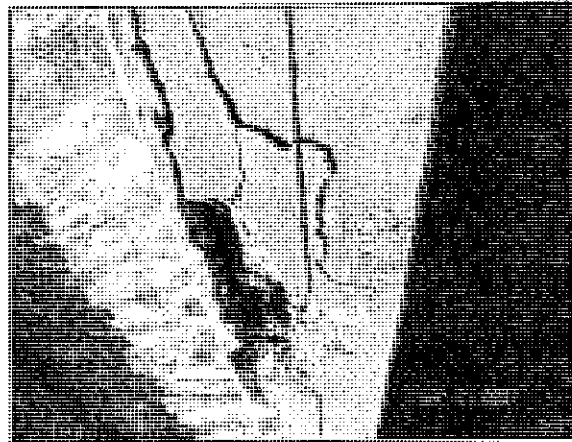
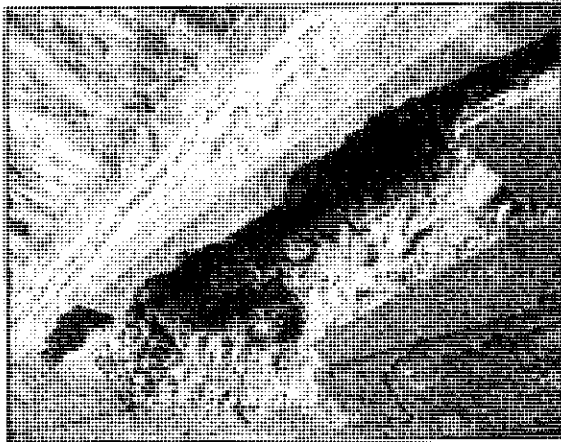
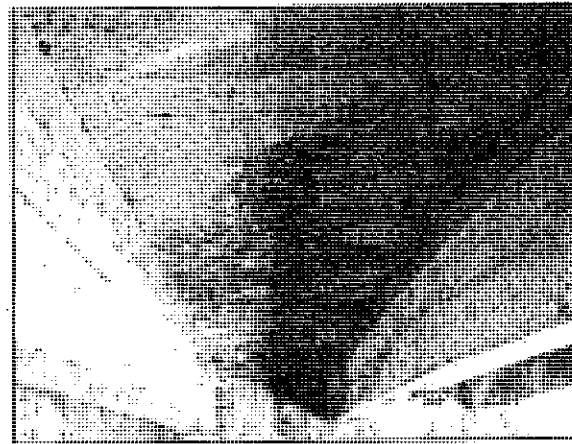
- There is major spalling and loss of concrete cover at the middle of the center deck girder. There is also spalling on the underside of the deck.

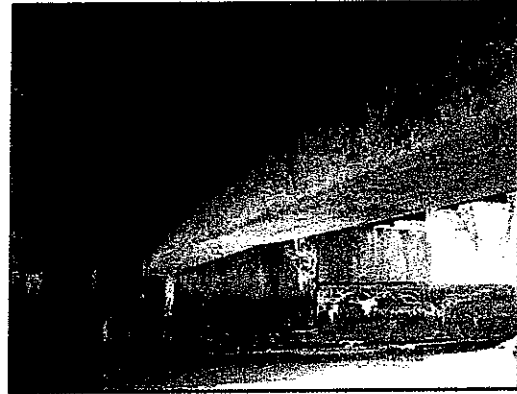
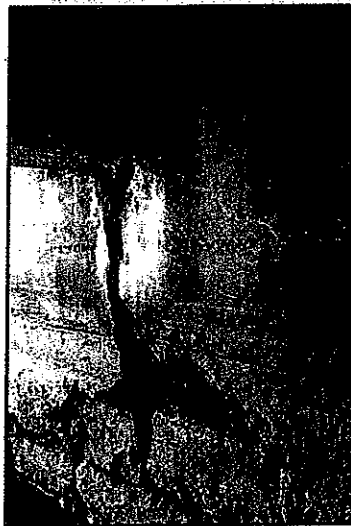
- There are major cracks with large chunks of concrete missing from the concrete sill abutments, especially on the south abutment. There was evidence of some movement and rotation of the west and east ends of the south abutment present during our September 21, 2007 inspection, but our present inspection showed the west end to be pushed in approximately 3" and the east end approximately 2".

West end of south abutment appeared to have moved in 3". East end pushed in 2".

Both the north and south approach roadways are exhibiting signs of settlement away from the bridge, as reported on September 21, 2007. This bridge should be replaced as soon as possible. The noted deficiencies have been present for considerable time; however, after review of the 2007 photos, it appears that they are progressing.

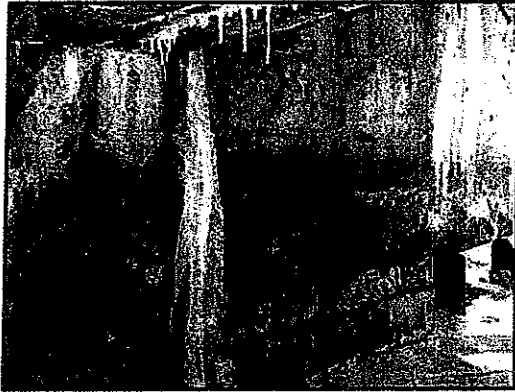
- The joints of the older stone masonry abutment foundations lack mortar and allow water to pass through them similar to the large cracks in the concrete abutment above. This is the reason for the ice buildups at the cracks and joints.

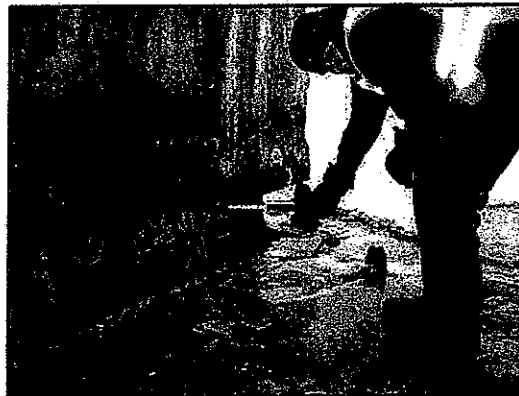
- The stone masonry abutment foundation at the east ends of the north and south abutments have been washed out and are missing. The remnants of timber piles, likely from a previous wingwall, are present on the east ends of the abutments. This was also observed on September 21, 2007.

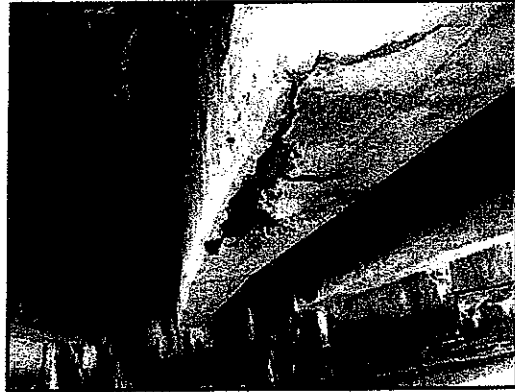
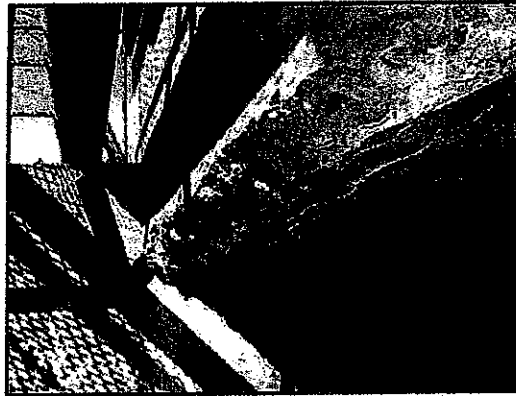
- There was major spalling and loss of concrete cover at the middle of the center deck girder observed on September 21, 2007, along with spalling on the underside of the deck. The deterioration has advanced on the center deck girder with exposed rusting reinforcing steel. There also appears to be advanced deterioration at the northwest corner of the deck.
