Community Assistance Planning Report No. 330

A RESTORATION PLAN FOR THE OAK CREEK WATERSHED

APPENDIX DAM

South Milwaukee Mill Dam (Field File # 40.05)
Photo Log
Inspection Report (November 27, 2012)

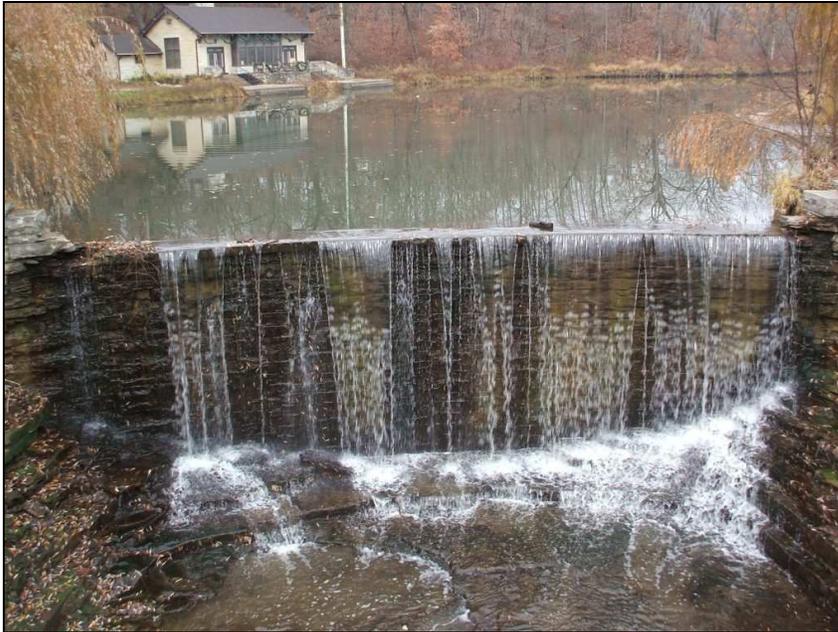
Photo #1 – Principal spillway
(November 19, 2012)

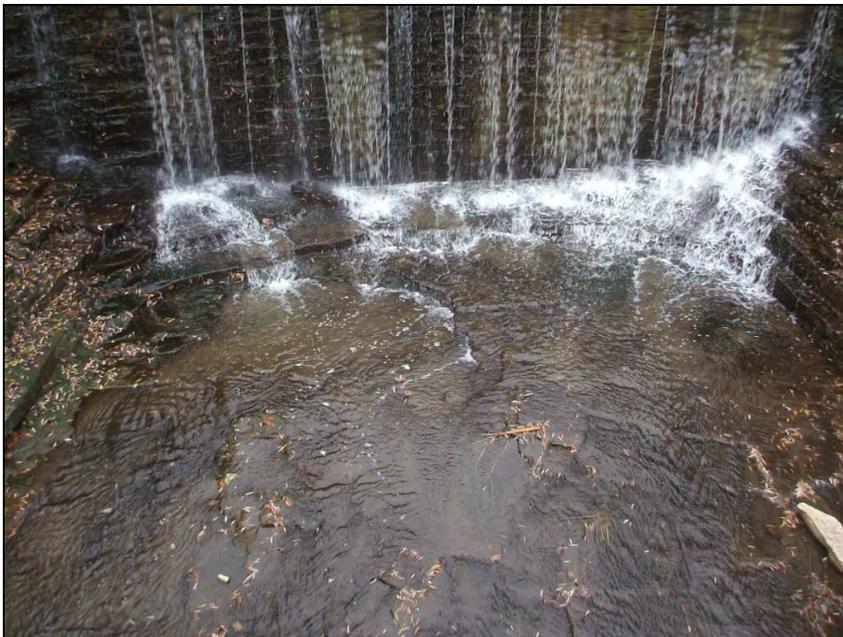
Photo #2 – Downstream stone apron
(November 19, 2012)

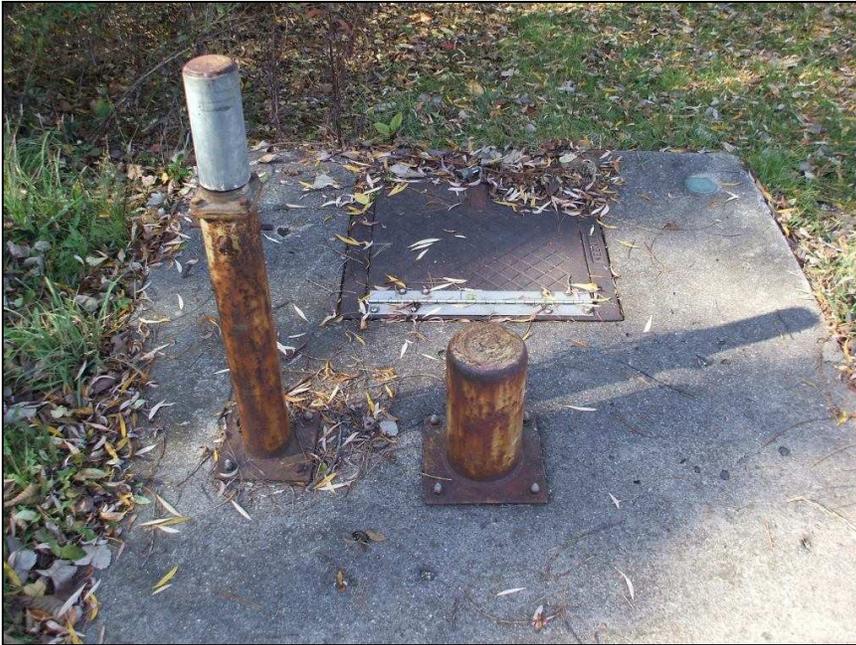
Photo #3 – Location of sluice gate and benchmark 481-E on right side of embankment (October 26, 2012)

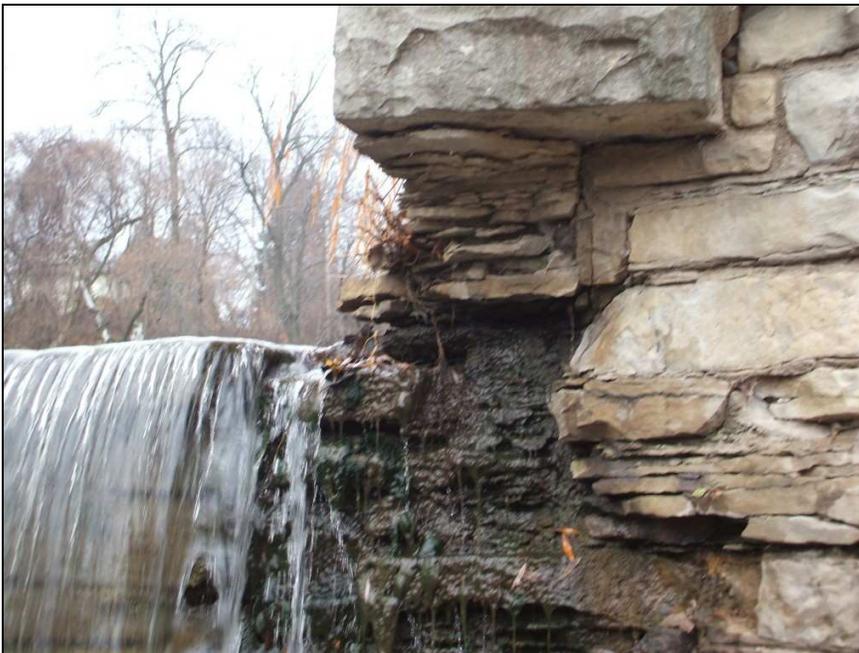
During the inspection, some deterioration and loss of the masonry-type section was observed at both abutments. The Department does not have adequate safety equipment to thoroughly inspect the condition of these components.

Photo #4 – Deterioration of dolomite stone near left abutment (November 19, 2012)

The extent of the investigation requires that an engineer registered in Wisconsin complete a structural evaluation of the spillway abutments and determine whether “masonry” repairs are required. The Department may establish additional timelines related to “masonry” repairs following the structural evaluation. If it is determined that repairs are necessary, submit the plans and specifications to this office for approval prior to initiating any work on the dam.

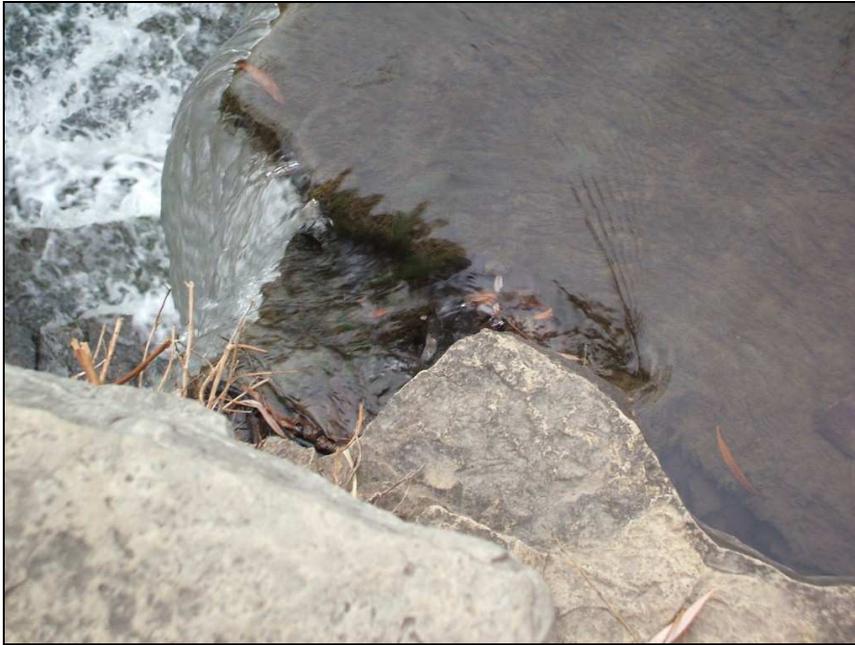
Photo #5 – Deterioration of dolomite stone near left abutment
(November 19, 2012)

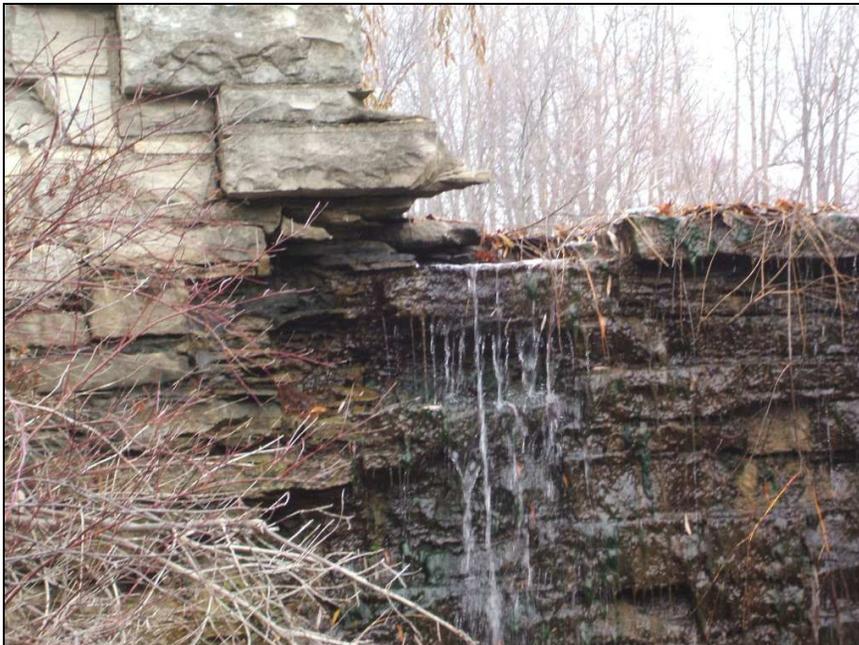
Photo #6 – Deterioration of dolomite stone near right abutment
(November 19, 2012)

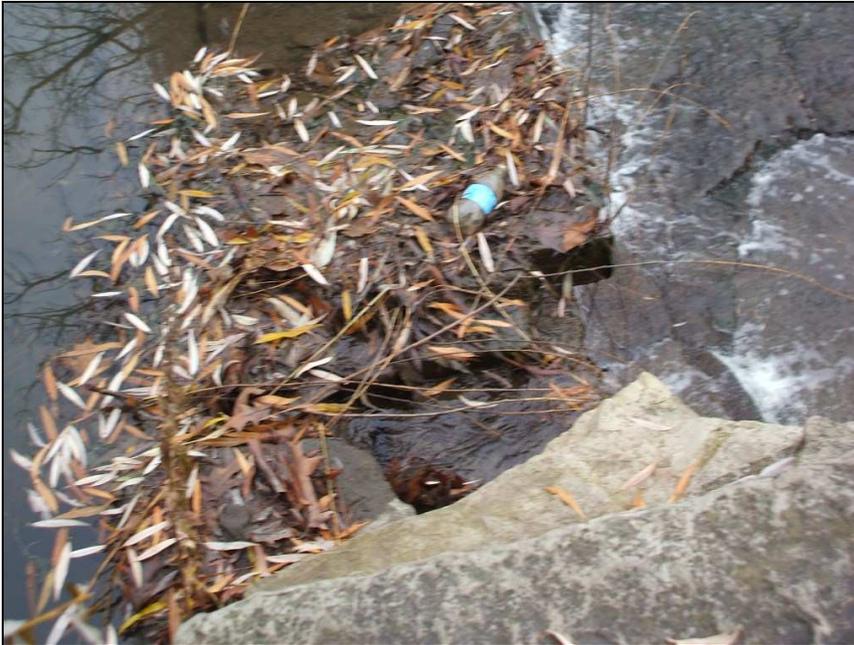
Photo #7 – Deterioration of dolomite stone near right abutment
(November 19, 2012)

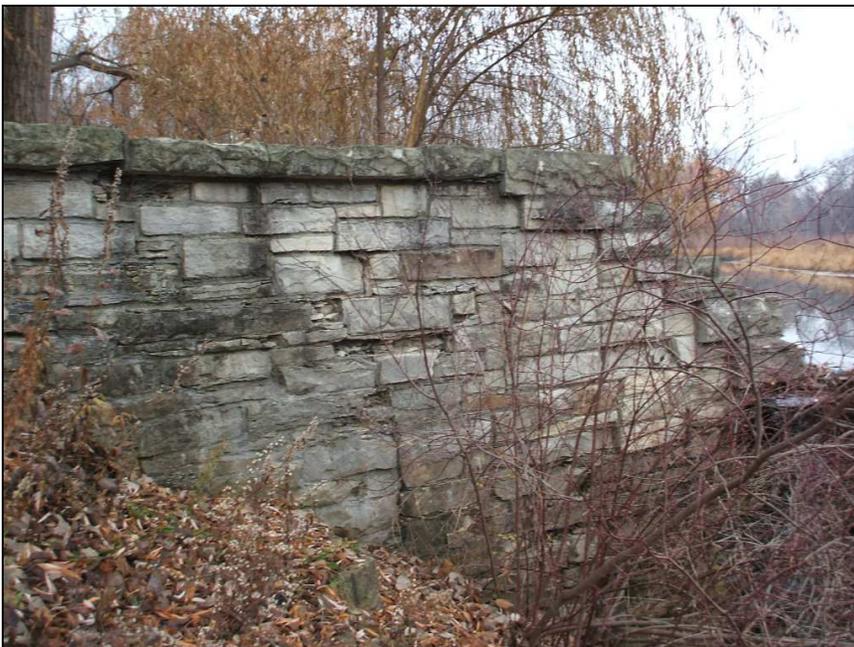
Photo #8 – Deterioration of dolomite stone on ride side of retaining wall
(November 19, 2012)

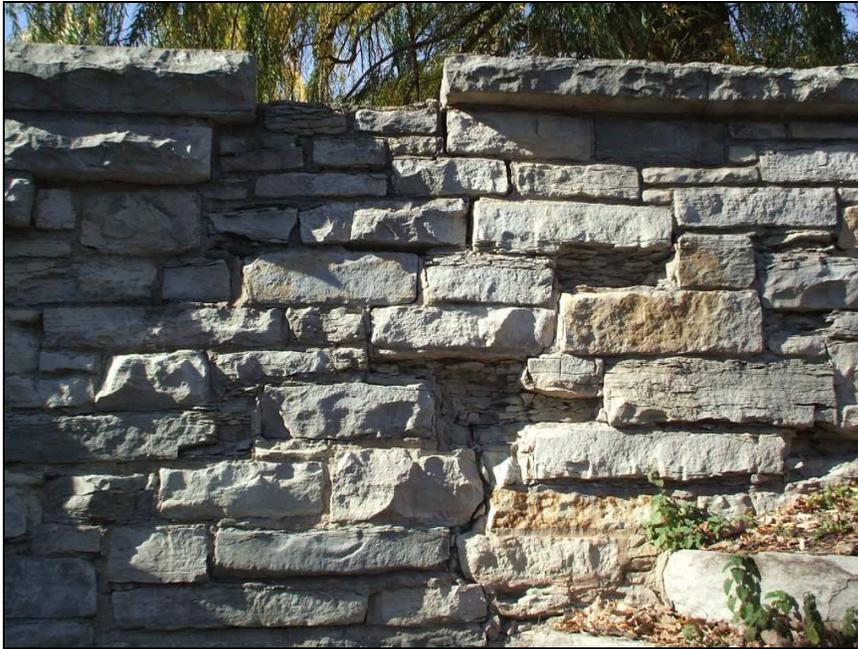
Photo #9 – Deterioration of dolomite stone on left side of retaining wall
(October 26, 2012)

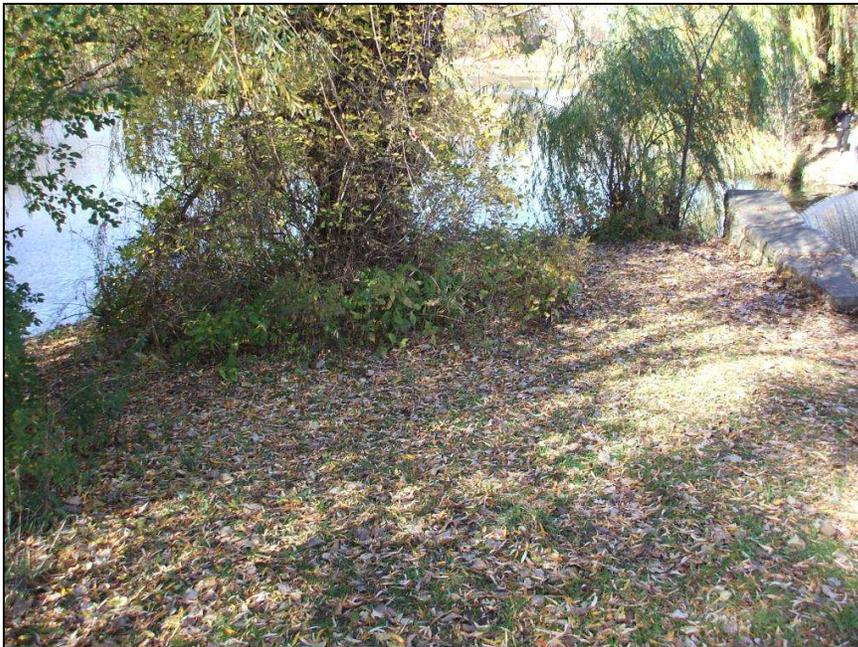
Trees and brush were noted growing on several portions of the embankment. Removal of vegetation is important for a number of reasons and I have included our Fact Sheet on "Vegetation Control on Dams" for your information. All the trees and brush are to be removed from either side of the spillway, the side slopes between the spillway and Mill Road bridge, and the side slopes downstream of the Mill Road bridge.

Photo #10 – Trees and brush on right embankment
(October 26, 2012)

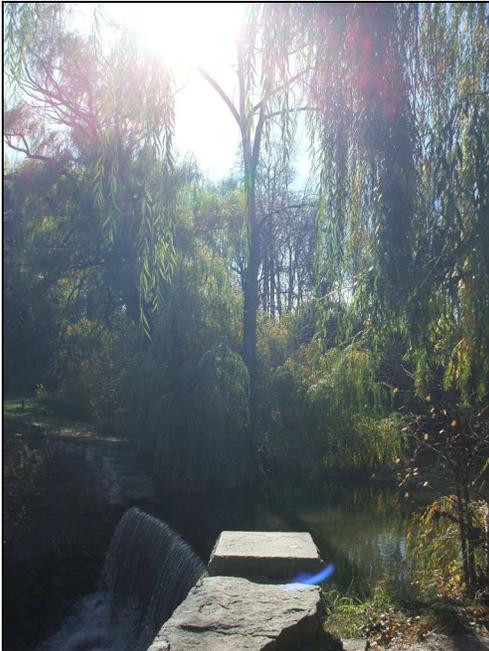
Photo #11 – Trees and brush on right embankment
(October 26, 2012)

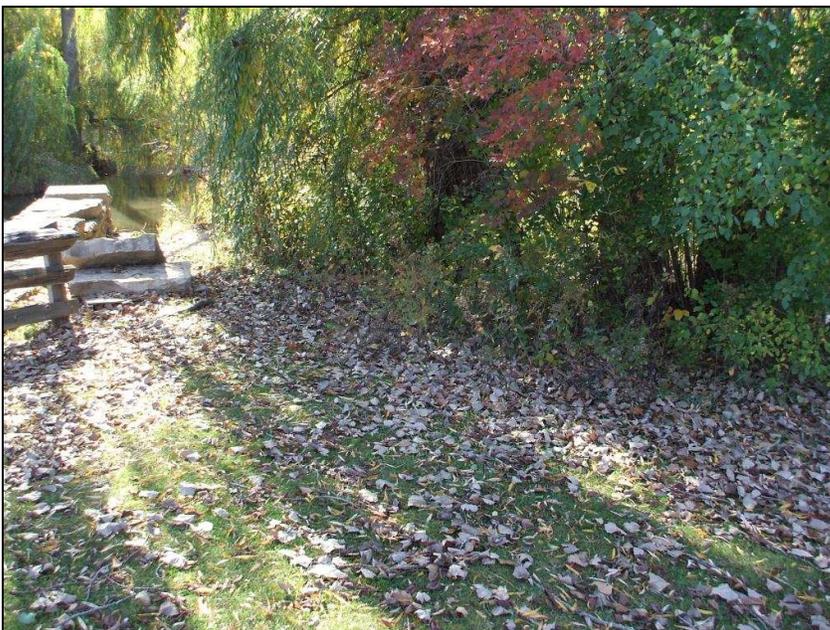
Photo #12 – Trees and brush on left embankment
(October 26, 2012)

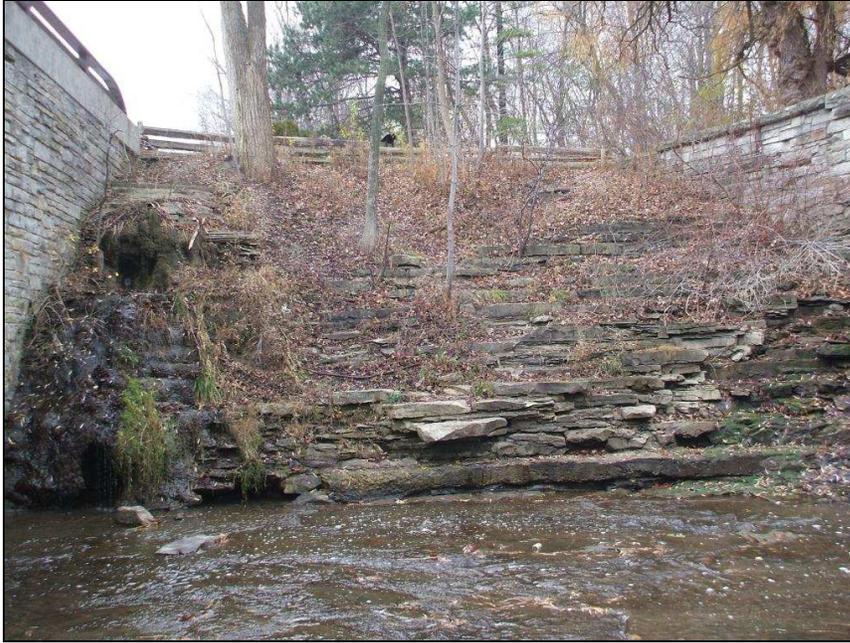
Photo #13 – Trees and vegetation on right side slope (embankment) between spillway and bridge (November 19, 2012)

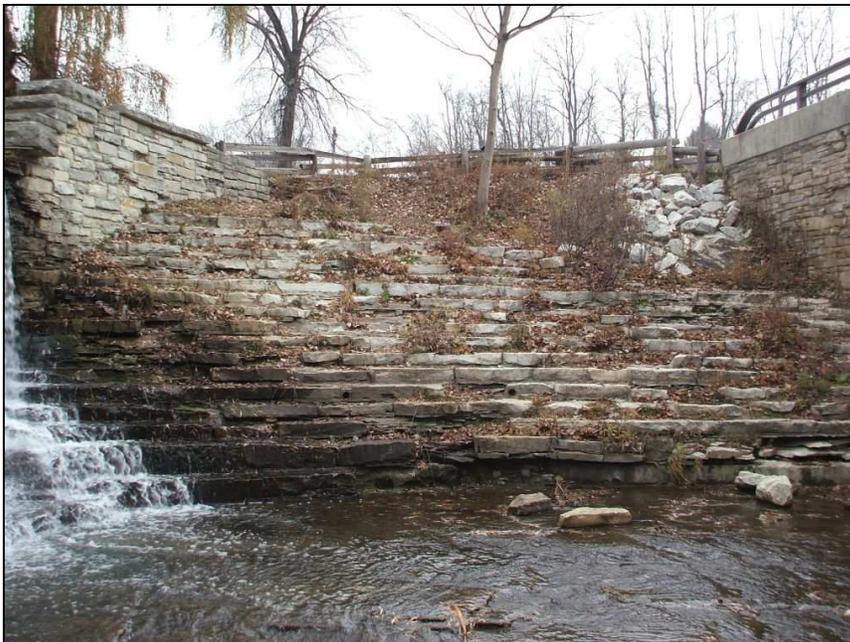
Photo #14 – Trees and vegetation on left side slope (embankment) between spillway and bridge (November 19, 2012)

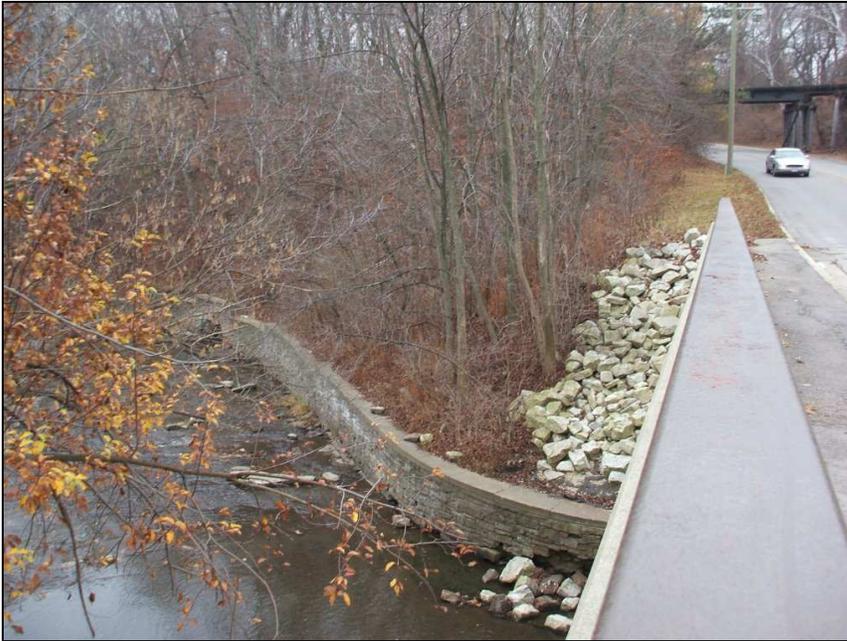
Photo #15 – Trees and brush on right downstream slope of embankment
(November 19, 2012)

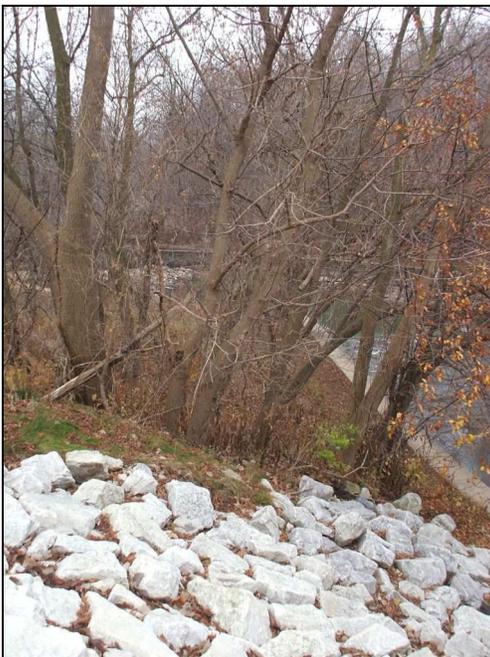
Photo #16 – Trees and brush on left downstream slope of embankment
(November 19, 2012)

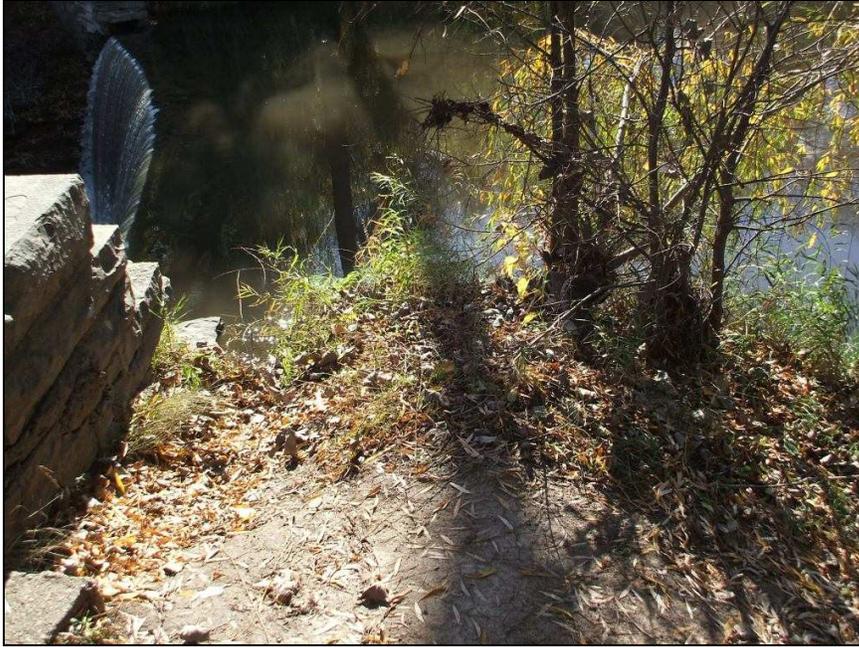
Photo #17 – Sparse grass on embankment caused by foot traffic
(October 26, 2012)

The embankment should then be mowed on a regular basis so that the growth does not exceed 6 inches at any time. Foot traffic has caused erosion and sparse grass at several locations on the embankment. Efforts should be made to maintain dense/healthy grass cover on the embankments.

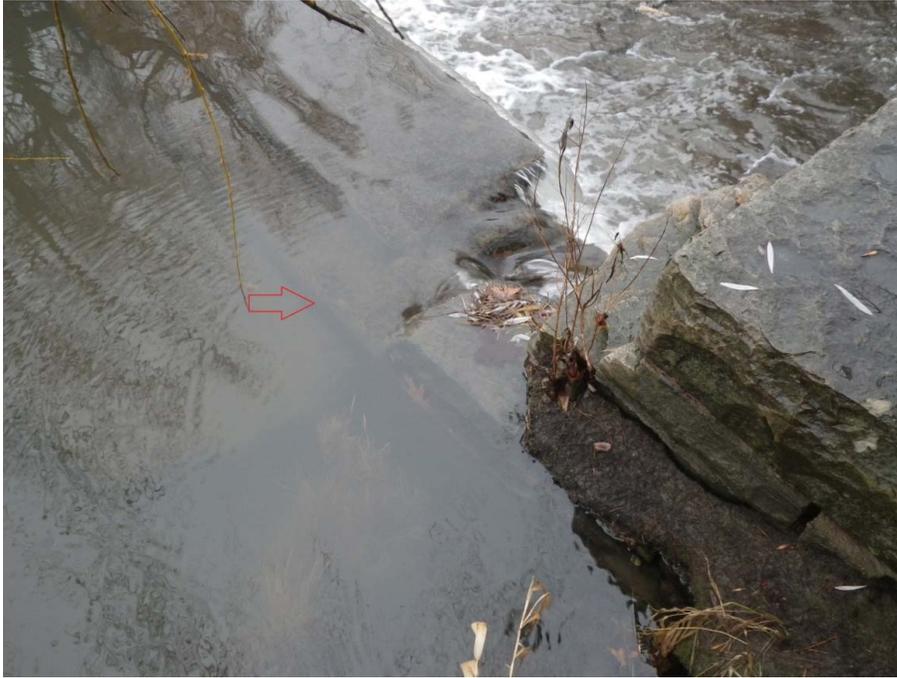
Photo 9: Right embankment at end of spillway. Note missing stone on end of spillway and top of concrete under water (arrow)

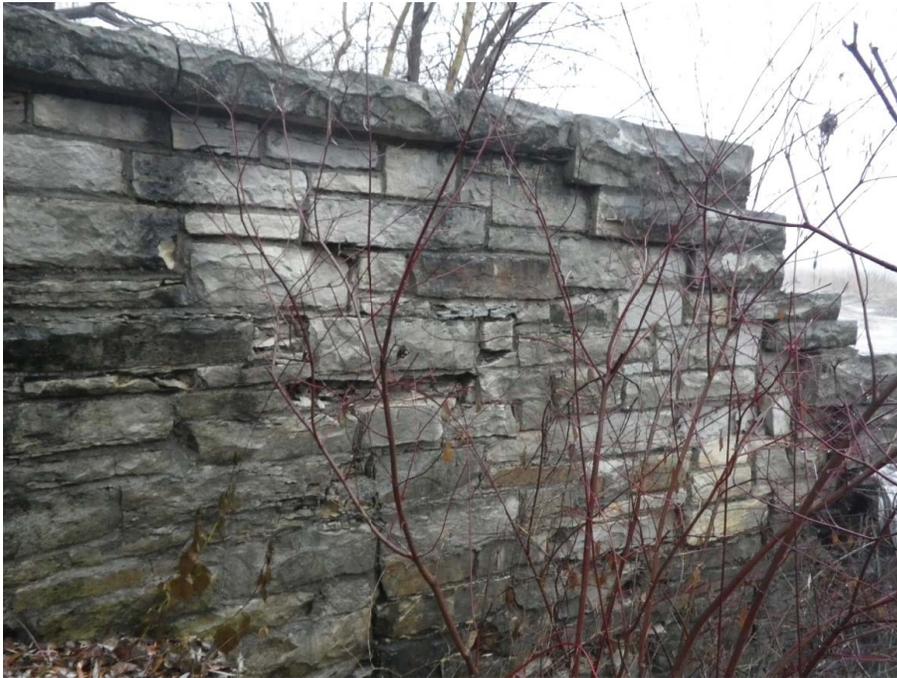
Photo 11: Right abutment stone and mortar, downstream. Note deteriorating and cracked stones.

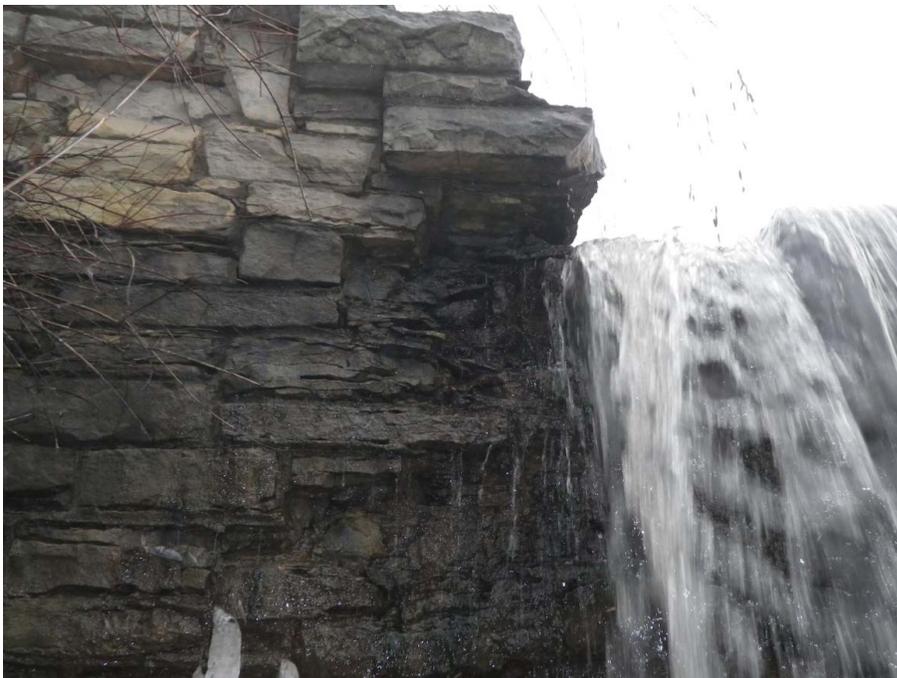
Photo 12: Right abutment downstream face at end of spillway. Note missing stone on spillway and weathered stone along edge

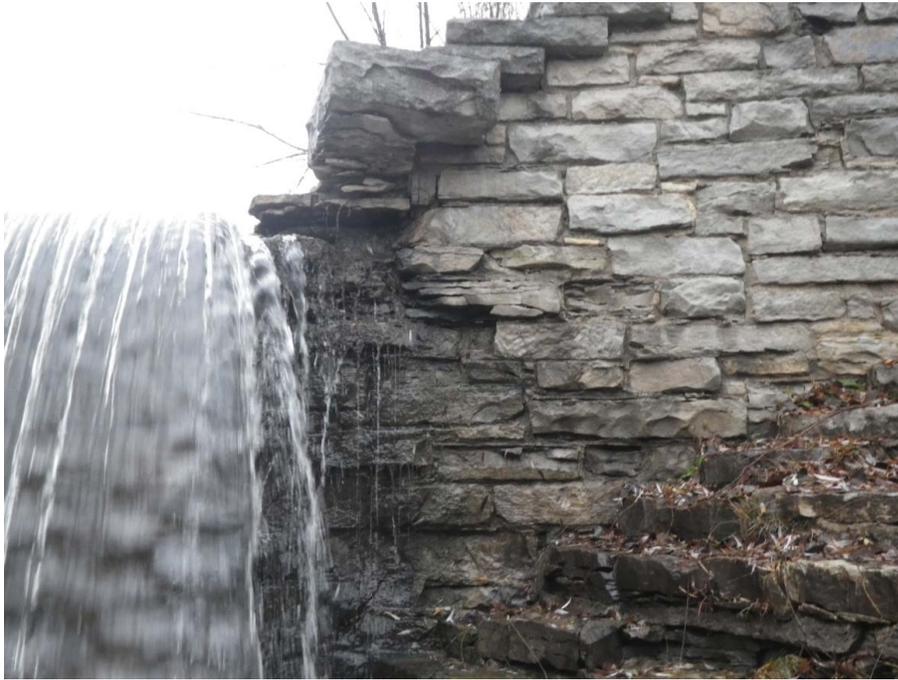
Photo 13: Left abutment downstream face at end of spillway. Note missing stone on spillway end and deteriorated stone off spillway

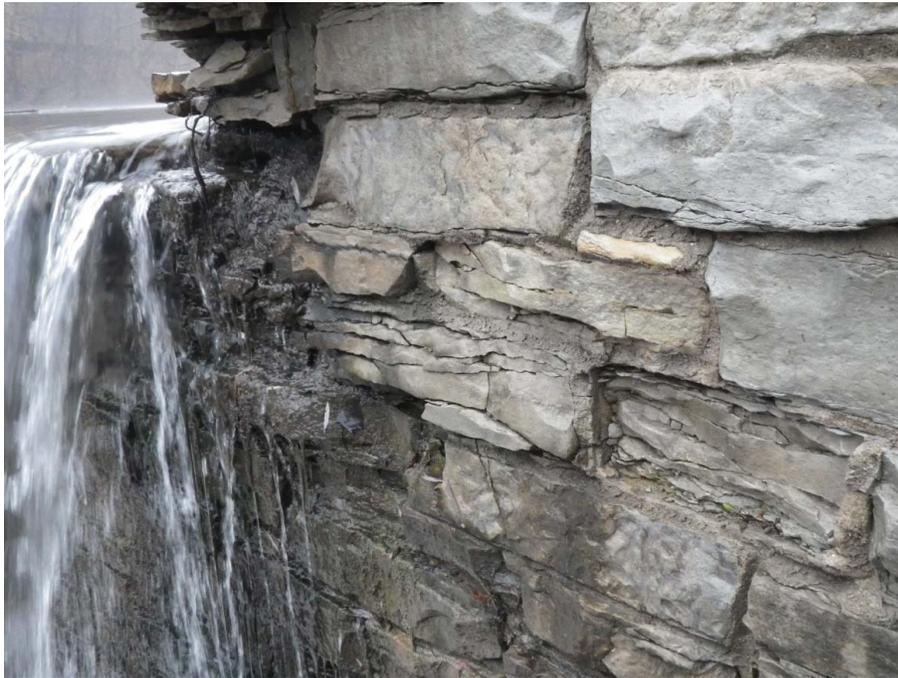
Photo 15: Left abutment downstream face. Note deteriorating stonework.

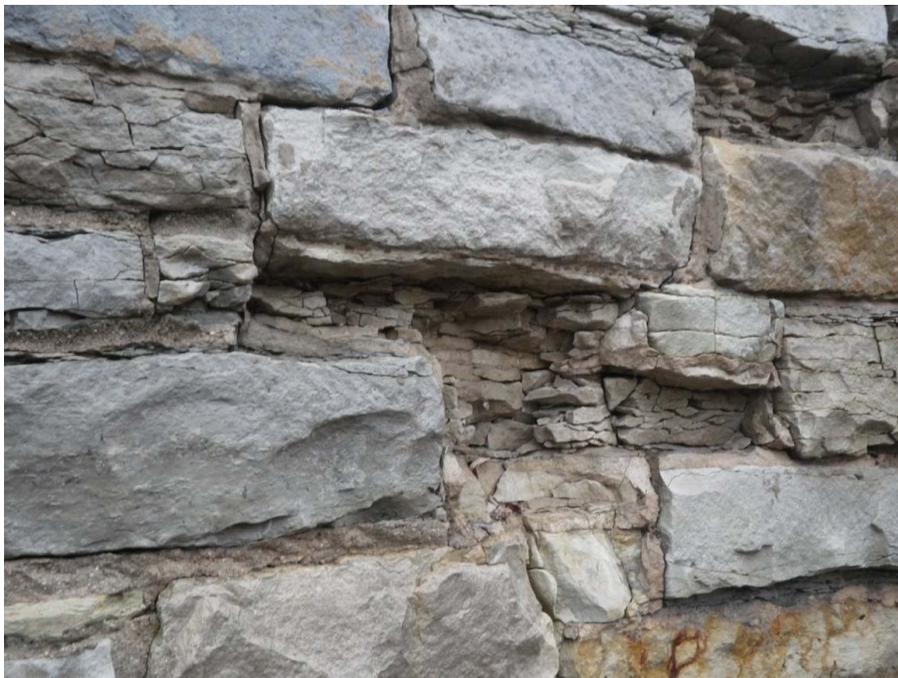
Photo 16: Left abutment downstream face. Note weathered stonework.

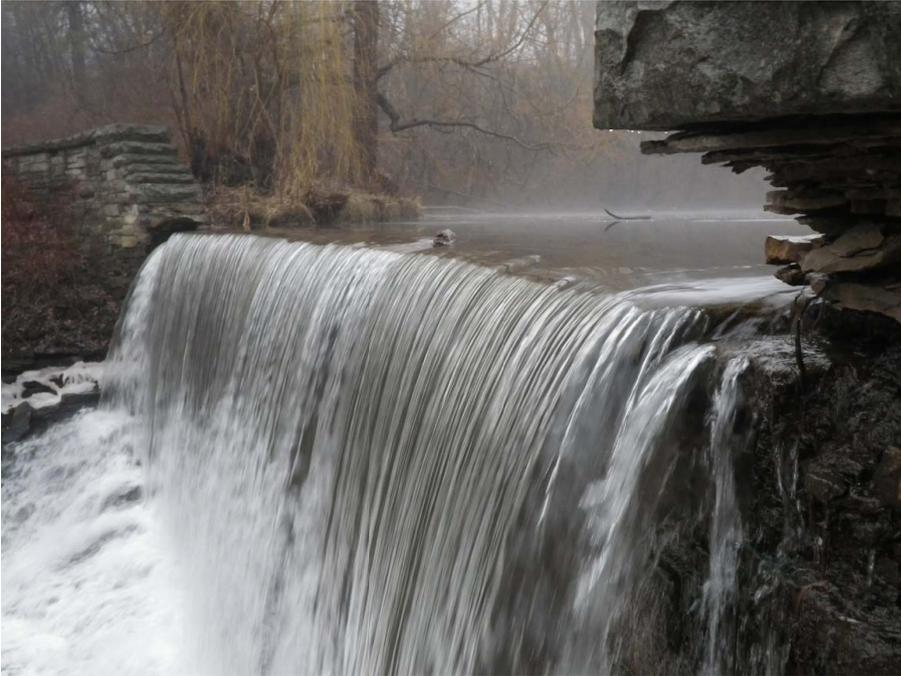
Photo 17: Spillway as viewed from left abutment. Note missing stones at corners.

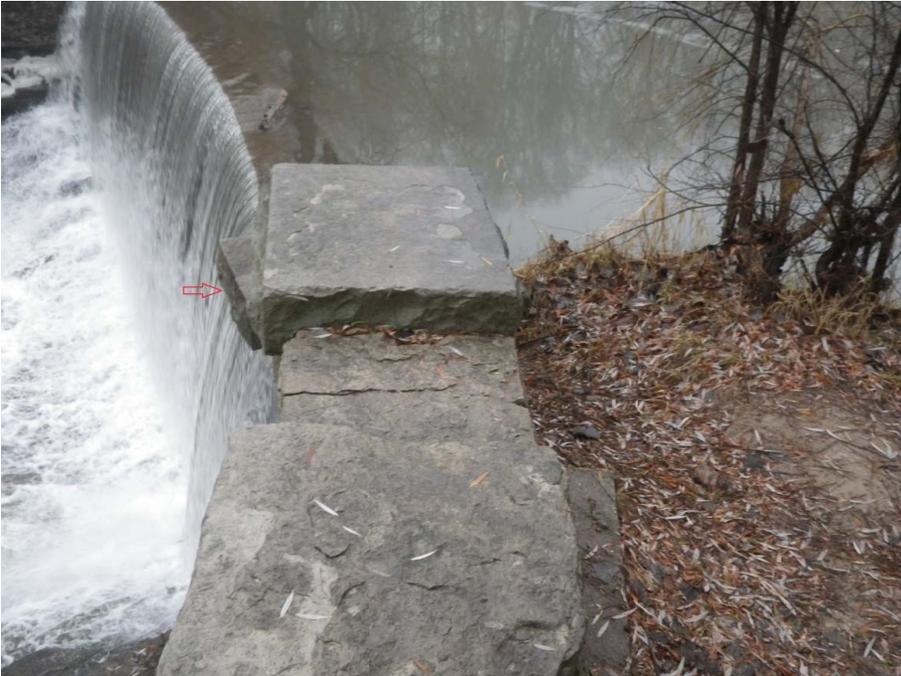
Photo 18: Top of left abutment. Note missing capstone and shifted stone (arrow).

| 1. Replace the two missing capstones and reset the shifted capstone on the left abutment. | September 1, 2019 |

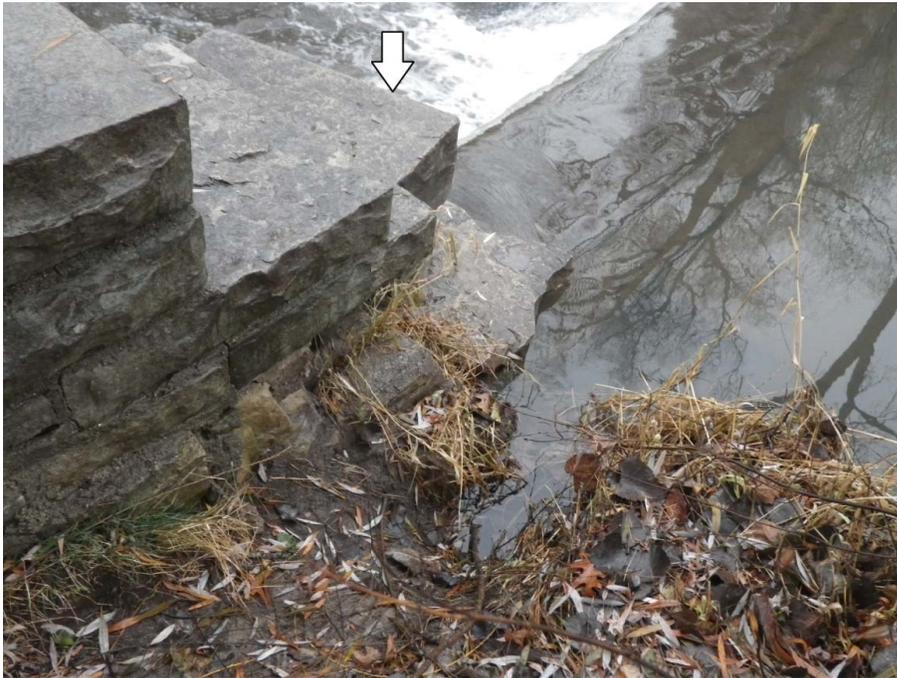
Photo 19: Left abutment at spillway, upstream side. Note shifted stone (arrow).

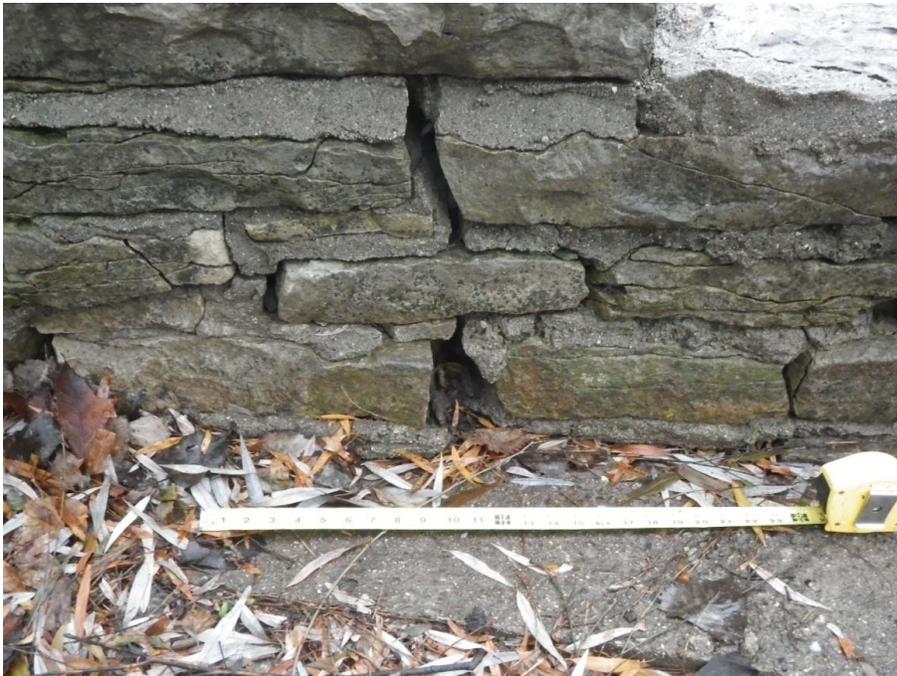
Photo 20: Left abutment, upstream side, showing cracking and shifting of joints near missing capstone. Note several cracked stones.

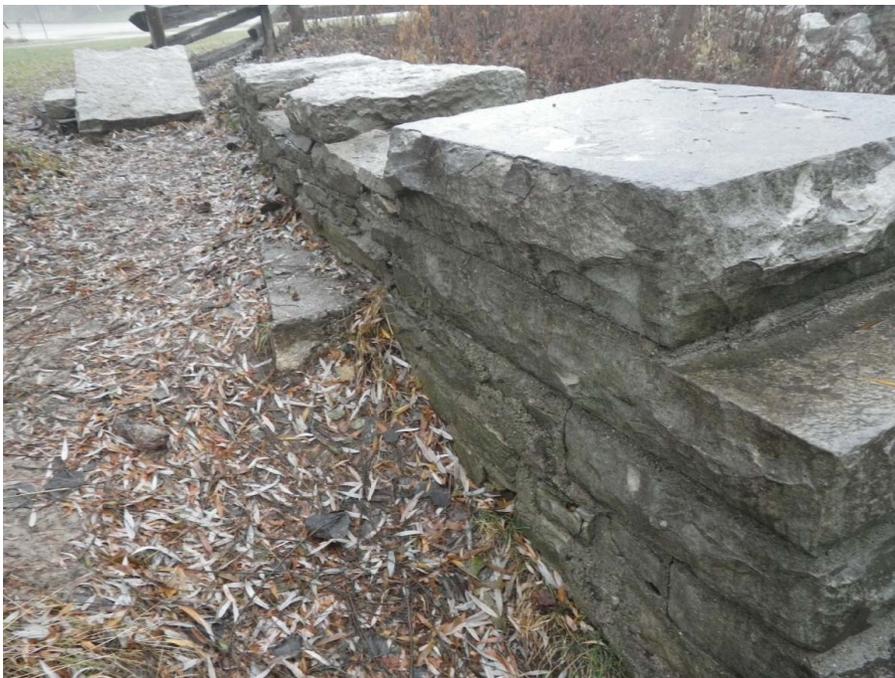
Photo 22: Left abutment upstream face. Note two missing capstones, stacked beyond.
