# Oak Creek Watershed Restoration Plan

## *Instream Survey Progress Update-Fall 2016*

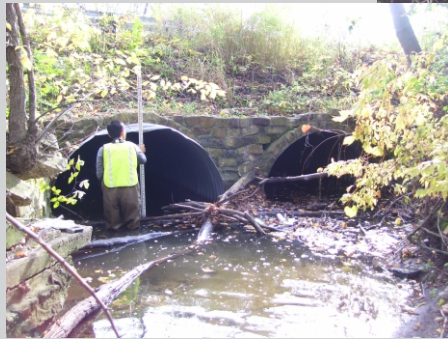
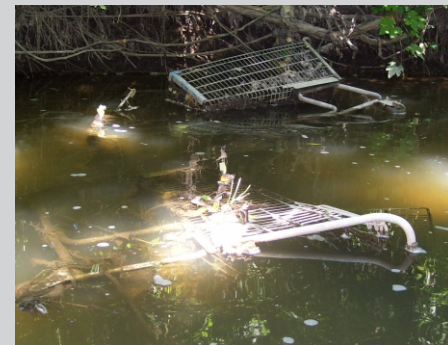
In total, 48 culverts and 34 bridges were assessed for general physical condition and for potential fish passage barriers. In addition, general conditions have been assessed for 75 stormwater outfalls that discharge directly to Oak Creek. The City of Racine Health Department has also been sampling effluent at selected stormwater outfalls within the Oak Creek watershed.

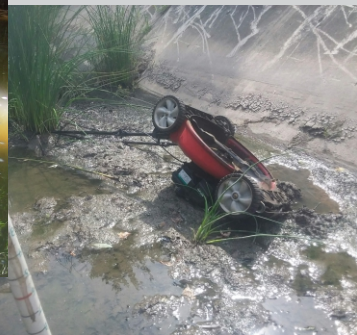
Locations of large trash items encountered during the stream survey were mapped and photographed. The location of these large trash items will be available to municipalities and other groups to assist in stream cleanup efforts.

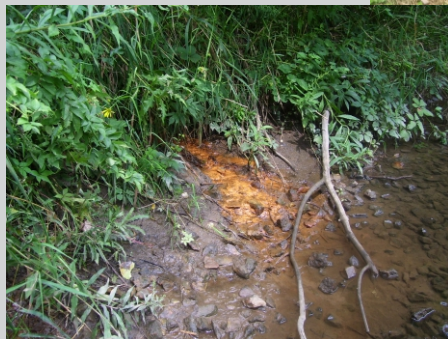
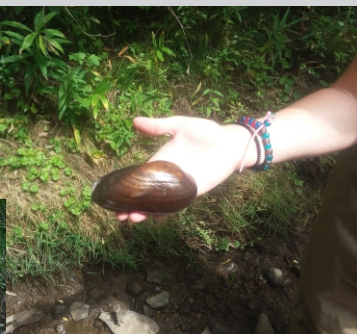
As the survey crew walks upstream, the location of notable features including springs and groundwater seepages, mussels, fish beds, alcove channels, tributaries, drain tiles, and trash in the stream are mapped and photographed. In the photo to the left, rust colored water indicates iron precipitation associated with groundwater seepage. The photo above shows a native freshwater mussel.

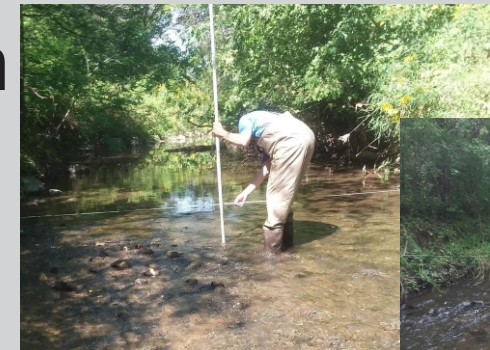
43 streambank erosion sites--ranging from moderate to severe erosion--were documented along the portion of the mainstem of Oak Creek that was surveyed in the summer and fall of 2016. At each site, measurements of length, maximum height, and average depth of eroding bank were collected. The sites were also mapped. These measurements will allow SEWRPC staff to estimate the amount of total suspended sediment and phosphorous that is entering the Creek from bank erosion.

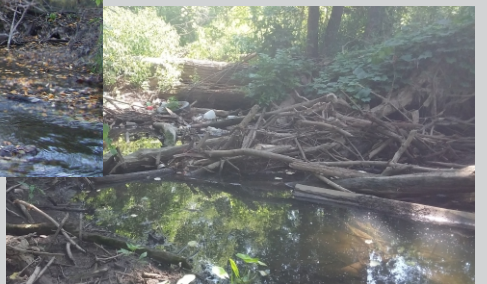
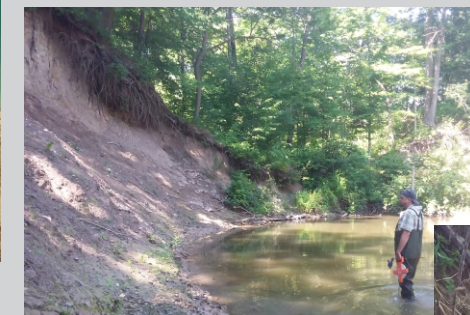
The presence and quantity of large woody debris (LWD) was recorded in both cross-section surveys and at large accumulations. LWD plays a vital role in the hydraulic, geomorphic, and biological function of streams. In general, LWD in a stream is good as it provides essential food and habitat for aquatic organisms. In some cases, however, LWD can form massive jams that span the entire width of the stream or block a culvert, altering the path of the stream or leading to flooding concerns and fish passage obstructions.
