# TRAFFIC CONTROL STUDY FOR THE VILLAGE OF FOX POINT

## MILWAUKEE COUNTY WISCONSIN

**MEMORANDUM REPORT  
NUMBER 114**

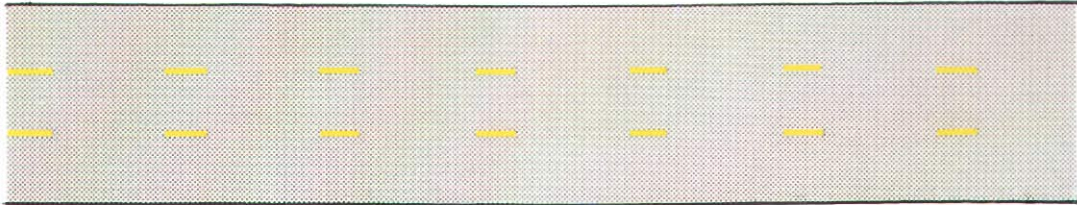
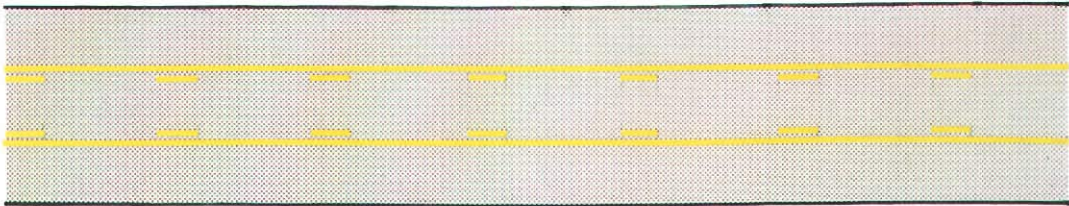
THE EXISTING LONGITUDINAL PAVEMENT MARKING SCHEMES  
ON N. LAKE DRIVE IN THE VILLAGE OF FOX POINT: 1993

As noted in the inventory, N. Lake Drive (STH 32) through the Village has three lanes delineated by pavement markings. Two different pavement marking schemes are utilized to delineate the lanes as shown in Figure 1. Alternative pavement marking scheme 1 shown in Figure 1 is utilized to delineate the three lanes on N. Lake Drive from the south corporate limit to approximately N. Holly Court; from a point about 400 feet north of E. Green Tree Road to E. Juniper Lane; from approximately E. Beach Drive to approximately E. Hyde Way; and from E. Fox Lane to the north corporate limit. Alternative pavement marking scheme 2 shown in Figure 1 is utilized to delineate the three lanes in the intervening segments of N. Lake Drive from approximately N. Holly Court to a point about 400 feet north of E. Green Tree Road; from E. Juniper Lane to approximately E. Beach Drive; and from a point between E. Hyde Way and N. Links Circle on the south to a point between E. Goodrich Lane and E. Fox Lane.

Each of the pavement marking schemes conveys different information to motorists utilizing the roadway. The broken yellow longitudinal pavement marking lines shown by alternative pavement marking scheme 1 in Figure 1 delineate the left edge of a lane where travel on the other side of the line is in the opposite direction. Motorists may cross a broken yellow line to overtake and pass a vehicle traveling the same direction.

A double longitudinal line consisting of a normal, broken yellow line and a normal, solid yellow line as shown by alternative pavement marking scheme 2 in Figure 1 delineates a separation between travel paths in opposite directions where overtaking and passing is permitted with care for traffic adjacent to the broken line and is prohibited for traffic adjacent to the solid line. This is a one direction, no-passing marking and is used on two-way, two- and three-lane roadways to regulate passing. It is also used to delineate the edges of a lane in which travel in either direction is permitted (but only as part of a left-turn maneuver). In the latter application, the markings are to be placed with the solid lines on the outside and the dashed lines to the inside of the lane as shown by alternative pavement marking scheme 2 in Figure 1. Traffic adjacent to

It should be noted that, while not required, pavement marking arrows, as shown in Figure 6, are recommended in the Manual on Uniform Traffic Control Devices to supplement the longitudinal pavement marking pattern and regulatory signing required for operation of the center lane as a two-way left-turn lane. Because the requisite regulatory signing is not provided, it may be concluded that all travel, including left turns, should be excluded from the center lane on those segments of N. Lake Drive where alternative pavement marking scheme 2 exists.

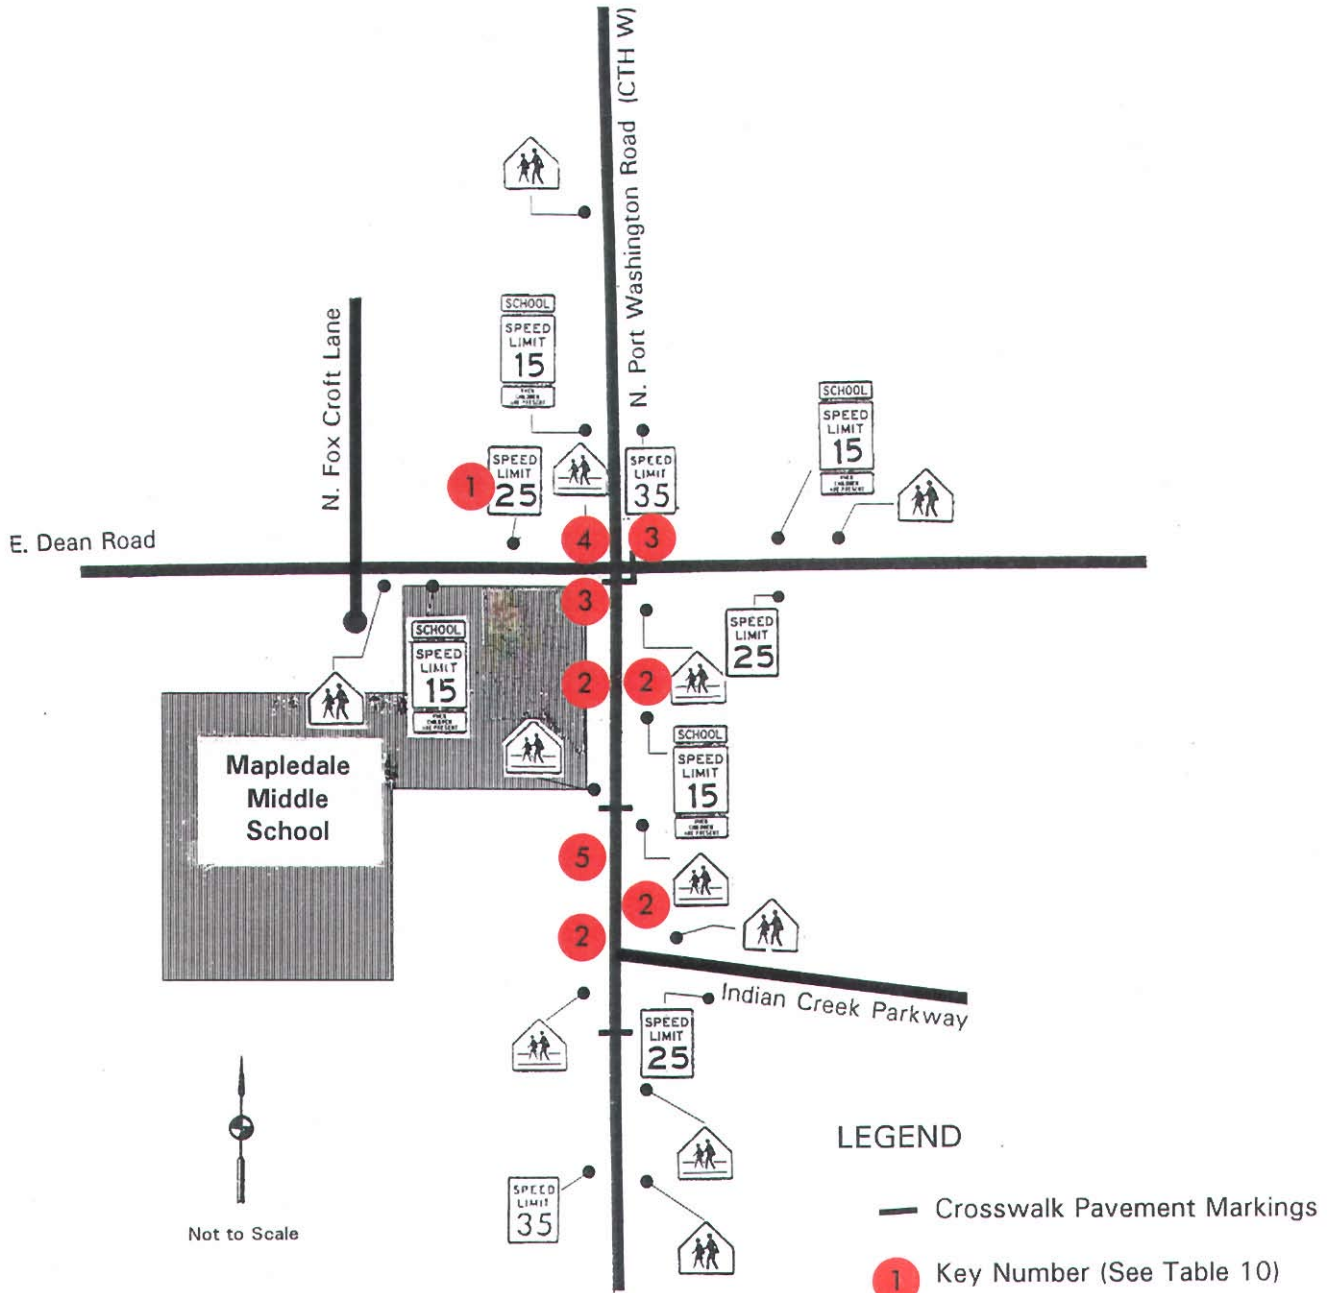
Figure 8

EXISTING AND RECOMMENDED SCHOOL ZONE TRAFFIC CONTROL ON  
ROADWAYS ADJACENT TO MAPLEDALE MIDDLE SCHOOL

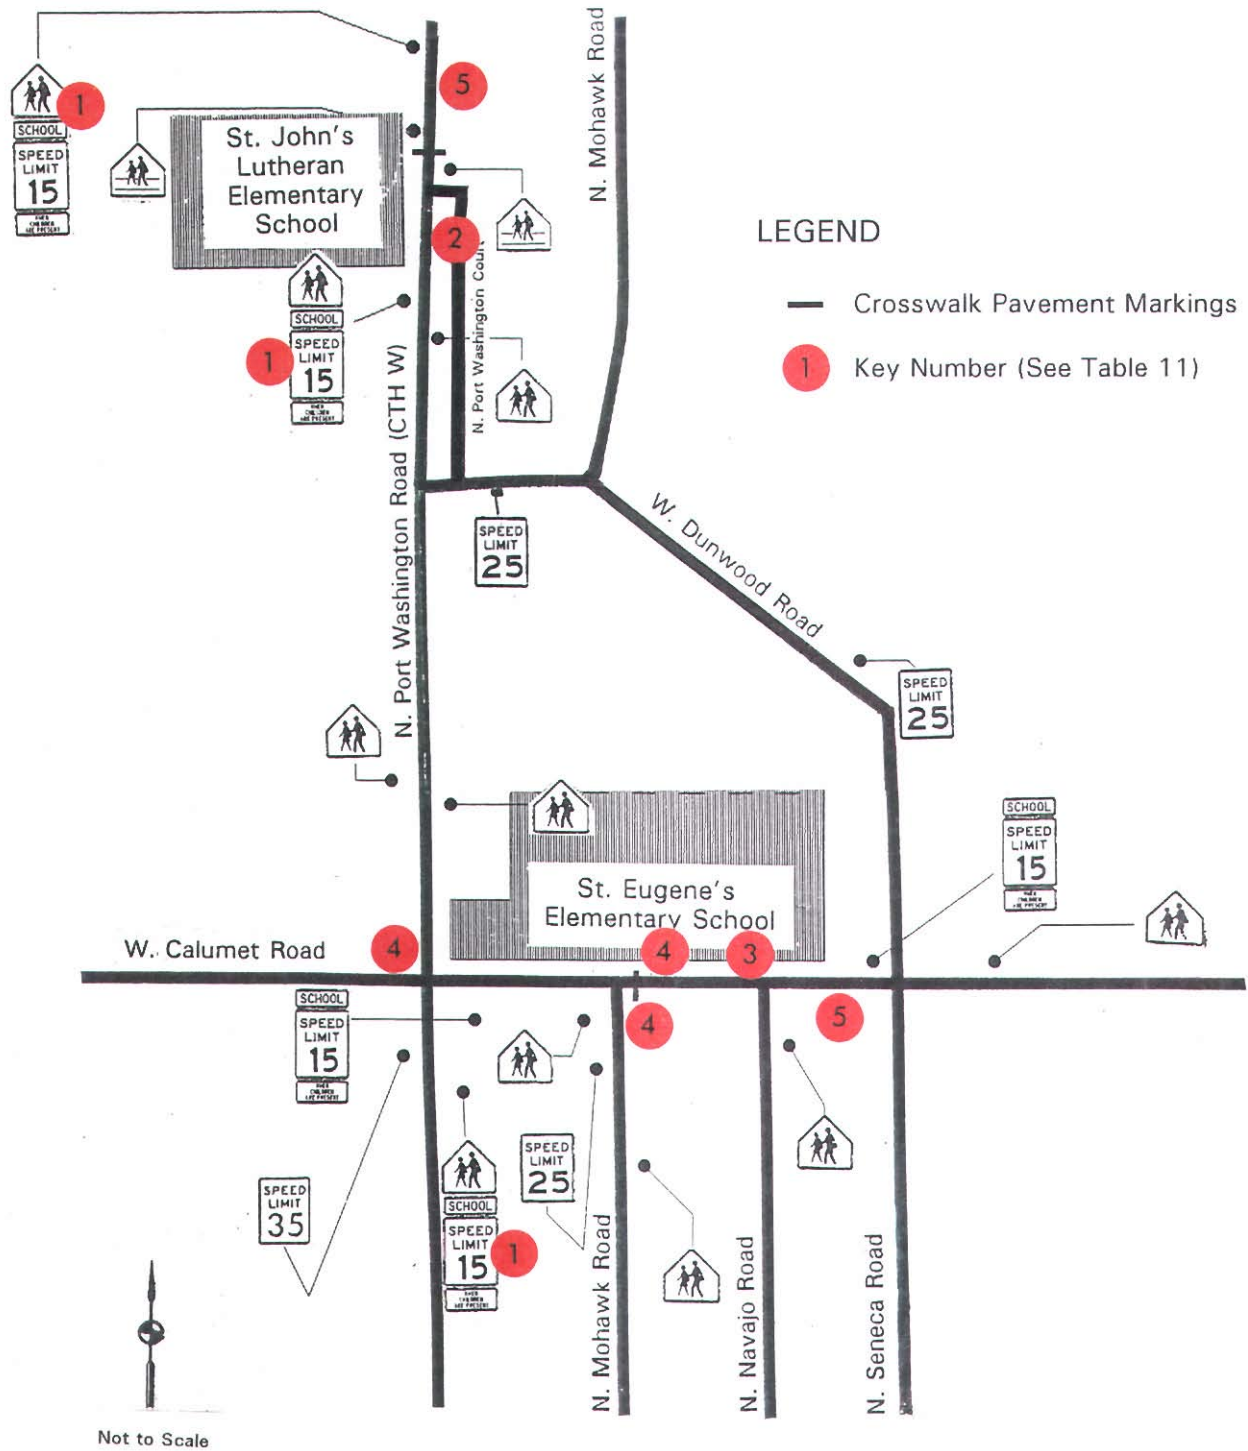
Figure 9

EXISTING AND RECOMMENDED SCHOOL ZONE TRAFFIC CONTROL ON  
ROADWAYS ADJACENT TO ST. EUGENE'S ELEMENTARY SCHOOL,  
AND ST. JOHN'S ELEMENTARY SCHOOL

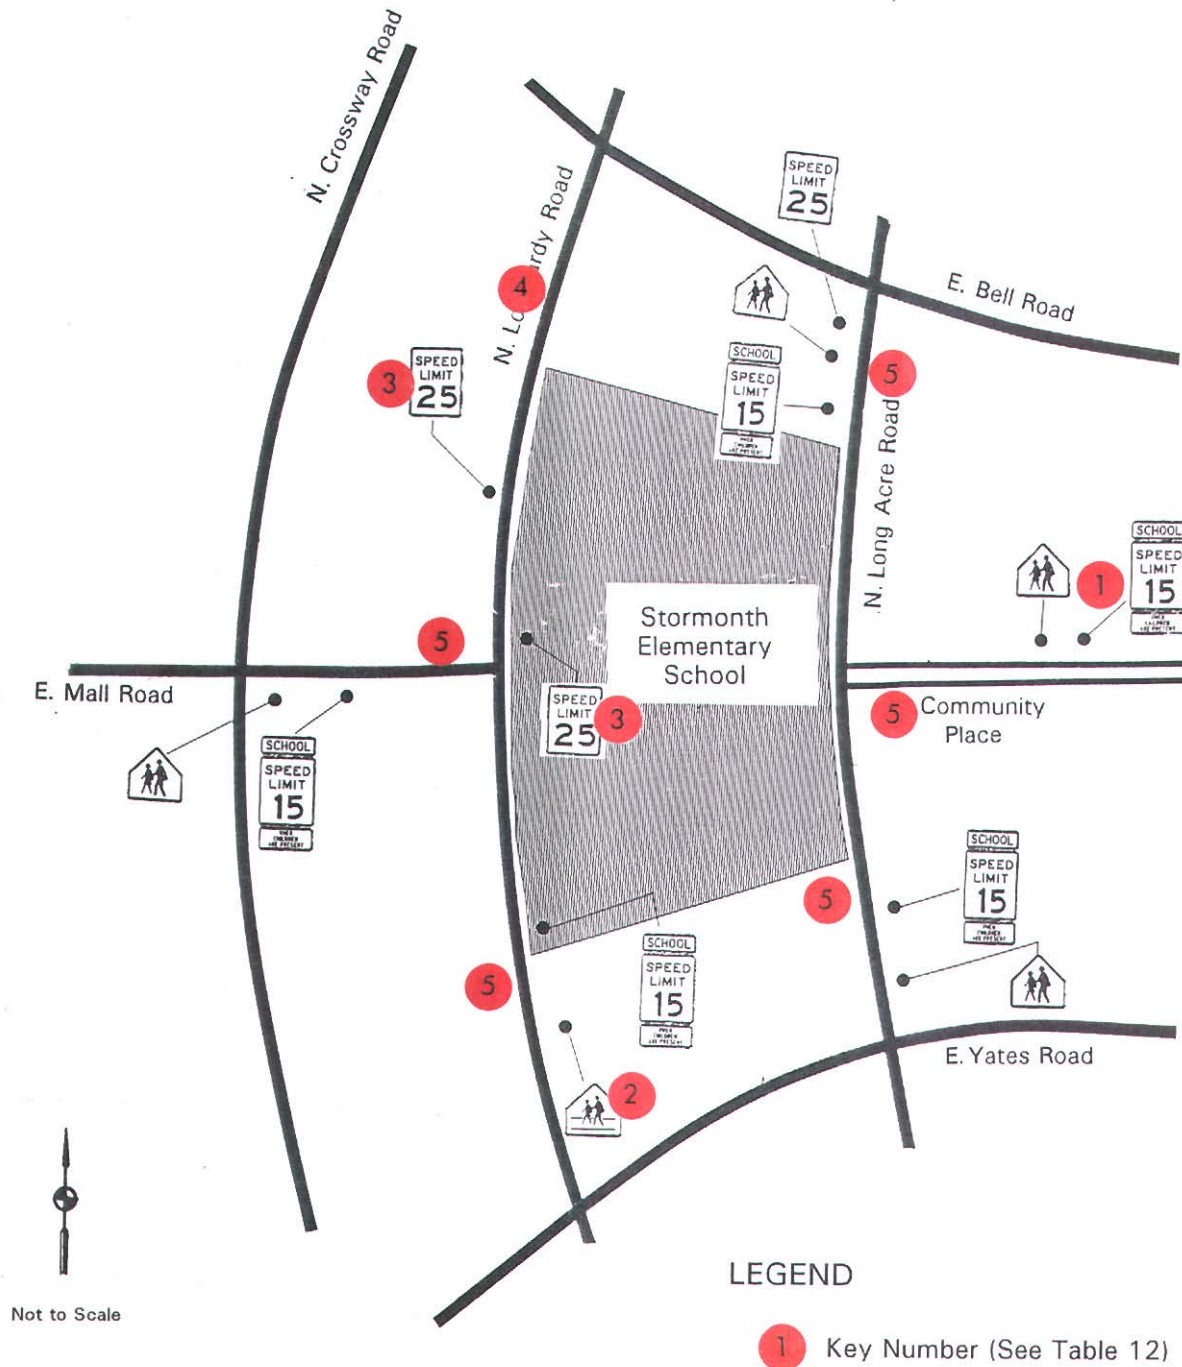
Figure 10

EXISTING AND RECOMMENDED SCHOOL ZONE TRAFFIC CONTROL ON  
ROADWAYS ADJACENT TO STORMONTH ELEMENTARY SCHOOL

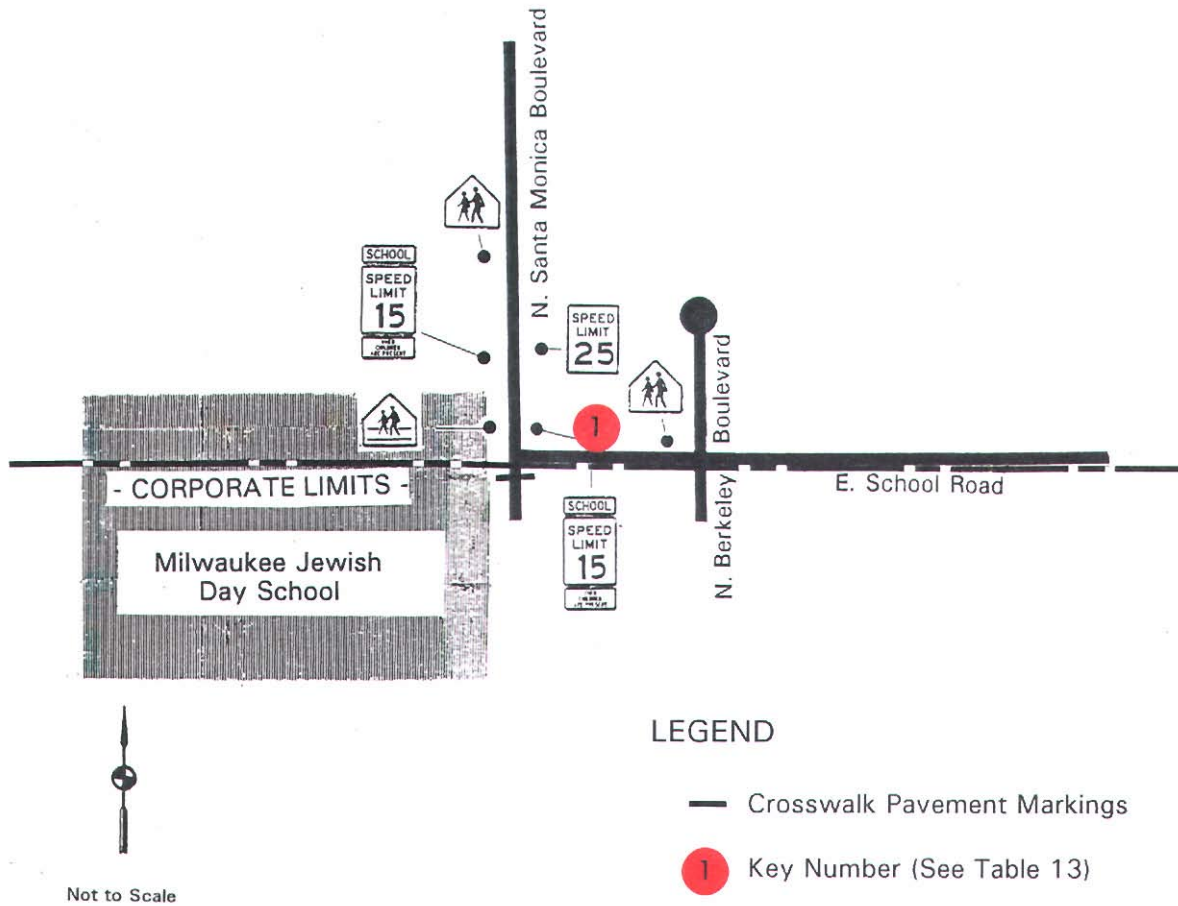
Figure 11

**EXISTING AND RECOMMENDED SCHOOL ZONE TRAFFIC CONTROL ON  
ROADWAYS ADJACENT TO MILWAUKEE JEWISH DAY SCHOOL**

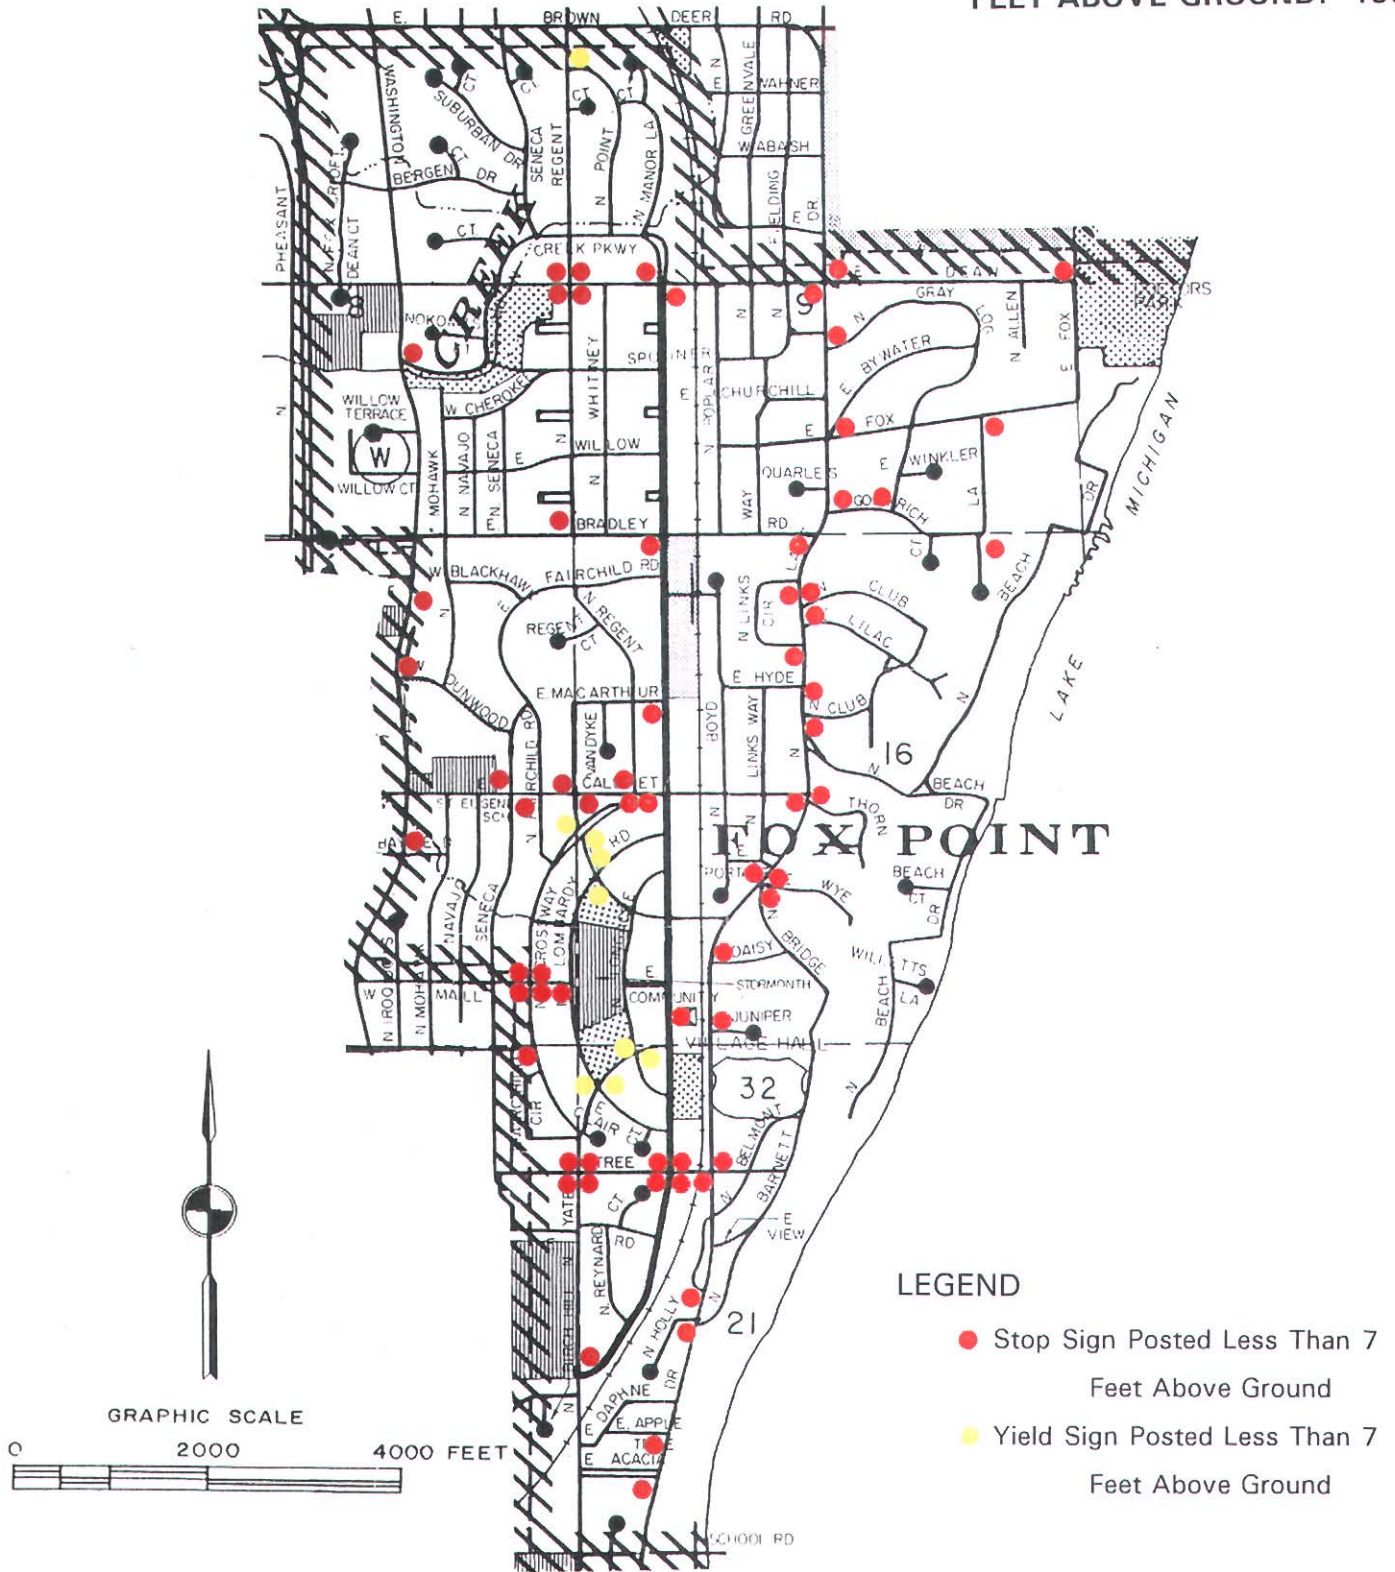
**STOP AND YIELD SIGNS  
POSTED LESS THAN SEVEN  
FEET ABOVE GROUND: 1993**

The alternative action considered to abate the problem of traffic control signs posted with substandard ground clearance was to raise these signs to meet the minimum seven foot height requirement. One advantage of posting signs at the required height is to substantially reduce the potential for a sign to be obstructed from a motorist's view thereby improving traffic safety. Another advantage is conformity with the sign height set forth in the Manual on Uniform Traffic Control Devices. A disadvantage of increasing the ground clearance to seven feet would not be effective if the sight obstruction is created by a truck making deliveries or collecting trash for example. Nevertheless, it is recommended that signs currently posted with substandard ground clearance be raised to seven feet at an estimated cost to the Village of \$4,500.
