SEWRPC Staff Memorandum

WATER QUALITY SAMPLE EVALUATION FOR SILVER LAKE, WAUKESHA COUNTY

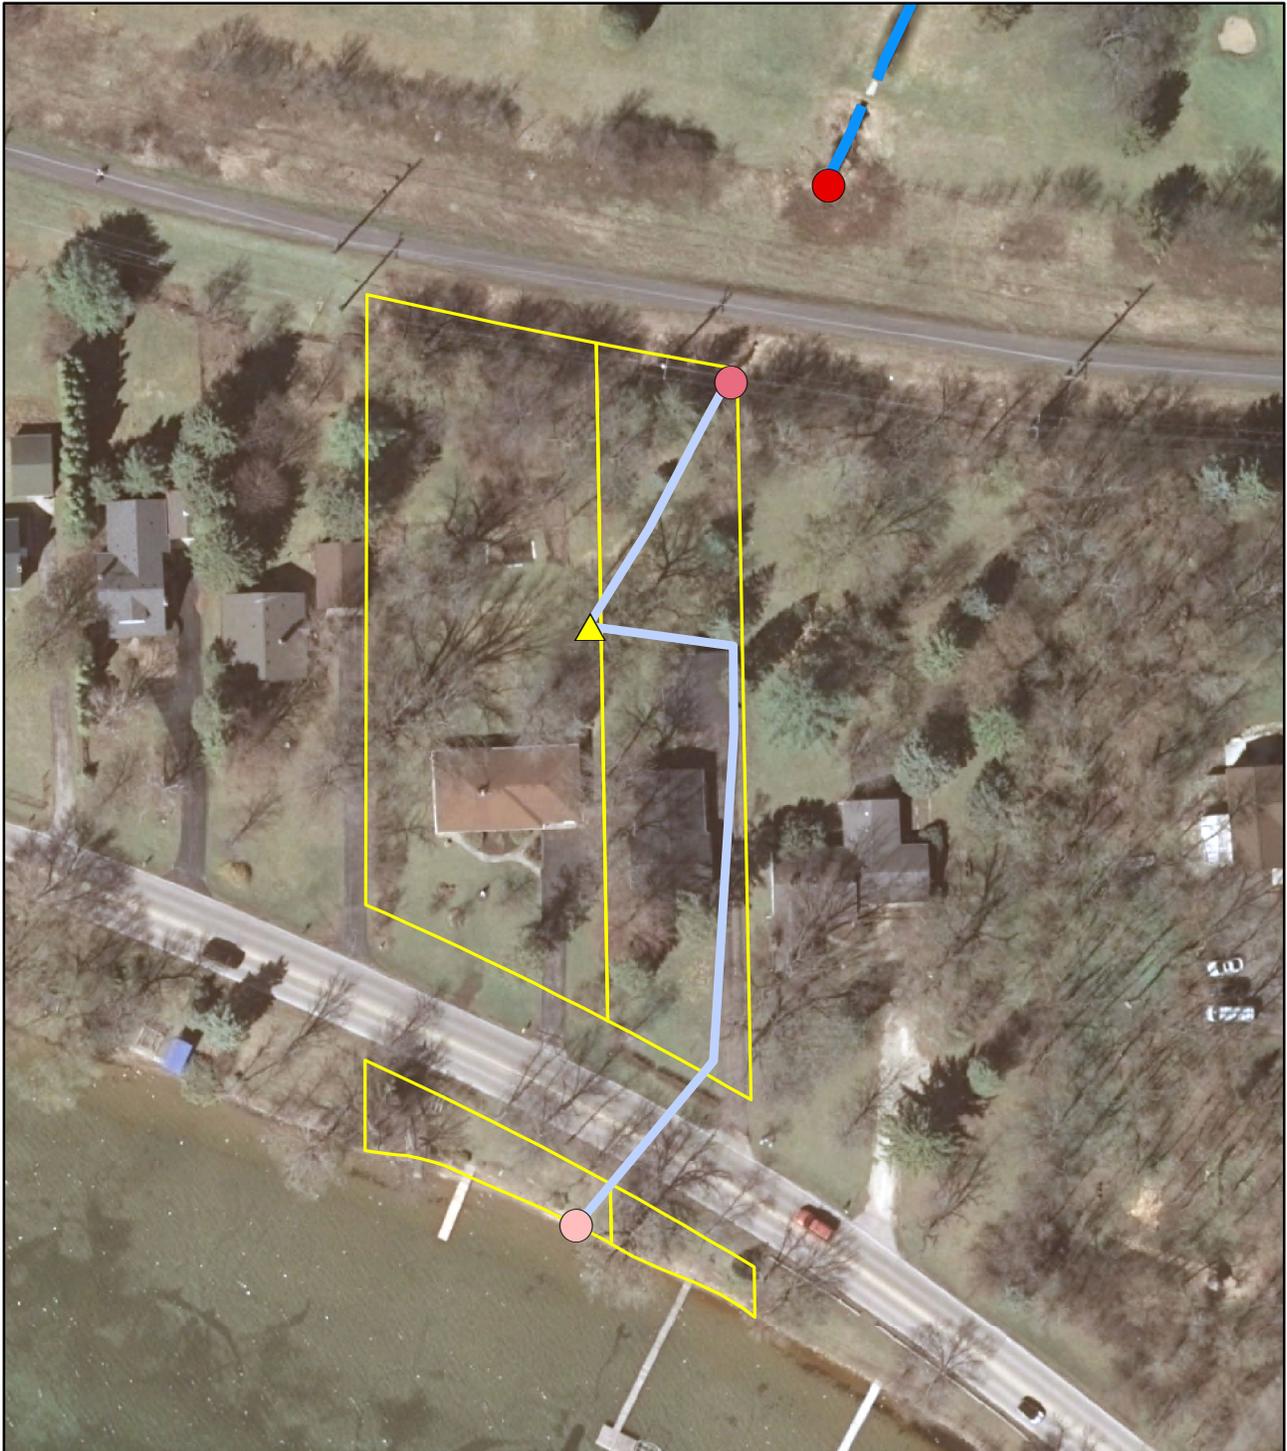
LOCATION OF DRAINAGE PIPES COMING FROM THE PAGANICIA GOLF COURSE

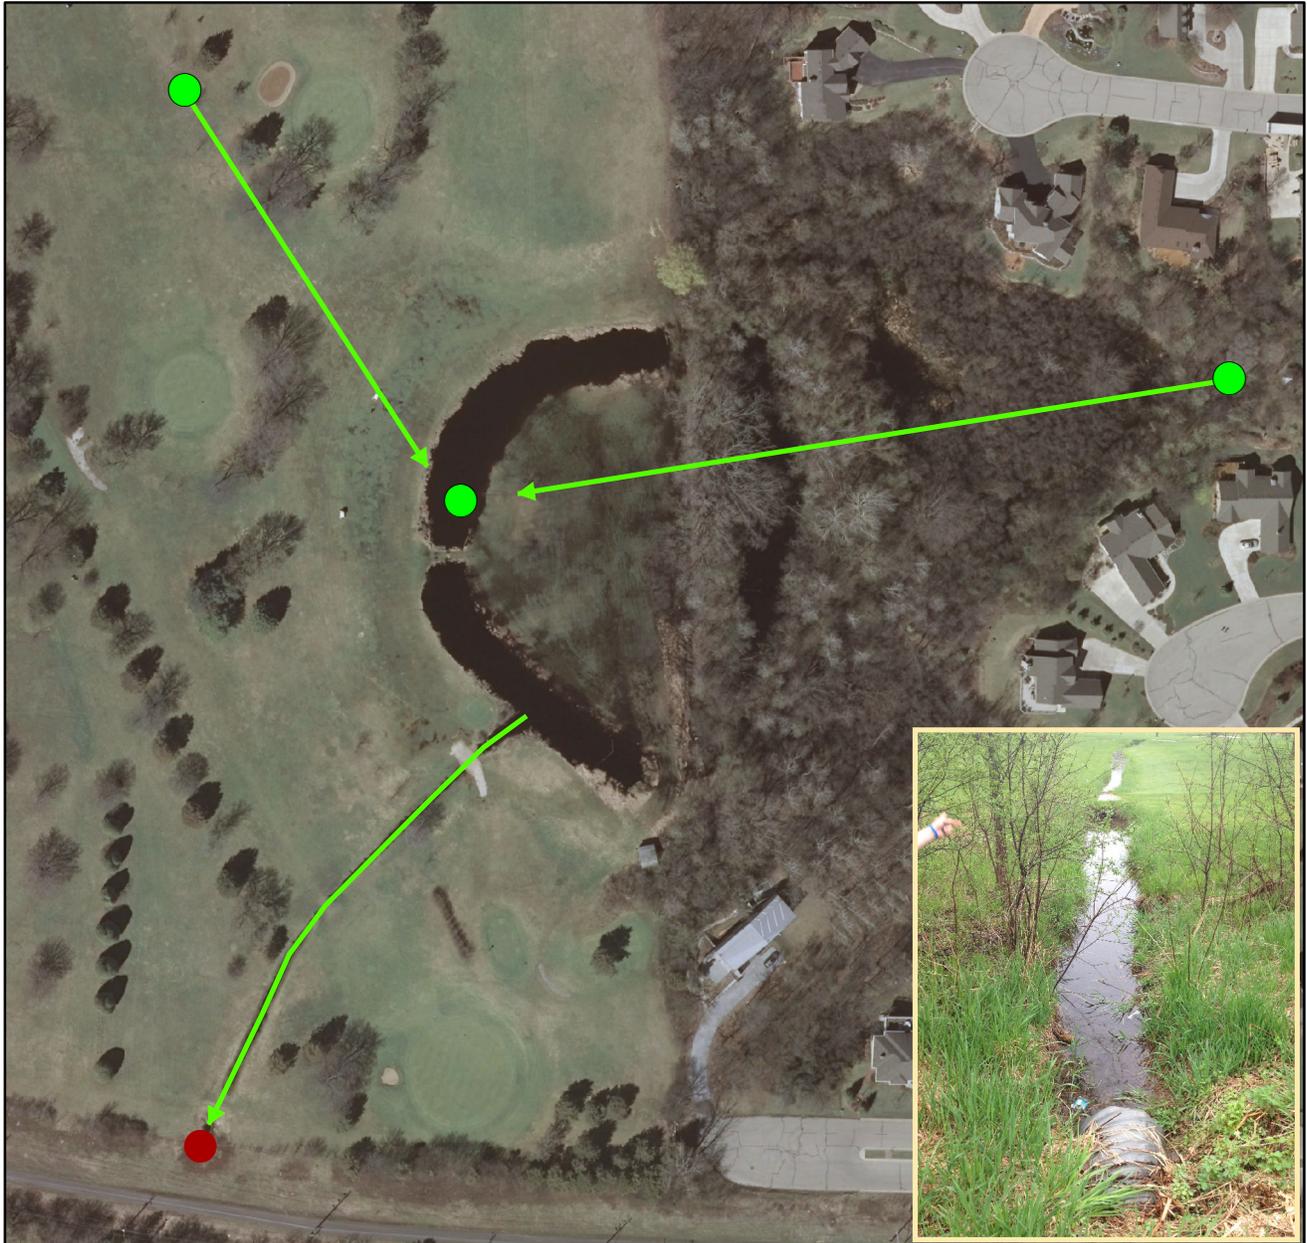
Map A-1

DRAINAGE FOR PAGANICA GOLF COURSE

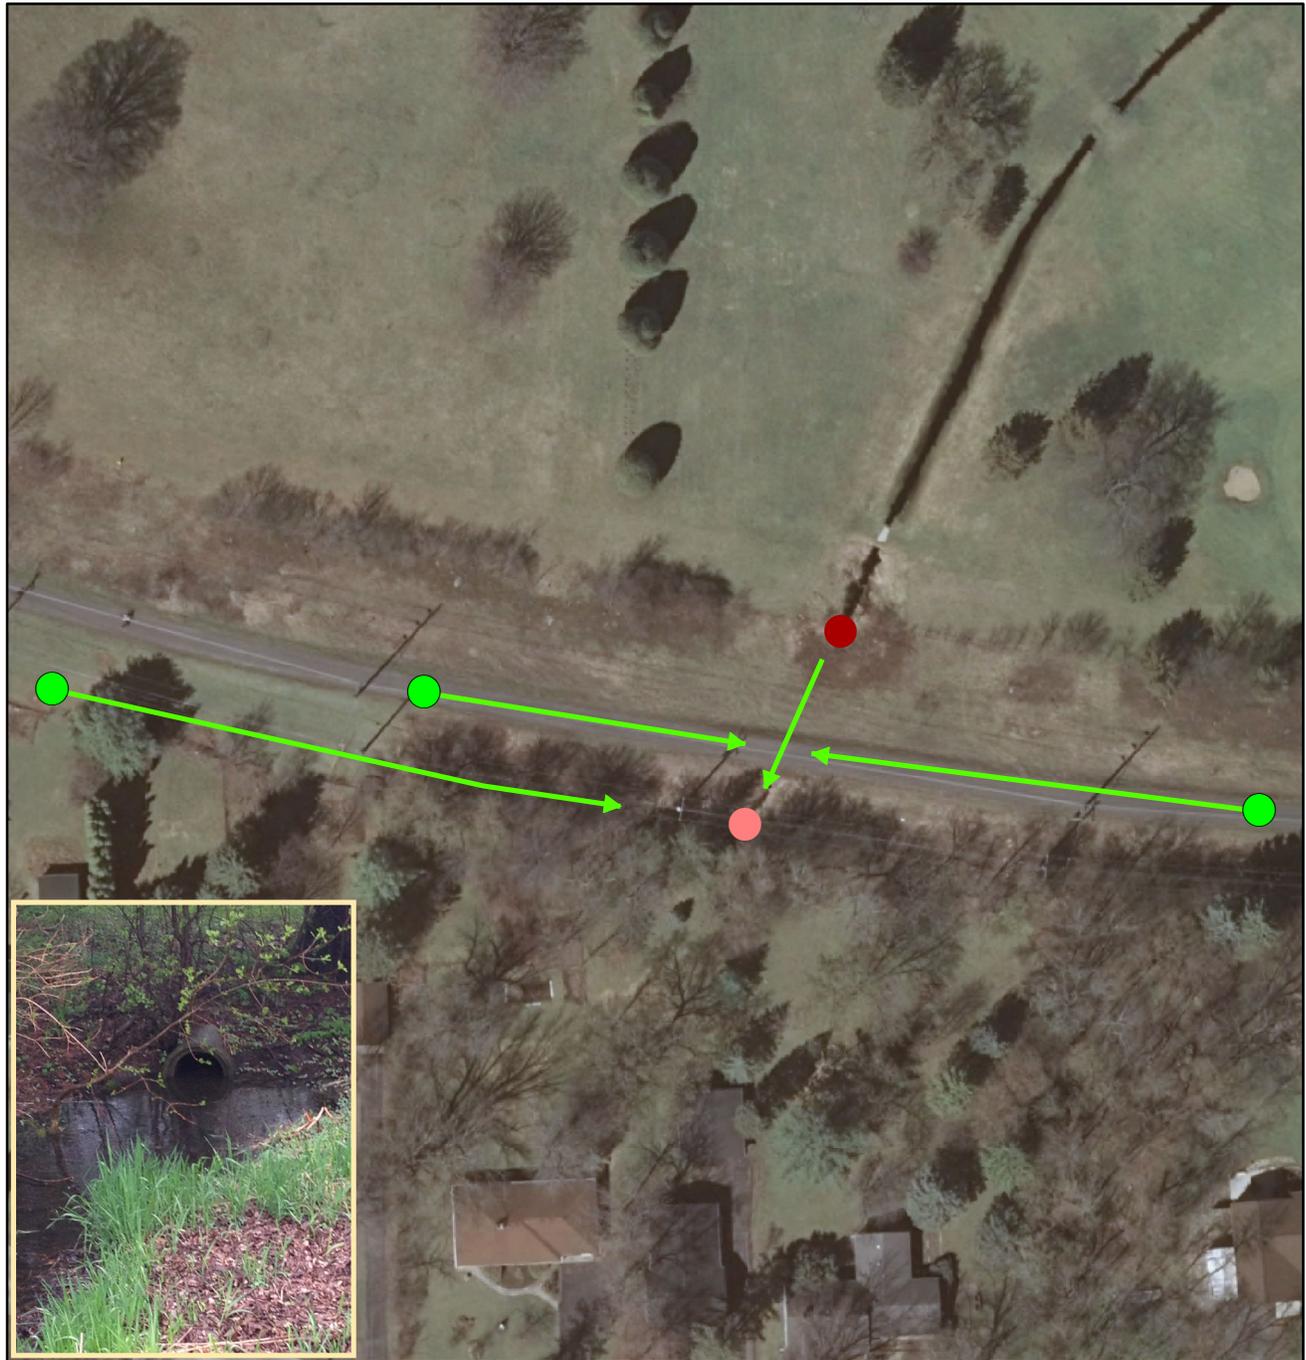
DRAINAGE FOR PAGANICA AFTER TRAIL

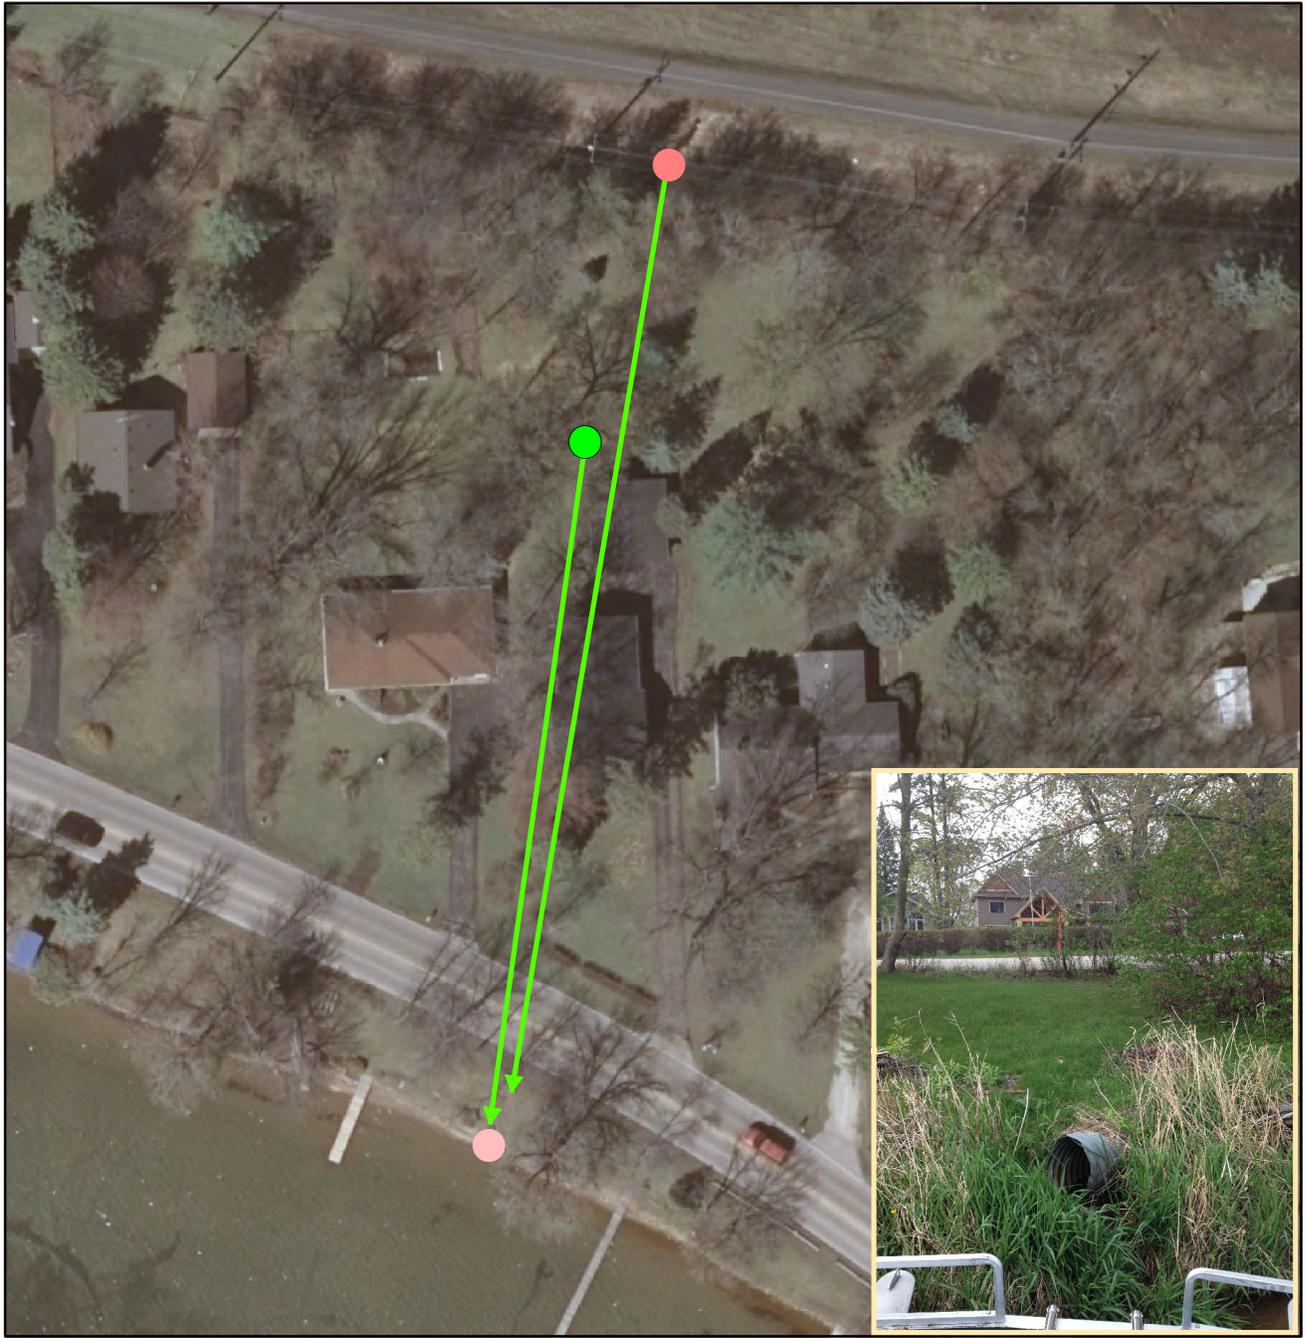
DRAINAGE FOR PAGANICA LAKE OUTLET

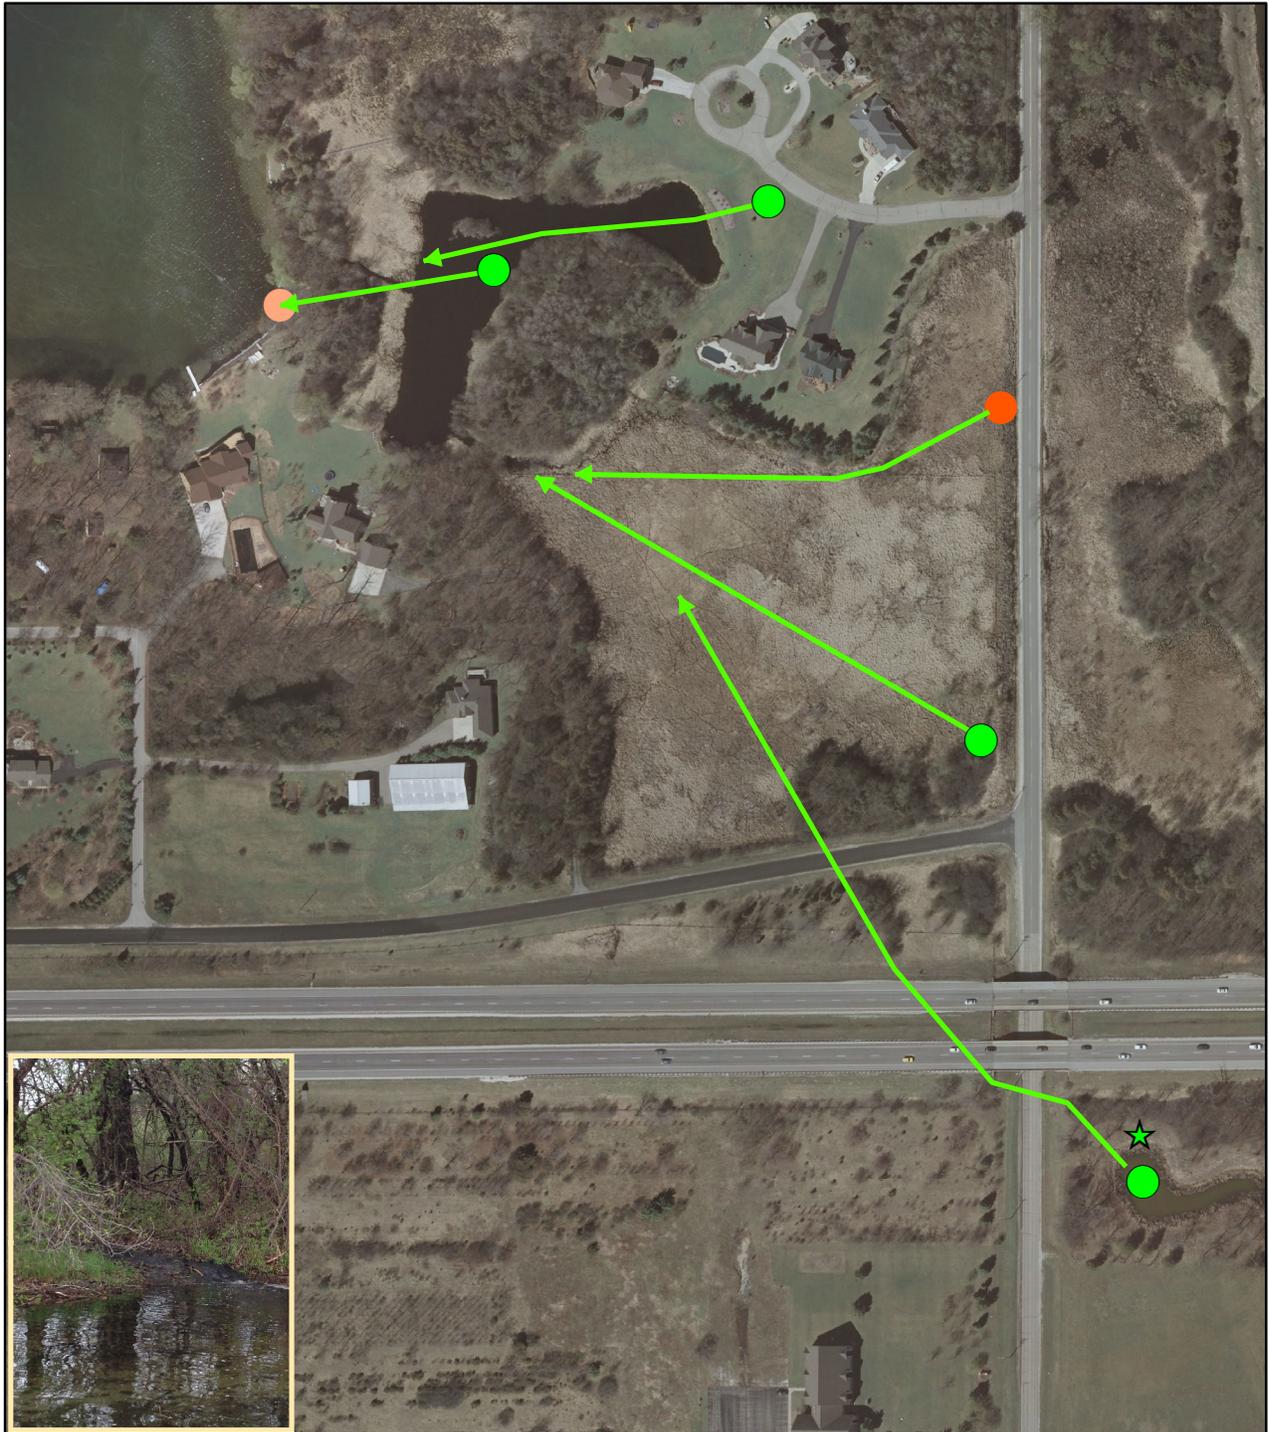
DRAINAGE FOR SOUTH WETLAND LAKE OUTLET
