# Root River Watershed Restoration Plan: Report on Chapter IV (partial)

Southeastern Wisconsin Regional  
Planning Commission

Presentation to the Root River  
Restoration Planning Group

# Chapter IV—Characterization of the Root River Watershed

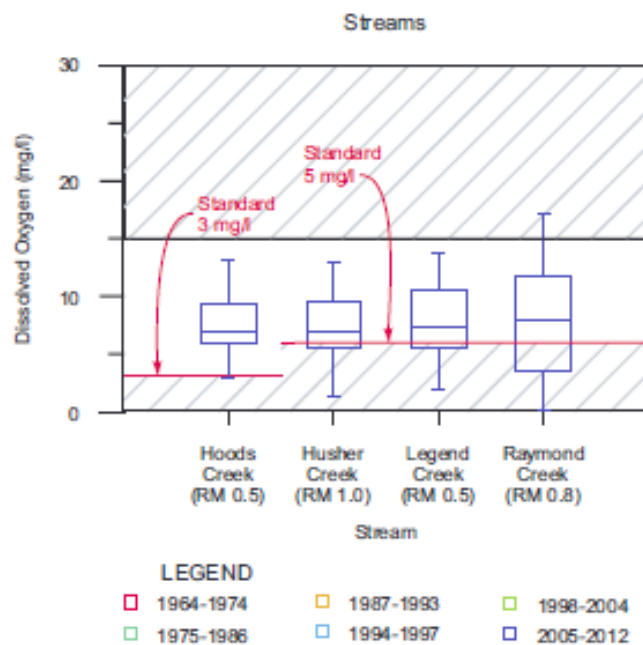
Figure IV-19

**DISSOLVED OXYGEN CONCENTRATIONS  
IN TRIBUTARY STREAMS IN THE  
ROOT RIVER WATERSHED: 2005-2012**

Saturation levels of dissolved oxygen of 140 percent and higher can cause fish kills. A 15 mg/l dissolved oxygen concentration translates to a saturation of approximately 150 percent at an average water temperature of 14 degrees Celsius.

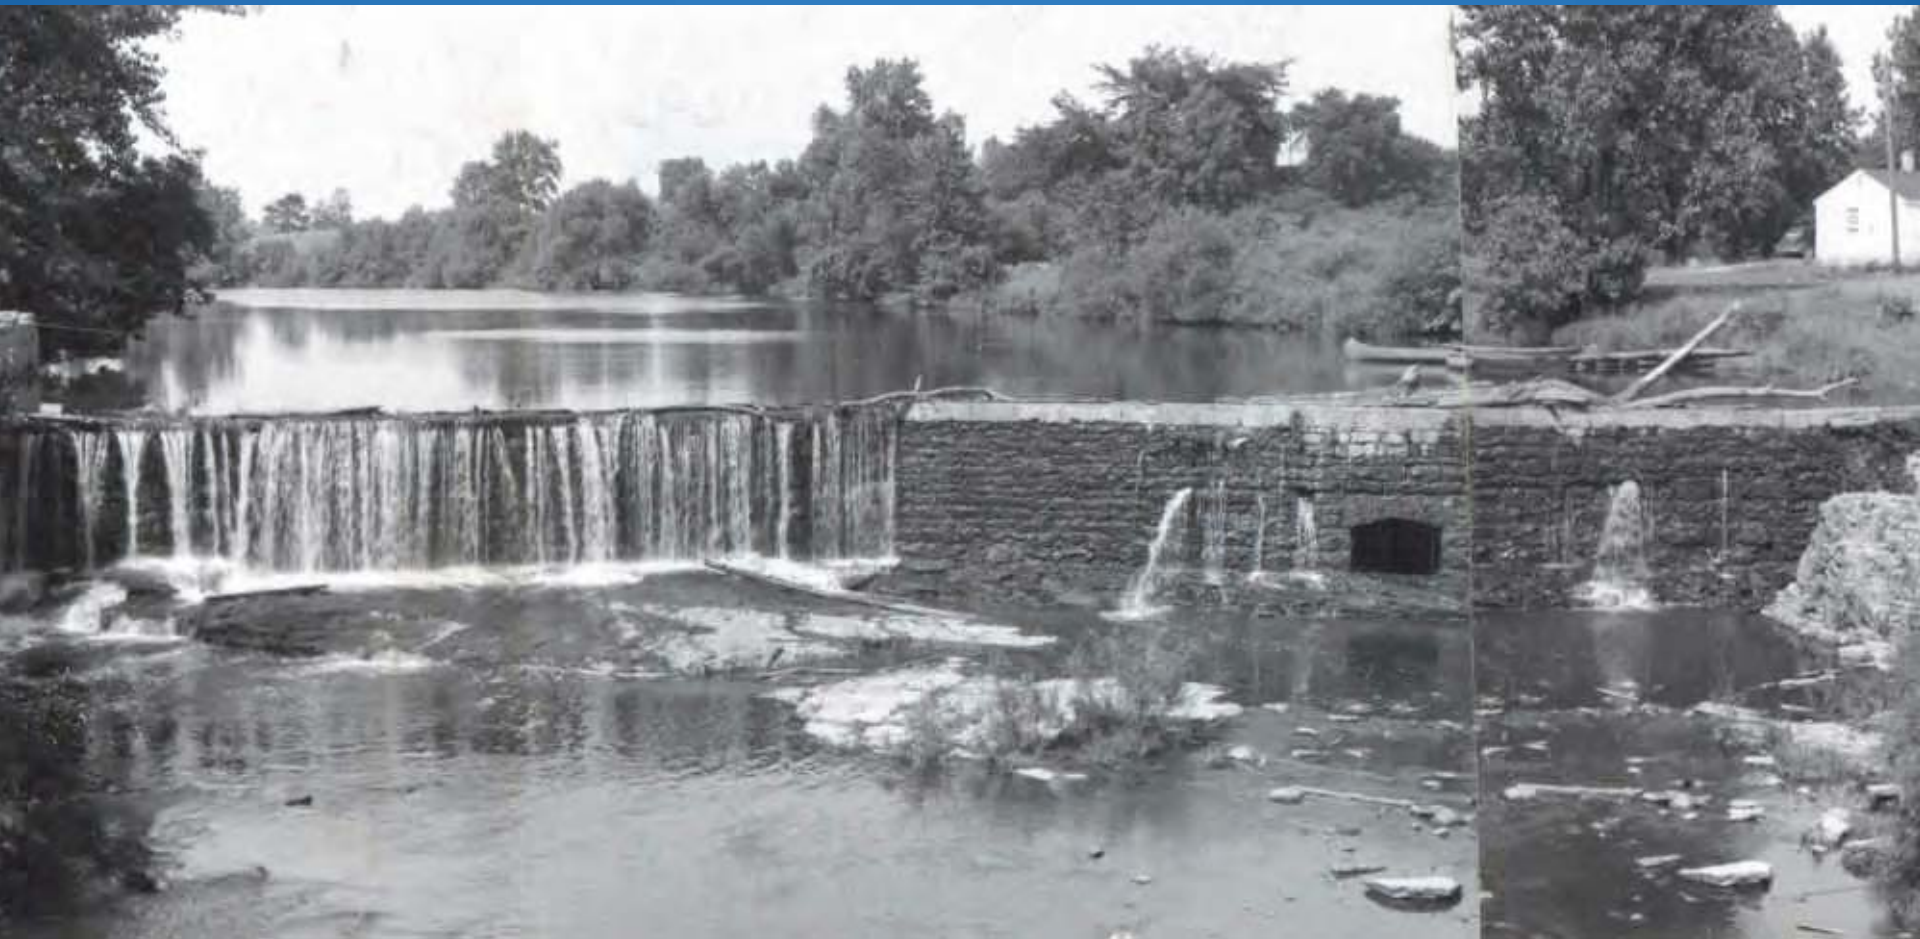
Horlick's Dam - Racine  
Fishway

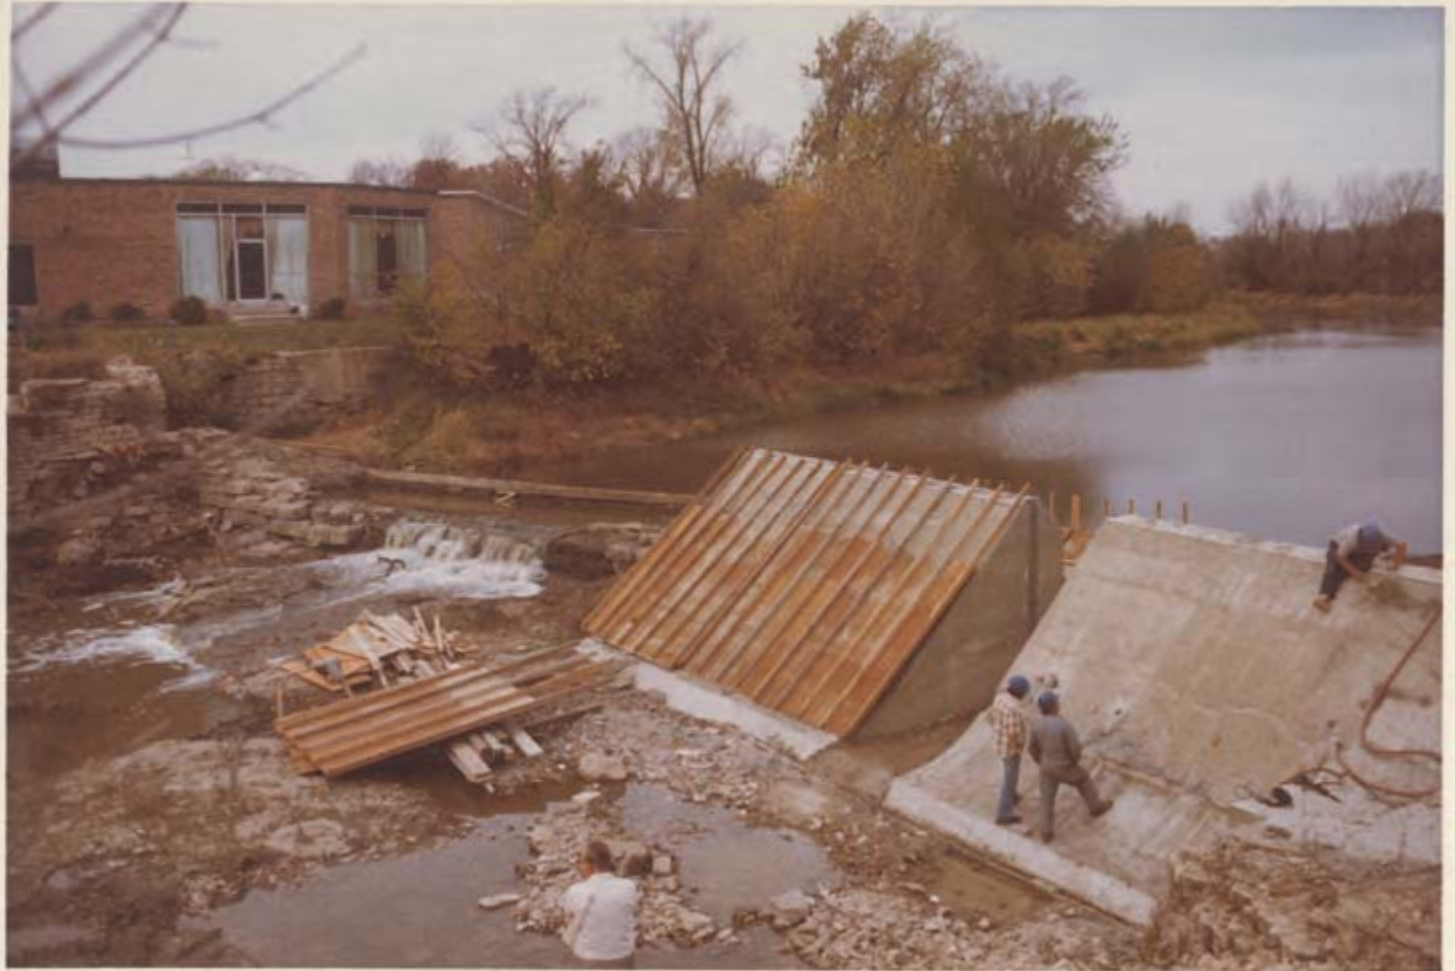
# 1975 Reconstruction

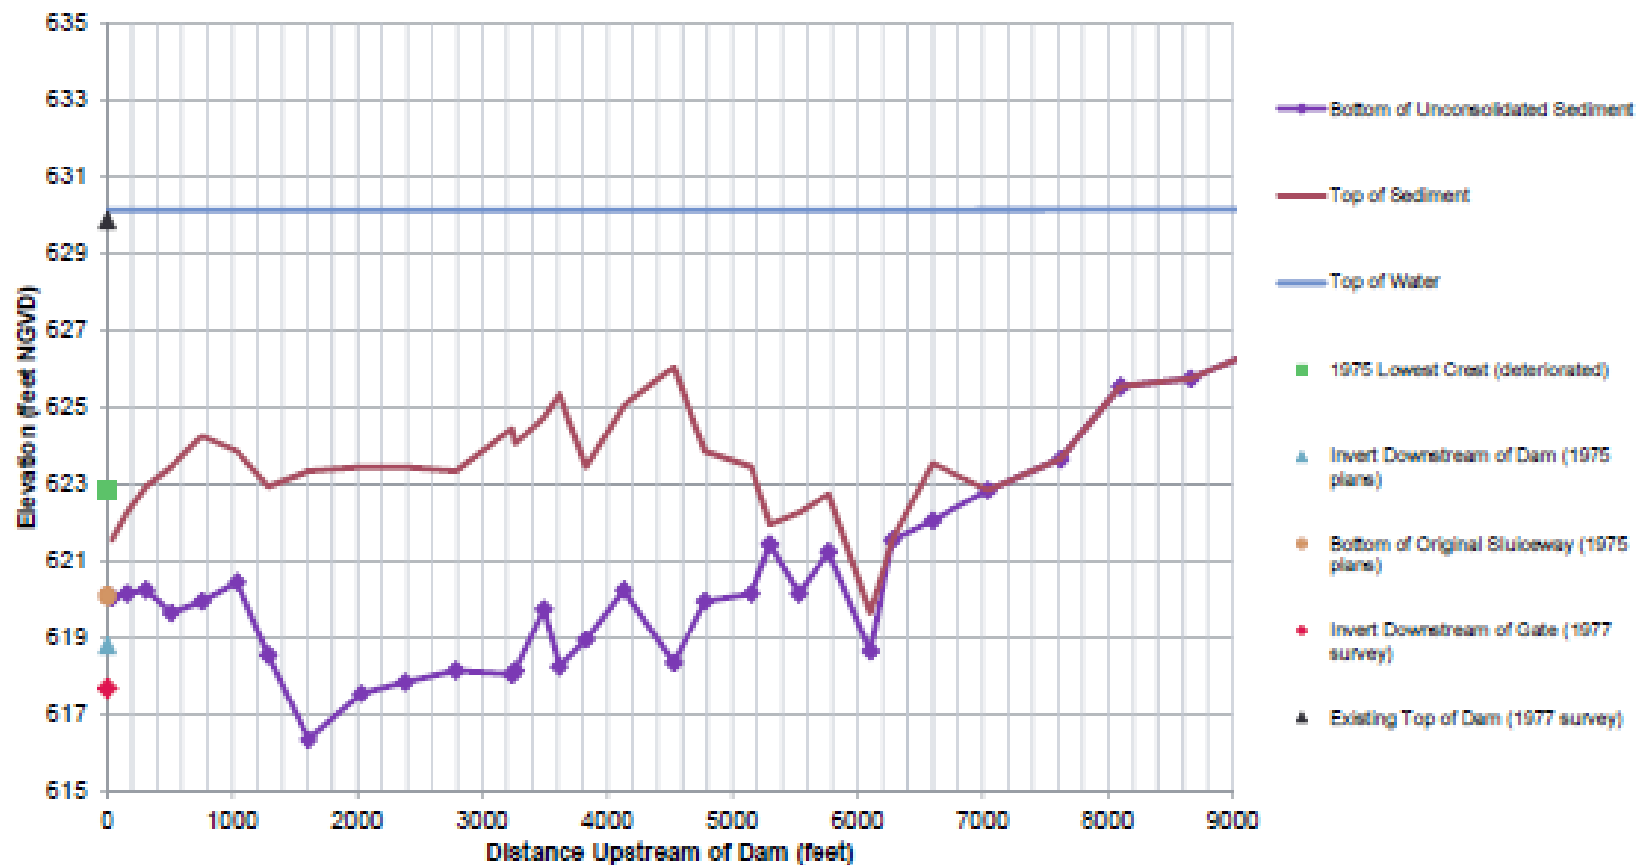
Figure IV-K

HORLICK IMPOUNDMENT PROFILE ON DECEMBER 1, 2011

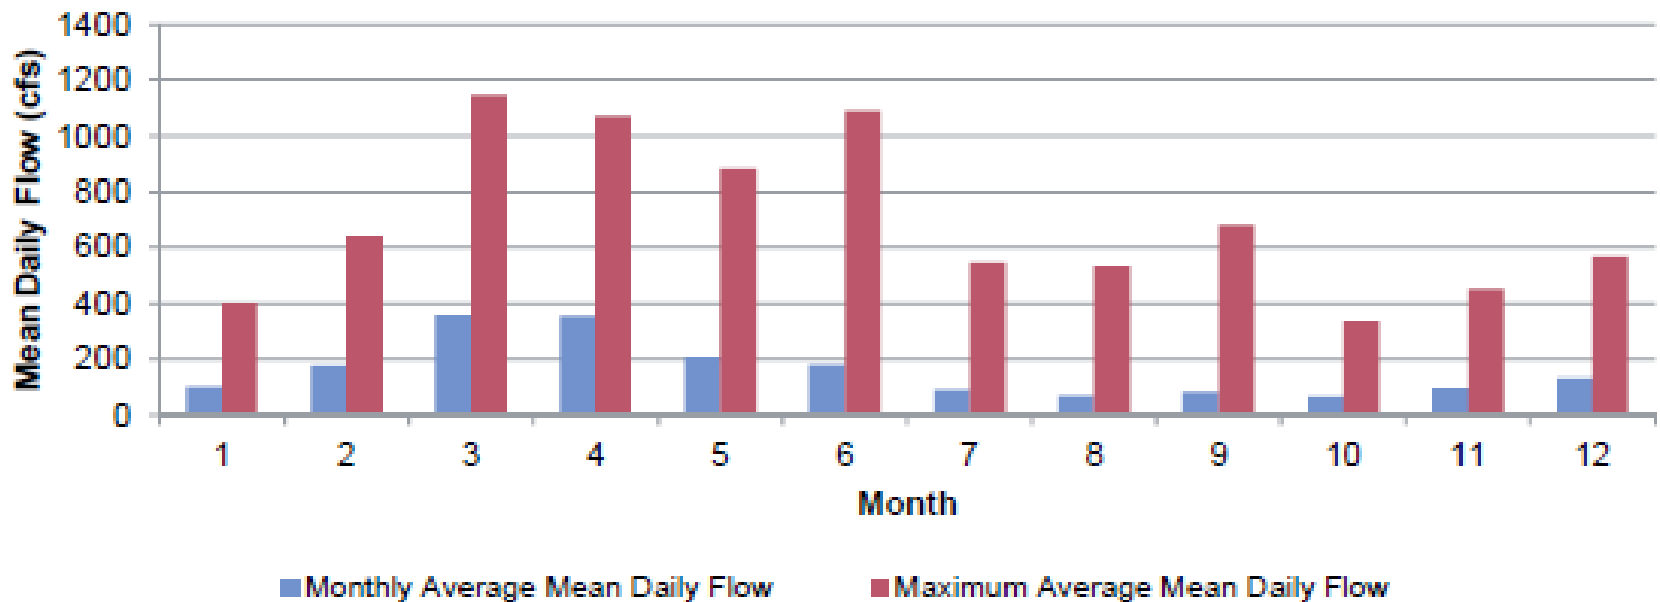
Figure IV-L

**MONTHLY AVERAGE AND MAXIMUM MEAN DAILY FLOW  
ROOT RIVER AT HORLICK DAM: WATER YEAR 1963 THROUGH 2011**
