Root River Ecological “Stream Health”

SEWRPC

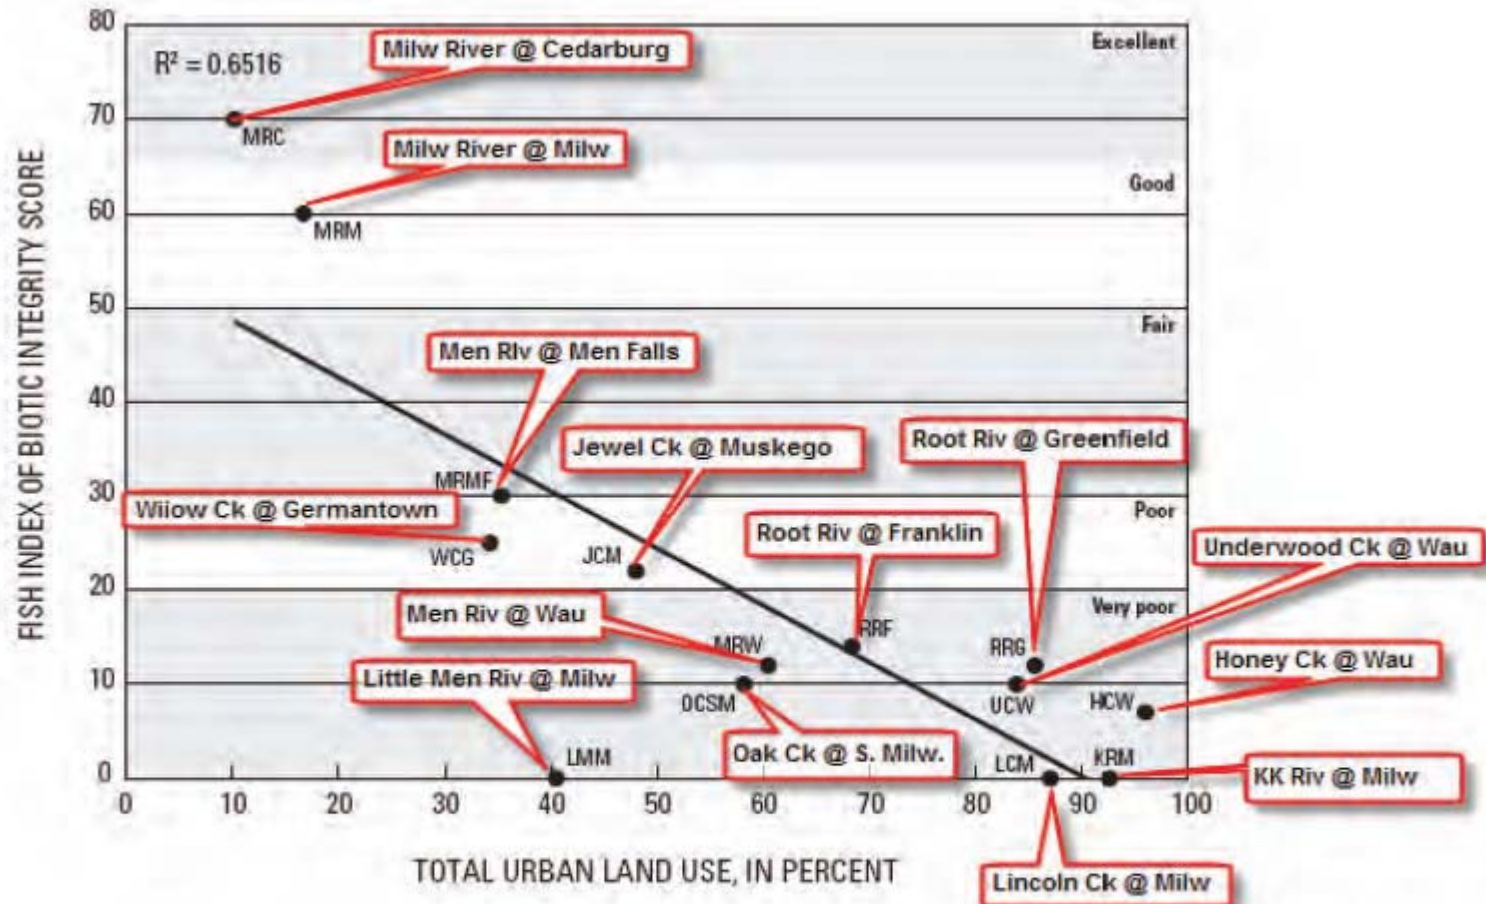
Fish IBI Scores Compared to Percent Urban Land Use Among Sites in the Greater Milwaukee Watersheds

Source: U.S. Geological Survey, Water Quality Characteristics for Selected Sites Within the Milwaukee Metropolitan Sewerage District Planning Area, Wisconsin, February 2004-September 2005, *Scientific Investigations Report 2007-5084*, 2007.

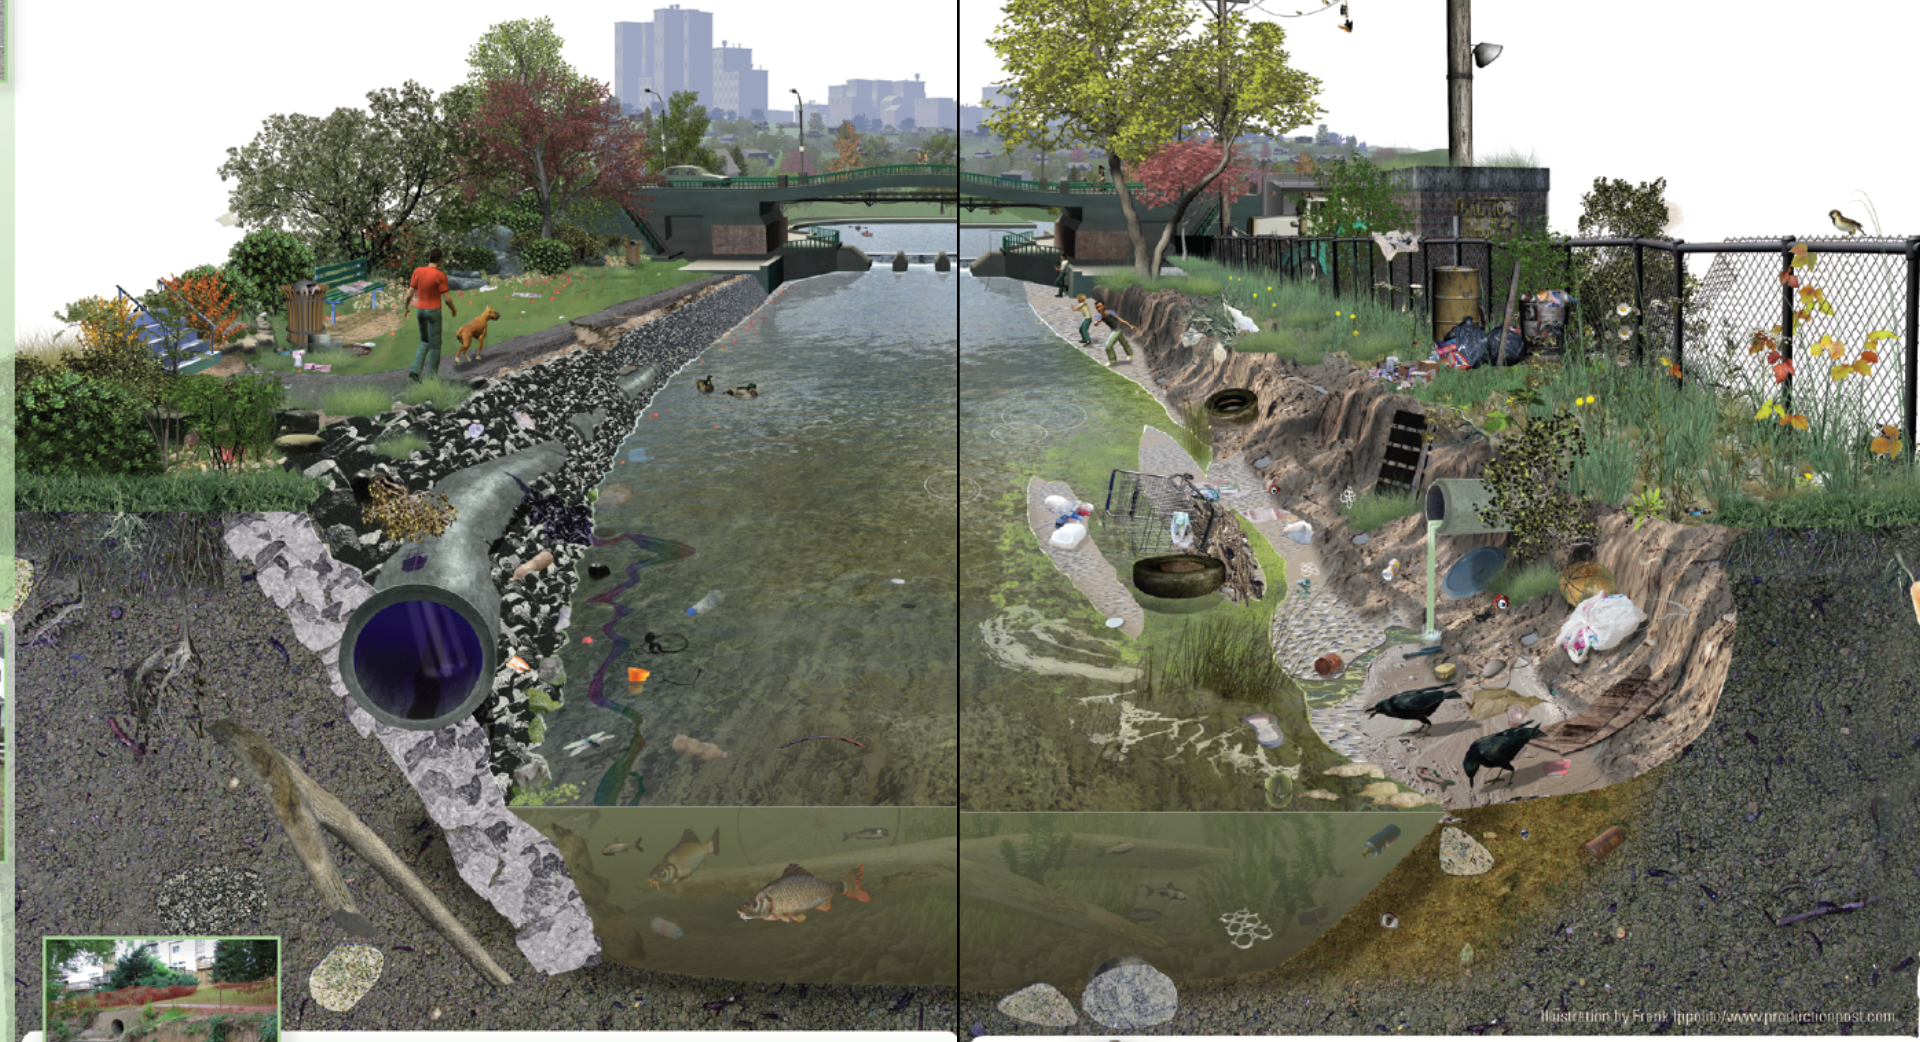
Dynamics of an Urban Stream Ecosystem

Urban development may have significant impacts on stream ecosystems that are often obvious to the casual observer.

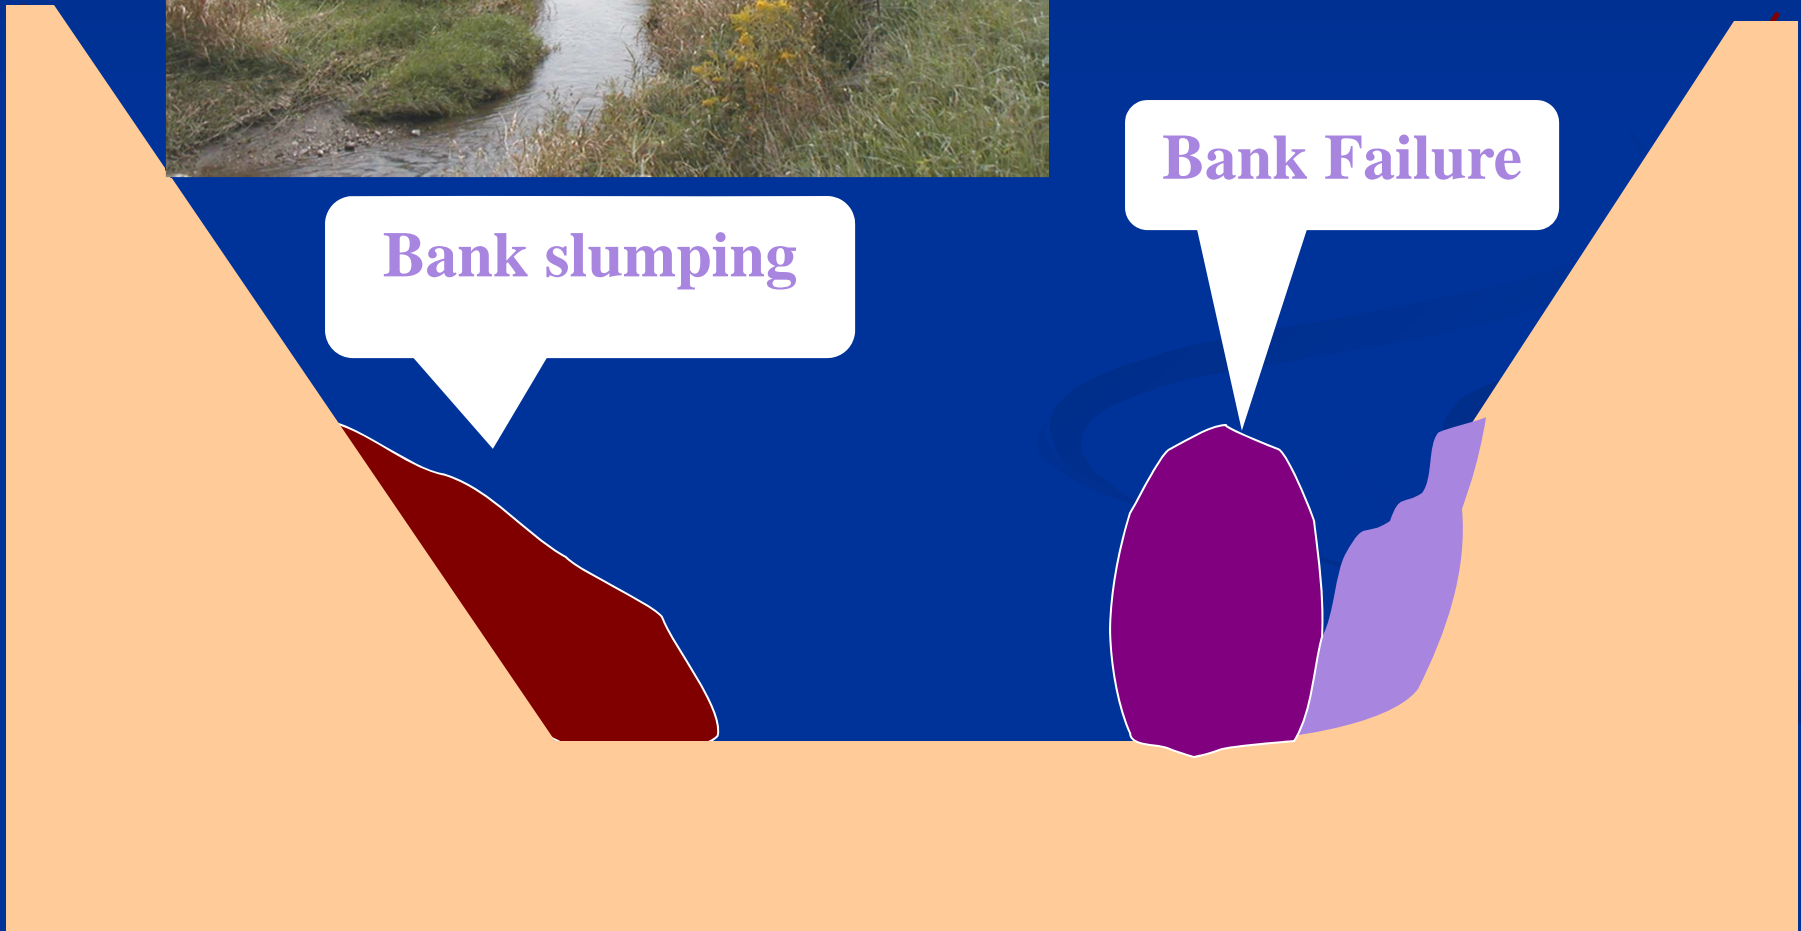
Two-Stage Design
can help prevent bank
slumping & Failure

Bank slumping

Bank Failure

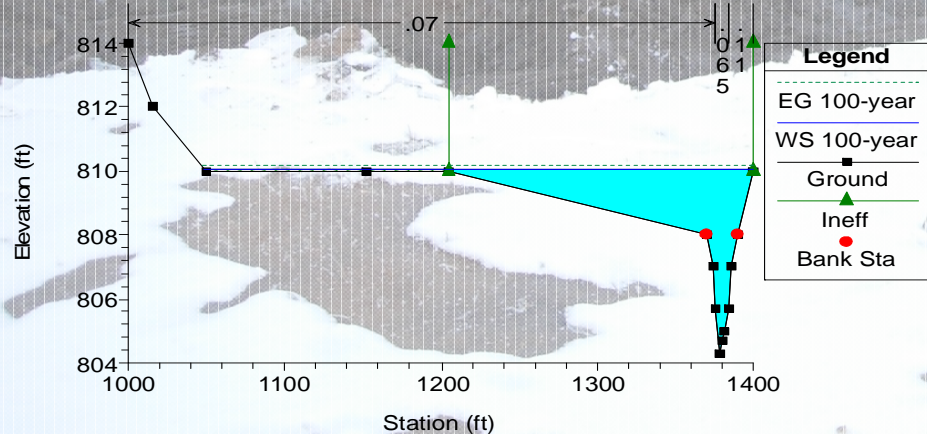
Existing Conditions

Upper Kelly Lakes Tributary Plan: Plan 22 4/2/2004
 UKL Tributary Cross Sec. Added From 2000 large-scale topo map

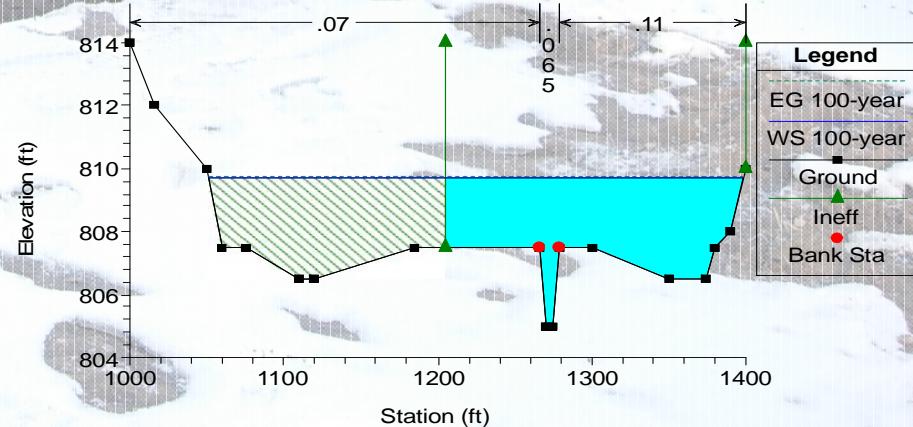
Proposed Conditions

Upper Kelly Lakes Tributary Plan: Plan 21 4/2/2004
 UKL Tributary Cross Sec. Added From 2000 large-scale topo map

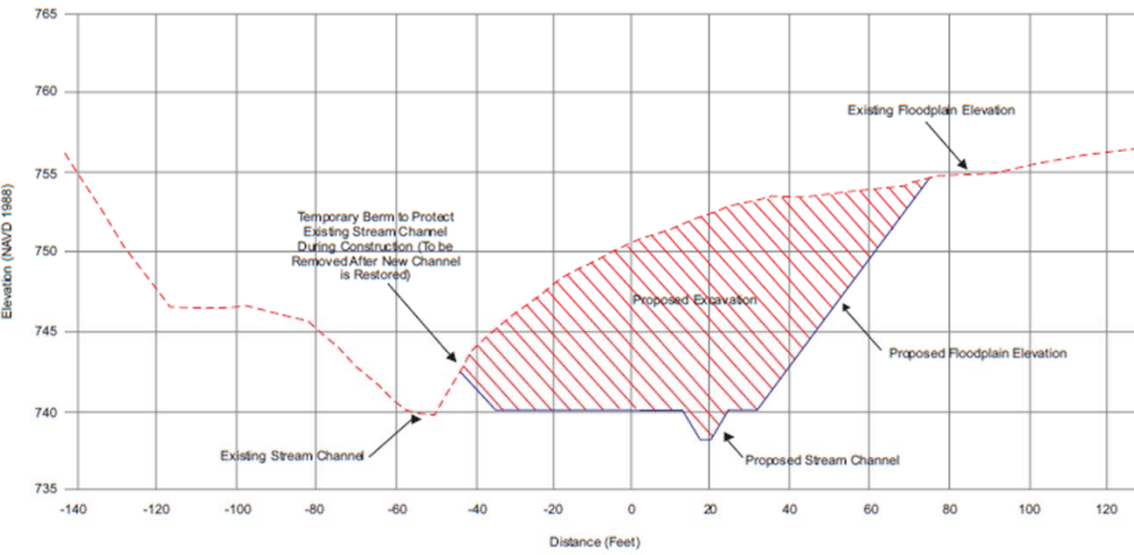
UNNAMED TRIBUTARY TO THE EAST BRANCH ROOT RIVER CANAL TYPICAL EXISTING AND PROPOSED FLOODPLAIN CROSS-SECTION

NOTE: Floodplain is defined here as a relatively flat valley floor formed by floods that overtop the banks of the stream and not as the area inundated during the regulatory 100-year recurrence interval flood.
