A RESTORATION PLAN FOR THE ROOT RIVER WATERSHED

Part Two
Appendices

COMMUNITY ASSISTANCE PLANNING REPORT
NUMBER 316

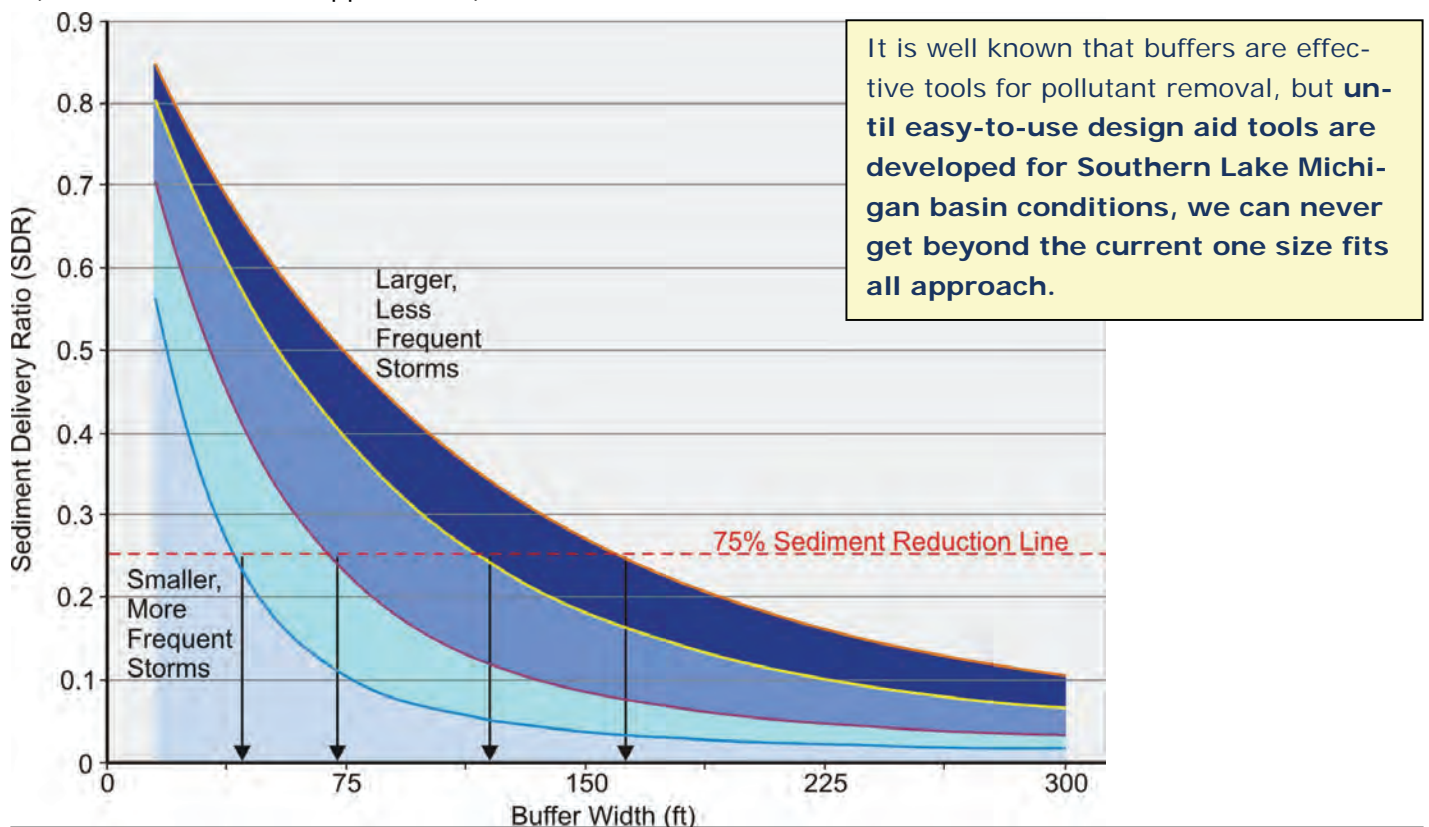
In the example below, 50-foot-wide buffers are necessary to achieve 75 % sediment removal during small, low intensity storms, while buffers more than 150 feet wide are necessary to achieve the same sediment reduction during more severe storms. Based on this information, decision-makers have the option of fitting a desired level of sediment removal into the context of their specific conditions. Under most conditions, a 75-foot width will provide a minimum level of protection for a variety of needs (SEWRPC PR No. 50, Appendix O.)

This generalized graph depicts an example of model output for an optimal buffer width to achieve a 75% sediment reduction for a range of soil and slope, vegetation, and storm conditions characteristic of North Carolina. (Adapted from Muñoz-Carpena R., Parsons J.E.. 2005. VFSMOD-W: Vegetative Filter Strips Hydrology and Sediment Transport Modeling System v.2.x. Homestead, FL: University of Florida. <http://carpena.ifas.ufl.edu/vfsmmod/citations.shtml>)

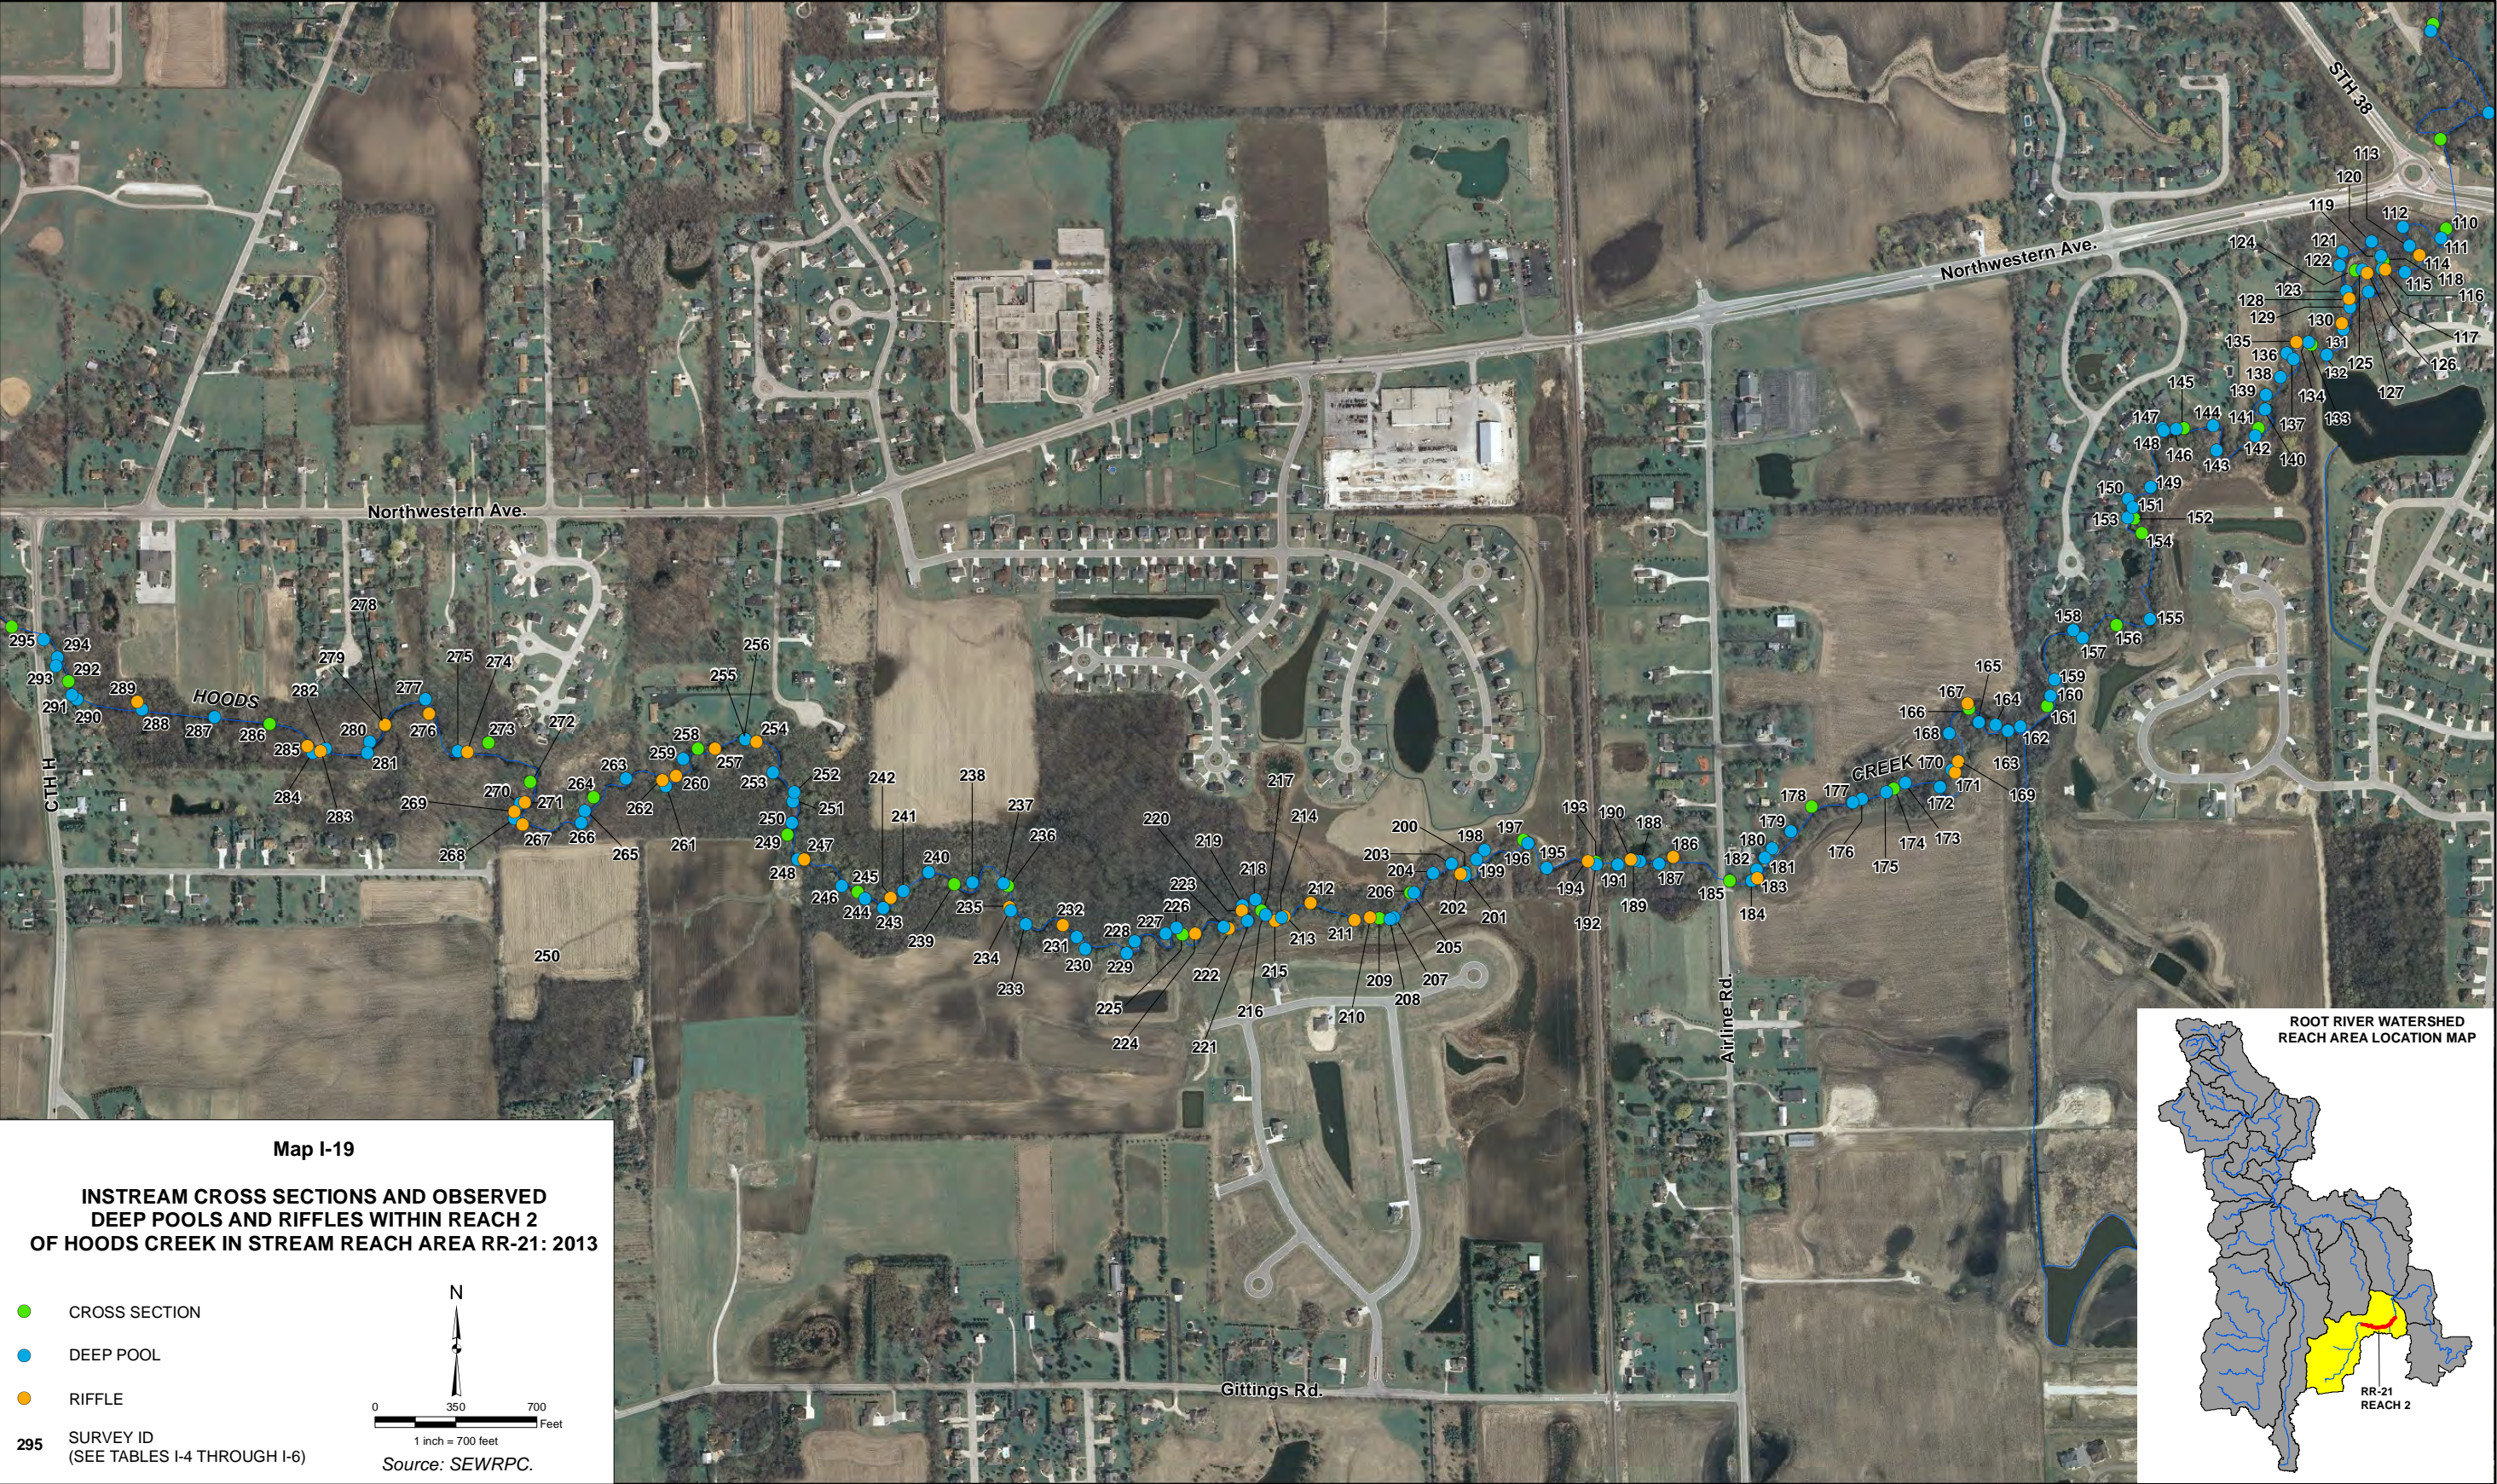
**INSTREAM CROSS SECTIONS AND OBSERVED DEEP POOLS
AND RIFFLES WITHIN REACH 1 OF HOODS CREEK IN STREAM REACH AREA RR-21: 2013**

Maps I-18 through I-20 identify the locations of cross-sections surveyed, as well as observed deep pools and riffles within Hoods Creek in reach area RR-21. Tables I-4 through I-6 identify the habitat characteristics associated with these surveyed cross-sections.

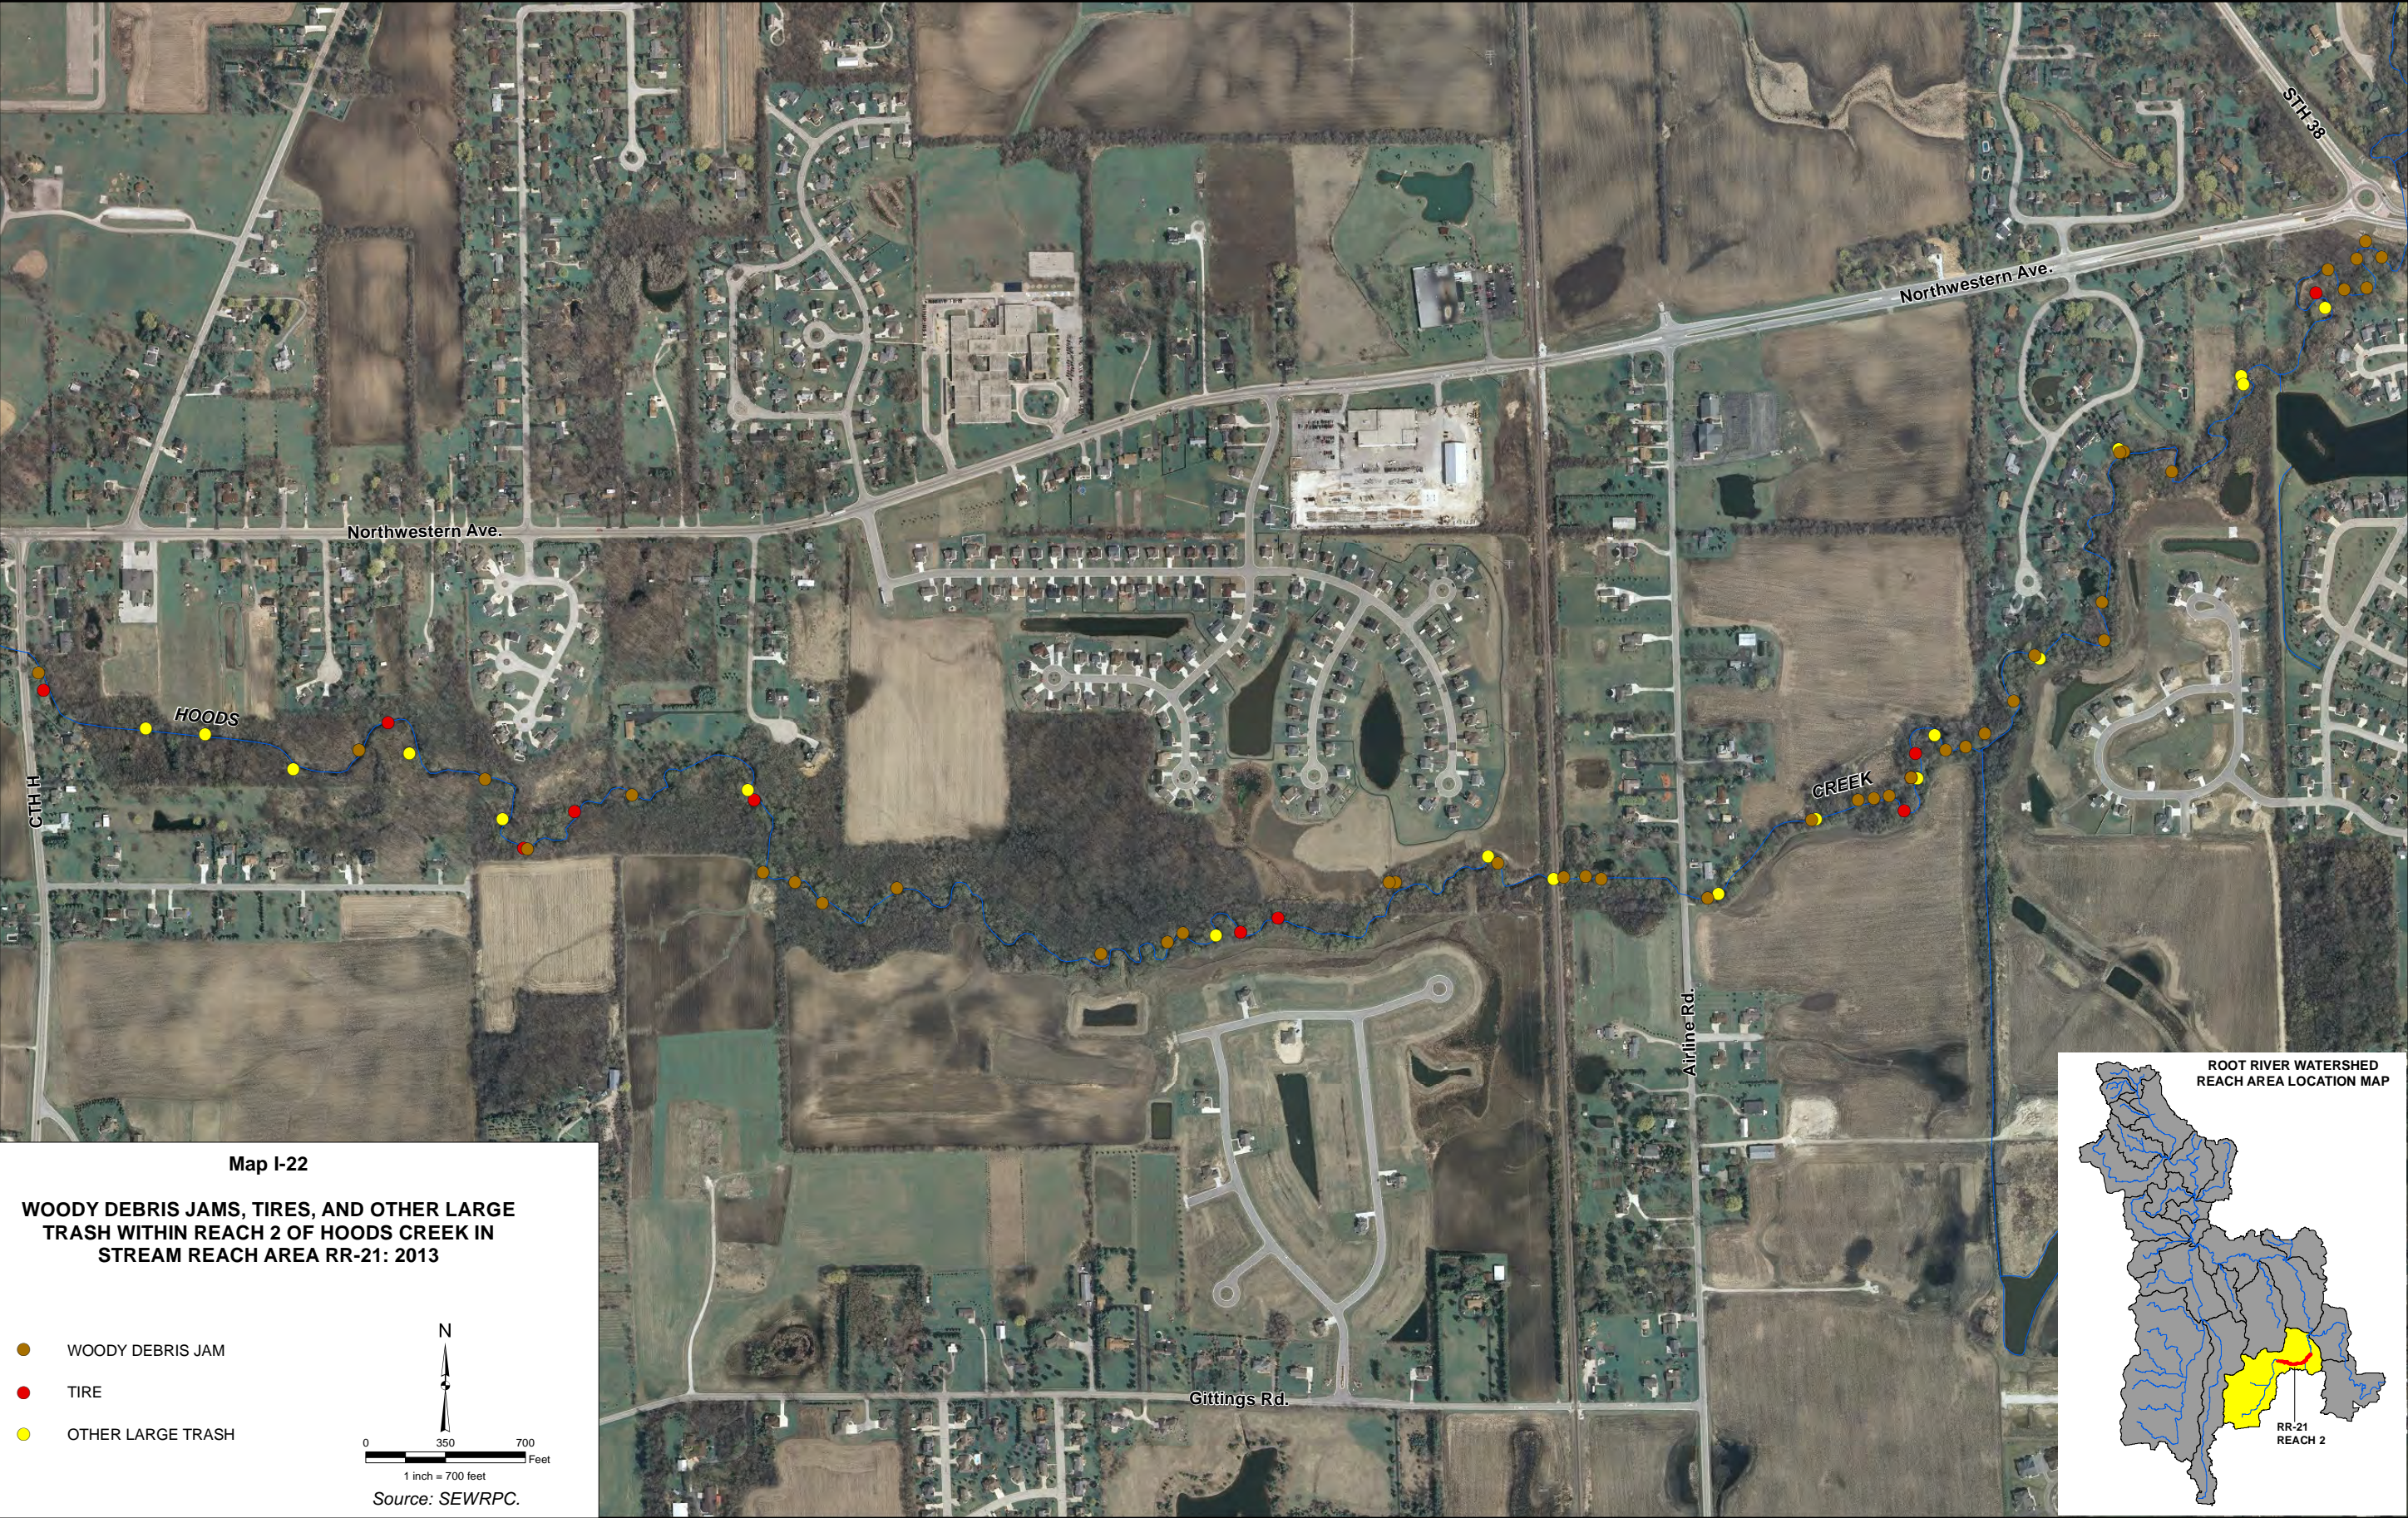
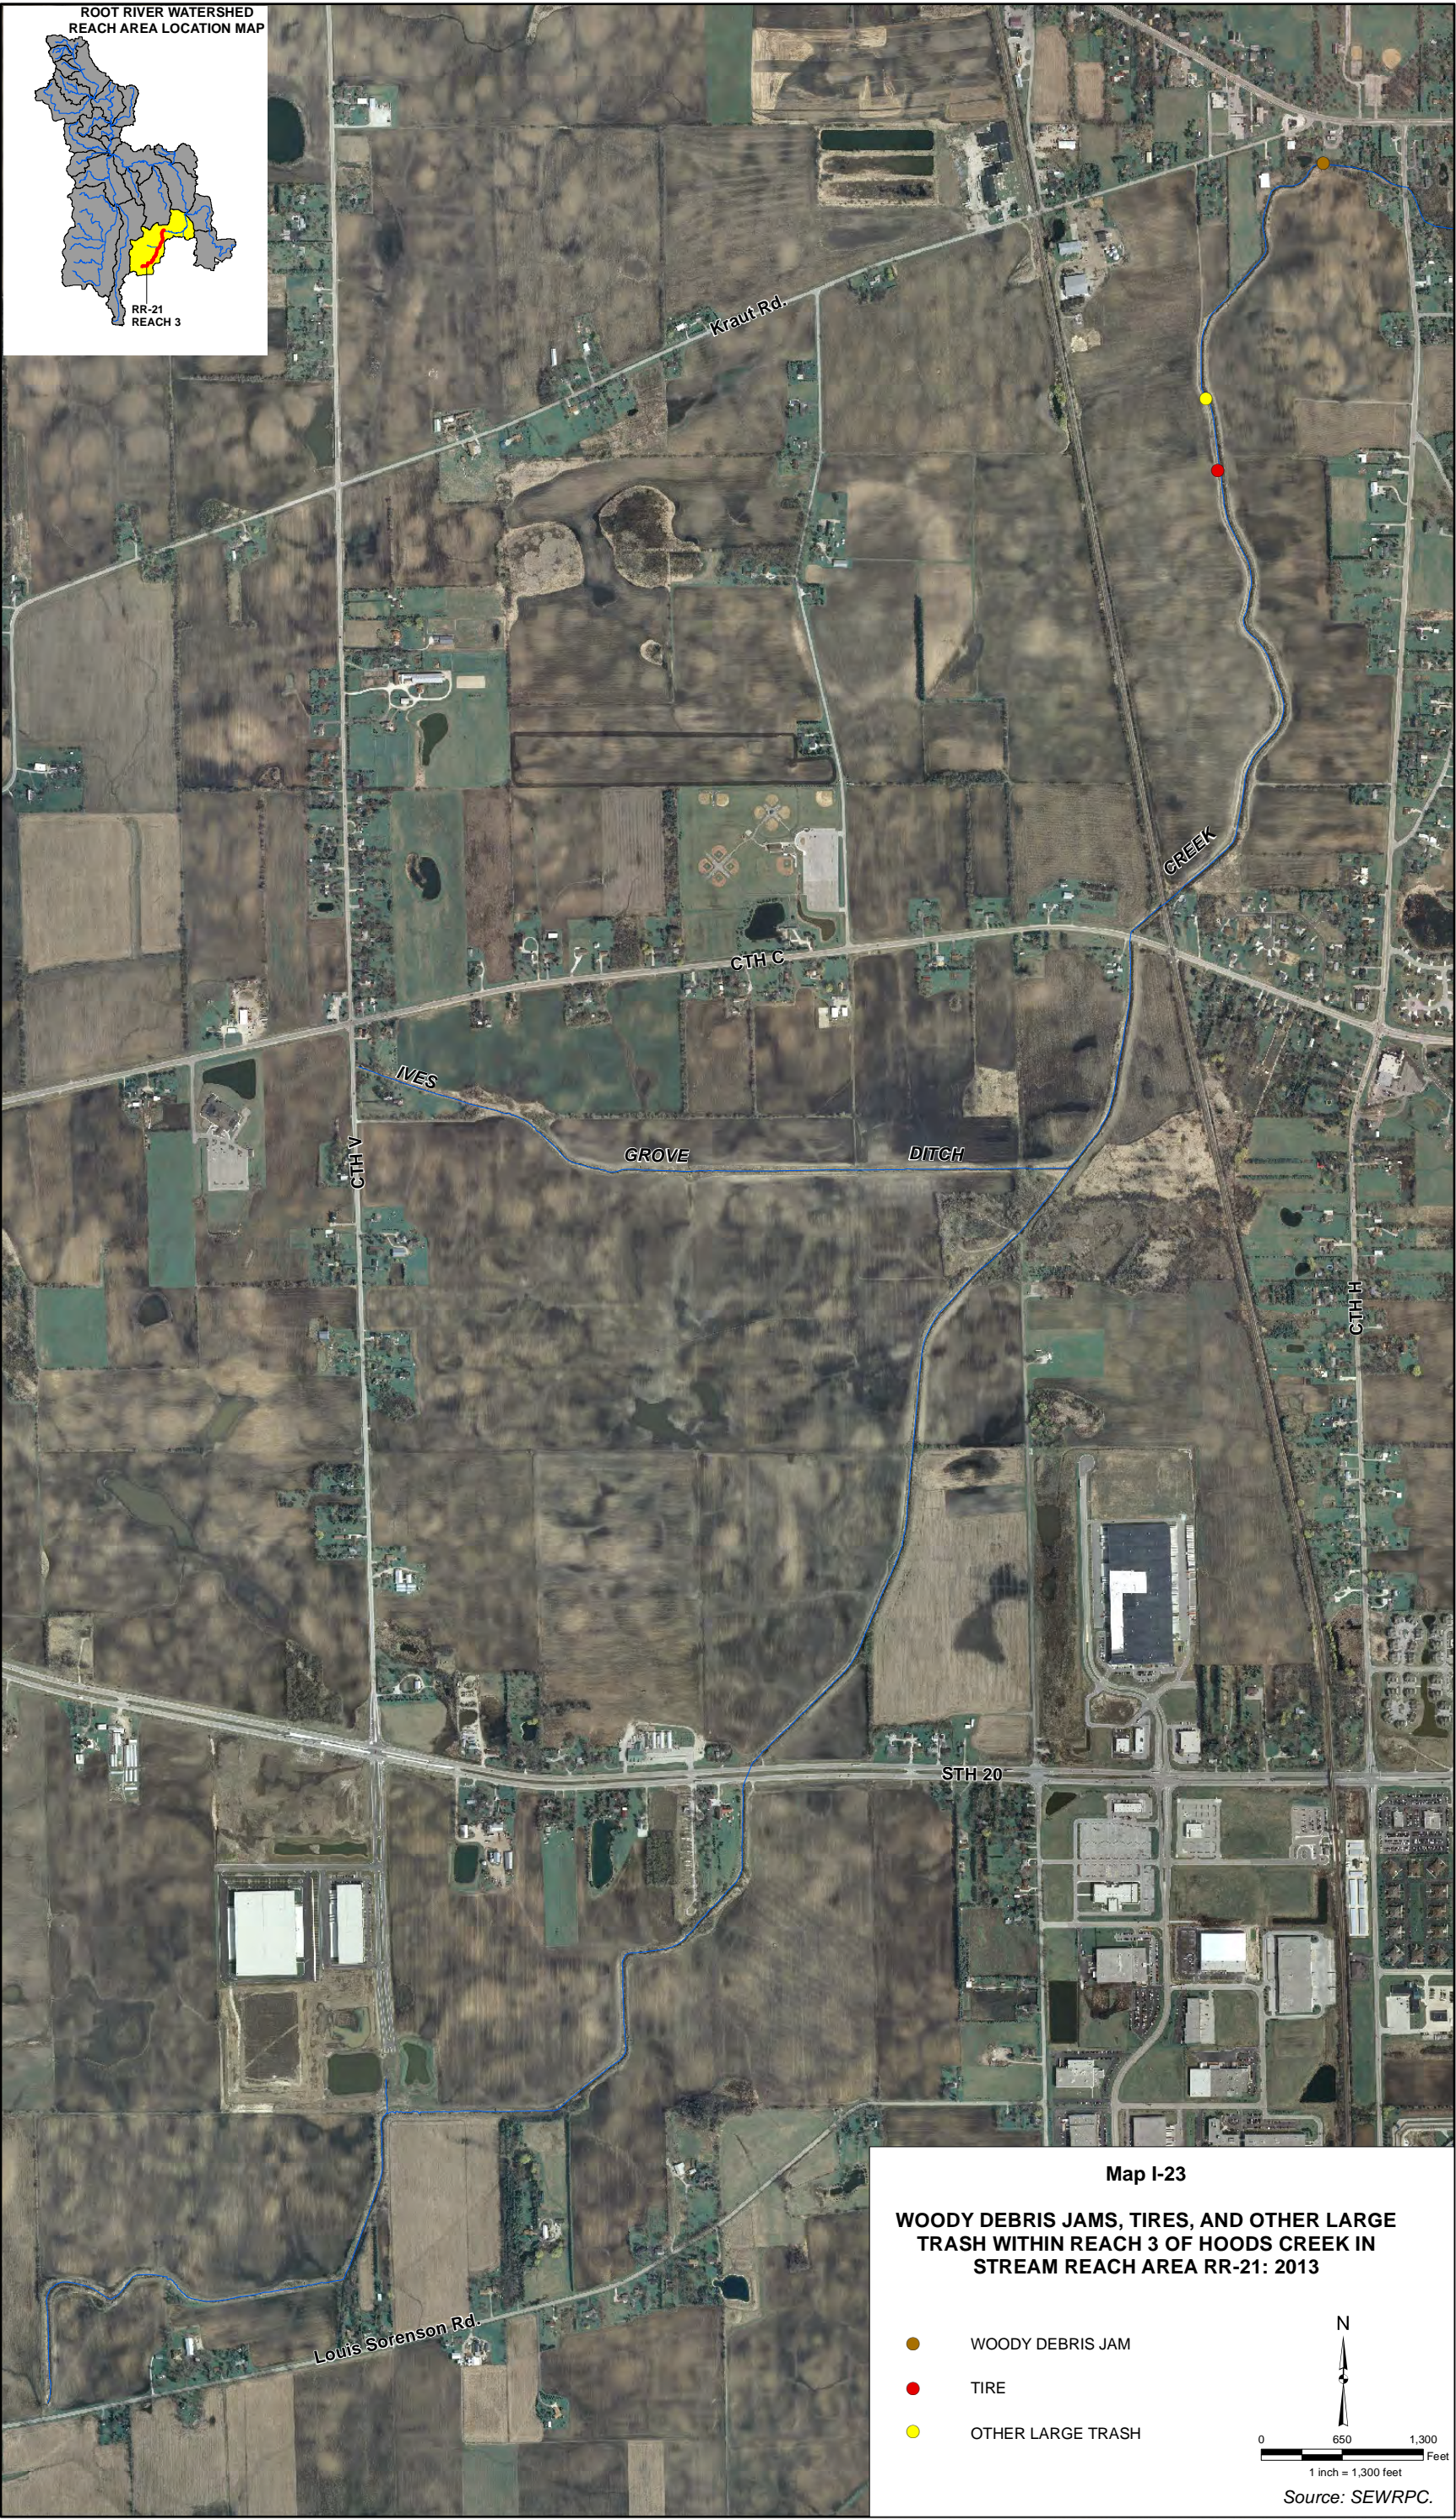
WOODY DEBRIS JAMS, TIRES, AND OTHER LARGE TRASH WITHIN REACH 1 OF
HOODS CREEK IN STREAM REACH AREA RR-21: 2013
