# STREAM CHANNEL STABILITY AND BIOLOGICAL ASSESSMENT OF QUAAS CREEK: 2002

## WASHINGTON COUNTY WISCONSIN

**SOUTHEASTERN WISCONSIN  
REGIONAL PLANNING COMMISSION**

MEMORANDUM REPORT  
NUMBER 151

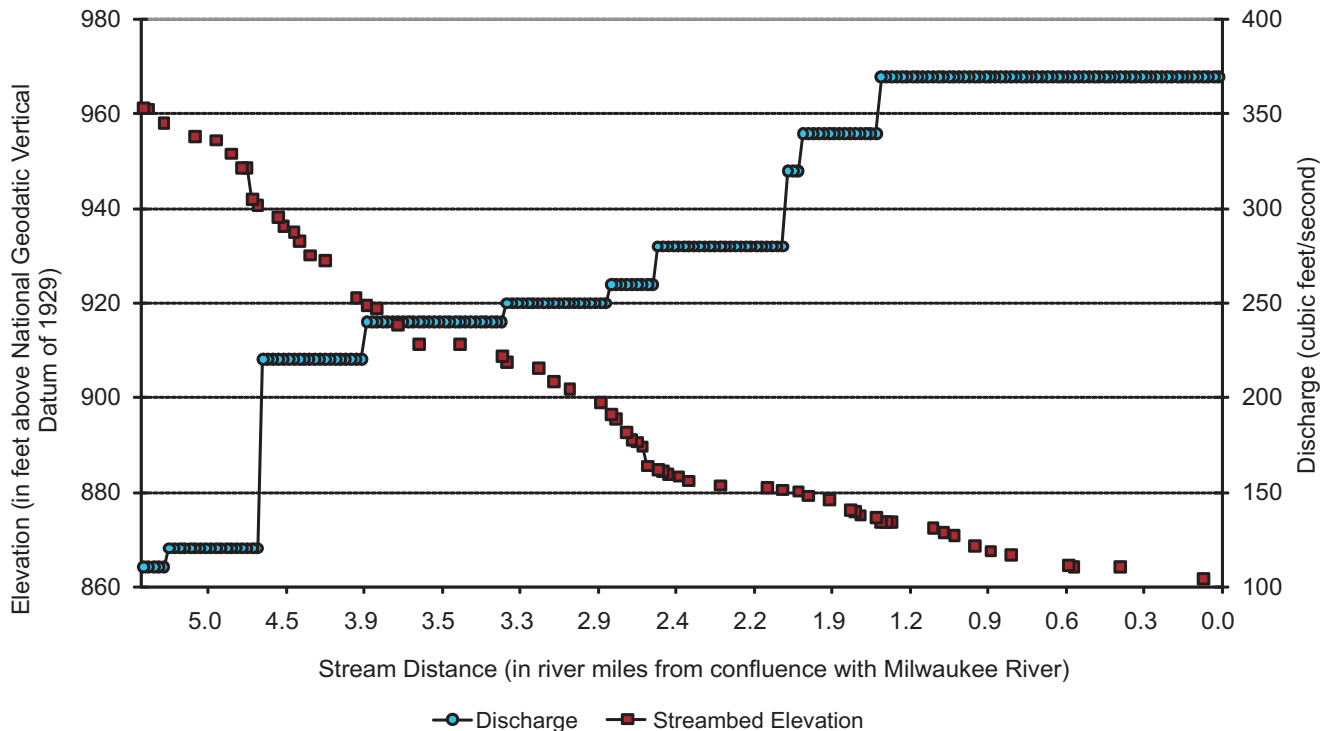
**TWO-YEAR RECURRENCE INTERVAL DISCHARGE AND  
STREAMBED ELEVATION PROFILES FOR QUAAS CREEK: 1996**

Figure 1 shows the peak flow rates for the two-year recurrence interval floods under planned land use and recommended drainage conditions from the headwaters of Quaas Creek to the confluence with the Milwaukee River set forth in the stormwater management plan for the City of West Bend.<sup>9</sup> Discharges range from 110 cubic feet per second in the upstream area to 370 cubic feet per second in the downstream reaches as shown in Figure 1. The two-year storm event is considered the dominant discharge event, which is responsible for the largest volume of sediment transport over a long period of record and typically ranges from a one- to three-year storm event.<sup>10</sup> In addition to the changes in discharge, Figure 1 also demonstrates changes in the bottom channel elevation profile of Quaas Creek within the limits of the project area.

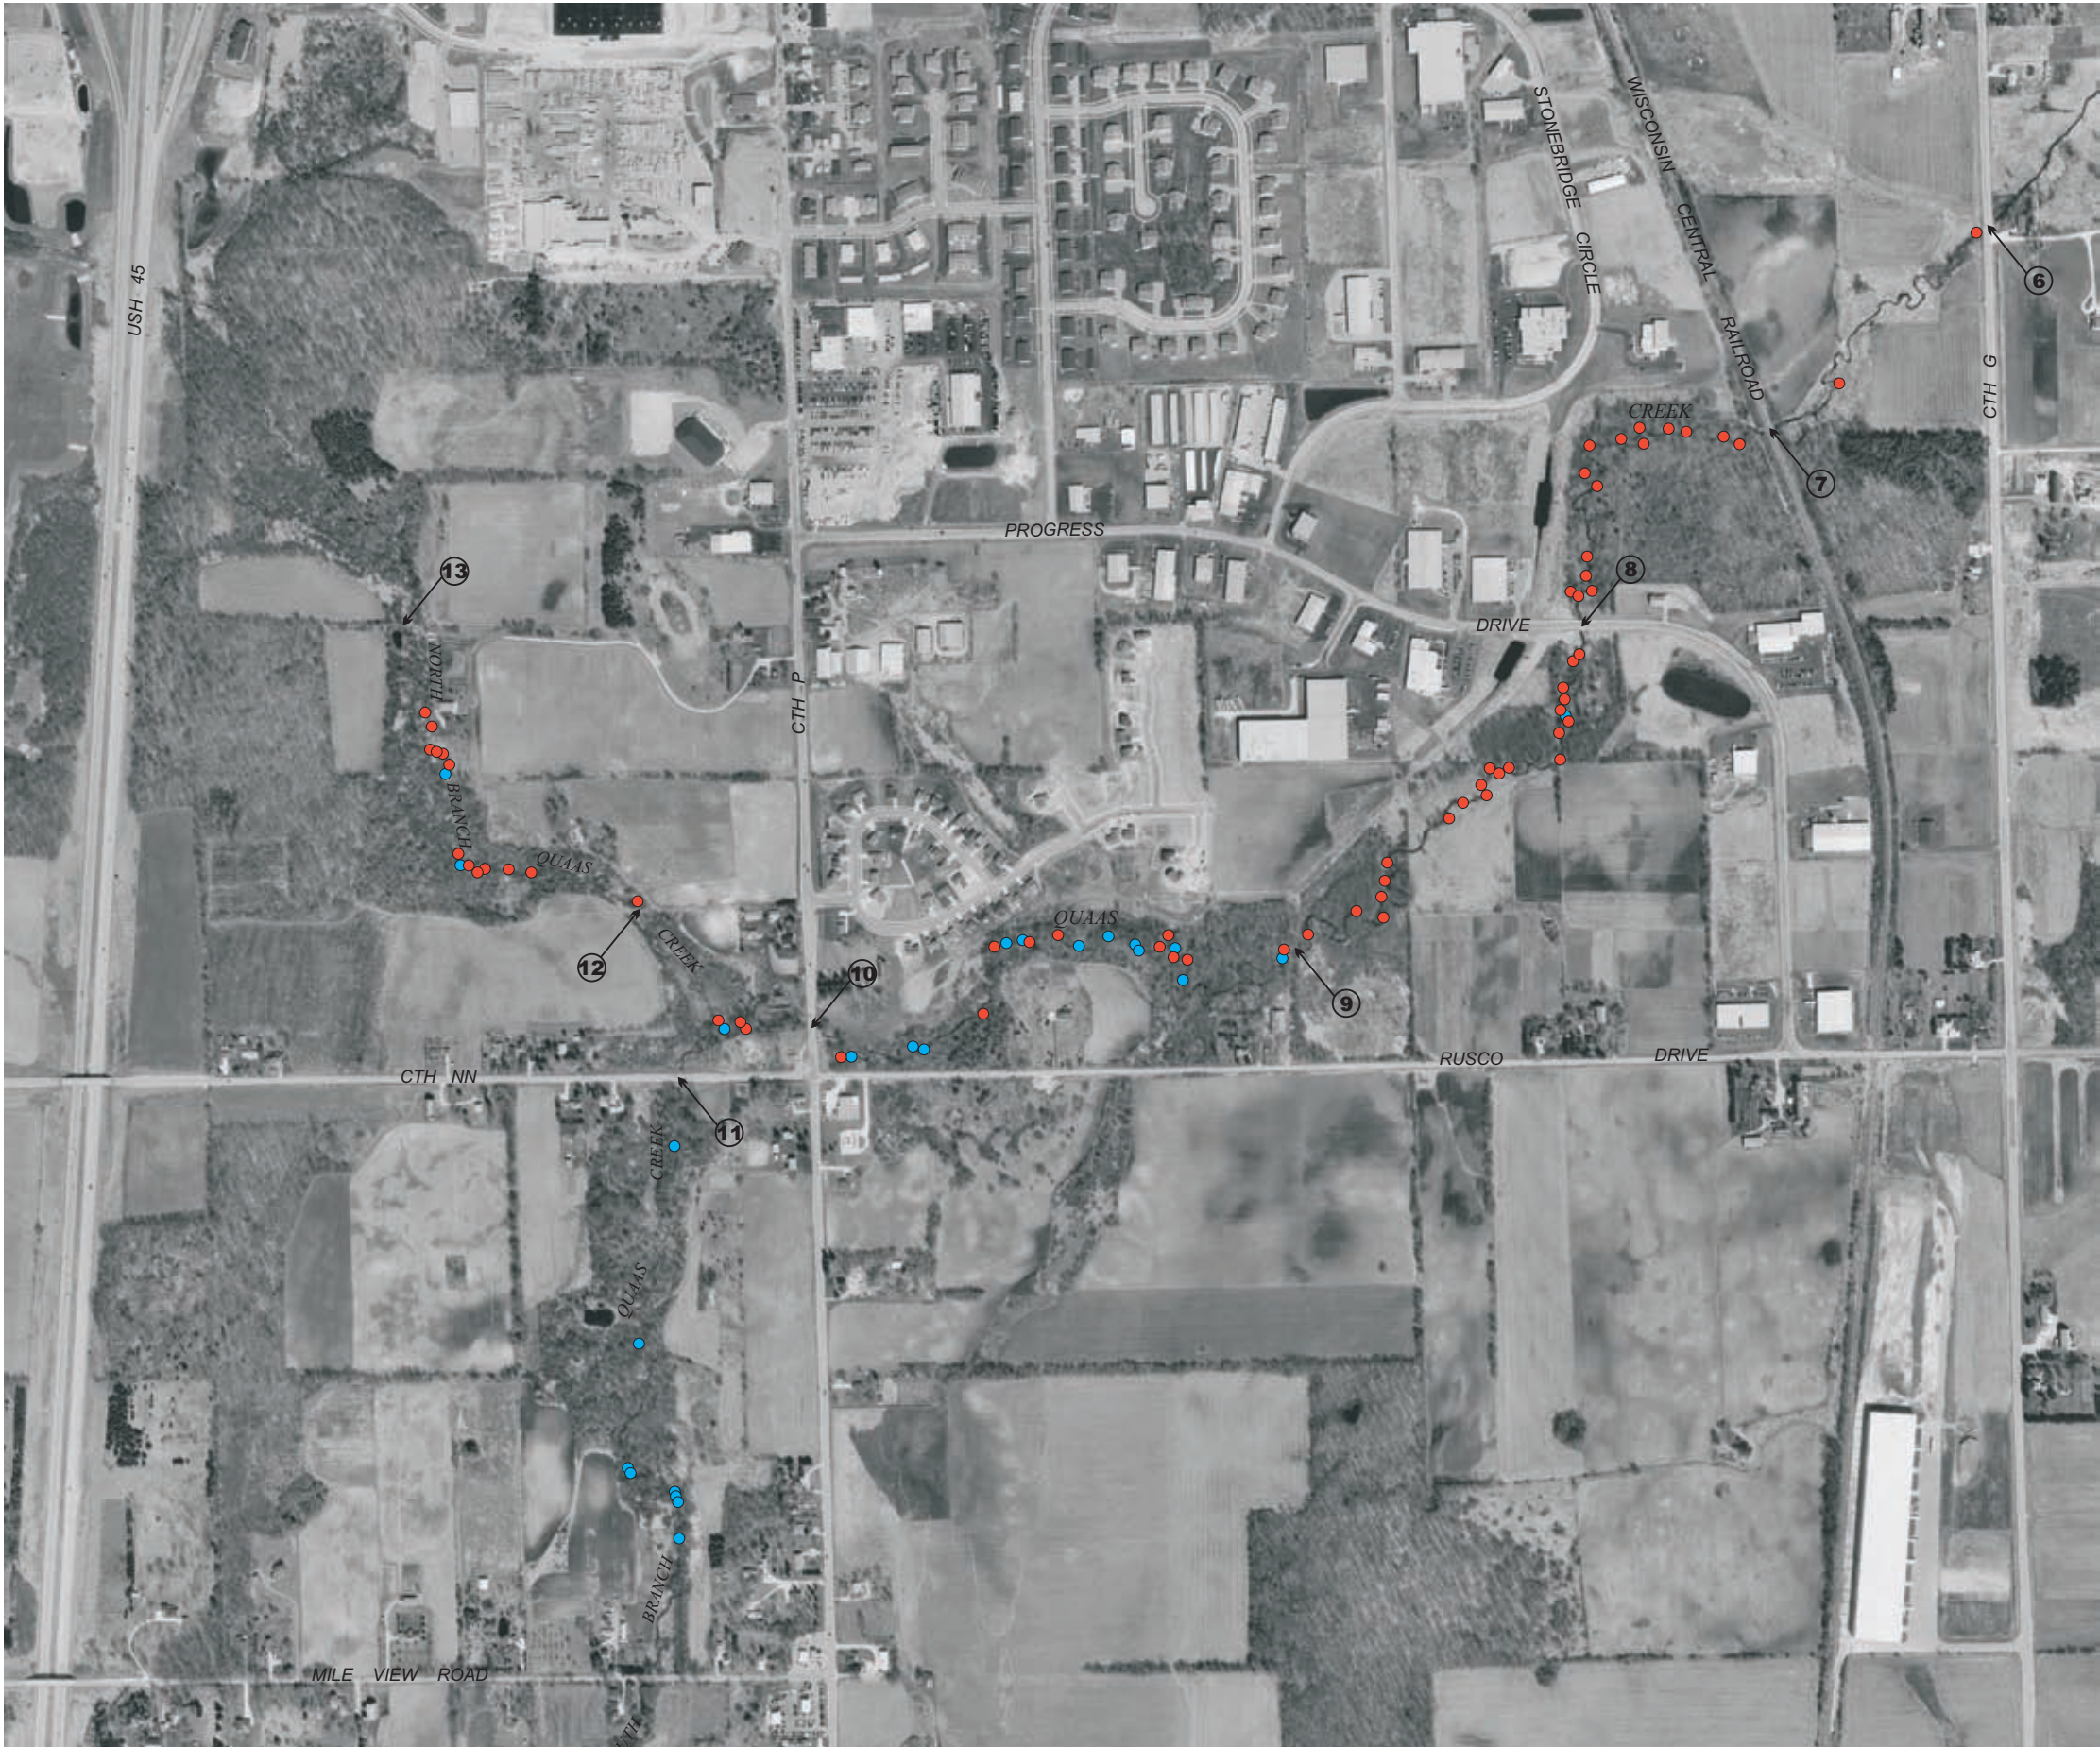
**Map 6**  
**STREAMBANK EROSION AND WOODY**  
**DEBRIS JAM SITES LOCATED WITHIN THE UPPER HALF**  
**OF THE QUAAS CREEK WATERSHED: FALL 2001**

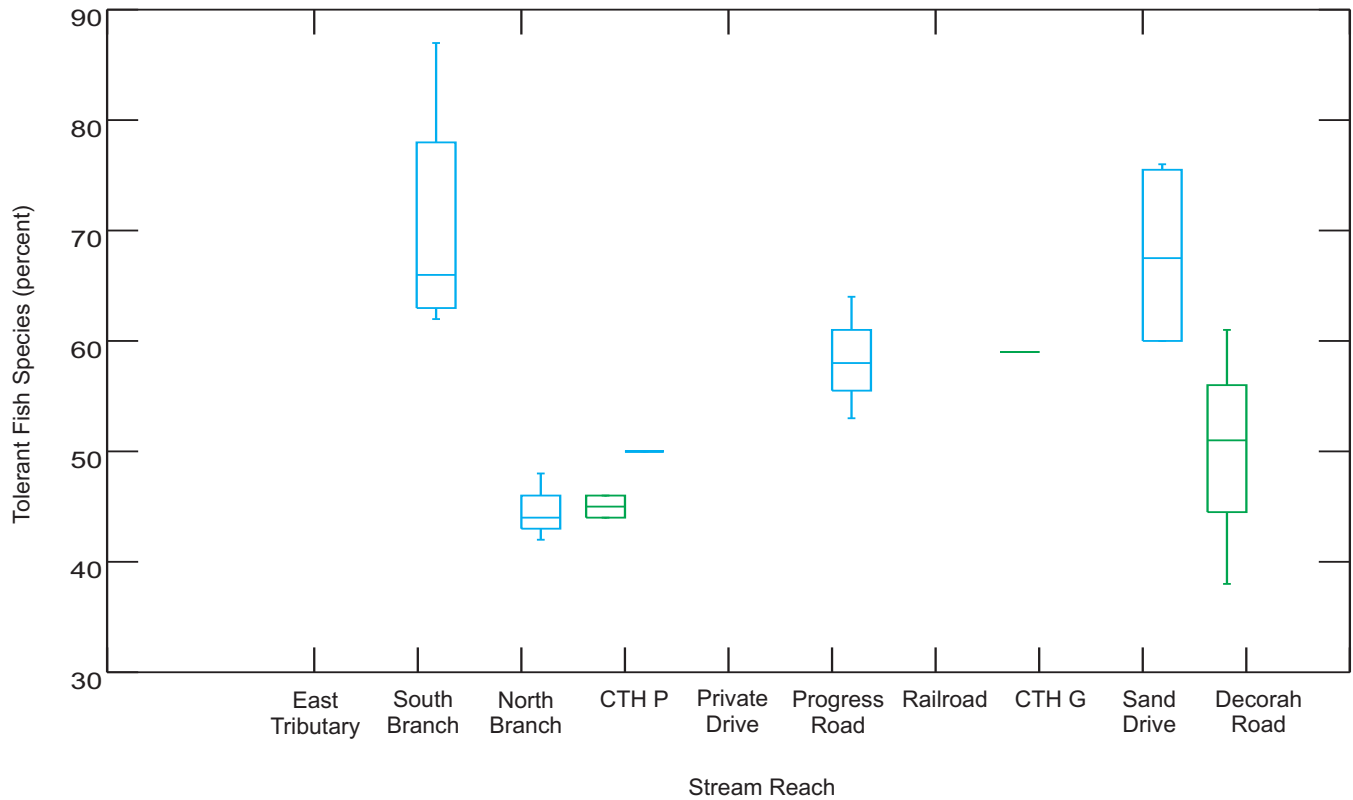
Figure 13

**HISTORIC AND CURRENT PERCENT OF TOLERANT FISH SPECIES  
AMONG REACHES WITHIN THE QUAAS CREEK WATERSHED: 1924-2001**

Despite the increase in IBI scores and native fish species as noted above, there has also been a general increase in the proportion of tolerant fish species throughout the watershed compared to historic fish species records in this watershed, except for the North Branch (Figure 13). The South Branch currently contains the highest proportion of tolerant species compared to the rest of the watershed. Conversely, the North Branch contains the lowest

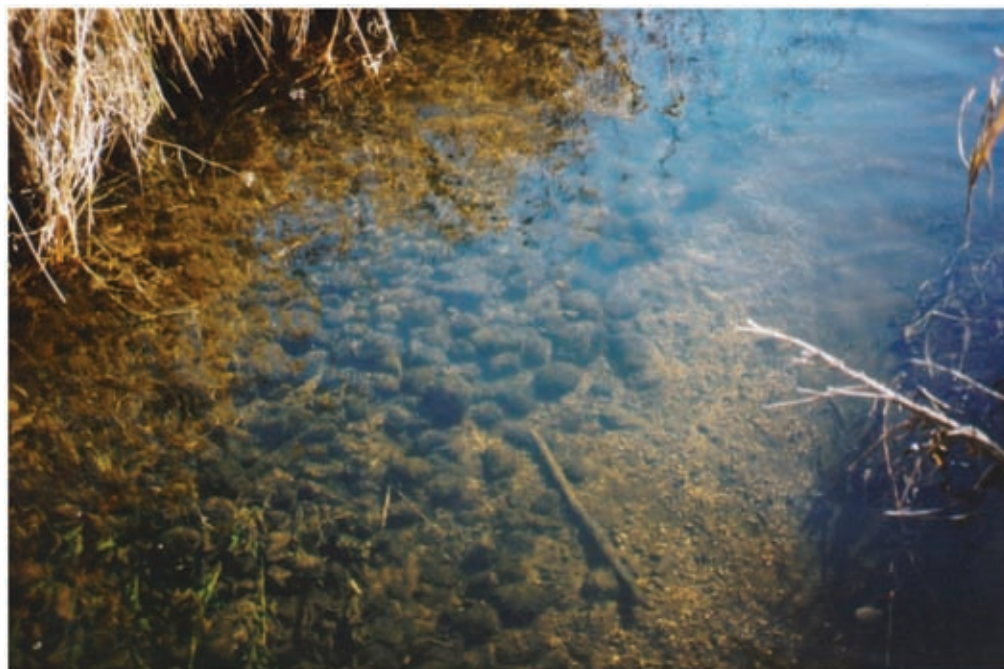
**Figure B-3**

**TYPICAL POOL HABITAT AND DIVERSITY OF SUBSTRATE OBSERVED  
WITHIN THE WISCONSIN CENTRAL RAILROAD REACH: FALL 2001**

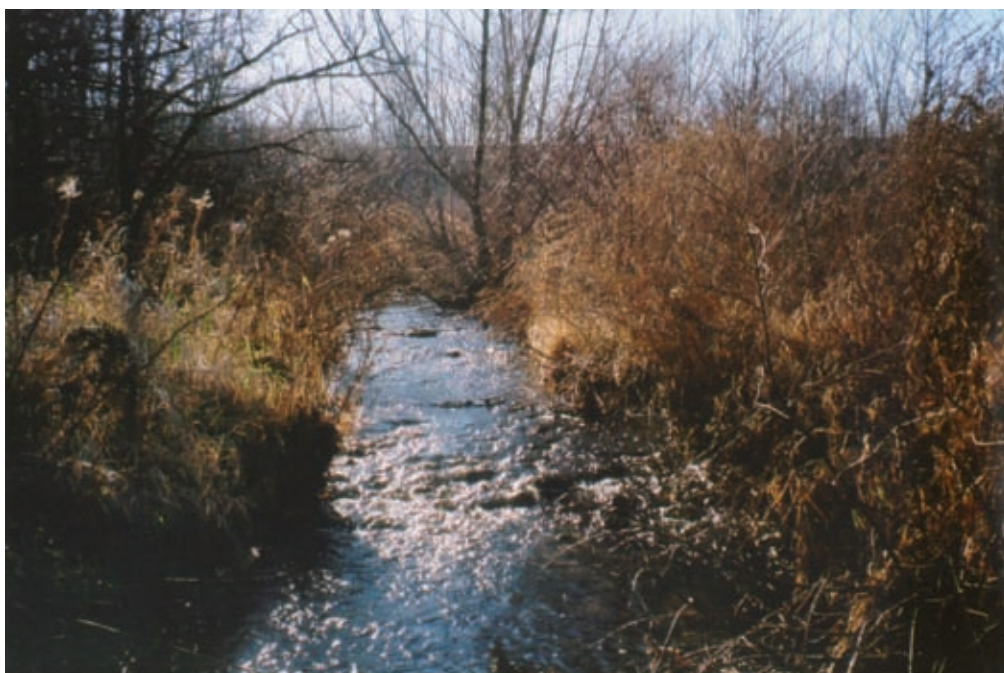
**Figure B-4**

**TYPICAL RIFFLE HABITAT AND HETEROGENEITY OF FLOW OBSERVED WITHIN THE CTH G REACH: FALL 2001**

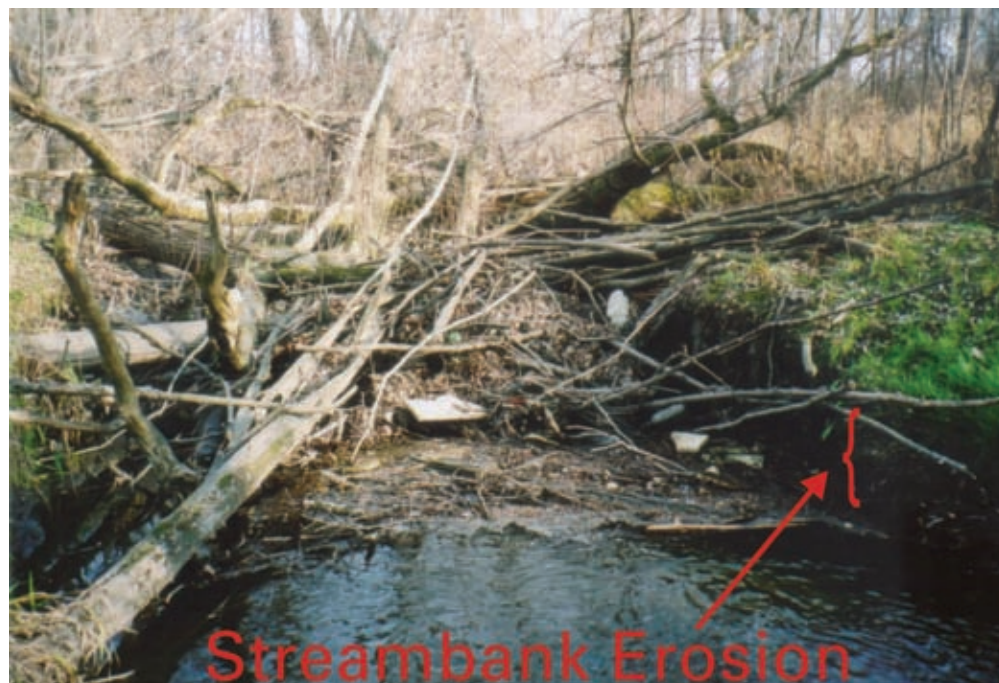
Figure B-5

**EXAMPLE OF WOODY DEBRIS JAM CHANNEL OBSTRUCTION AND ASSOCIATED  
LOCALIZED BANK EROSION LOCATED WITHIN THE CTH G REACH: FALL 2001**

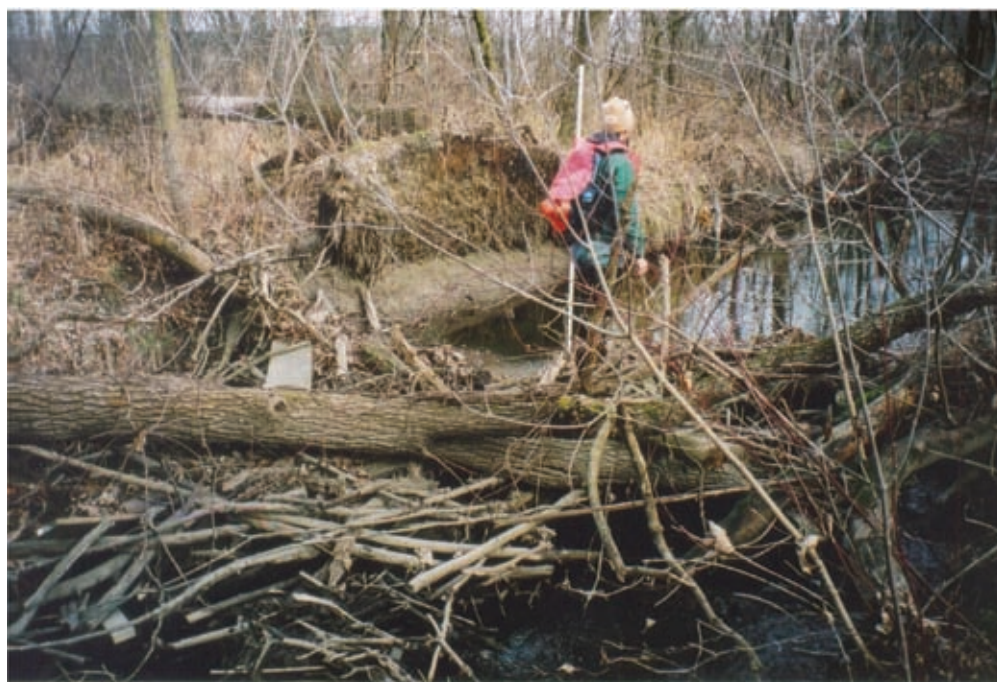
Figure B-6

**EXAMPLE OF WOODY DEBRIS JAM CHANNEL OBSTRUCTION AND ASSOCIATED  
LOCALIZED BANK EROSION LOCATED WITHIN THE SAND DRIVE REACH: FALL 2001**

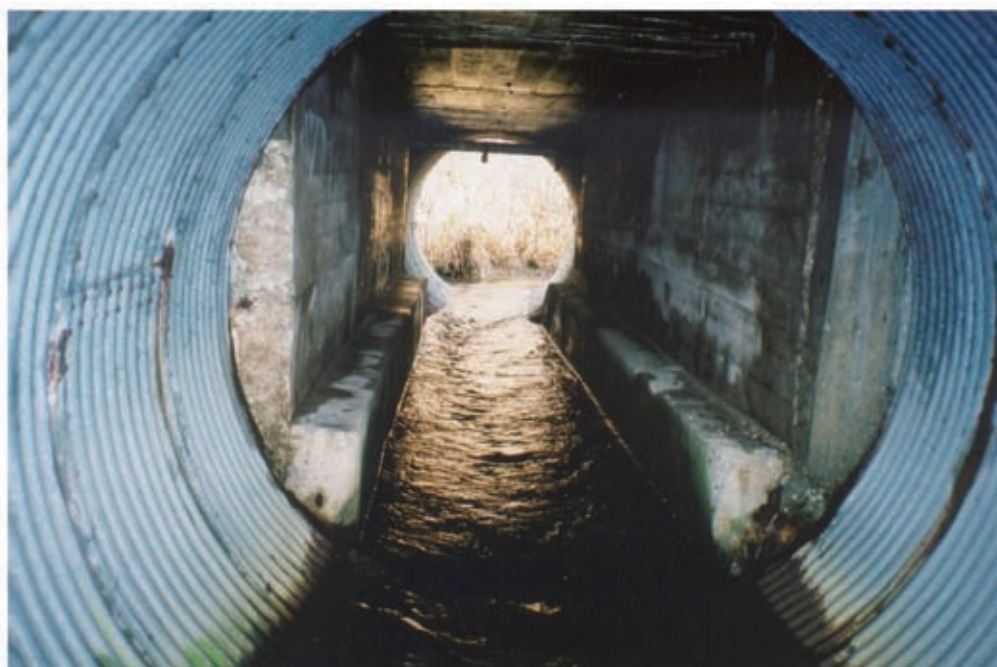
**Figure B-8**

**POTENTIAL HYDROLOGICAL OBSTRUCTION WITHIN THE CULVERT STRUCTURE AT THE CTH P ROAD CROSSING OF THE MAIN CHANNEL OF QUAAS CREEK**
