Big Cedar Lake Comprehensive Plan Update

BCLPRD Meeting
November 19, 2024

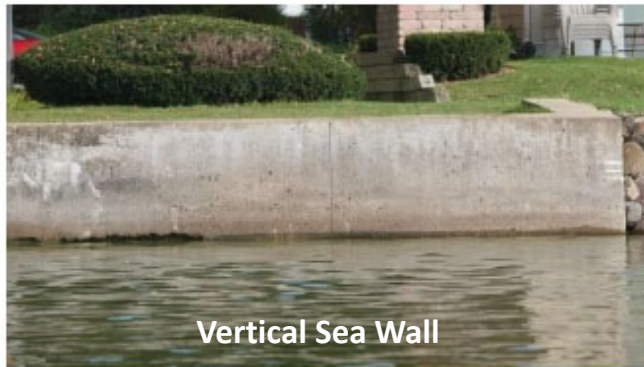
Vertical Sea Wall

➤ Bank zone

- Assess type of shoreline protection
 - Seawall, riprap, vegetation, other
- Looks for signs of erosion

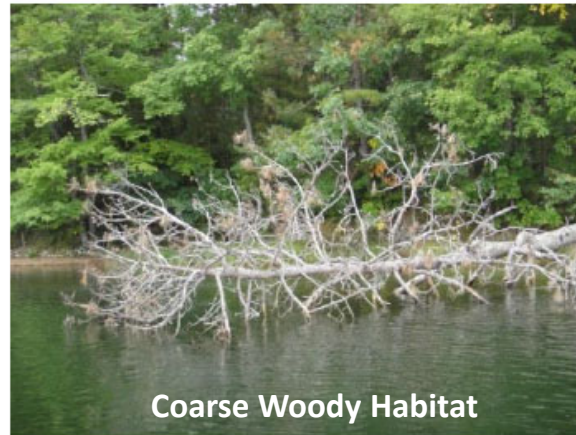
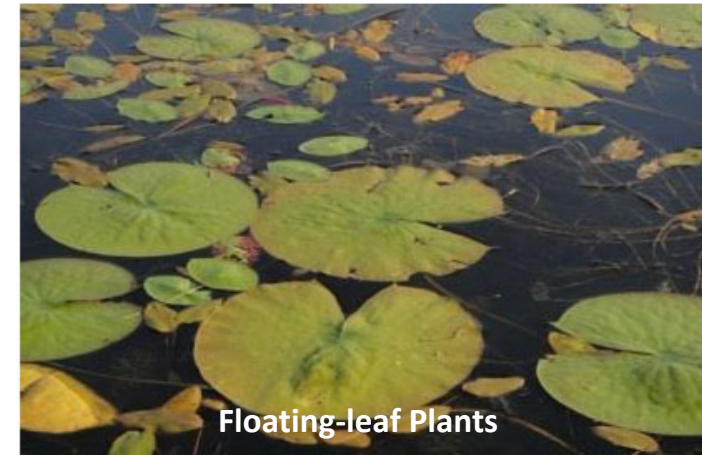
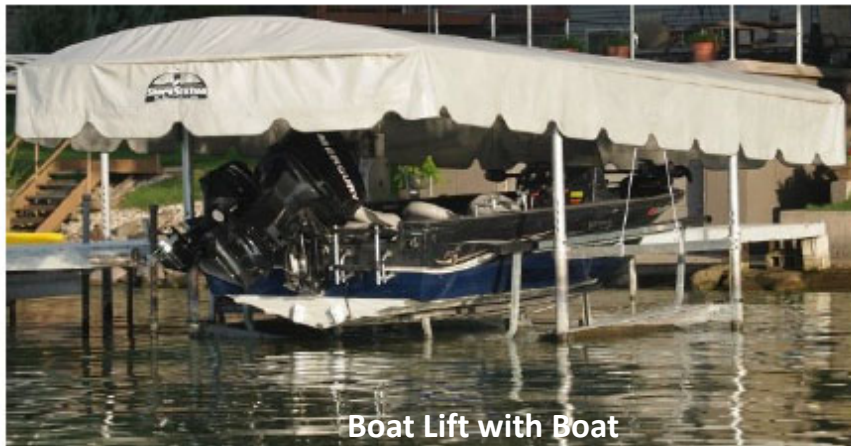
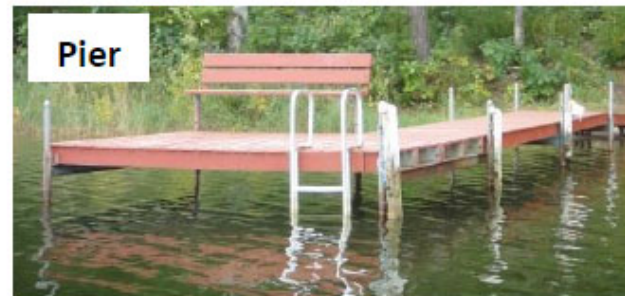
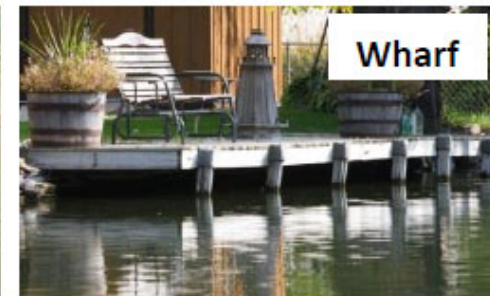
➤ Littoral zone

- Number of human structures
 - Piers, boats, boat lifts, etc.
- Presence of aquatic vegetation
- Coarse woody habitat

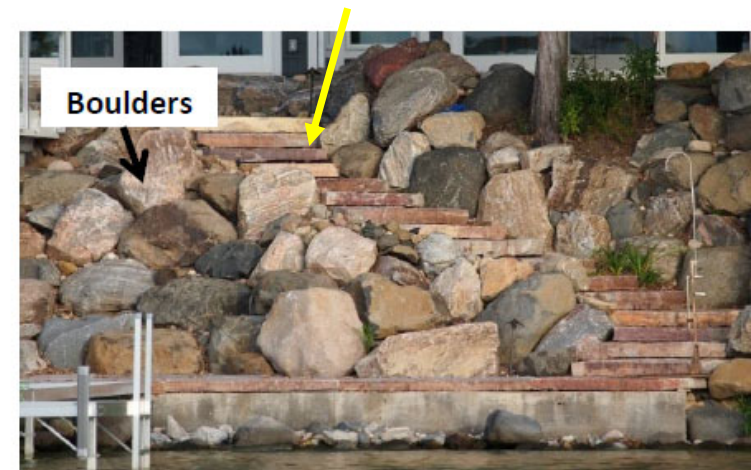
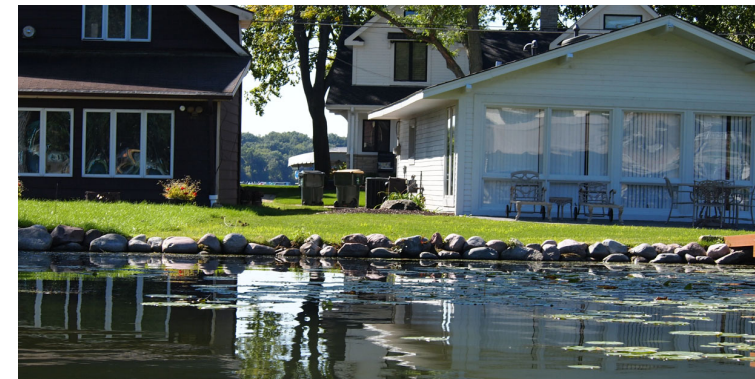
Impervious Surface Path to Lake

- Most parcels had at least one runoff concern
 - 429 parcels (78%) with lawn sloping to lake
 - 342 parcels (62%) with trail or stair to lake
 - 41 parcels (7.5%) with bare soil near lake
- Majority of bank zone is heavily armored
 - 6.65 miles of shoreline (60%) with riprap
 - 0.95 miles (8.6%) with sea wall
- 28 parcels had notable erosion along shoreline

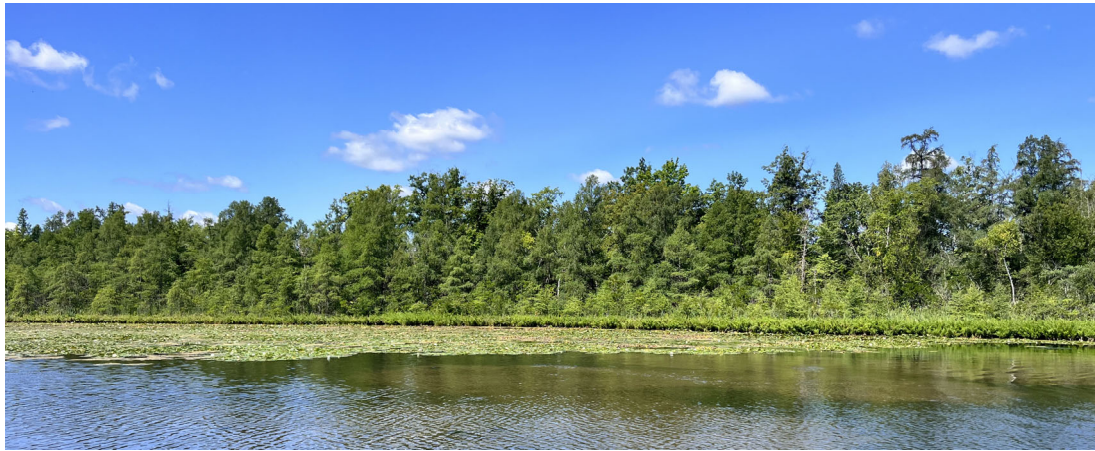
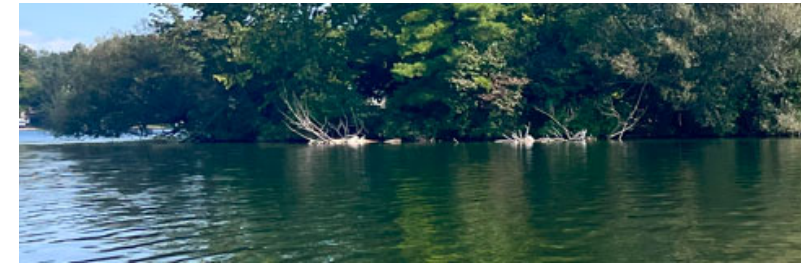
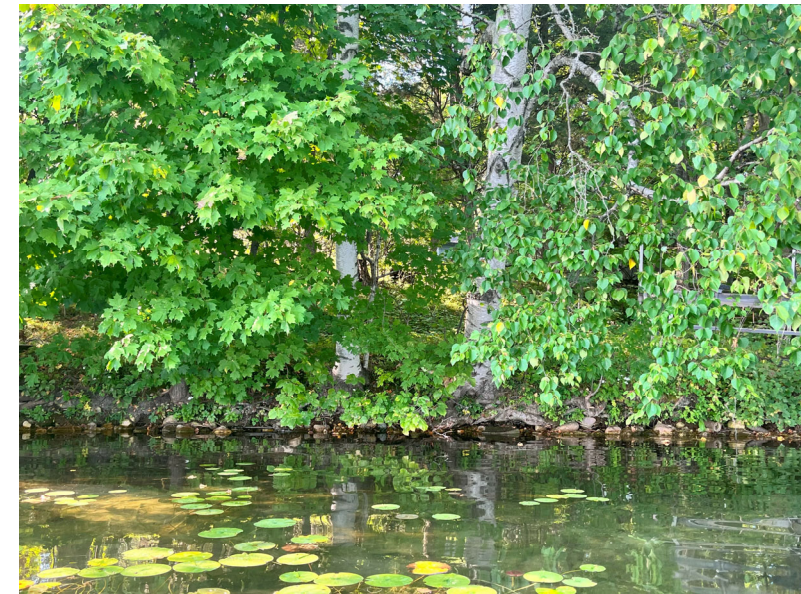
➤ Limited areas of aquatic habitat

- 79 parcels (14%) with floating-leaf vegetation
- 20 parcels with emergent vegetation
- 17 pieces of coarse woody habitat

➤ Largest areas on islands and in north basin

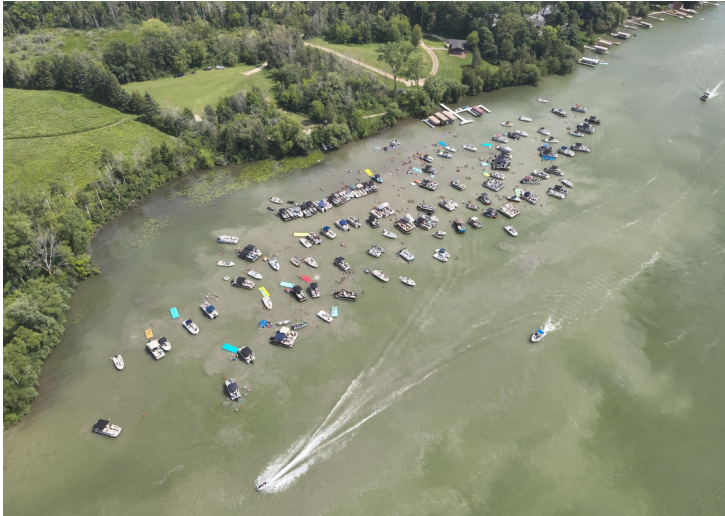
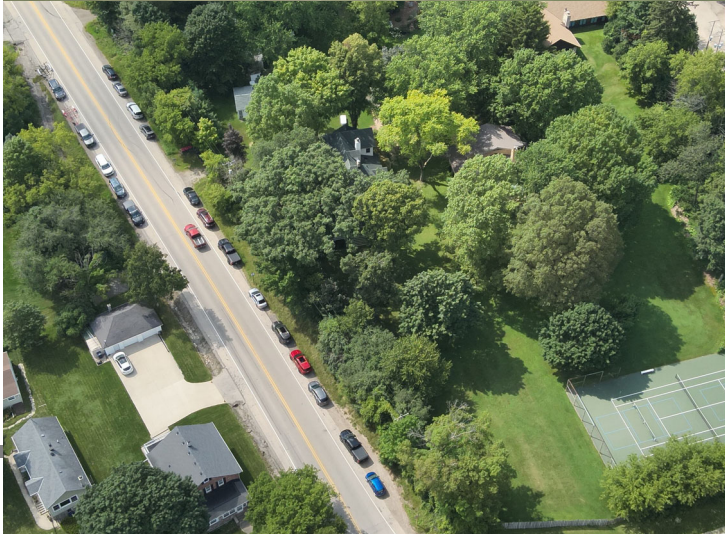
➤ Sandbar boat counts:

- July 20th: 126 boats
- August 31st: 69 boats

➤ Moored boat count: August 8th

- 956 total boats
 - 786 powerboats
 - 50 sail boats
 - 120 personal watercraft

➤ Photos of cars parked along County Hwy K
