Community Assistance Planning Report No. 330

A RESTORATION PLAN FOR THE OAK CREEK WATERSHED

Chapter 4

INVENTORY FINDINGS

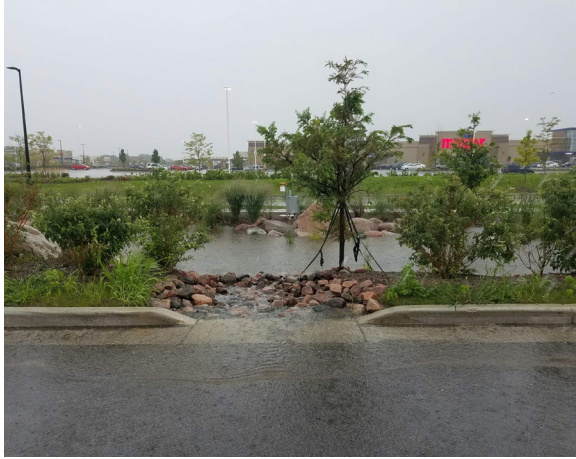
Bioswale Capturing Runoff from
Parking Lots at Drexel Town Square

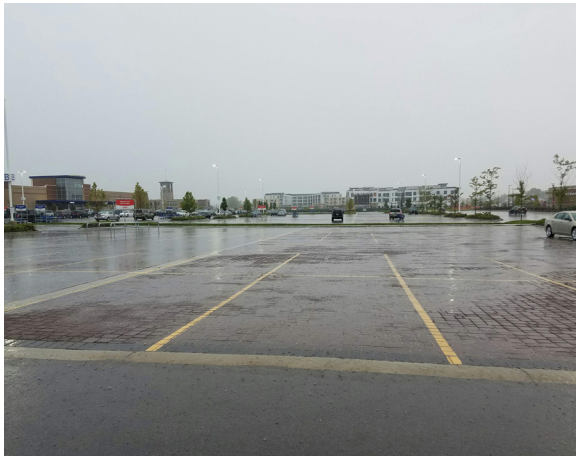
Porous Pavement Infiltrating Runoff from
Parking Lot at Drexel Town Square
