Oak Creek Watershed Restoration Plan

Summary
Chapter 4 – 2nd half
May 2020

Chapter 4

Inventory Findings

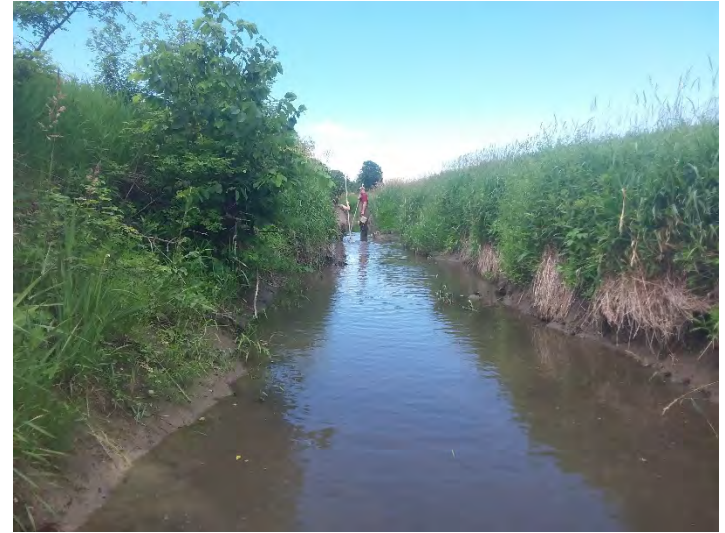
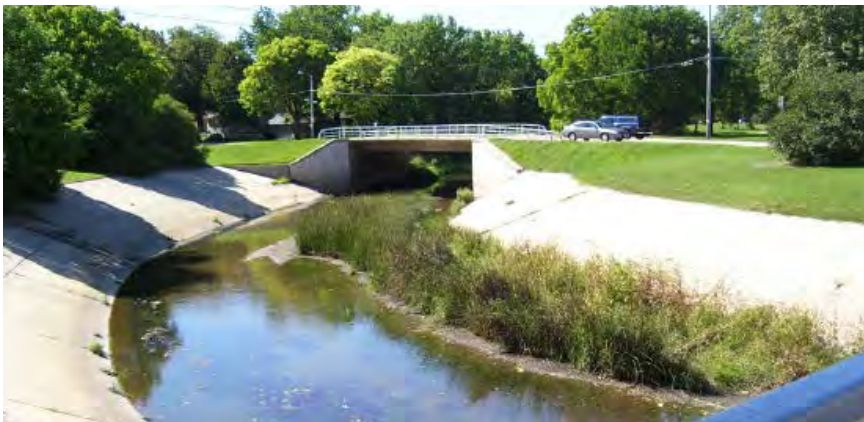
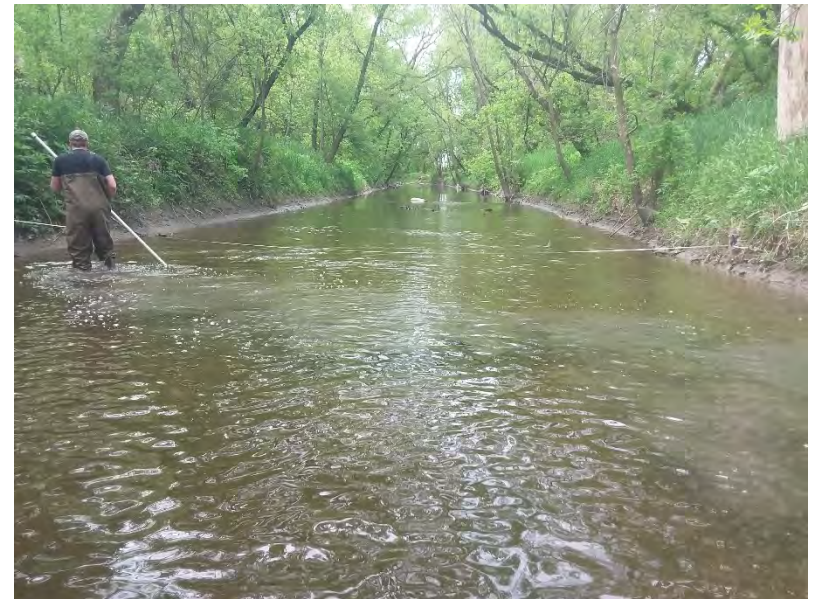
- Channel modifications come at a high ecological and aesthetic cost including:
 - Reduced diversity of instream habitat types (pools/riffles/runs)
 - Low baseflow water velocities which can lead to excessive deposition of silt
 - Greatly decreased connection of streams to their floodplain
 - This reduces storage capabilities to disperse flood waters, decrease destructive energy, and allow pollutants to settle out across the floodplain
 - Increased streamflow velocities during peak-flow
 - Streambank and streambed erosion

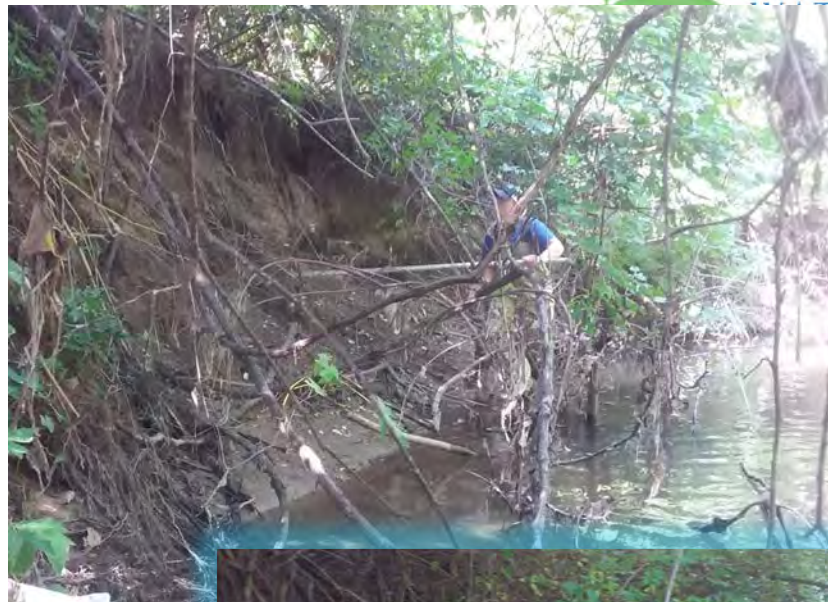
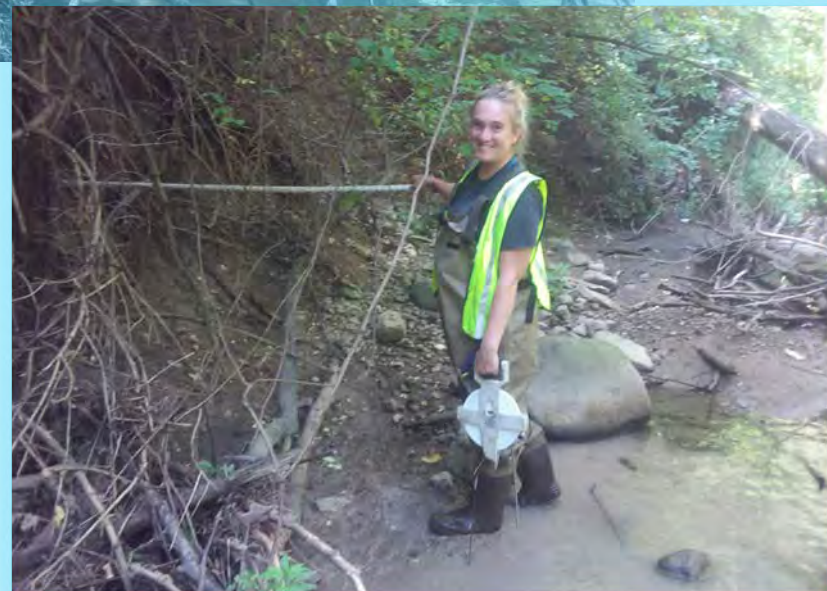
- Streambank erosion is a normal function of a stream system and not all streambank erosion is “bad”
 - Streambank erosion can provide needed bed material, channel diversity, and promote varied aquatic habitats
- However, excessive streambank erosion associated with a heavily altered and unstable stream system can contribute to:
 - Water quality degradation by releasing too much sediment (and associated nutrients) to the water
 - Aquatic habitat degradation caused by sedimentation
 - Damage to vital infrastructure (roads, culverts, and stormwater infrastructure)

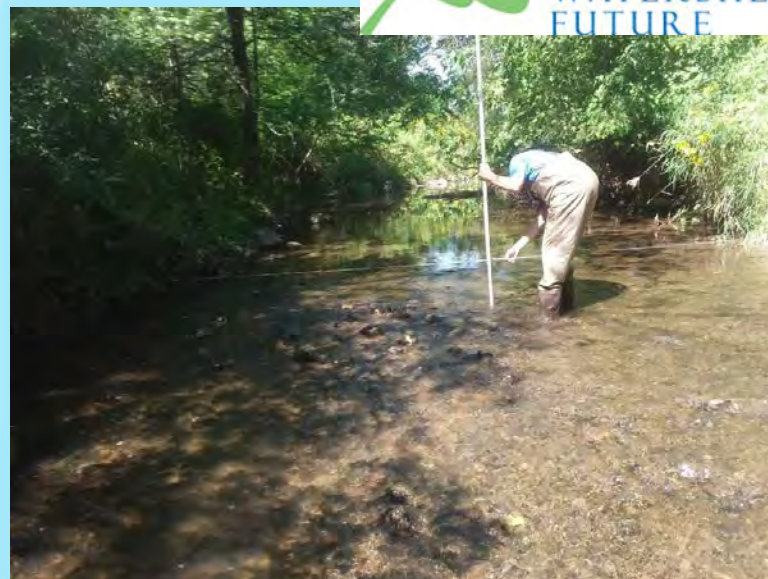
The following for each transect survey were measured:

- Bankfull width
- Bank height/slope (shape), undercut bank measurements
- Channelized bank height/width
- Water width
- Fish & macroinvertebrate cover types & amount
- Stream shading

Measured at 5 points along the transect:

- Bankfull depth
- Water and sediment depths
- Substrate composition
 - clay, silt, sand, gravel, cobble, boulders

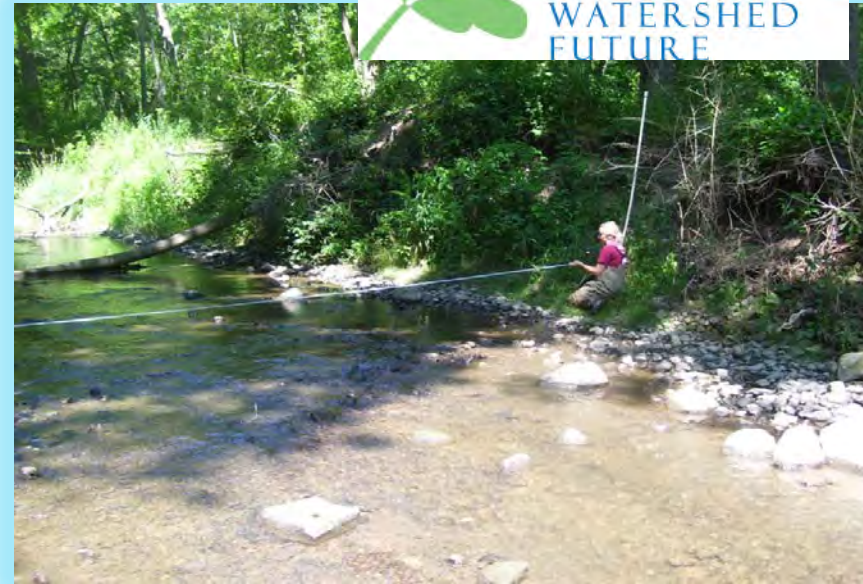
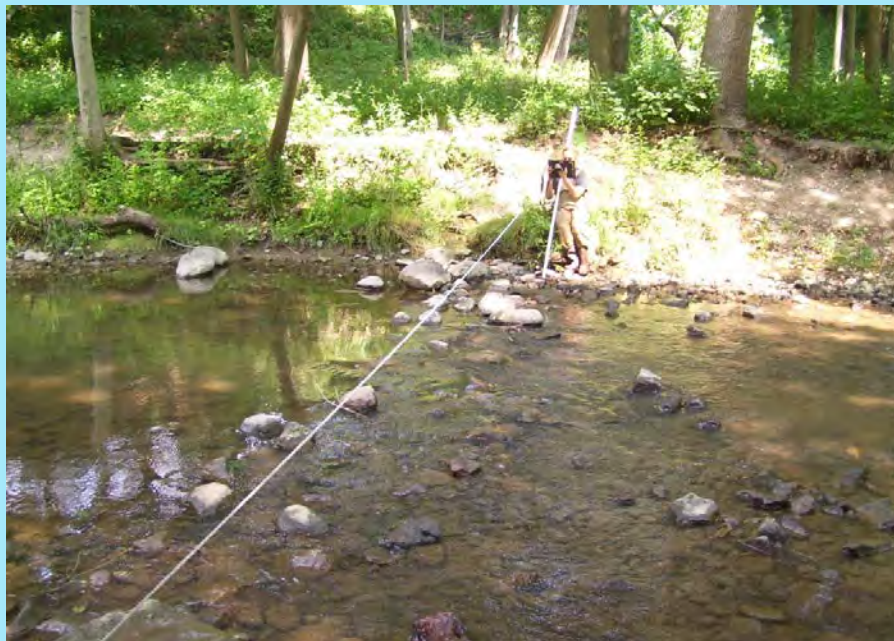
- Quantify available habitat for aquatic organisms (pools, riffles, runs, substrate types, cover, woody debris, shading)
- Give insight regarding physical process and channel change over time (natural and human induced)
- Define the range of flow variation (baseflow, bankfull, flood flow)

- Tell story of that particular habitat site and when analyzed collectively can tell a story about conditions at larger scales (reach and watershed scales)
- Identify problem areas
- Provides a baseline of information to compare to future studies
- Transect surveys were conducted at 162 locations along Oak Creek, North Branch, and Mitchell Field Drainage Ditch

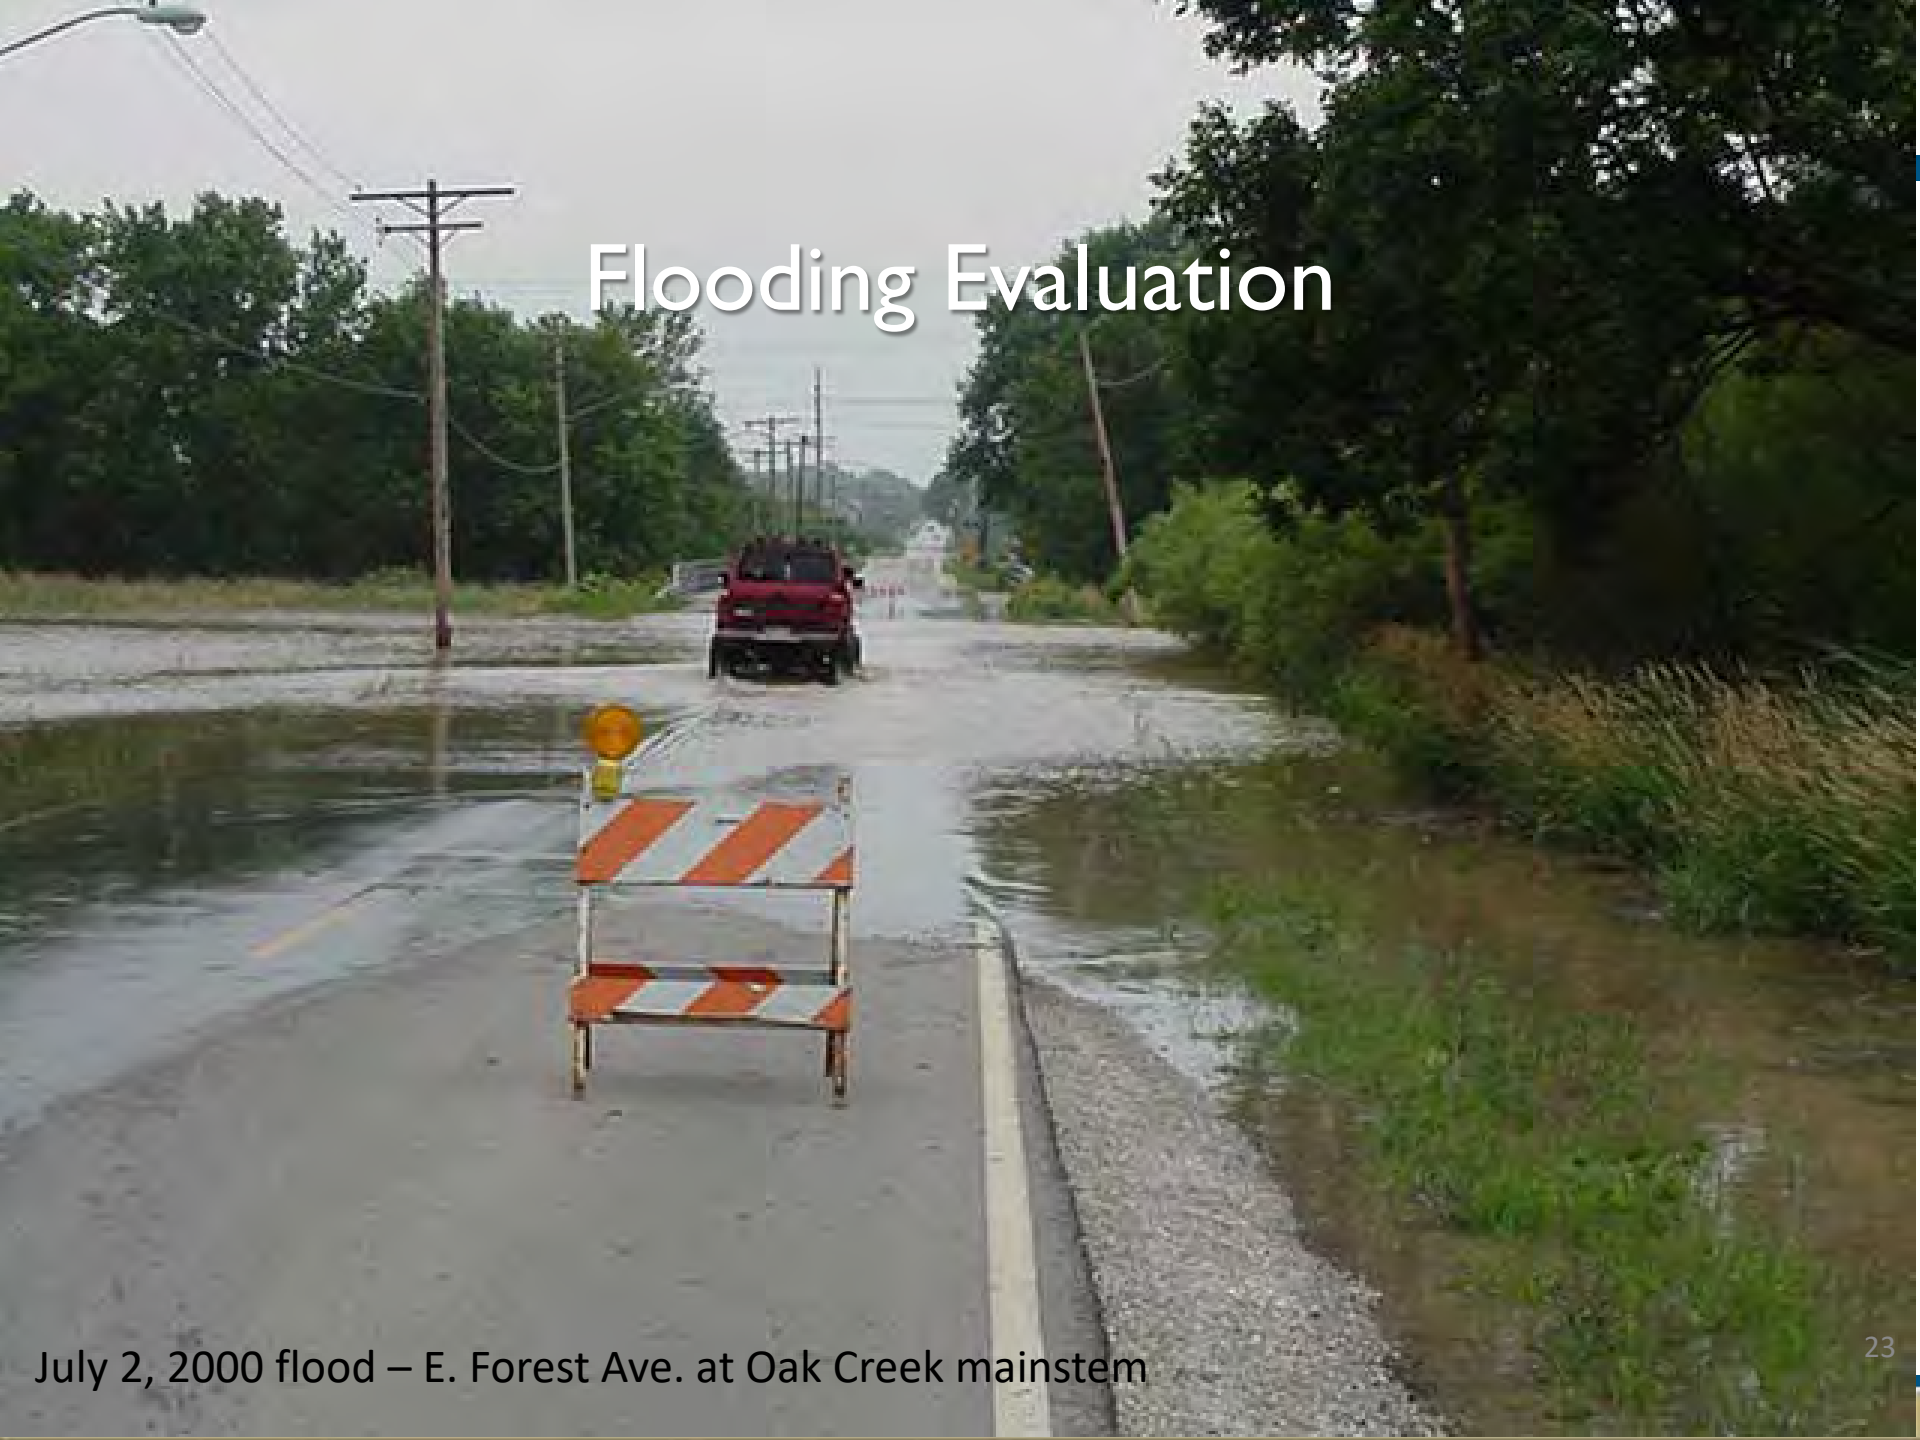
July 2, 2000 flood – E. Forest Ave. at Oak Creek mainstem

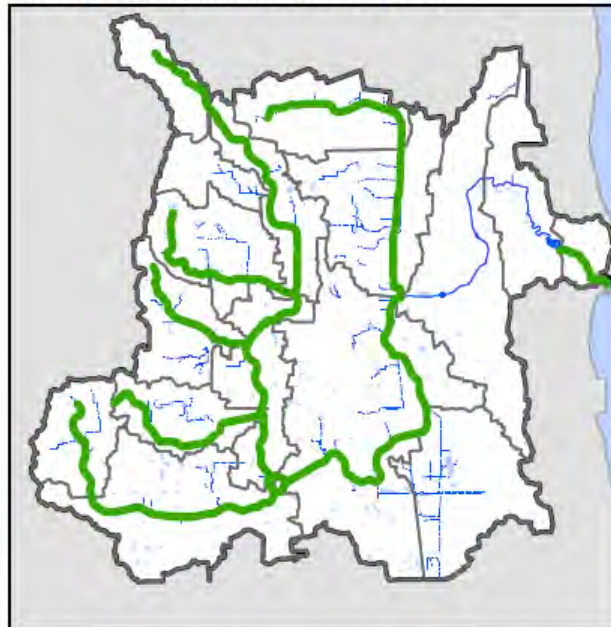
BROOK STICKLEBACK: PRESENT-DAY

- US Geological Survey modeled present-day fish communities and stream conditions
 - Analyzed stream condition and fish distribution changes under climate change scenarios
- Anticipated increase in stream temperature and streamflow under climate change
 - Decreased distribution of coolwater fish species (e.g., brook stickleback)
 - Increased distribution of invasive common carp

Green Line Indicates Modeled Species Distribution

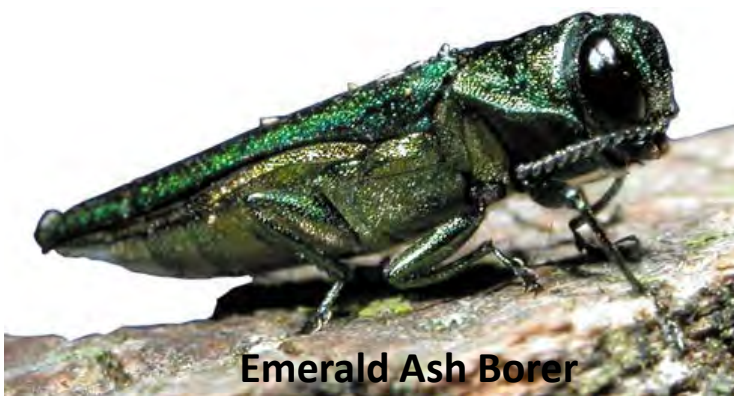
Emerald Ash Borer

■ Emerald ash borer causing extensive ash tree die-offs

- Higher stream temperatures with canopy loss can stress coolwater fish species

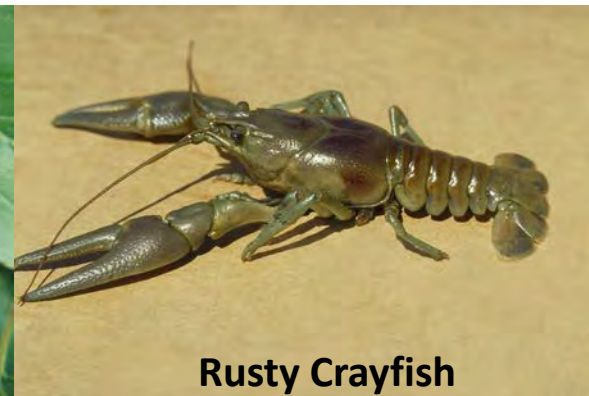
Rusty Crayfish

- Common carp, rusty crayfish, and zebra mussels observed in watershed
- Compete with native species, decrease stream clarity, and destroy aquatic vegetation

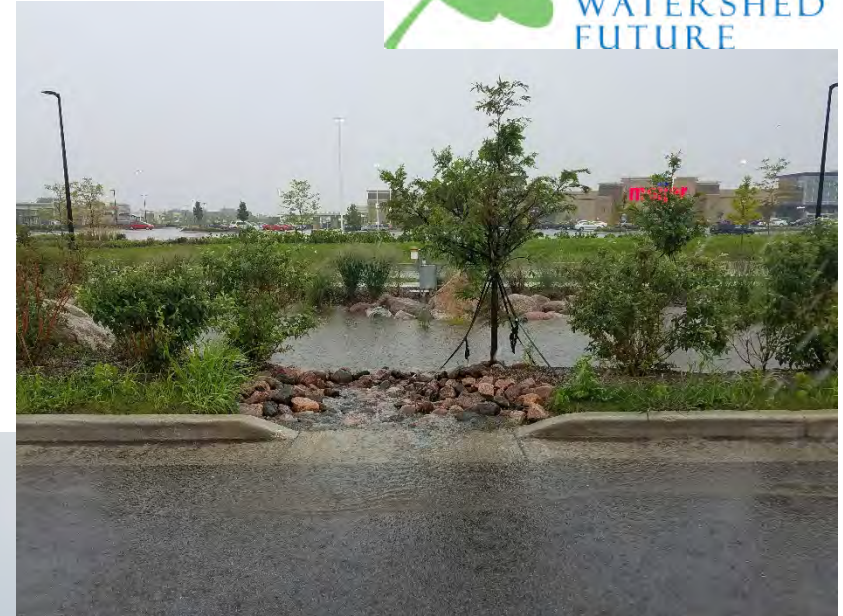
- Generally, stormwater BMPs installed in areas of the watershed developed prior to 1990 consisted of storm sewers, curb and gutter, catch basins, and grass swales.
- Development and redevelopment since 1990 continue to utilize these practices along with the addition of wet and dry stormwater detention basins and green infrastructure.
- Emerging stormwater management technologies differ from traditional practices in that they seek to better mimic the deposition of precipitation on an undisturbed landscape by retaining and infiltrating stormwater onsite.
- The most visible installations of green infrastructure within the Oak Creek watershed were installed as part of the Drexel Town Square development in the City of Oak Creek (see photos here)
