Community Assistance Planning Report No. 330

A RESTORATION PLAN FOR THE OAK CREEK WATERSHED

Chapter 4

INVENTORY FINDINGS

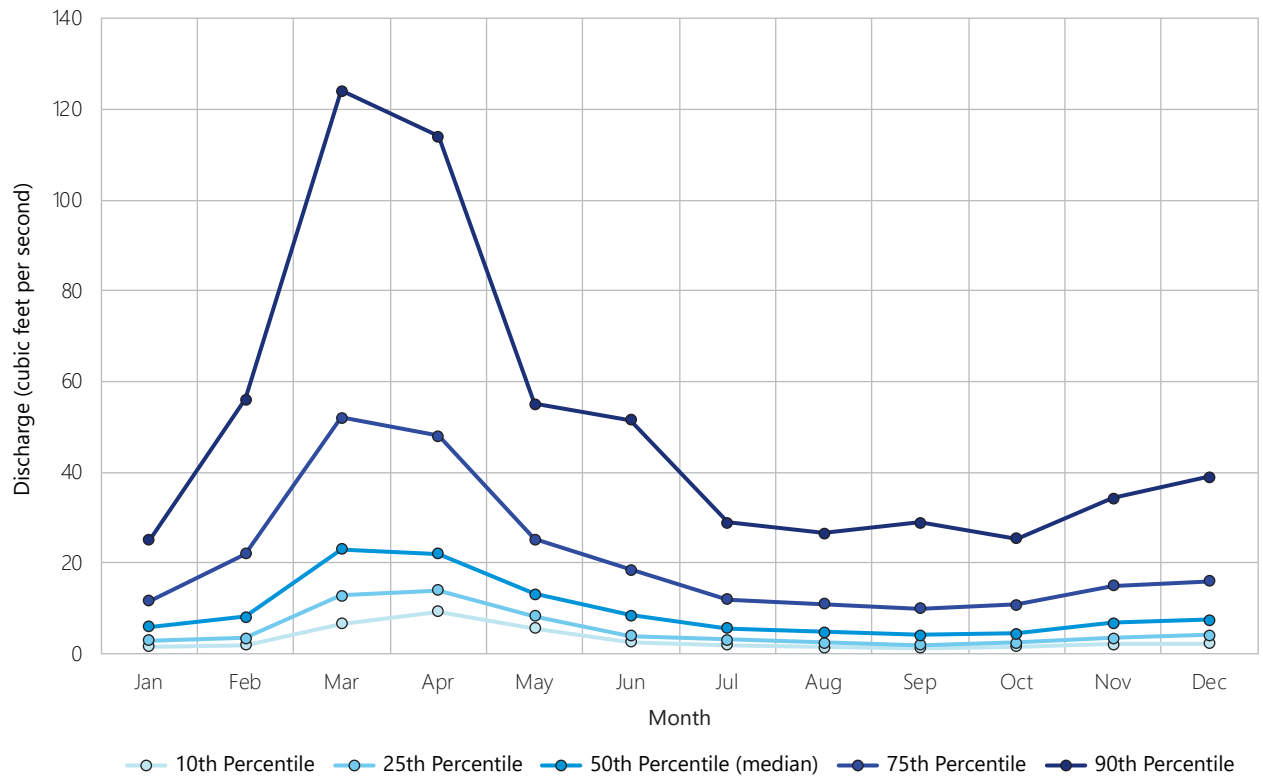
**Figure 4.X-Seasonal
Seasonal Percentiles of Stream Flow in Oak Creek
at the USGS Gage at 15th Avenue (RM 2.8): 1963-2017**

Figure **4.X-Seasonal Flow** shows the seasonal pattern of streamflow in Oak Creek at the stream gage at 15th Avenue over the period of record, October 1963 through December 2017. The average daily discharge data were disaggregated into months and the flow value for the 10th percentile, 25th percentile, 50th percentile (median), 75th percentile, and 90th percentile ranks were determined for each month.³ The 50th percentile ranks indicate typical flow conditions at this gage and show a strong seasonal pattern. This pattern begins in January, when the flow in the stream is relatively low. From January through March, flow increases rapidly in response to snowmelt and spring rains. Peak flow typically occurs in March. Following this, flow decreases over late spring and summer. This decrease results from a number of factors, including the end of snowmelt, increases in evapotranspiration due to higher temperatures, and increased infiltration of precipitation due to thawed soil conditions. The lowest flows of the year usually occur in September for Oak Creek. Flow then increases relatively slowly over the fall and winter, reaching a second peak in December. The peak that occurs in December is typically much lower than the peak that occurs in March.

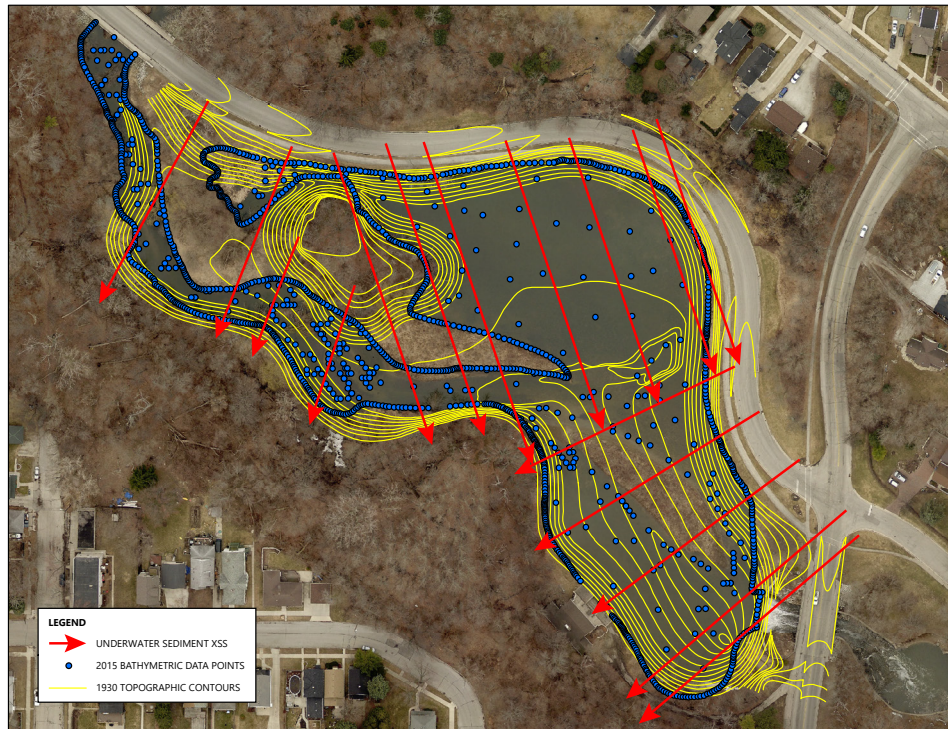
Below Water Cross Sections

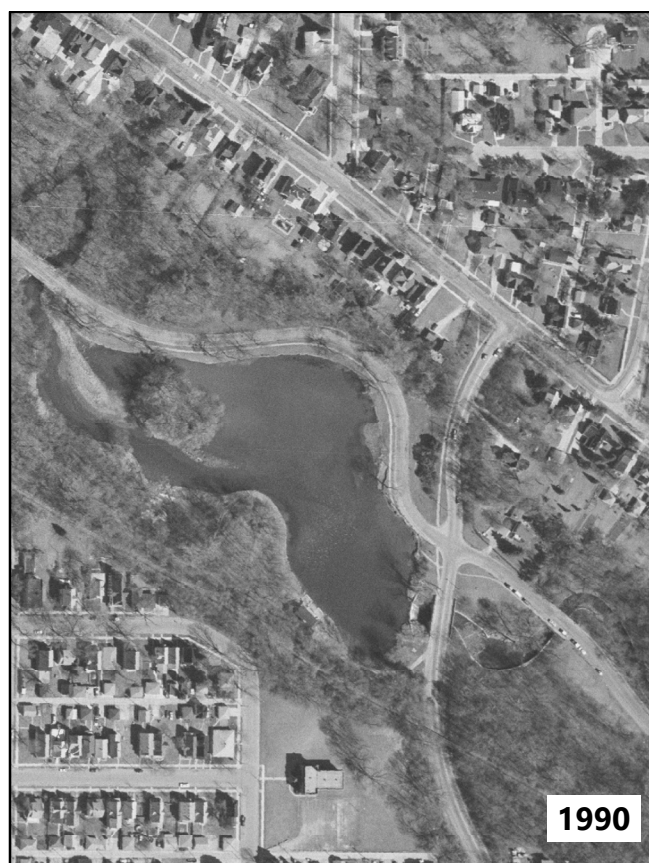
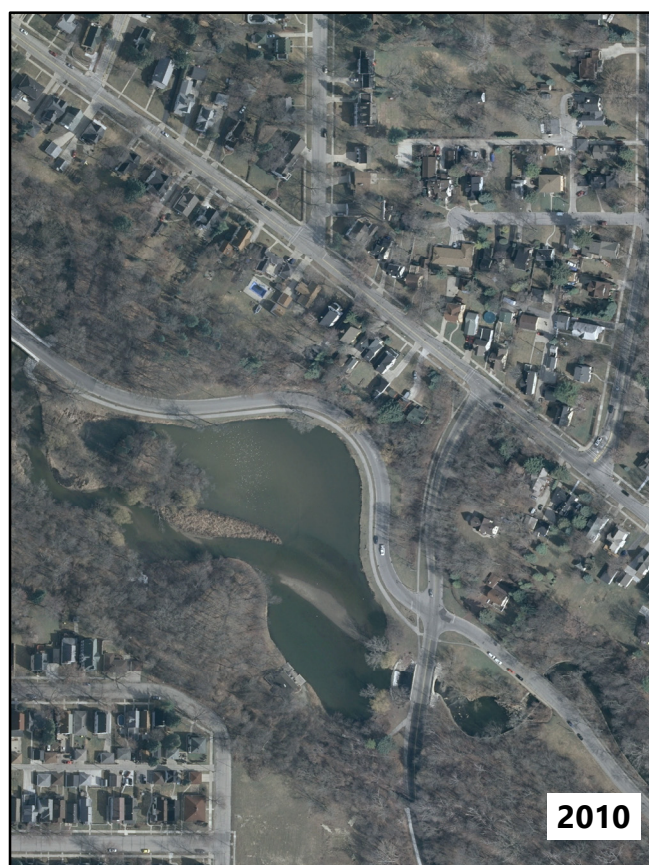
Figure 4.Dam-8
Oak Creek Mill Pond Comparison: 1980, 1990, 2005, and 2010

Figure 4.Dam-8 shows a comparison of historical aerial photographs of the Mill Pond area for 1980, 1990, 2005, and 2010. All of the aerial photos appear to have been taken in spring which may have coincided with high water conditions at the Mill Pond. The year 1980 photo was taken after the late 1970s dredging and shows the absence of a peninsula near the inlet to the pond and island in the southeastern portion of the Mill Pond. The year 1990 photo indicates sediment starting to accumulate in the pond at the inlet and near the pond island (this island was part of the original plans for the pond). It is unclear if this photo was taken before or after the 1990 dredging effort. Sediment continued to drop out in the pond by the year 2005 photo, with the peninsula at the inlet connecting to the eastern portion of the pond island. The year 2010 aerial photo is starting to show the formation of the southeastern island near the Mill Pond dam. The 2015 aerial photo, which is the most recent, shows a larger sediment island by the dam (Map 4.Dam-1).

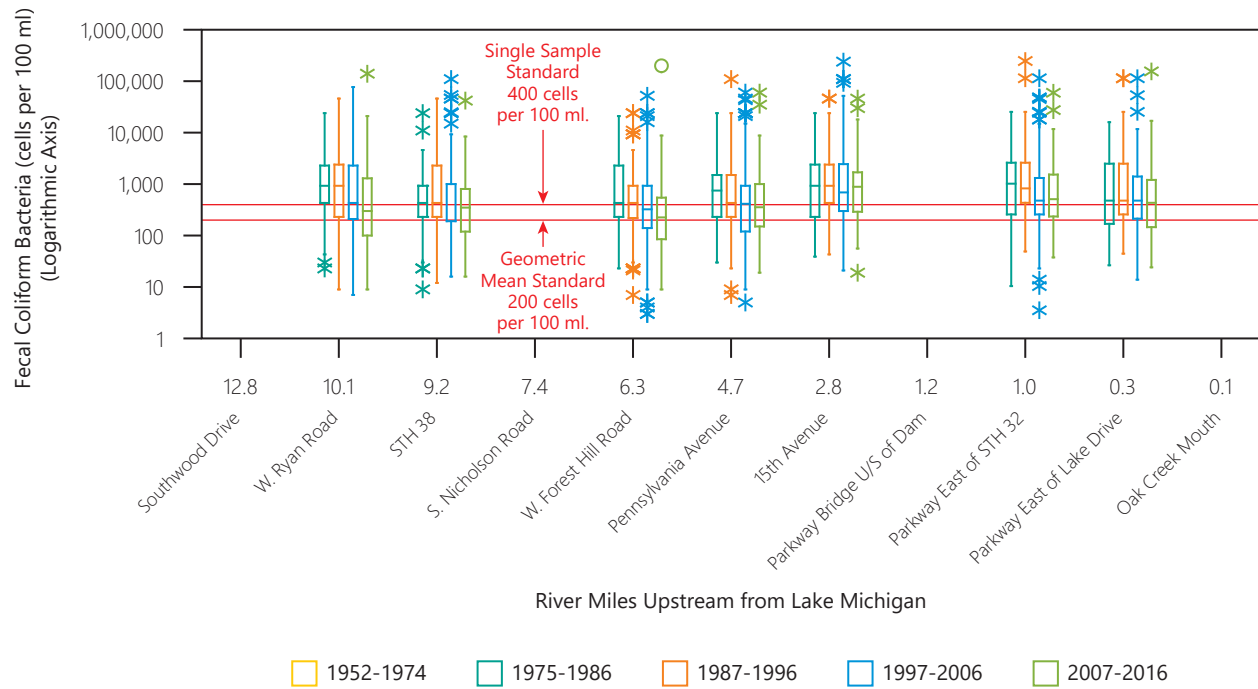
Figure 4.X Bact-1
Concentrations of Fecal Coliform Bacteria at Sites Along the Mainstem of Oak Creek: 1952-2016

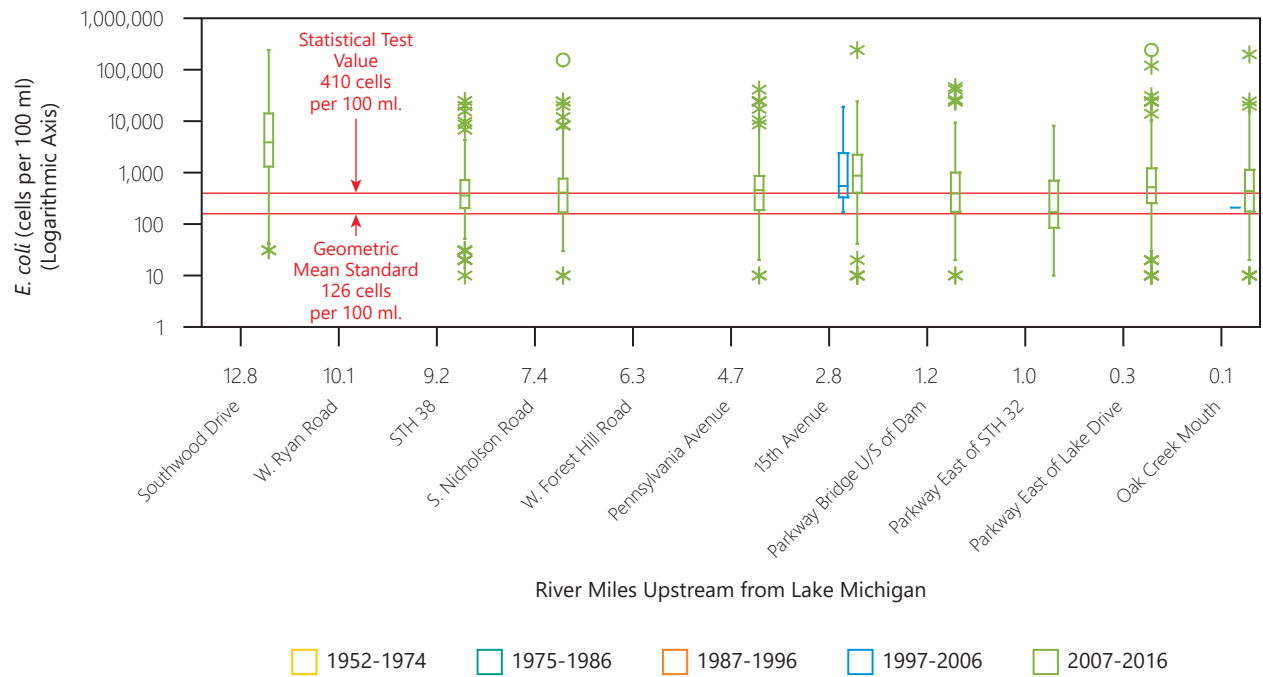
Figure 4.X Bact-3
Concentrations of *E. coli* Bacteria at Sites Along the Mainstem of Oak Creek: 1952-2016

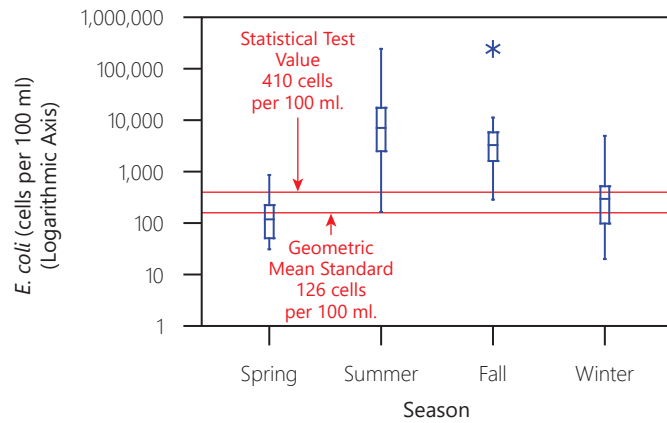
Figure 4.X Bact-6
Seasonal Concentrations of *E. coli* Bacteria in Oak Creek at Southwood Drive (RM 12.8): 2007-2016

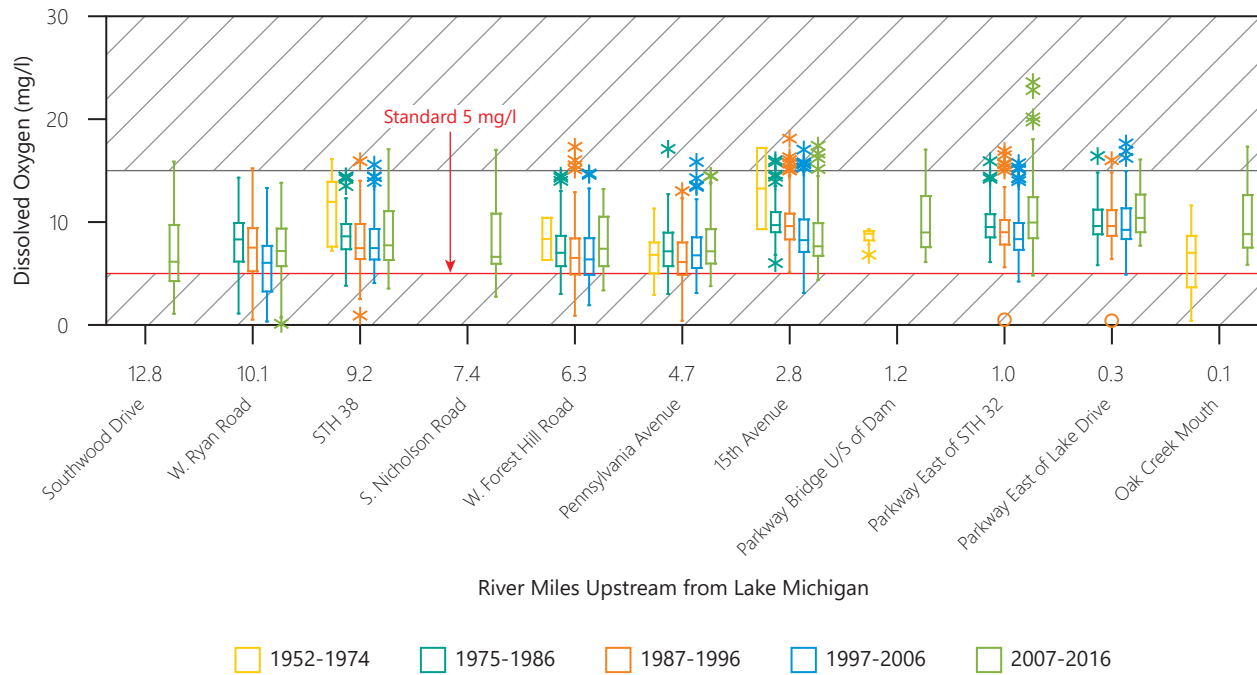
Figure 4.X Dissolved Oxygen-1
Concentrations of Dissolved Oxygen at Sites Along the Mainstem of Oak Creek: 1952-2016

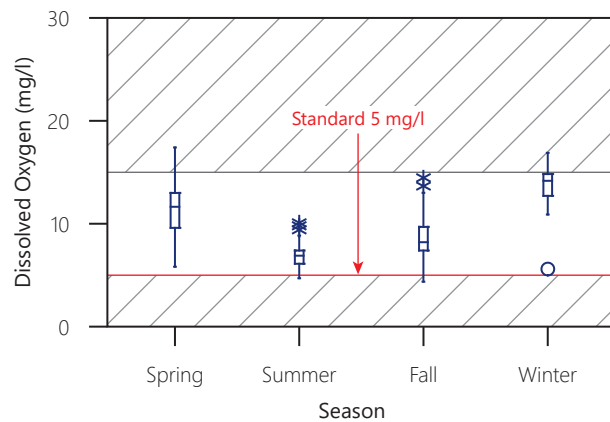
Figure 4.X Dissolved Oxygen-4
Seasonal Concentrations of Dissolved Oxygen
in Oak Creek at Oak Creek Parkway East
of STH 32 (RM 1.0): 2007-2016

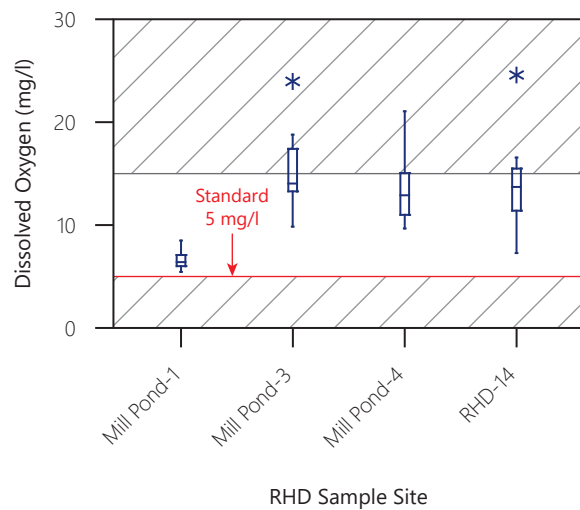
Figure 4.X Dissolved Oxygen-6
Concentrations of Dissolved Oxygen at Sites
in the Oak Creek Mill Pond: 2015-2016

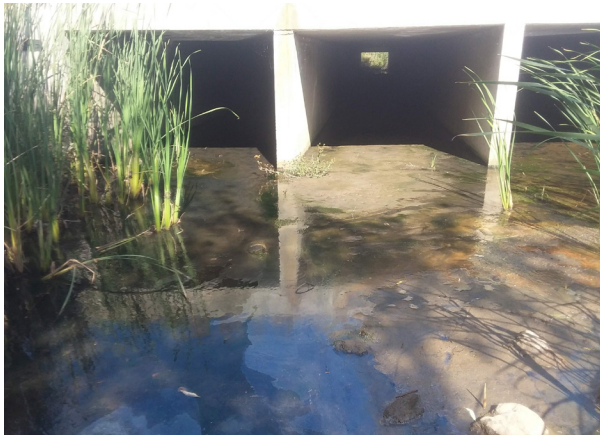
Figure 4.X Dissolved Oxygen-7
Oily Blue Water Flowing out of College
Avenue Culvert into the Mitchell Field
Drainage Ditch: September 29, 2017

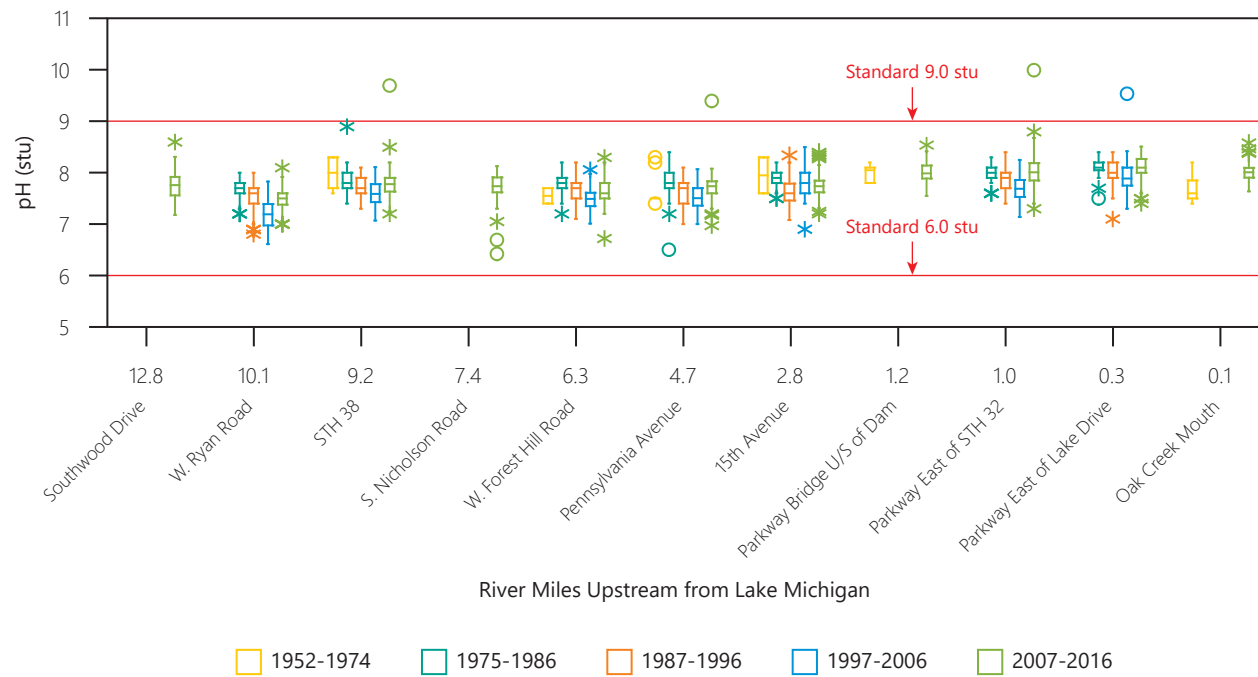
Figure 4.X pH-1
pH at Sites Along the Mainstem of Oak Creek: 1952-2016

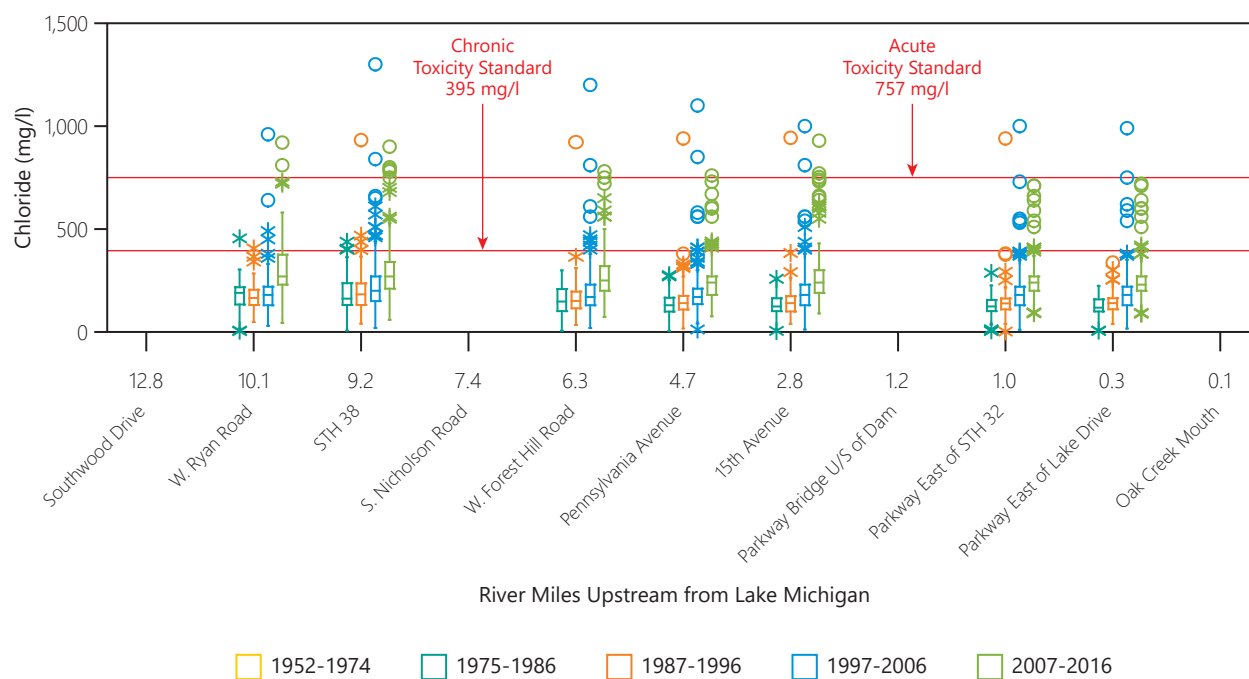
Figure 4.X Chloride-1
Concentrations of Chloride at Sites Along the Mainstem of Oak Creek: 1952-2016

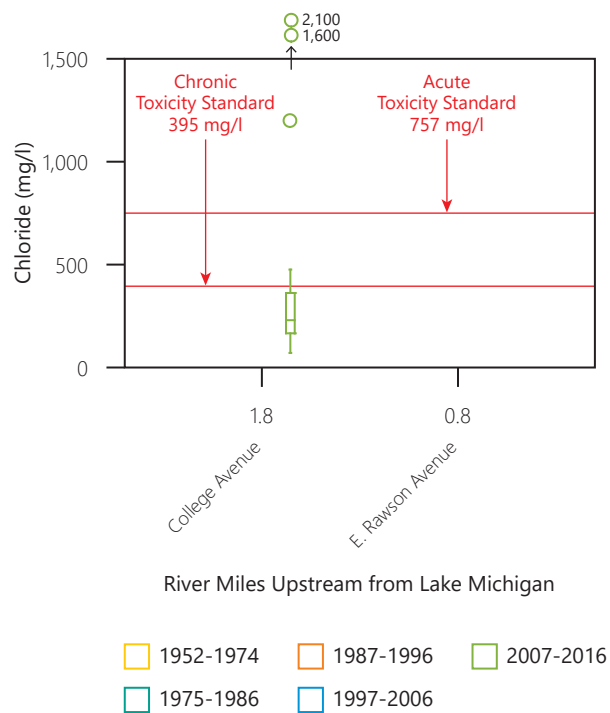
Figure 4.X Chloride-2
Concentrations of Chloride at Sites Along
the Mitchell Field Drainage Ditch: 1952-2016

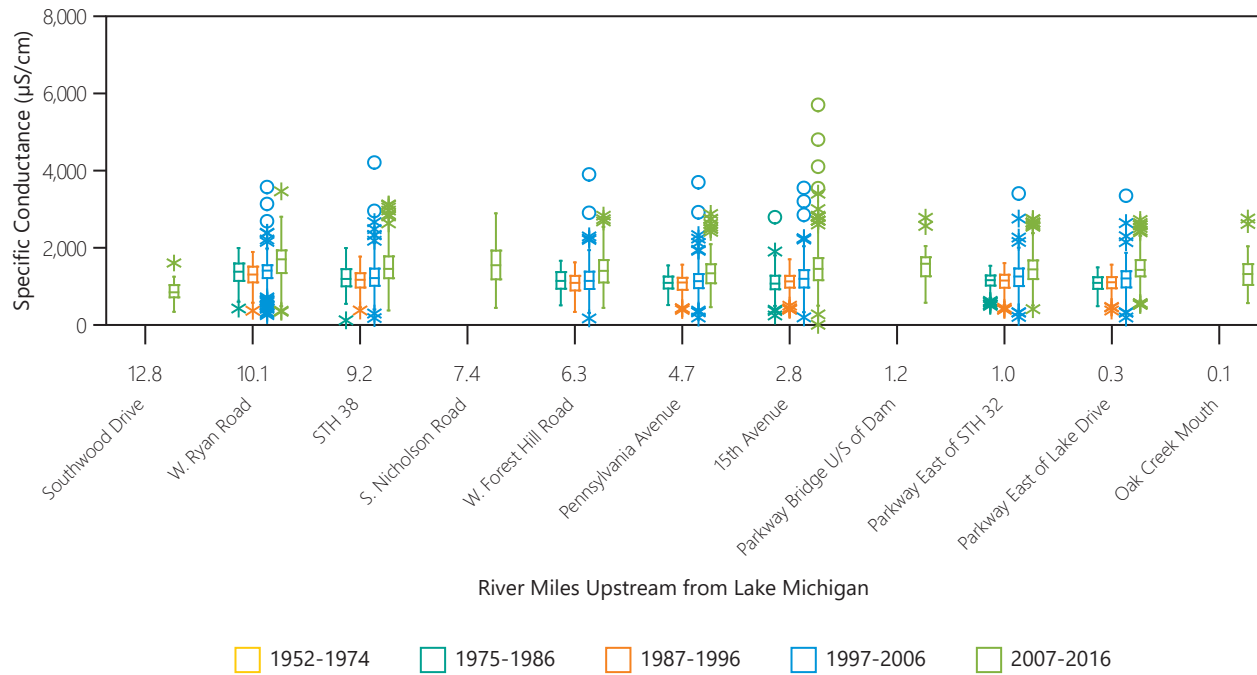
Figure 4.X Conductance-1
Specific Conductance at Sites Along the Mainstem of Oak Creek: 1952-2016

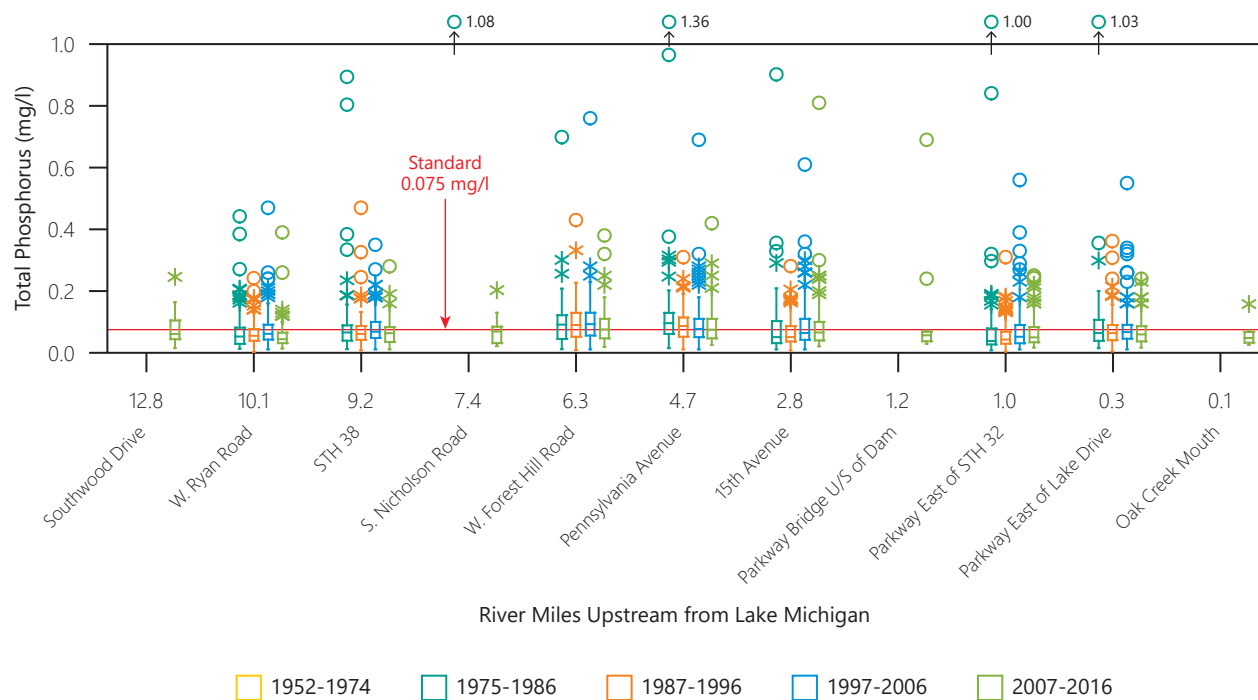
Figure 4.X Tot-P-1
Concentrations of Total Phosphorus at Sites Along the Mainstem of Oak Creek: 1952-2016
