Community Assistance Planning Report No. 330

A RESTORATION PLAN FOR THE OAK CREEK WATERSHED

## **Chapter 4**

# **INVENTORY FINDINGS**

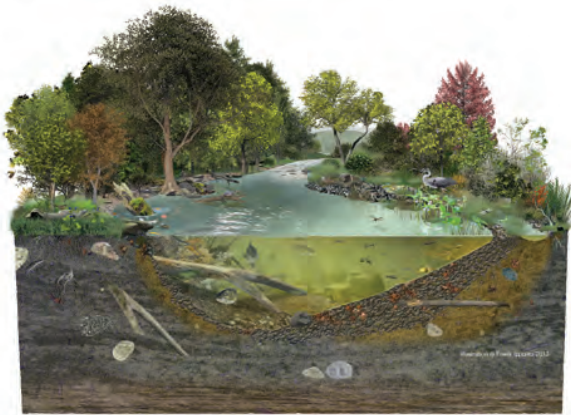
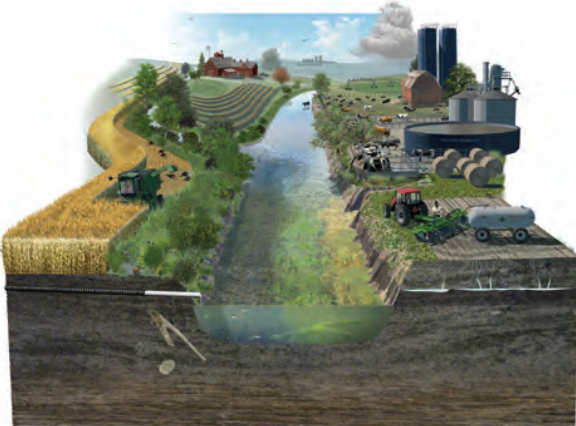
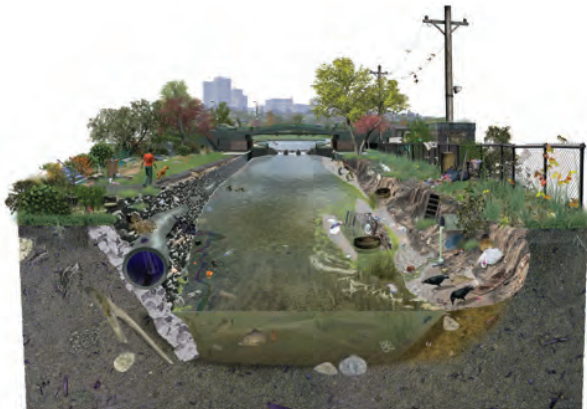
Natural Stream Ecosystem

Agricultural Stream Ecosystem

Urban Stream Ecosystem

The health of a stream system is a direct reflection of its watershed. The interaction of a stream's physical, chemical, and biological components determines its ecological health (see **Figure 4.1**). Reduced stream health is often associated with human-induced changes that influence the physical and chemical properties of streams and the lands that surround them. Changes in the land use and hydrology of a watershed commonly result in degradation of water quality and habitat, and in turn, the degradation of the resident biological communities.

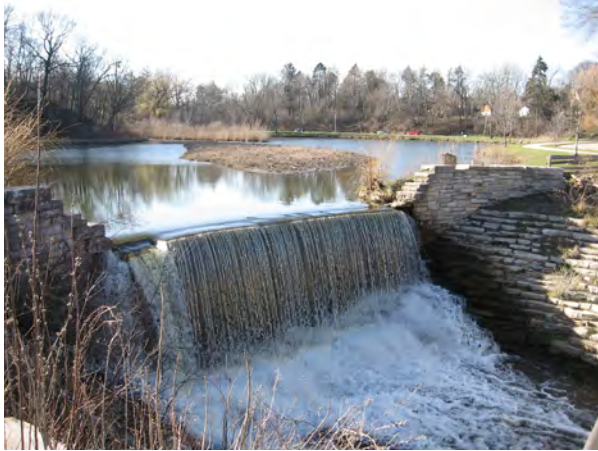
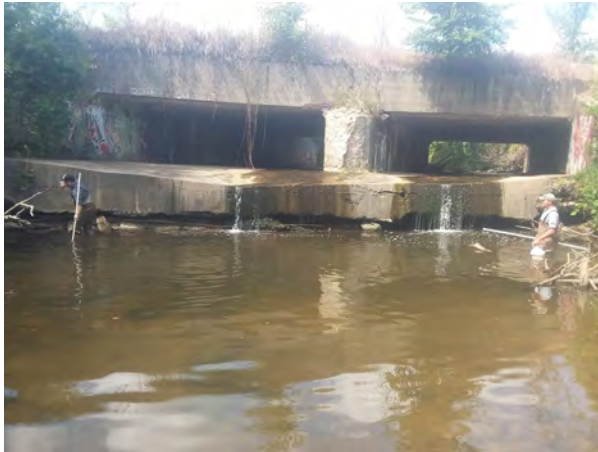
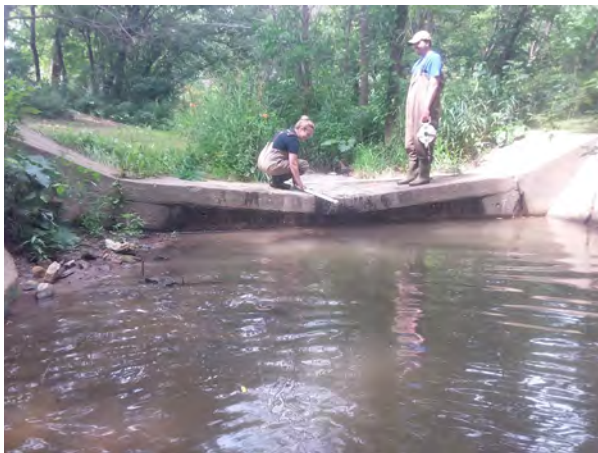
**Figure 4.27**  
**Examples of Fish Passage Impediments Caused**  
**by Significant Elevation Drops in Structures**

**Structure Number 4**  
Mill Pond Dam

**Structure Number 65**  
Canadian Pacific Railroad

**Structure Number 52**  
Concrete Weir Crossing Oak Creek

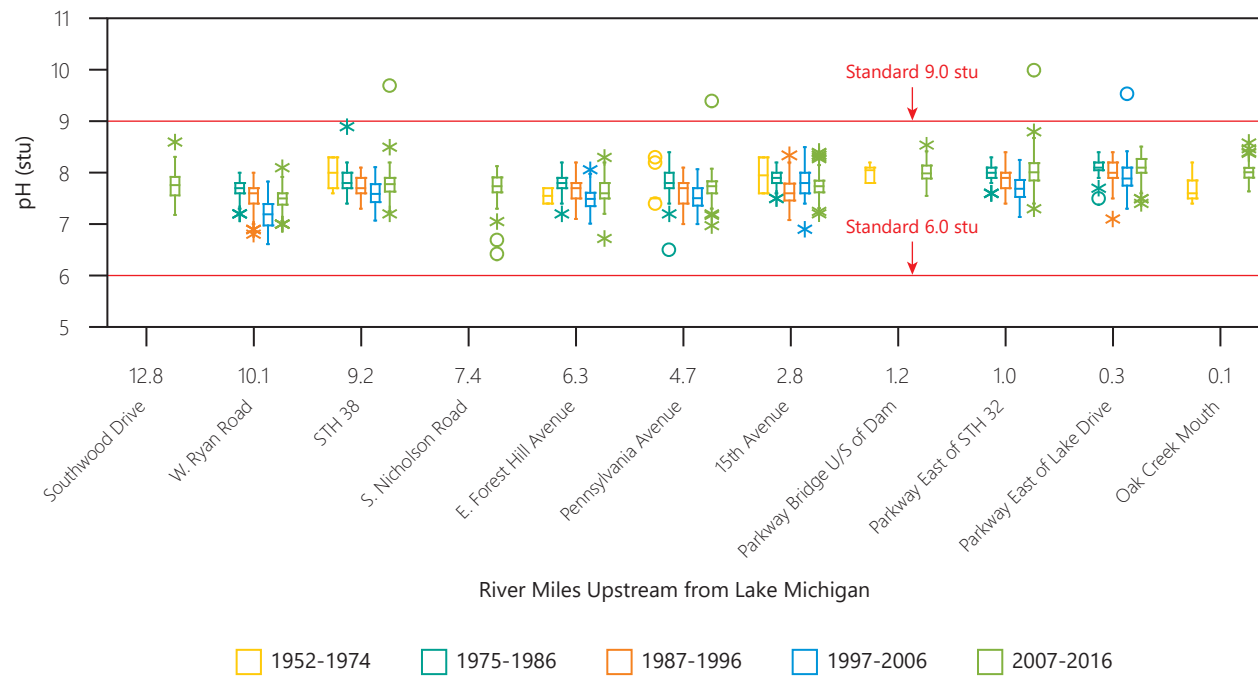
**Figure 4.80**  
**pH at Sites Along the Mainstem of Oak Creek: 1952-2016**

Figure 4.80 shows the values of pH at selected sampling stations along the mainstem of Oak Creek. During the period 2007 through 2016, pH in the mainstem of Oak Creek ranged between 6.36 stu and 10.00 stu with a median value of 7.80 stu. Values of pH at these stations were only rarely outside the range of 6.0 stu to 9.0 stu specified in Wisconsin's water quality criteria, with over 99.9 percent of samples complying with the criteria. The few measurements that were outside this range were between 9.0 stu and 10.0 stu. In addition, at most sampling stations pH varied by less than  $\pm 1.0$  stu from the station's mean value.

Figure 4.80 shows two trends in the data. First, at those sampling stations for which sufficient data are available to assess temporal trends, pH in the Creek decreased between the periods 1975 through 1986 and 1997 through 2006 and then increased during the period 2007 through 2016. Depending on the sampling station, the decrease in median pH ranged between 0.2 stu and 0.5 stu, with the median at most stations decreasing by about 0.3 stu. The subsequent increase in median pH ranged between 0.1 stu and 0.3 stu, with the median at most stations increasing by about 0.2 stu.

The second trend observed in Figure 4.80 is that pH in Oak Creek tended to increase from upstream to downstream. This increase was not continuous along the length of the Creek. Rather, most of the increase appeared to occur at two locations. One increase occurred between the sampling stations at W. Ryan Road (RM 10.1) and STH 38 (RM 9.2). During the period 2007 through 2016, the increase in the median value of pH between these two stations was about 0.30 stu. Given that the confluence of the North Branch of Oak Creek with the mainstem of Oak Creek is located between these two stations, some of the increase in median pH between these two stations may be attributable to water flowing into Oak Creek from the North Branch

The pH increases may also reflect inputs of groundwater into the mainstem of Oak Creek. Shallow groundwater in the Oak Creek watershed consists of hard water, with hardness in excess of 120 mg/l as calcium carbonate ( $\text{CaCO}_3$ ).<sup>121</sup> Water this hard is generally alkaline and usually has a high pH. As part of field surveys, Commission staff identified two suspected sites of groundwater seepage into the mainstem of Oak Creek between stations at W. Ryan Road (RM 10.1) and STH 38 (RM 9.2) (see Map 4.25). Two other suspected sites of seepage were identified just upstream of the Mill Pond. While the amount of seepage observed at these sites during the field survey was not great, it may be contributing to the increases in pH shown in Figure 4.80.

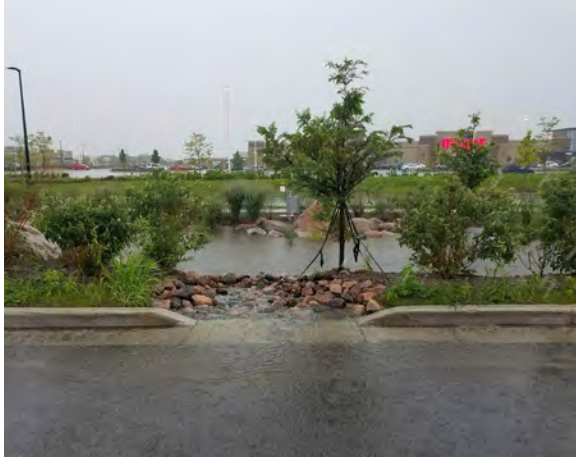
Bioswale Capturing Runoff from  
Parking Lots at Drexel Town Square

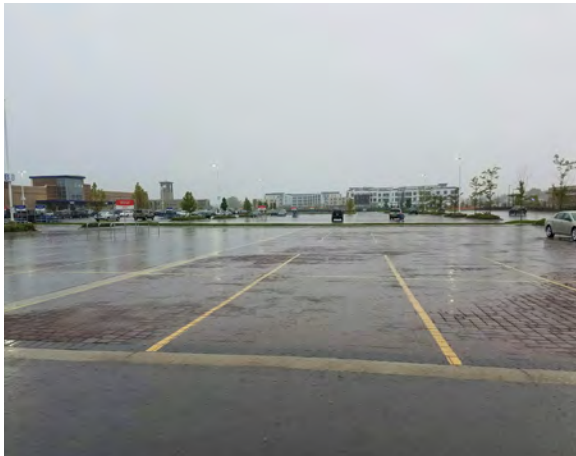
Porous Pavement Infiltrating Runoff from  
Parking Lot at Drexel Town Square

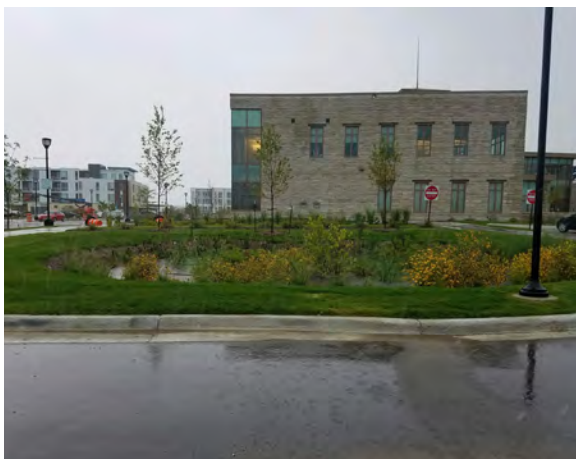
Rain Garden Capturing Runoff  
at the Oak Creek City Hall and Library

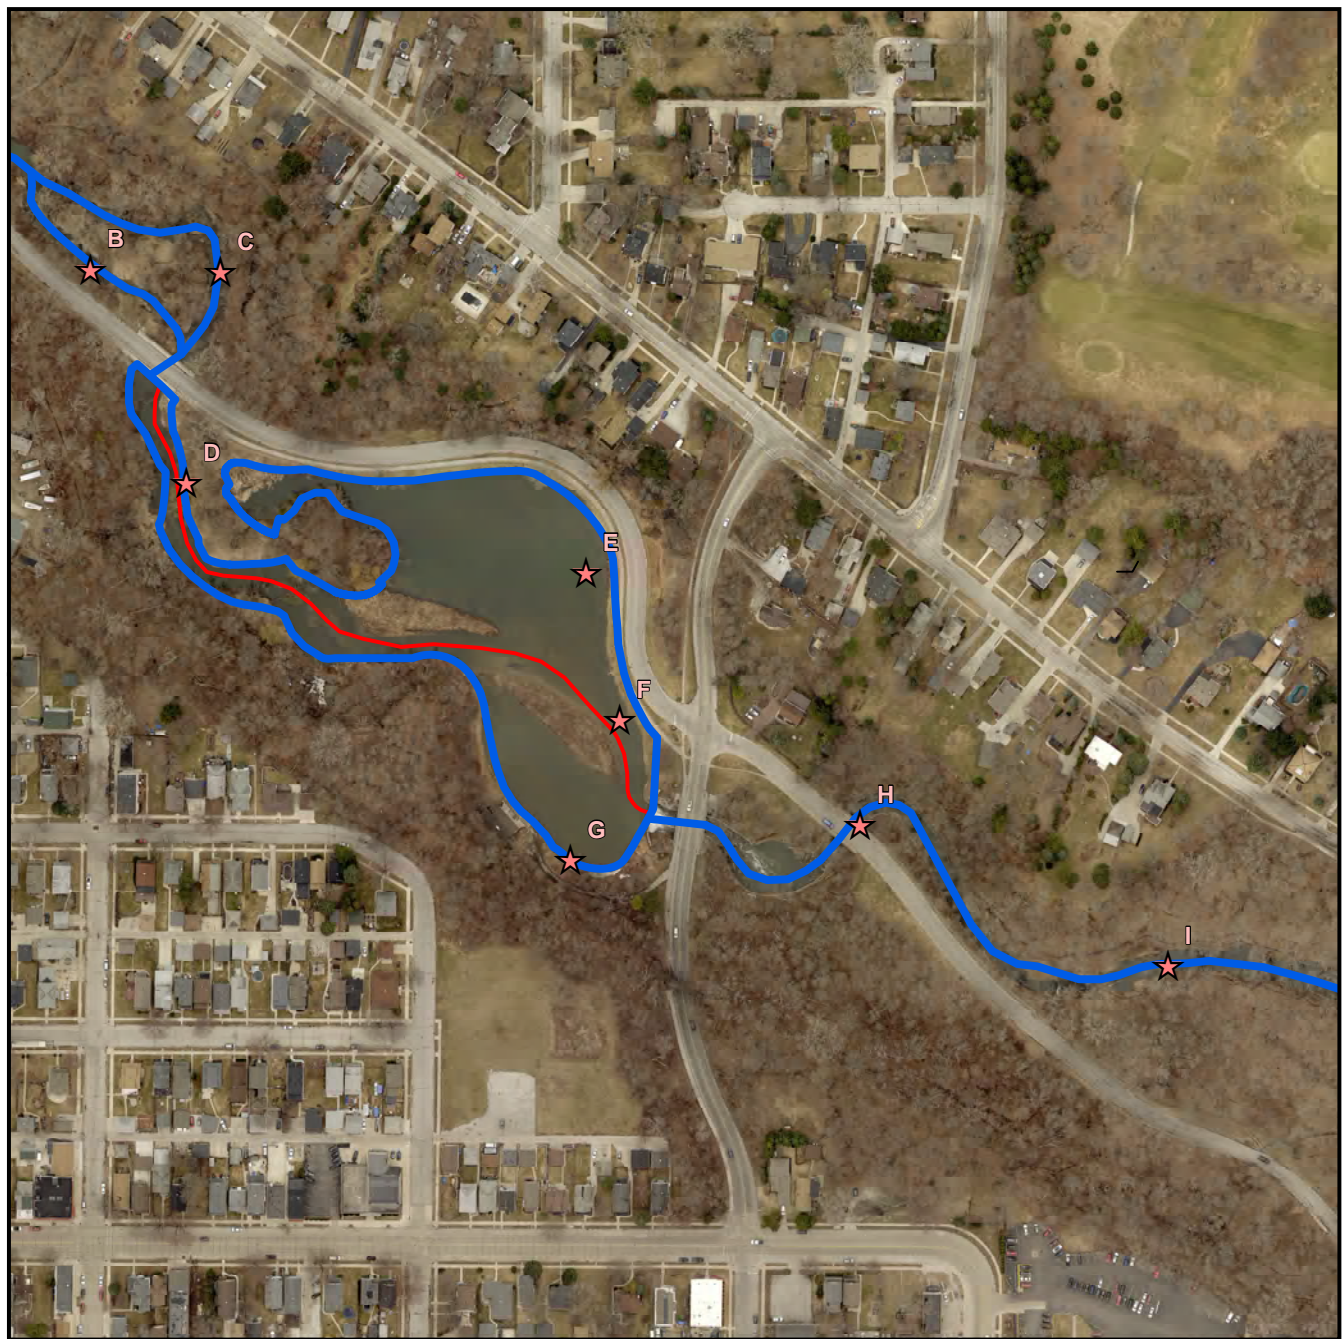
Map 4.24  
Continuous Temperature Monitoring Sites in Oak Creek Upstream, Within, and  
Downstream of the Mill Pond: June 7 through October 10, 2019

- 2015 PERENNIAL STREAM
- PATH OF WATER FLOW THROUGH THE MILL POND
- ★ TEMPERATURE LOGGER LOCATION
