SEWRPC Technical Report No. 61

FIELD MONITORING AND DATA COLLECTION FOR THE CHLORIDE IMPACT STUDY

Chapter 4

DATA MANAGEMENT AND DOCUMENTATION

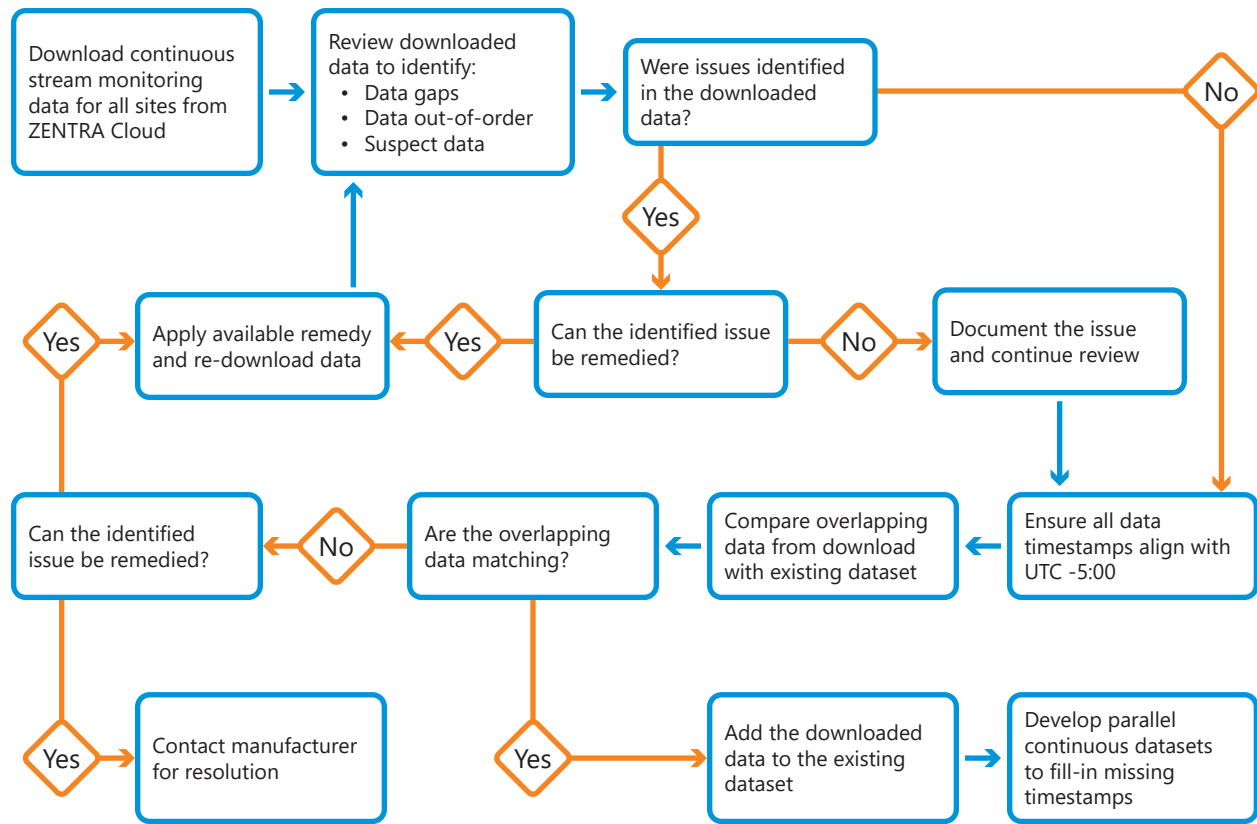
Figure 4.1
Continuous Stream Monitoring Data Download and Review Process

Raw continuous datasets for the stream monitoring sites were constructed incrementally from the periodic downloads, starting from site installation through decommission. However, before the downloaded data were added to the raw continuous dataset for each site, the data were reviewed and evaluated for acceptability. The continuous monitoring data download and review process described in the following paragraphs is illustrated in **Figure 4.1**.

During review, the datasets were examined to identify data gaps, repeated data, data with timestamps out of chronological order, or suspect data that might indicate an issue with the equipment. The continuous datasets were subject to two different types of data gaps: sensor gaps occurred when the in-stream sensor was unable to communicate with the data logger, while telemetry gaps occurred when the data loggers were unable to either record data or upload data. Telemetry gaps could be caused by the loss of battery power or an equipment problem, preventing the device from recording data. Telemetry gaps could also occur when a device was unable to upload data to the ZENTRA Cloud platform due to an issue with the communication components or problems with ZENTRA Cloud. For sensor gaps, the timestamps are present in the dataset during the sensor gap periods, but "NA" is displayed in place of the missing sensor data. In

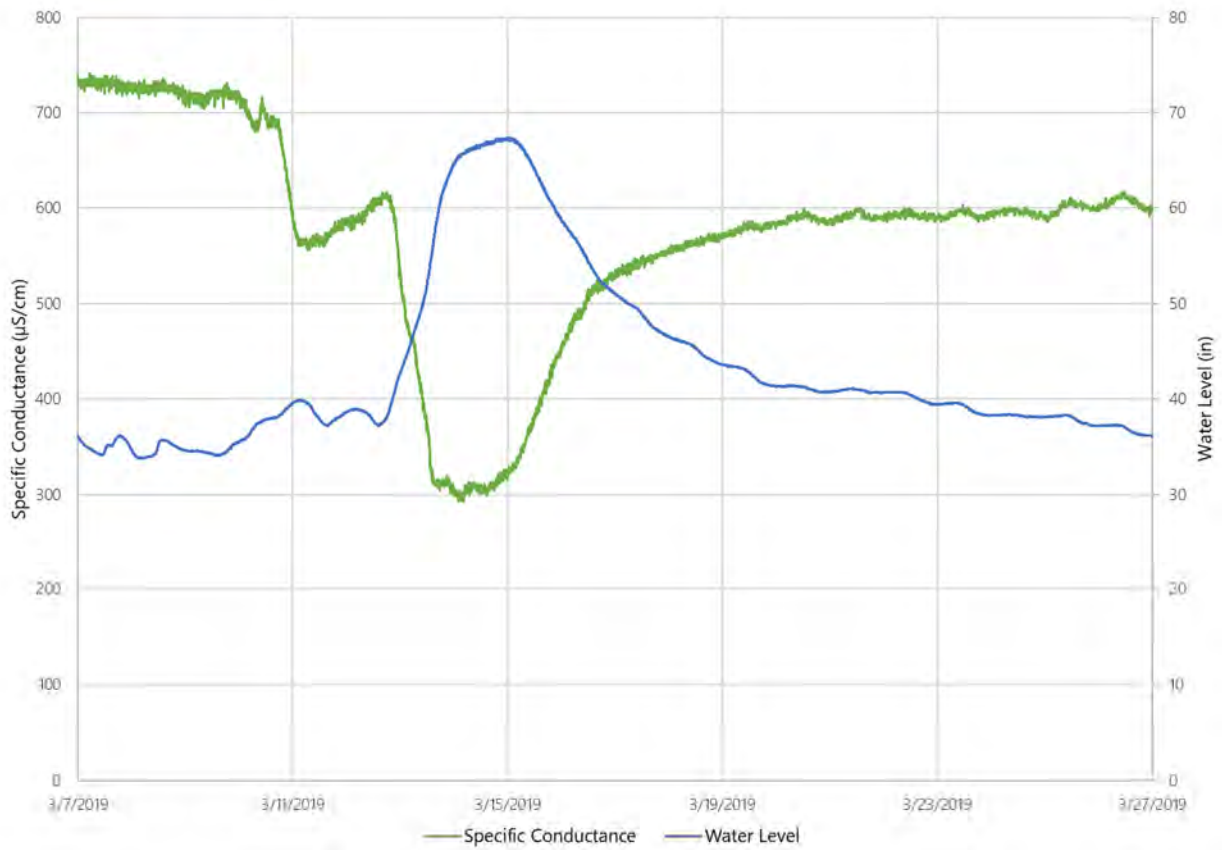
Figure 4.2
Stream Water Level and Specific Conductance During a Precipitation Event

Simultaneous visualization of specific conductance and water level highlighted the relationship between the two variables and was critical to the process of identifying data potentially affected by fouling. Specific conductance measures the ability of water to conduct electricity. Water level is related to the amount of water flowing in the stream. In many situations, there is an inverse relationship between specific conductance and water level. As the amount of water flowing in a stream increases, water levels rise. Under some conditions this increase in water volume will dilute the number of ions in the water, causing a decrease in specific conductance. **Figure 4.2** shows an example of this dilution effect that was observed during a precipitation event at a stream monitored for this Study. When the amount of water entering the stream due to the rainfall and runoff decreased, water levels receded, and specific conductance levels typically

rebounded. Additionally, a different signal may occur under other conditions. For example, during spring thaw in an urbanized area, water from melting snow may transport additional chloride to waterways. Under these conditions, specific conductance may increase as water levels increase.

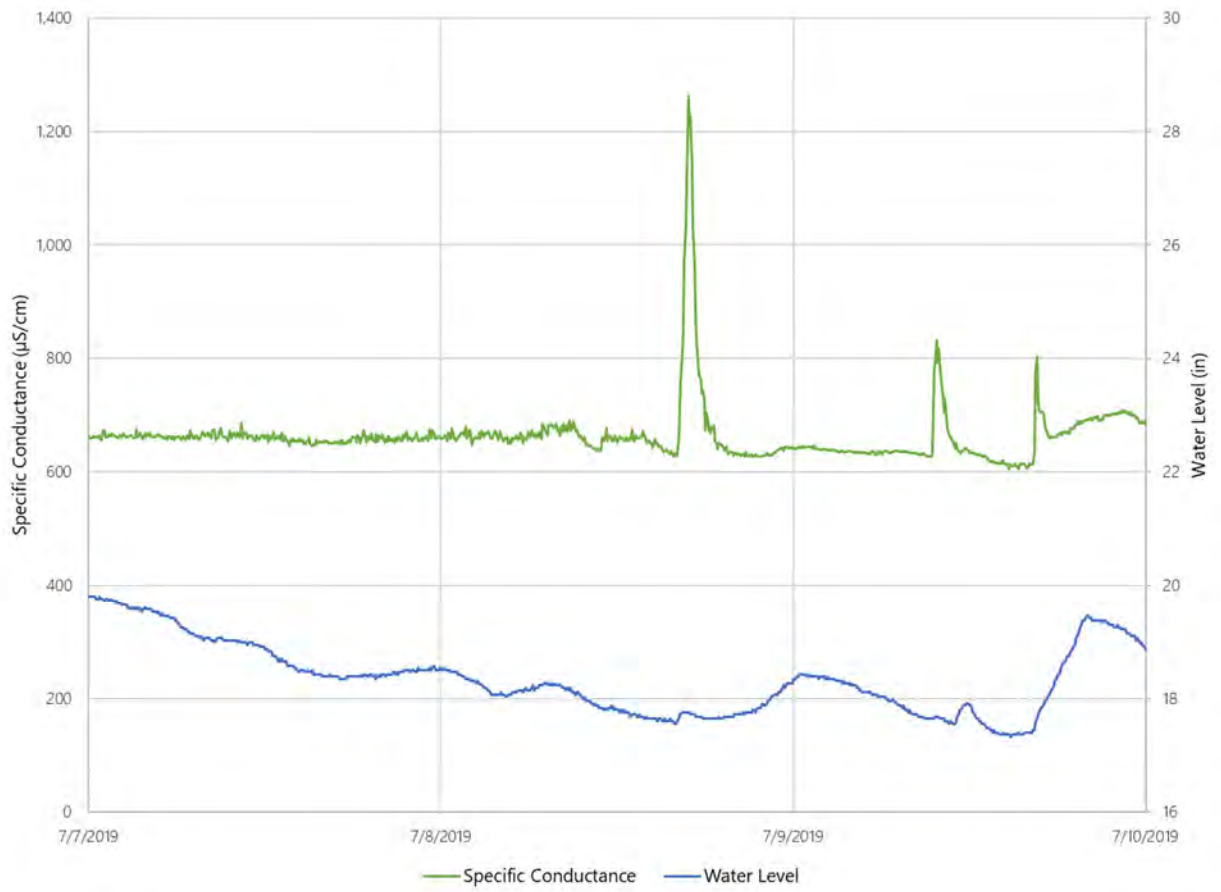
Figure 4.3
Example of Specific Conductance Spike Data Signature

A spike in the continuous dataset is characterized by an unusually high, short duration increase in specific conductance that rapidly returns to its prior level (see [Figure 4.3](#)). Spikes that had greater than 25 percent divergence from the initial reading were investigated further, as such spikes could result from legitimate increase in conductance caused by the first flush of chloride-laden runoff into the stream due to a precipitation event. The majority of the specific conductance spikes examined were explained by changes in water level or in the meteorological records and did not require any adjustment. When a water level increase or weather event did not precede the spike, it was flagged as potentially erroneous data. Given their short duration, spikes are likely to have little effect on future analyses for this Study. Because of this, no adjustments were made to specific conductance spikes in the Study dataset.

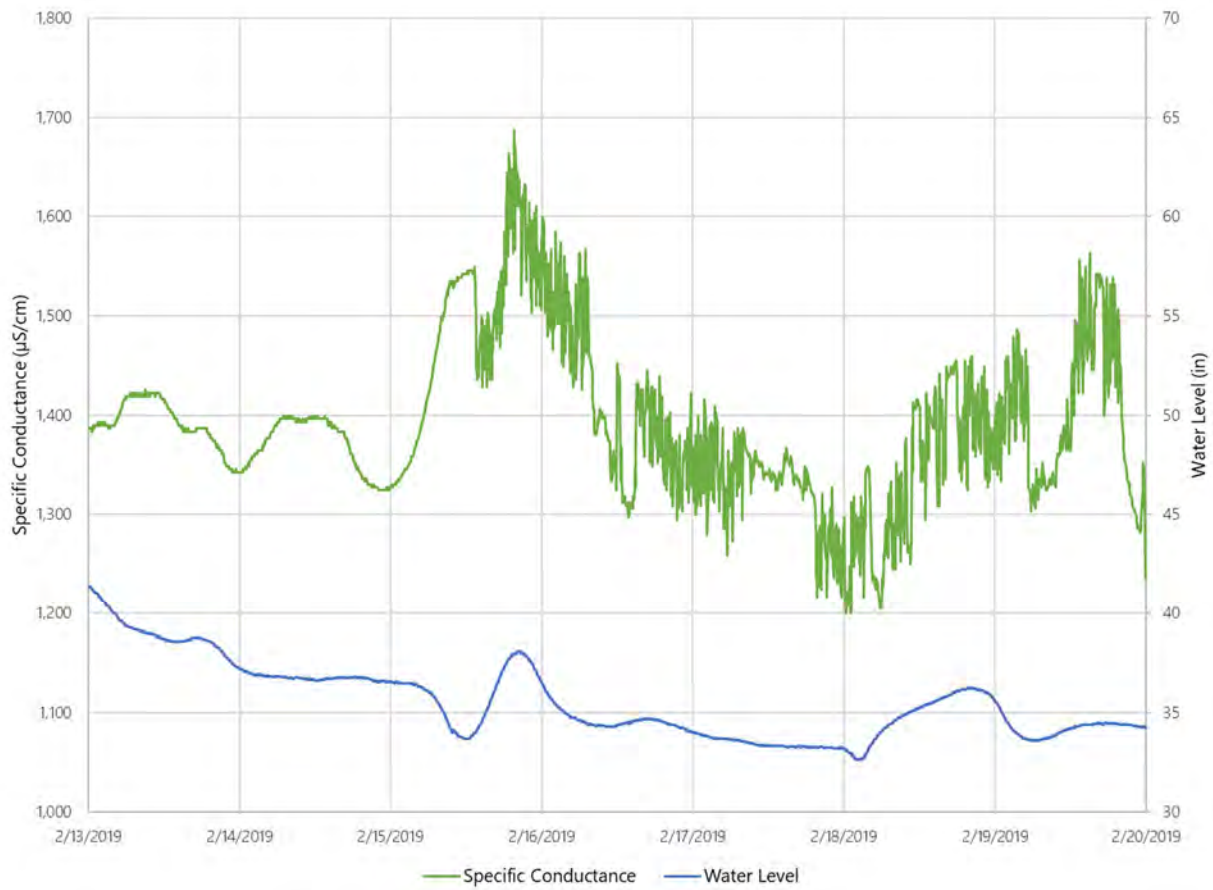
Figure 4.4
Example of Specific Conductance Noise Data Signature

Noise in the data was defined by repeated high frequency fluctuations in specific conductance (see [Figure 4.4](#)). Some noise events in the CTD-10 dataset lasted for a few hours, while others lasted for weeks or months. The cause of these fluctuations could not be identified. Potential explanations include radio frequency interference or invertebrates interfering with the electrodes in the sensor, but these hypotheses could not be substantiated. The short duration and relatively small magnitude of individual fluctuations during noise events suggested that noise would have limited impact on analyses for this Study. Because of this, no adjustments were made to noise in the continuous specific conductance datasets.

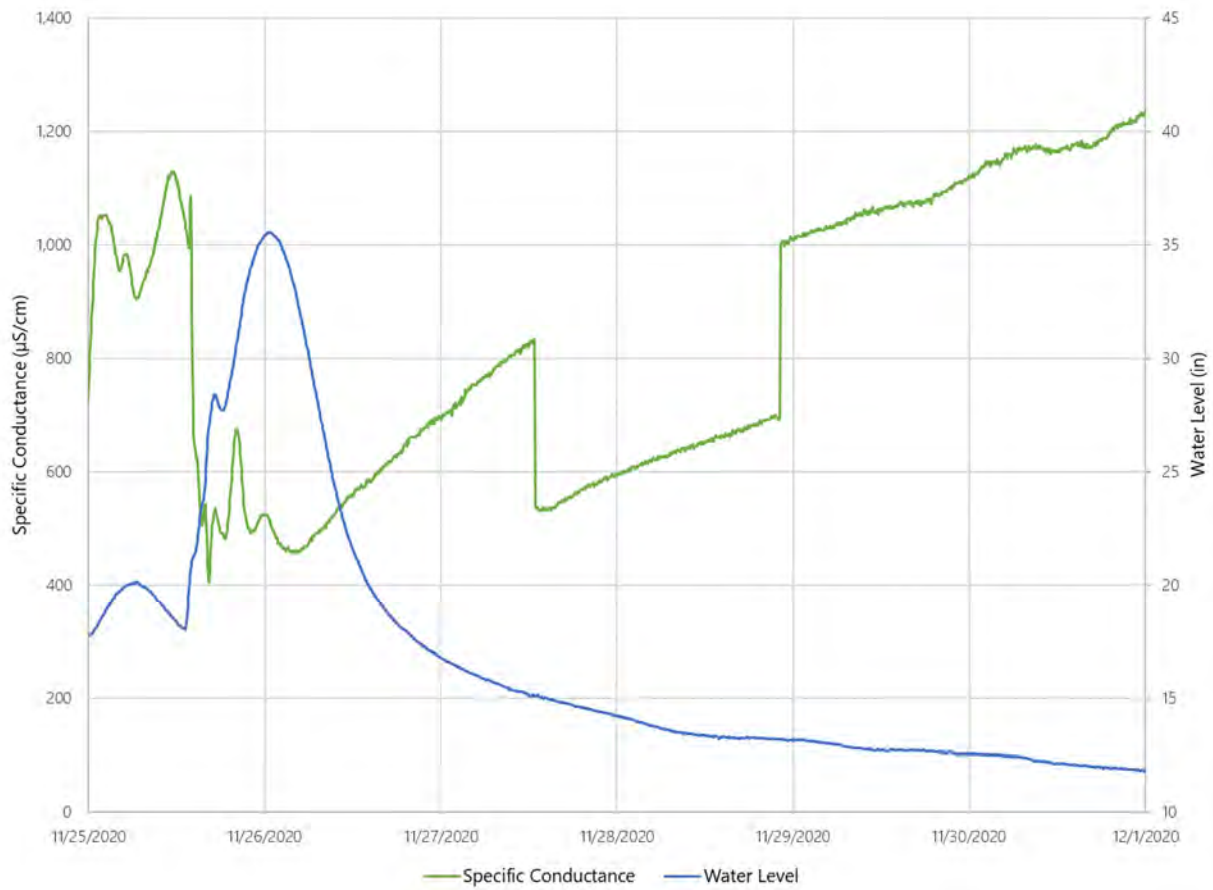
Figure 4.5
Example of Specific Conductance Tooth Data Signature

A tooth in the data was characterized by sudden decrease or increase in specific conductance followed by a period during which conductance remains at the lower or higher level. This period is followed by a sudden return to the original level (see [Figure 4.5](#)). Tooth-type signatures were identified when changes in measured specific conductance of at least 10 percent occurred over periods of 15 minutes or less. These were less common than some of the other signatures and only five instances of this example were recorded. The cause of this data signature could not be identified. Because of their rarity, no adjustments were made to the continuous specific conductance datasets for these instances.

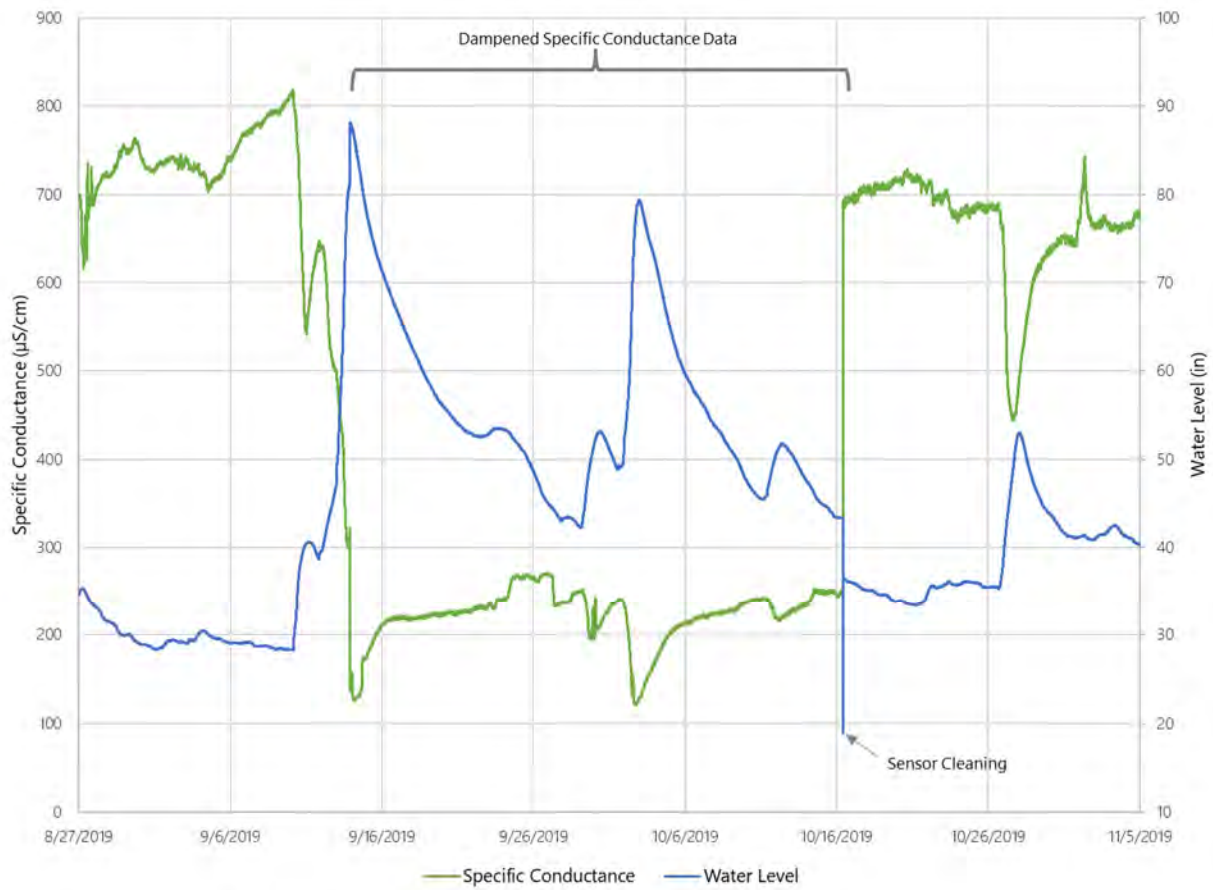
Figure 4.6
Example of Dampened Specific Conductance Data Signature

Dampened data was characterized by magnitudes of specific conductance that were unusually low given the other data at the site and the specific hydrologic context (see [Figure 4.6](#)). The amplitude of fluctuations in specific conductance was also often reduced during dampening. Three signatures in the specific conductance data suggested that dampening might be affecting readings. First, a large increase in specific conductance following cleaning of a CTD-10 sensor was considered a sign of dampening. Second, failure of the specific conductance readings to recover to the pre-event level following a hydrologic event was an indication that the CTD-10 sensor data were dampened. Third, specific conductance readings taken by the handheld sonde that were substantially higher than those taken simultaneously by the CTD-10 sensor were signs of potential dampening.⁷ The presence of more than one indicator was considered stronger evidence of potential dampening. The dampened data was likely the result of CTD-10 sensor fouling that affected the performance of the CTD-10 sensor and lowered specific conductance readings. Since this artificial lowering of specific conductance could lead to underestimates of calculated instream chloride concentrations, instances of dampened data due to sensor fouling were investigated as described in the following section.

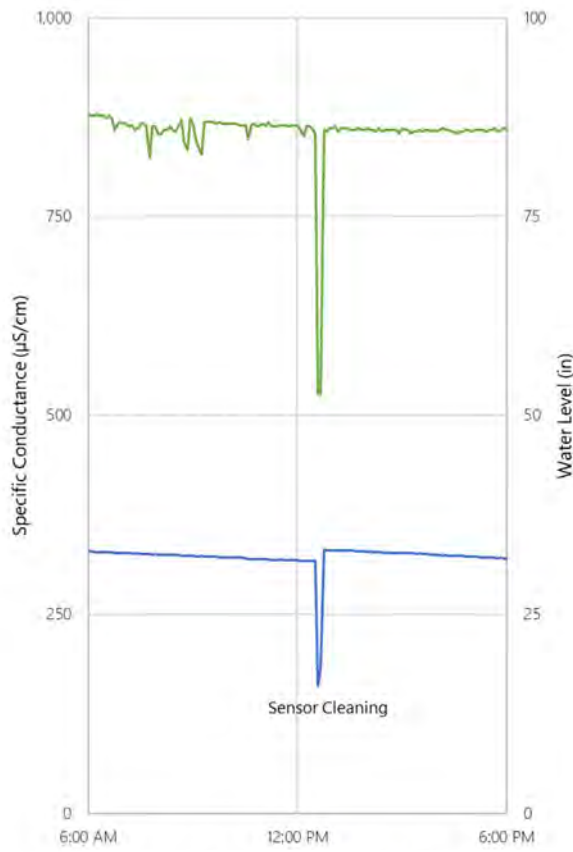
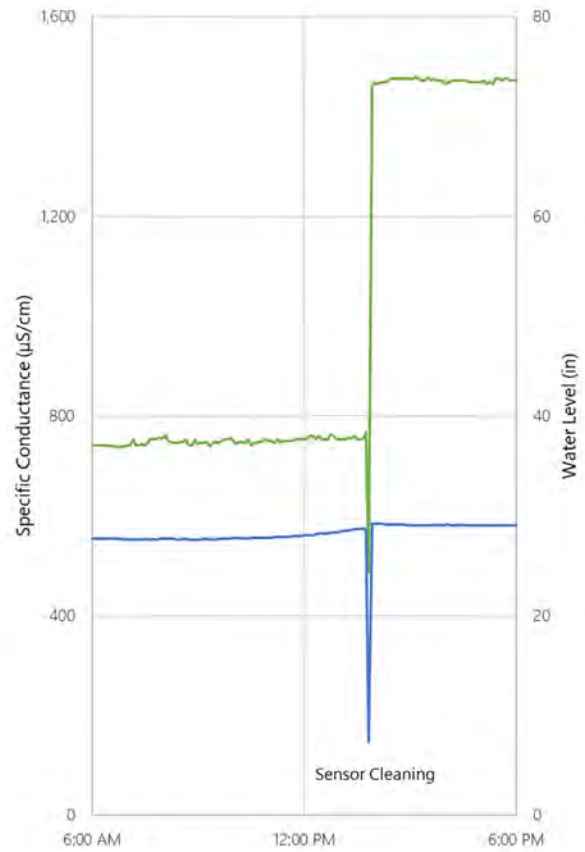
Figure 4.7
Examples of Data Signatures Associated with CTD-10 Sensor Cleanings

Sensor fouling was typically identified by reviewing data from site visits during which the CTD-10 sensor was replaced, cleaned, or otherwise maintained. As previously mentioned, large differences in specific conductance values measured by the sensor before and after maintenance were an indication that the sensor had been fouled or was performing poorly prior to the site visit. **Figure 4.7** illustrates some typical data signatures observed in the continuous datasets during a sensor cleaning, showing how the specific conductance and water level data abruptly decreased to near zero while the sensor was removed from the stream for maintenance. The figure also demonstrates how sensor maintenance can affect specific conductance measurements, comparing small and large differences in specific conductance values before and after cleaning.

The extent of sensor fouling was estimated based on the magnitude of the change in specific conductance values prior to and following CTD-10 sensor replacements and equipment maintenance. Specific conductance changes of less than 10 percent fall within the range of sensor accuracy and were not considered for data adjustment, even if there was additional evidence in the field notes that the sensor had been fouled. When the difference in specific conductance before and after CTD-10 sensor cleanings was greater than 10 percent, the specific conductance data were assumed to be affected by significant sensor fouling and were considered for data adjustment using the procedure describe in the next section. Typically, when the change in specific conductance resulting from a sensor cleaning was greater than 50 percent, the data prior to the cleaning were not considered for data adjustment as these data were deemed too greatly impacted to be adjusted. In these situations, the affected data were flagged such that concerns about the accuracy of the specific conductance readings could be reviewed for subsequent Study analyses. Furthermore large, abrupt changes in specific conductance that occurred between site visits were not considered candidates for data adjustment.

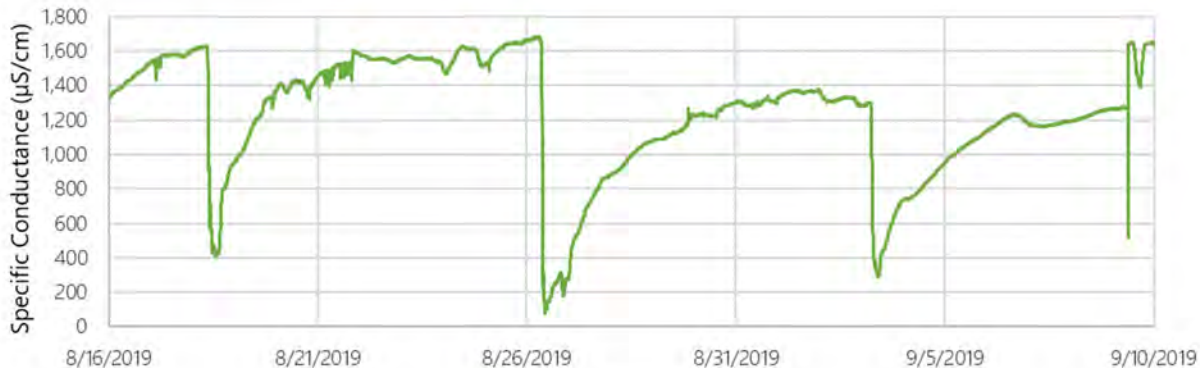
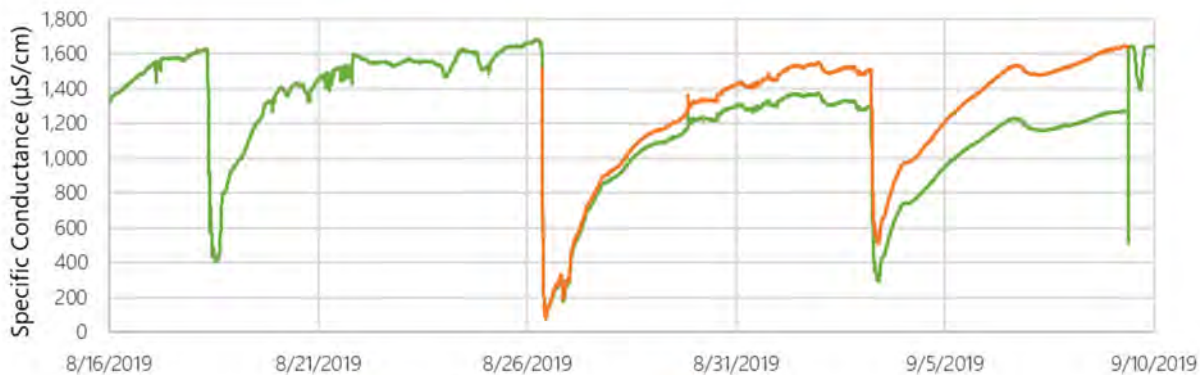
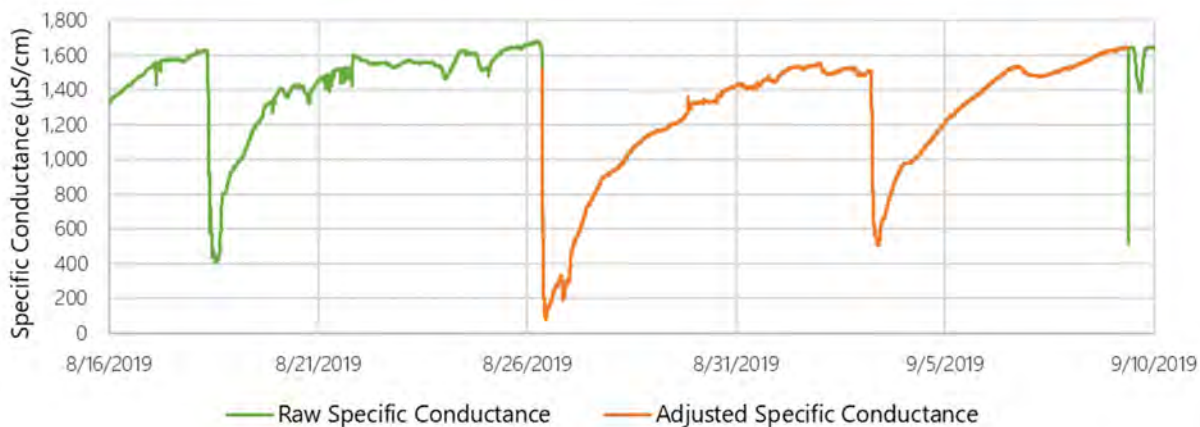
Figure 4.8
Specific Conductance Data Adjustment Example

The calculations for the data adjustment were performed by the driftR program. Data for the affected duration and the specific conductance values before and after the cleaning of the sensor were entered into the program. The software calculated an adjusted value for each reading in the portion of the data record that was affected by fouling which can be seen represented in orange in [Figure 4.8](#).

The adjusted data were reviewed visually using dygraphs that show both the raw and corrected specific conductance data. This review examined whether the adjusted data followed patterns similar to those in data records not affected by fouling. These patterns included whether specific conductance fluctuations occurred in response to hydrological events and whether patterns were similar to those observed elsewhere in the data record. **Table 4.1** summarizes the portions of the specific conductance datasets for which adjustments were made.
