SUMMARY NOTES OF THE MAY 1, 2013 MEETING OF THE ROOT RIVER WATERSHED RESTORATION PLAN ADVISORY GROUP

Horlick Dam Alternatives

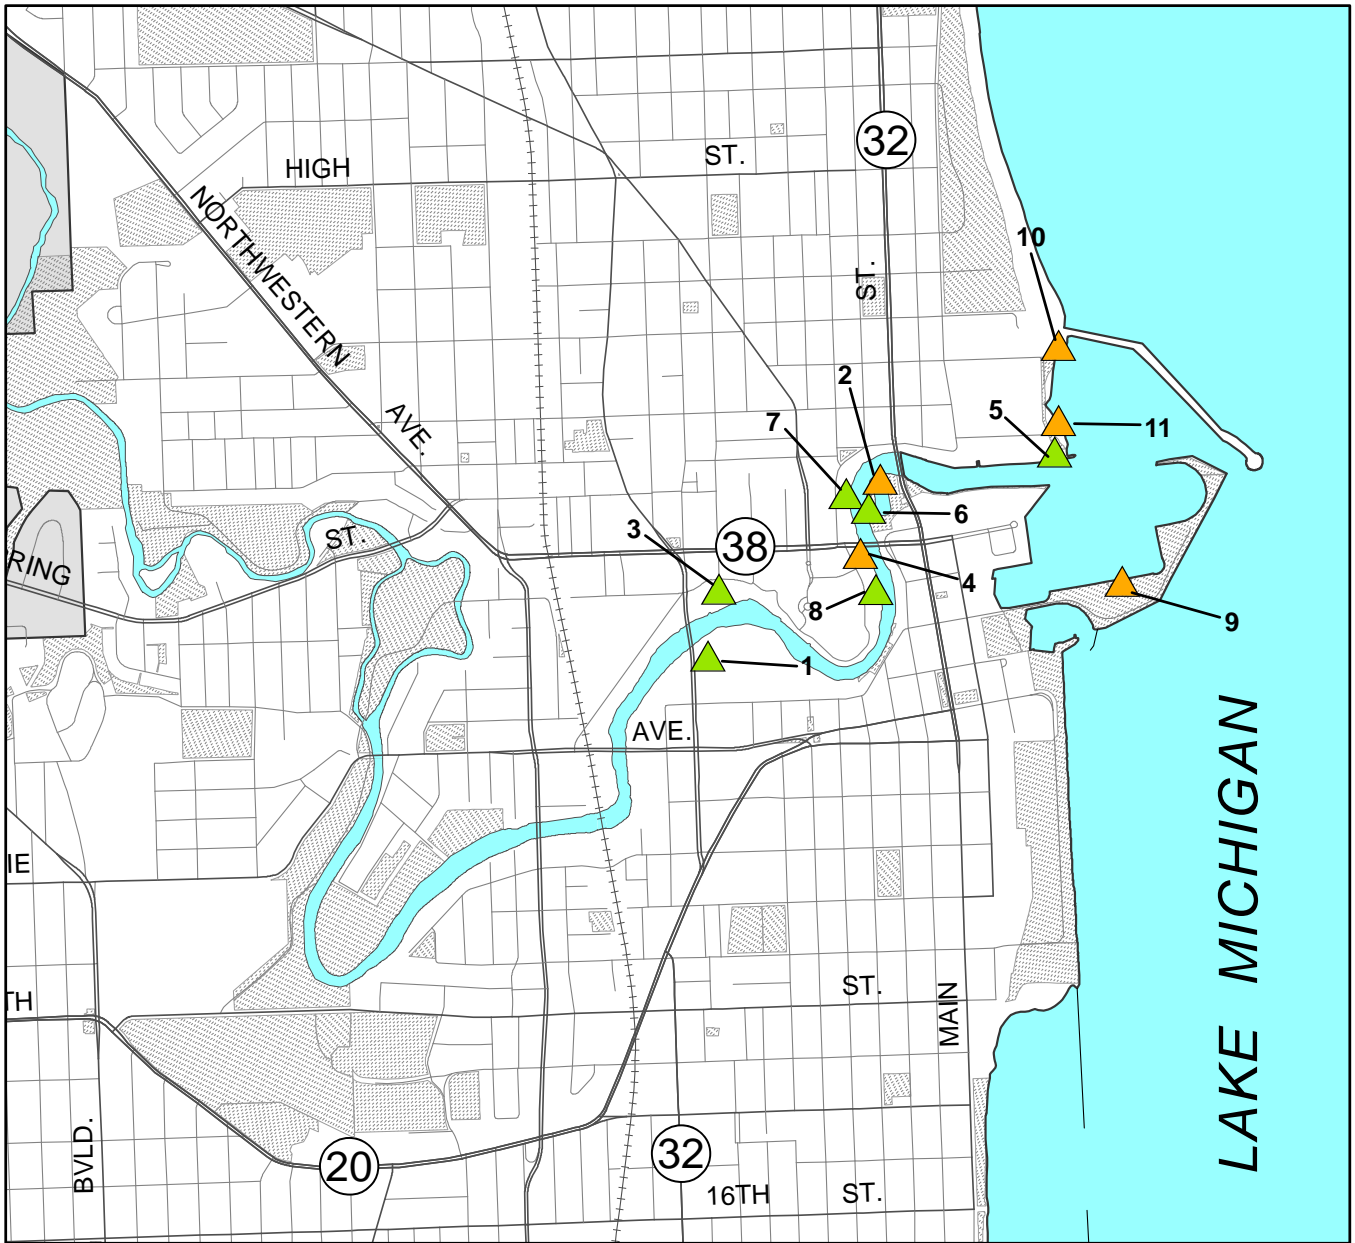
Map-Rec-E

MARINAS AND YACHT CLUBS ON THE ROOT RIVER: 2013

Regarding Map IV-Rec-E, “Marinas and Yacht Clubs on the Root River: 2013,” Ms. Warner noted that Belle Harbor Marina is public, so its symbol should be orange. Mr. Osterman asked that Reef Point Marina, which is owned by Racine County be added to Map IV-Rec-E, and Ms. Kinzelman mentioned the Racine Yacht Club and the Rooney Park public dock. Ms. Kinzelman noted that all the marinas in the Racine harbor are designated as clean marinas.

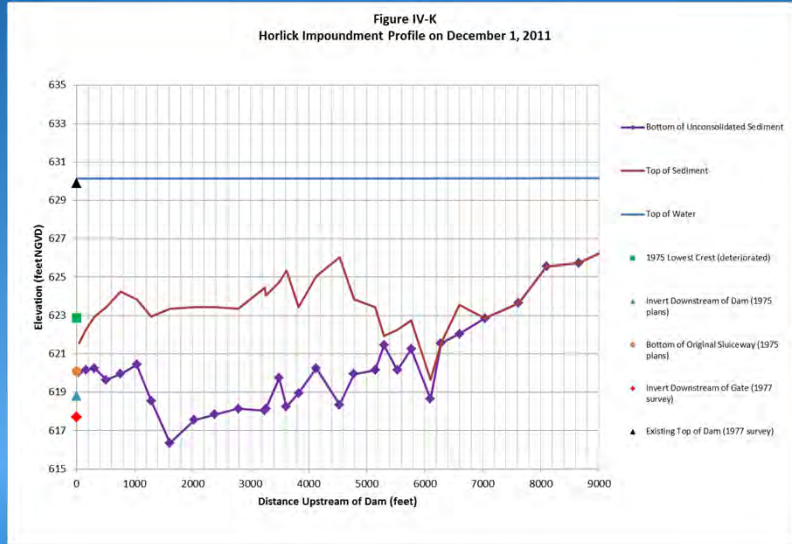
Sediment Profile - 2011 Field Work

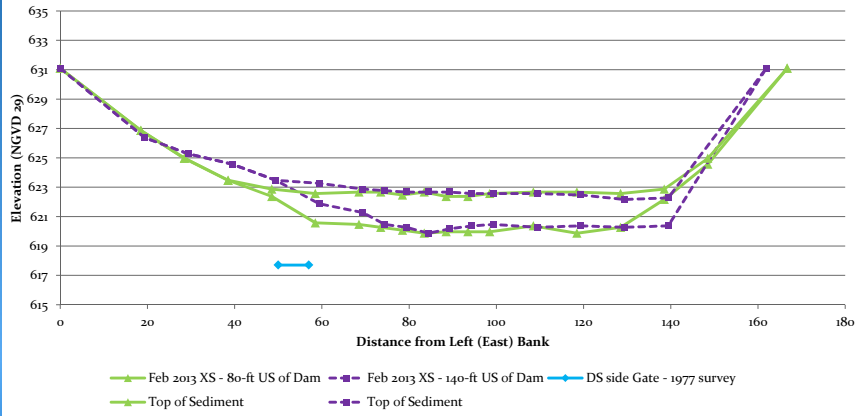
Horlick Dam Impoundment - Top of Sediment and Rod Refusal
(looking downstream)

Ms. Kletti said that field investigation by the SEWRPC staff indicated the existence of an apparent hard “shelf” at about elevation 620 feet above National Geodetic Vertical Datum, 1929 adjustment (NGVD 29) that extends from the upstream side of the dam to a location about 1,000 feet upstream. She noted that about four to five feet of sediment have collected in the impoundment above the top of the shelf. In response to a question from Mr. Hahn, Ms. Kletti indicated that, if the dam were removed, the shelf itself could represent somewhat of a barrier to fish passage. Craig Helker, WDNR Water Resources Management Specialist, said that test data for the sediment in the impoundment indicate slightly elevated levels of polycyclic aromatic hydrocarbons (PAHs). Ms. Kletti mentioned that the sediment sampling depths may not be deep enough to fully characterize the sediment quality, and that this needed more examination.

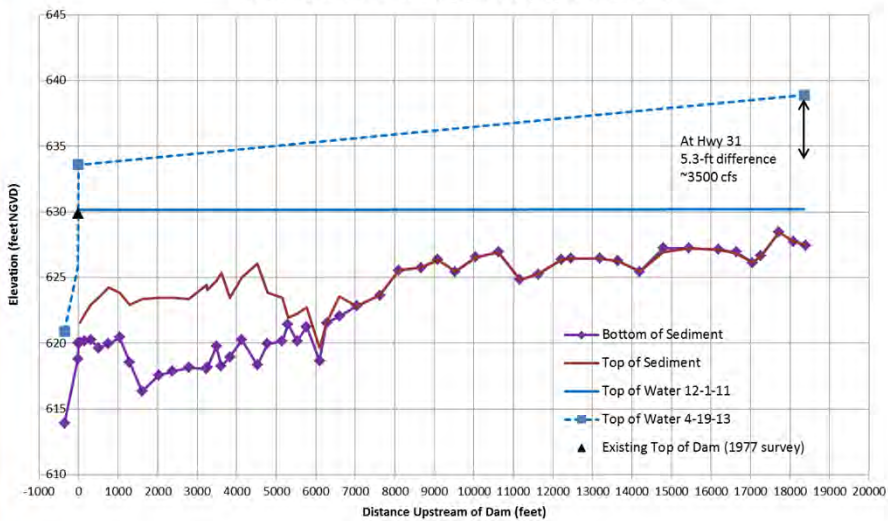
Horlick Impoundment Profile 12/1/11 and 4/19/13 Water Profile

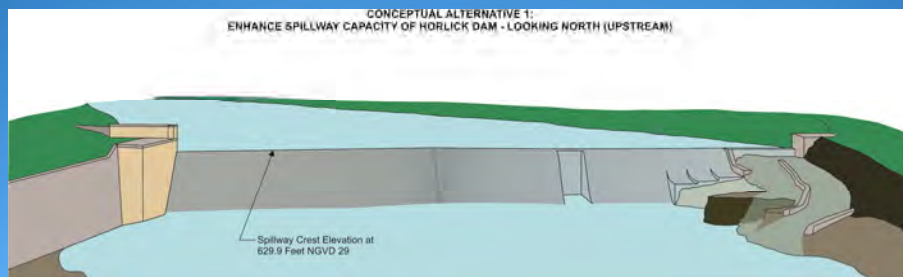
Modify Dam to Enhance Spillway Capacity

1 - Utilize Current Fishway Area

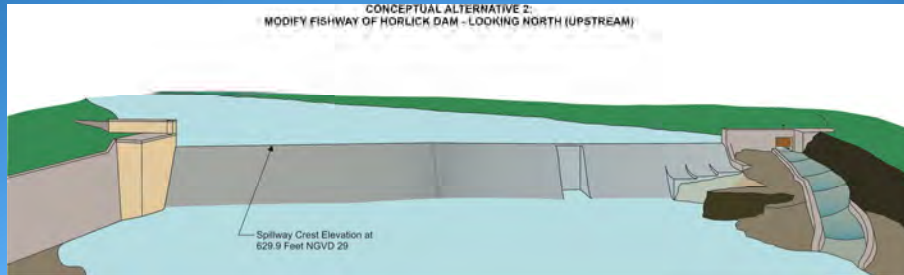
Modify Dam to Enable Fish Passage

2 - Modify Current Fishway

Thomas Slawski, SEWRPC Principal Planner, noted that the need to extend a fishway further into the River arose because the land area on the east bank (left, looking downstream) upstream of the dam is a capped landfill that cannot be disturbed. In reply to a question from Ms. Lourigan, Dr. Slawski said that this alternative shows a passive fishway design.

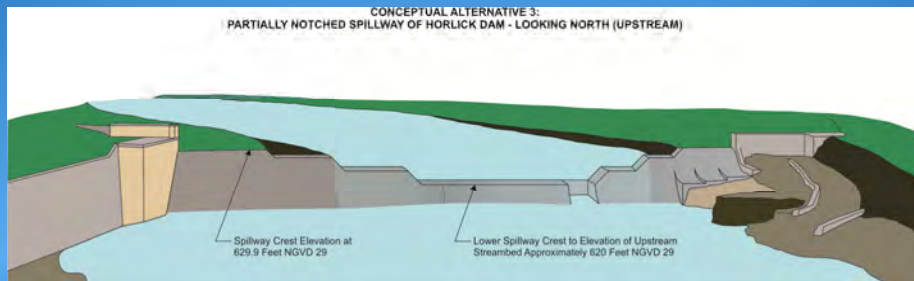
Modify Dam to Enhance Spillway Capacity and Fish Passage

3 – Partial Notch of Current Dam Spillway

Ms. Lourigan noted that, if the spillway crest were lowered as called for under this alternative, the dam hazard rating might be reduced to low hazard because, if the dam were to fail, the smaller hydraulic head would result in a lower flood wave that would propagate downstream.

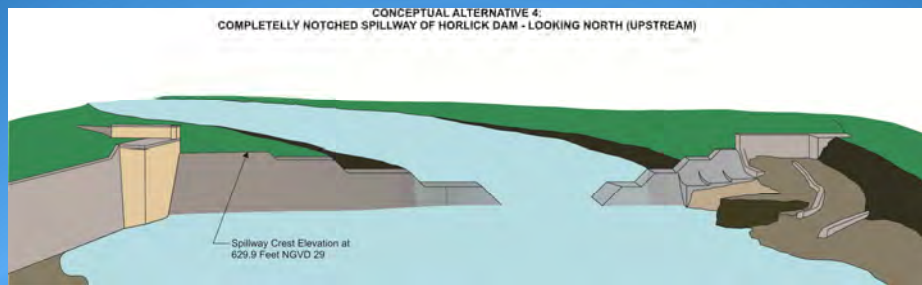
Remove Dam

4 – Complete Notch of Current Dam Spillway

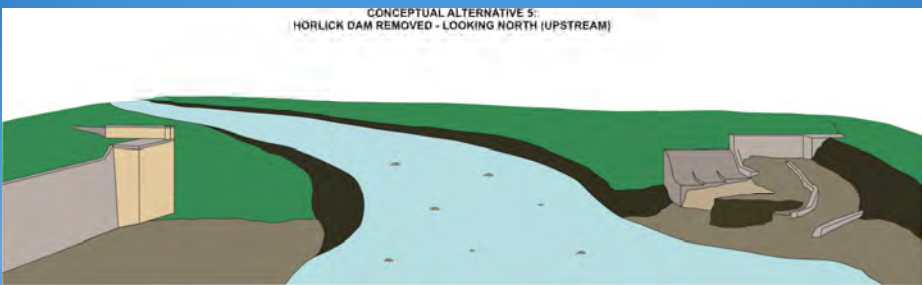
Remove Dam

5 – Full Removal

Finally, Ms. Kletti, described a conceptual alternative calling for complete removal of the dam, except for relatively small portions of the left and right abutments. With regard to the apparent shelf or ledge in the streambed, Dr. Slawski said that the dam had failed and been rebuilt just downstream several times and the observed ledge may be part of an older dam.

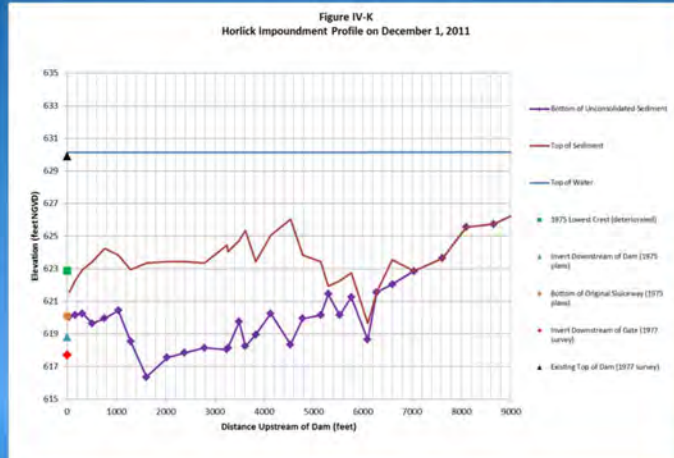
Sediment Profile - 2011 Field Work

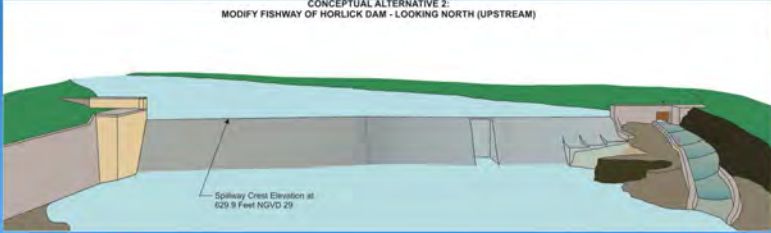
CONCEPTUAL ALTERNATIVE 2:
MODIFY FISHWAY OF HORLICK DAM - LOOKING NORTH (UPSTREAM)

Spillway Crest Elevation at 629.9 Feet NGVD 29

This diagram illustrates a cross-section of a dam and its spillway. The dam is shown on the left, with a spillway extending to the right. The spillway is depicted as a series of steps or a fishway. A line points to the crest of the spillway, which is labeled with the elevation '629.9 Feet NGVD 29'. The river is shown flowing from left to right, passing through the spillway. The background shows a green hillside on the left and a brown embankment on the right.

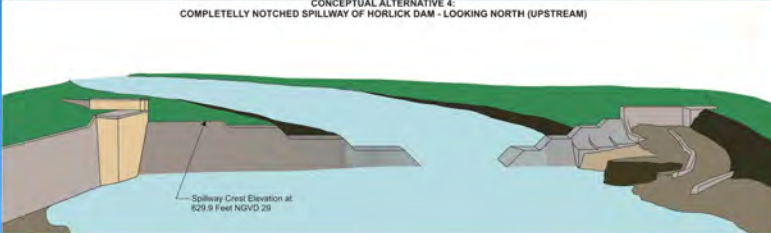
CONCEPTUAL ALTERNATIVE 4:
COMPLETELY NOTCHED SPILLWAY OF HORLICK DAM - LOOKING NORTH (UPSTREAM)

Spillway Crest Elevation at 629.9 Feet NGVD 29

This diagram illustrates a cross-section of a dam and its spillway. The dam is shown on the left, with a spillway extending to the right. The spillway is depicted as a series of steps or a fishway. A line points to the crest of the spillway, which is labeled with the elevation '629.9 Feet NGVD 29'. The river is shown flowing from left to right, passing through the spillway. The background shows a green hillside on the left and a brown embankment on the right.
