Root River Watershed Restoration Plan

Horlick Dam Alternatives

Presentation to the Root River Restoration Planning Group
August 28, 2013

Southeastern Wisconsin Regional
Planning Commission

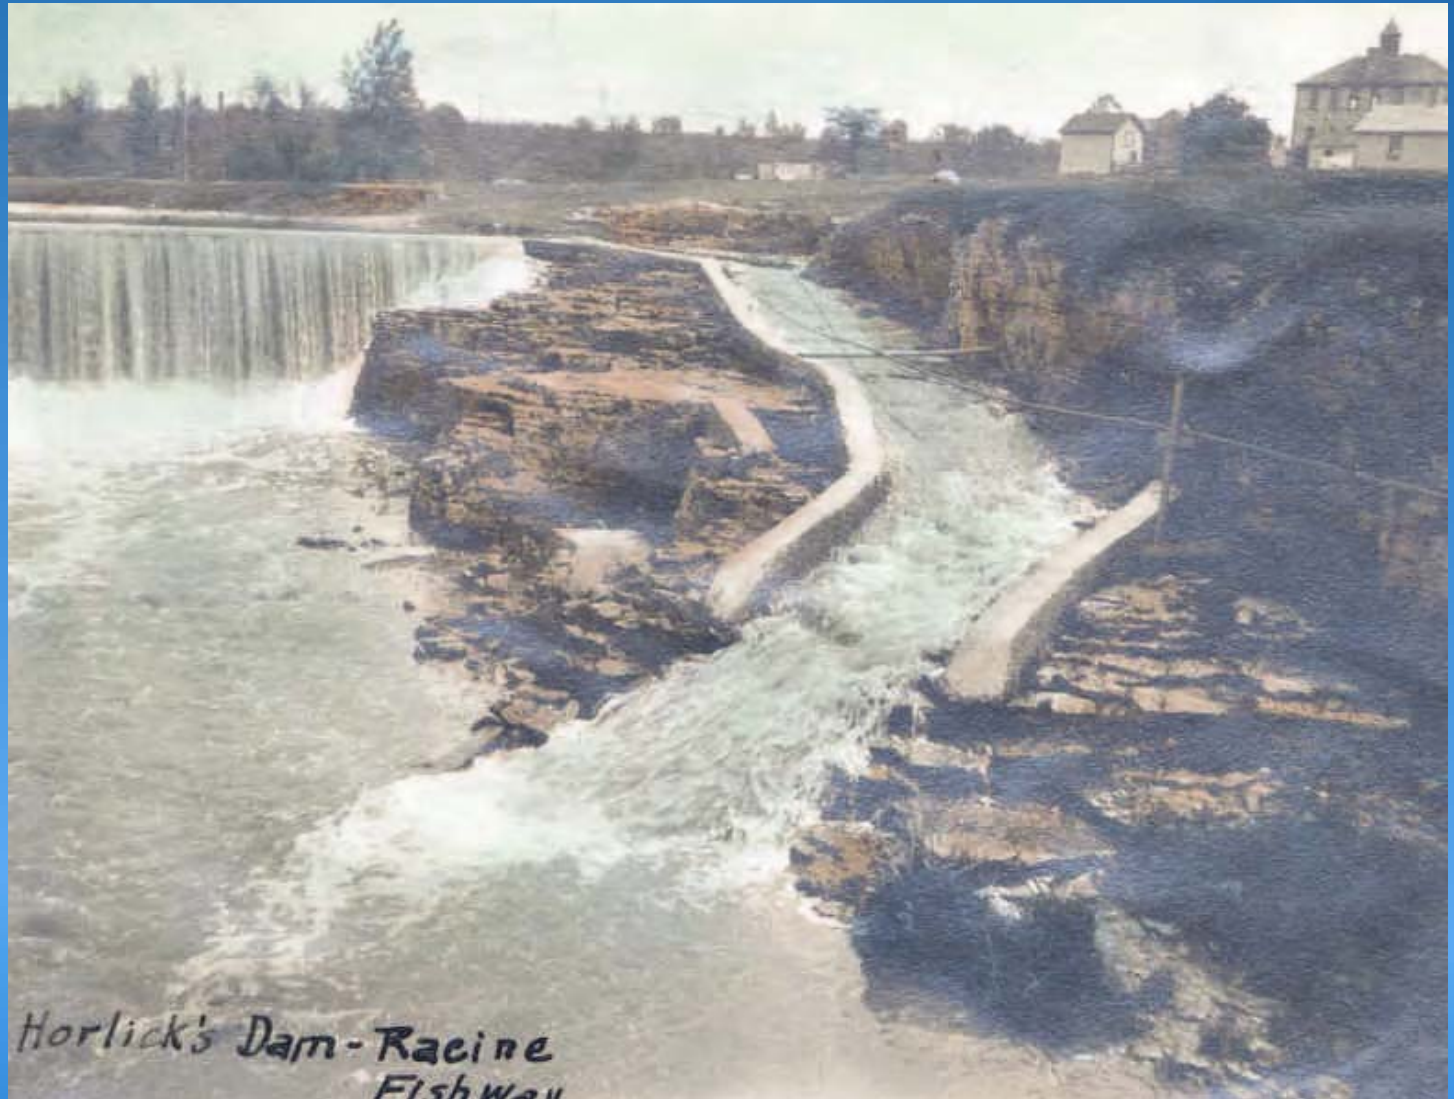
1915 Fishway

Horlick's Dam - Racine
Fishway
