Baseline Assessment of Water Quality

Root River Watershed Restoration Plan

Data Analysis Report

2011 – 2013

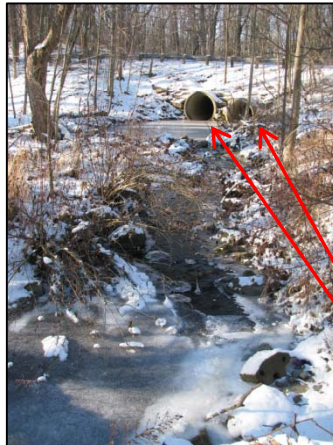
Looking upstream from sampling point in winter. Note two culvert pipes underneath road bridge.

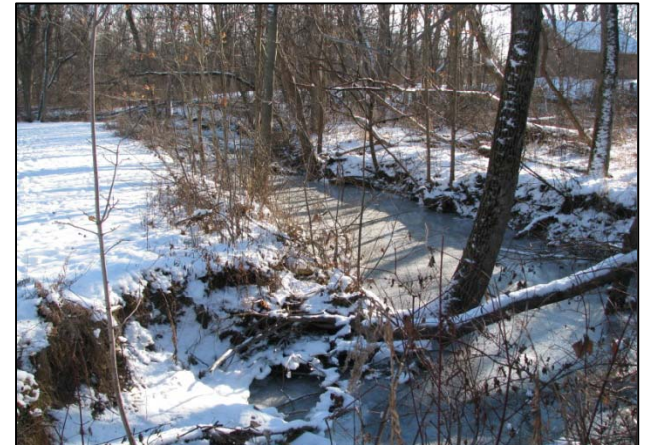
Looking downstream from sampling point in winter. Note tree growth and stabilization along bank.

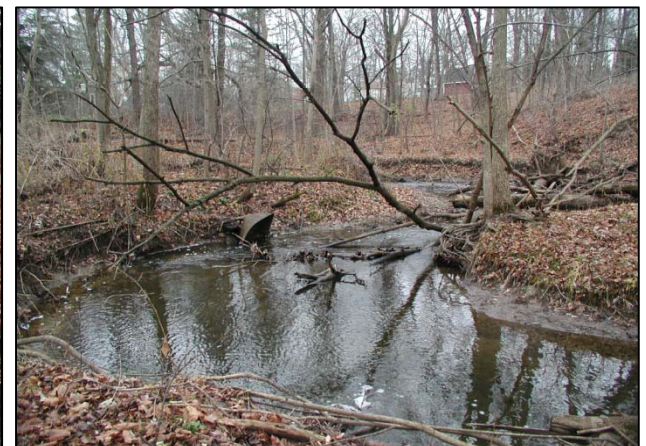
Good meander and sinuosity at 50 meters upstream of sampling point. Mature wooded habitat provides near to full canopy cover.

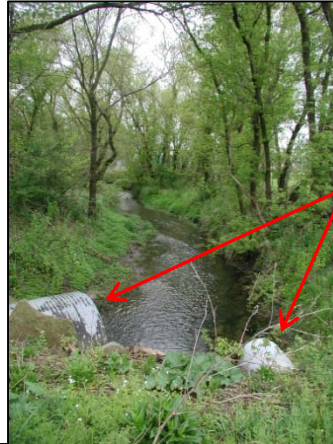
Two culverts

Looking upstream across 67th Drive from the sampling point in spring. Two culvert pipes join underneath road bridge to form one.

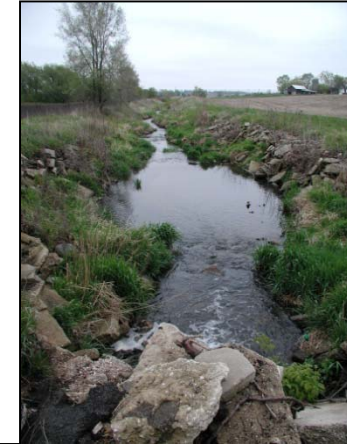
Looking downstream from sampling point in spring. Note rock stabilization on stream banks, limited meander, and agricultural land on right.

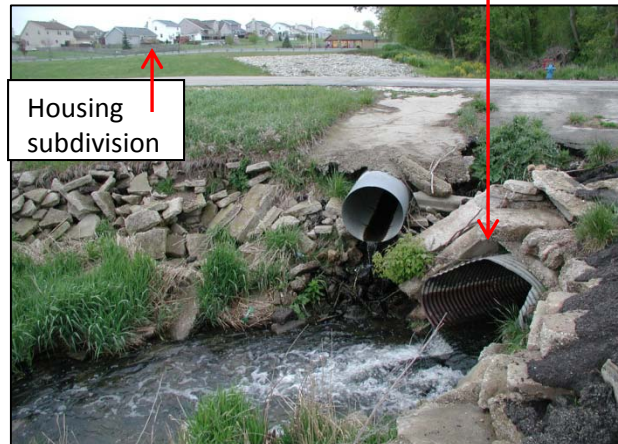
Housing subdivision

Culvert for main canal flow is on right and storm water outfall for park and housing subdivision is on left.

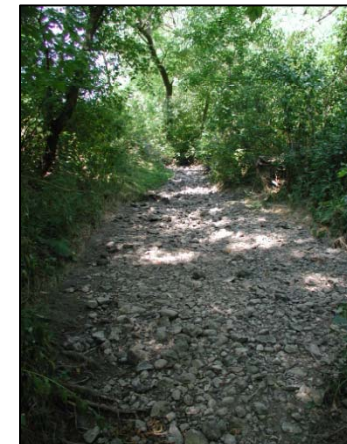
Canal streambed upstream of wastewater effluent pipe is ephemeral, depending upon rainfall for flow.

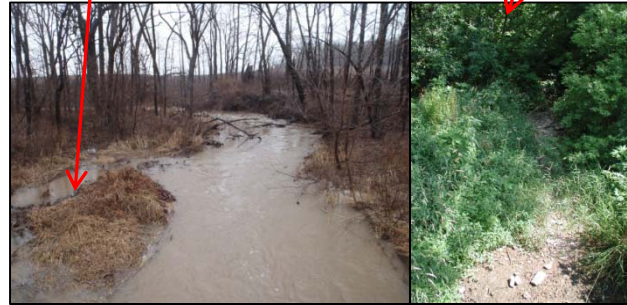
Flood plain connection

This creek is not ephemeral but can have extremely low flow during dry periods. Water sometimes built up during low flow periods, particularly around woody debris.

Looking upstream from sampling point during high flooding period in winter (left) and close to no flow in summer (right).

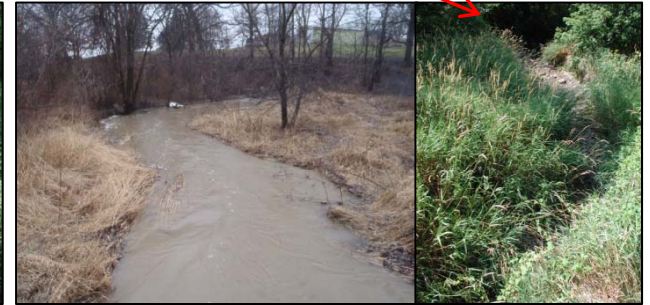
Highly vegetated in summer

Looking downstream from sampling point during high flooding period in winter (left) and close to no flow in summer (right).

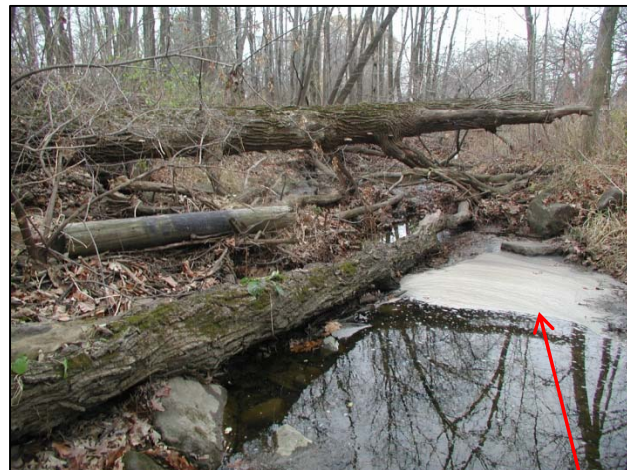
Woody debris buildup with aggregated scum upstream of sampling point.

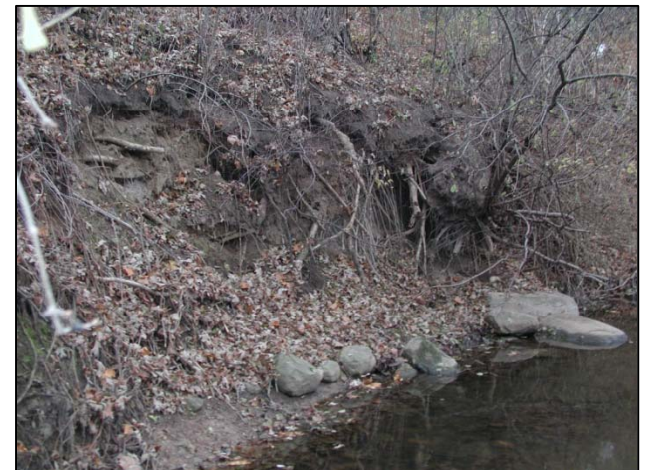
Steep eroded slope located below residential area 50 meters downstream of sampling point.

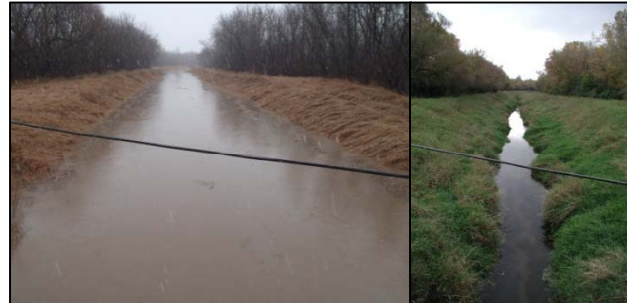
Looking upstream from sampling point during high flooding period in winter (left) and lower flow in fall (right).

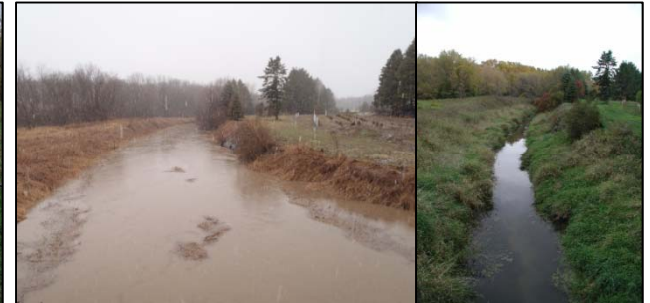
Looking downstream from sampling point during high flooding period in winter (left) and lower flow in fall (right).

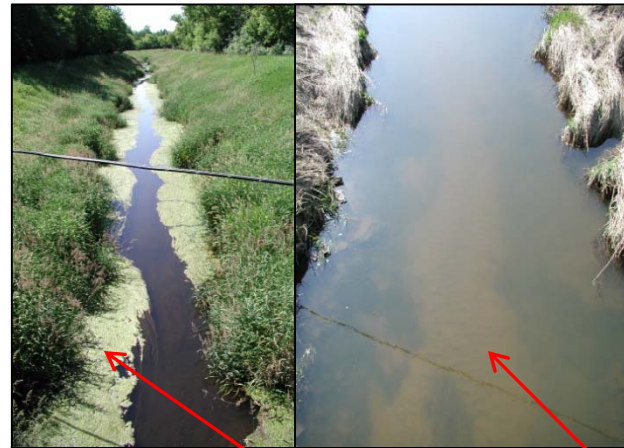
Algal blooms and vegetative buildup could be high during the summer months, likely due to little canopy and high nutrients. Channelization allows for buildup of fine sediments in the canal. Planting additional trees for canopy and investigating areas to re-establish a meander would be beneficial.

Accumulation of high algal growth (left) and fine sediment in canal bed (right).

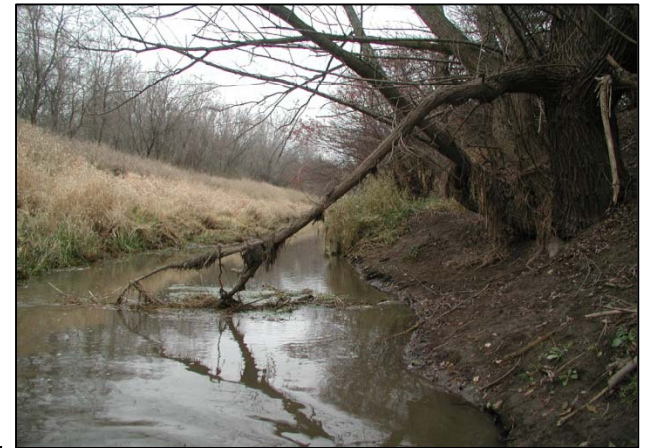
Trees closer than 5 meters to stream bank provide canopy (erosional). Bank with tall grasses show little erosion (depositional).

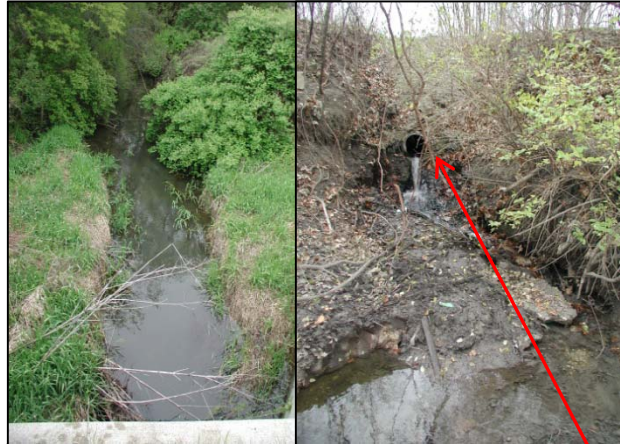
Looking upstream from sampling point during summer (left). Upstream, Fonk's Wastewater Treatment Plant effluent discharge pipe (right).

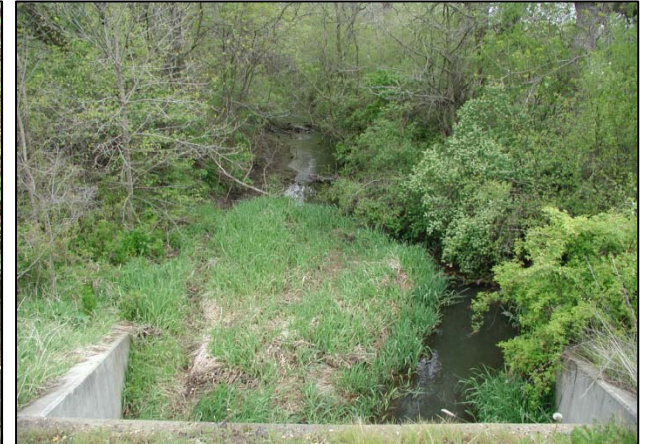
Looking downstream across Highway 11 from sampling point in summer.

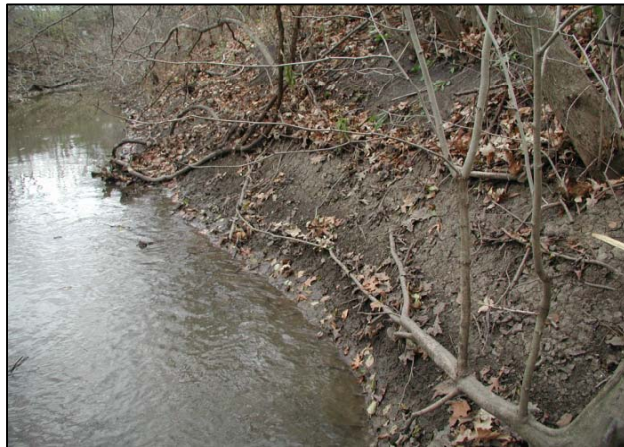
Highly eroded east bank 100 meters upstream of sampling point.

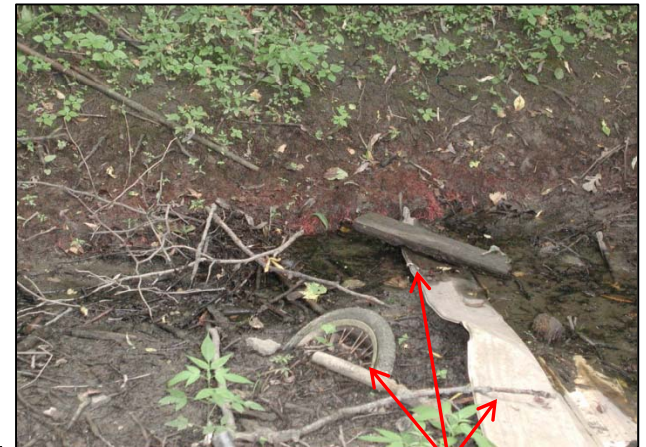
Accumulation of large pieces of trash in mucky sediment during low flow period.

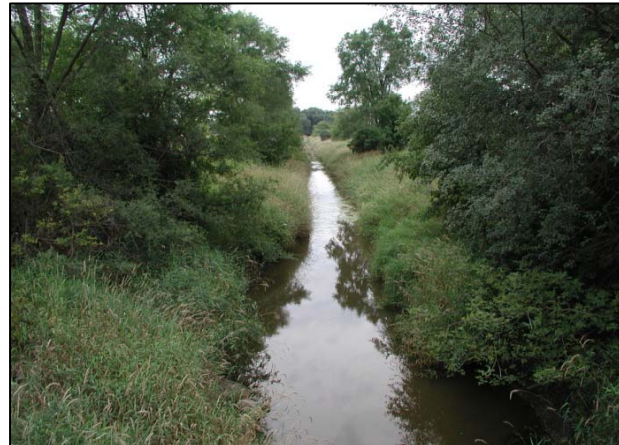
Looking upstream from sampling point during summer. Note highly channelized but vegetated stream banks.

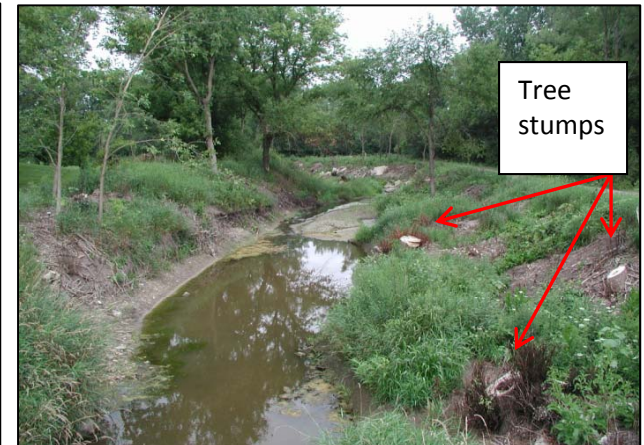
Looking downstream from sampling point in Summer, 2011. Note tree stumps and less vegetation than 2012 (below).

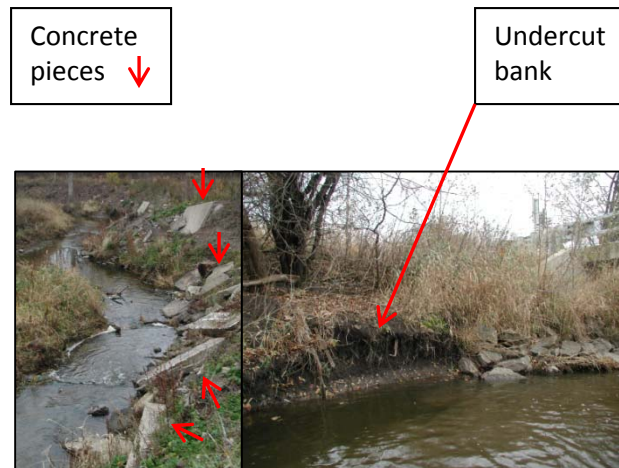
This canal section is classified as Limited Forage Fish. Large pieces of concrete were observed downstream along the east bank, possibly placed as an erosion control measure.

Large pieces of concrete 75 meters downstream of sampling point (left). Eroded undercut banks on upstream west bank (right).

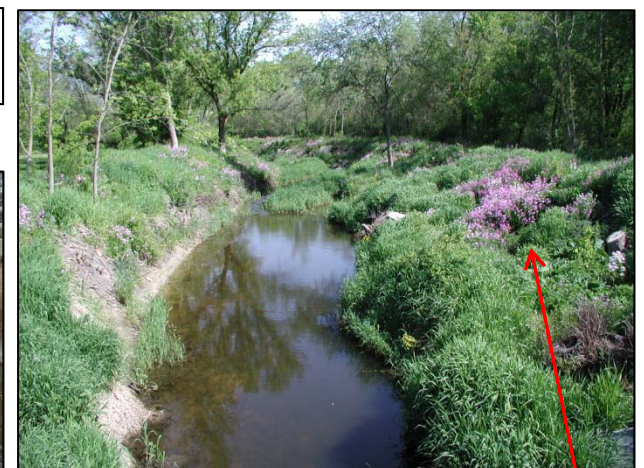
Looking downstream from sampling point in Summer, 2012. Note extensive vegetative growth and purple loosestrife on right bank.

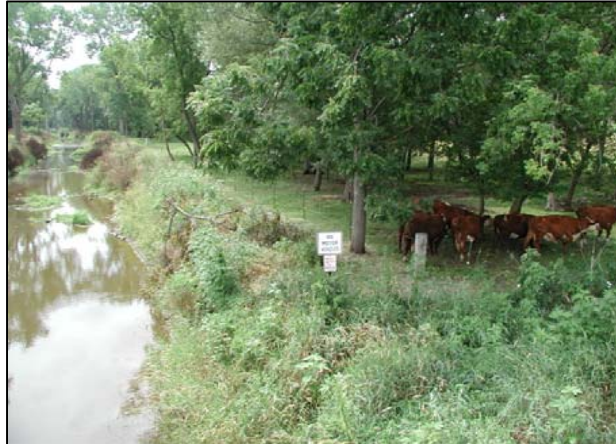
Due to highly eroded banks, fine sediment build-up was high. Extensive algal growth occurred during the summer, likely due to high nutrients and full direct sunlight. Potential sources of bacteria and nutrients are plentiful and there are currently no mechanisms in place to prevent runoff. Wide buffer strips with trees could provide filtration, shade, and bank stabilization.

Looking upstream from sampling point in summer. Note cattle grazing land fenced off to within 5 meters of west (right) bank.

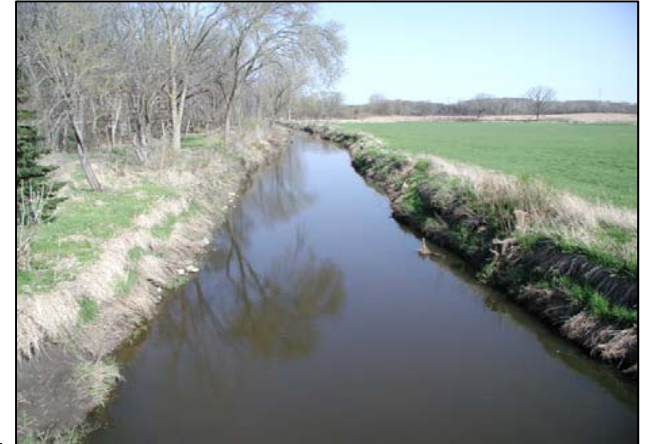
Looking downstream from sampling point in spring. Row crops are planted within a few meters of east (right) bank.

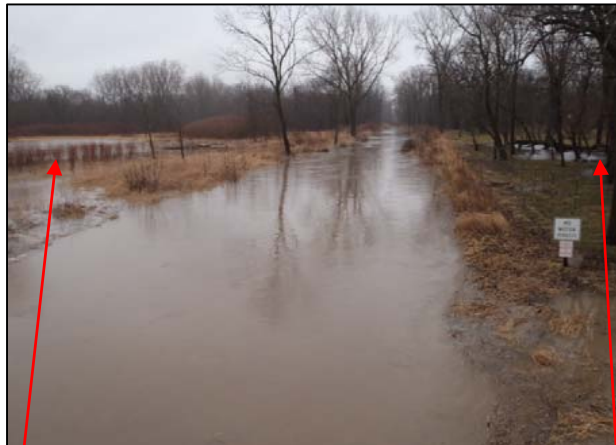
Looking upstream from sampling point during winter flooding episode. Flooded areas in parkland (left) and in cattle grazing land (right).

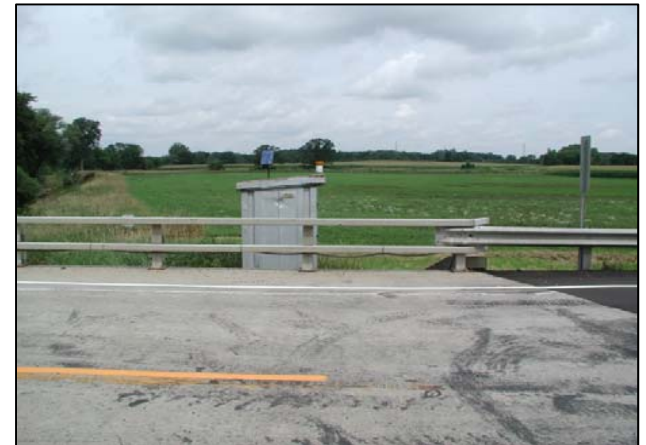
U.S. Geological Survey Discharge Gauging Station on east (right) bank provides continuous volumetric flow rate measurements.

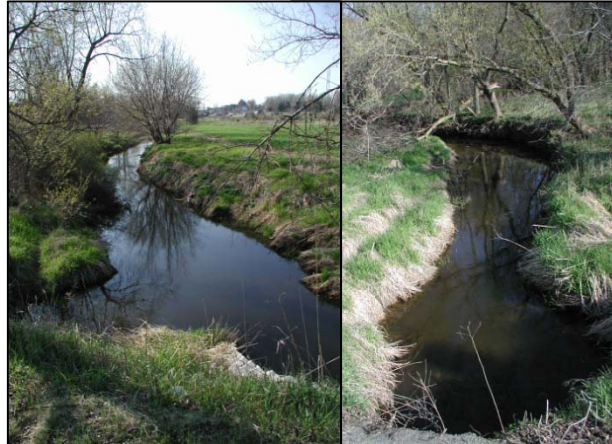
Looking upstream (left) and downstream (right) from the sampling point in summer.

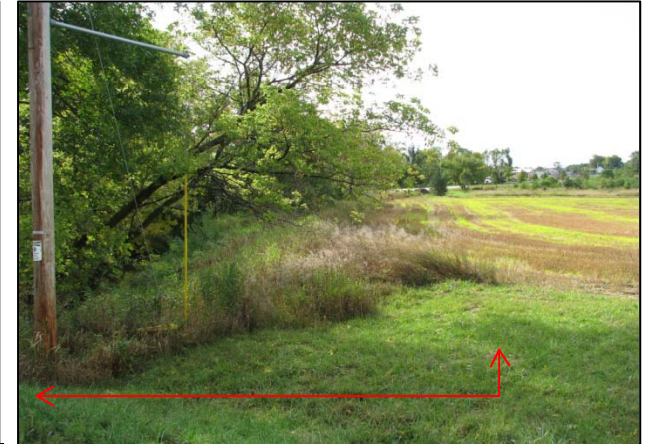
West bank buffer upstream measures between 4 and 10 meters wide between creek and surrounding agricultural field.

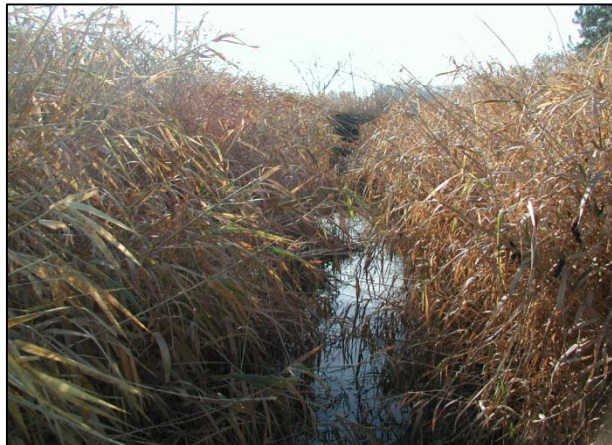
Upstream of sampling point in highly channelized area that becomes very dense with reed/grass growth.

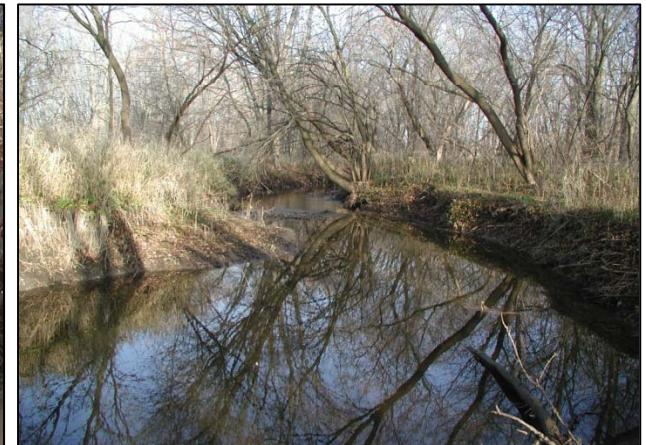
Downstream of sampling point the banks are gentler, meanders occur, and adequate tree canopy exists.

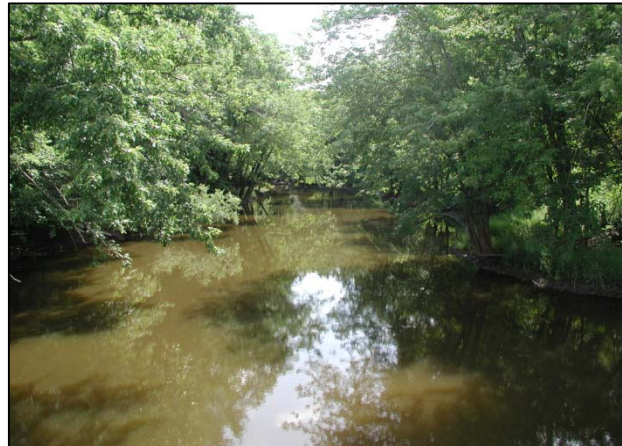
Looking downstream during normal flow conditions from sampling point in summer. Upstream is similar habitat conditions.

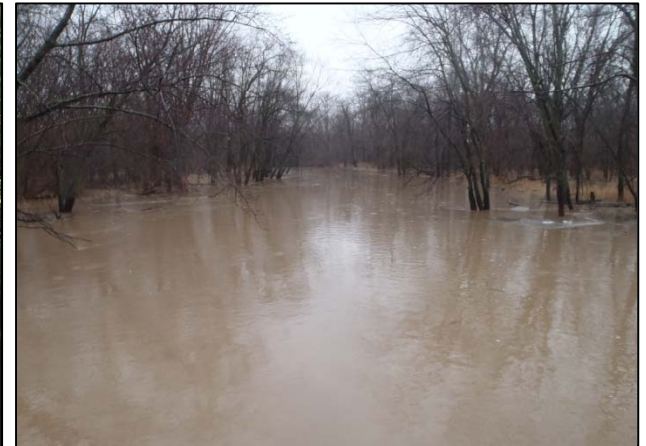
Looking downstream during flood conditions from sampling point in winter. Bank slopes are moderate and river connects with flood plain.

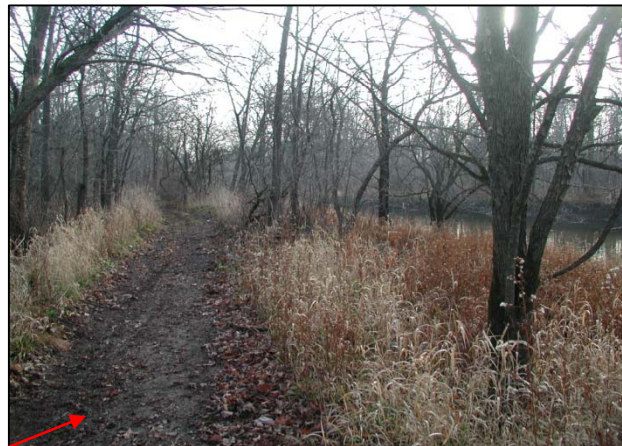
Upstream of sampling point on north bank is Milwaukee County Parks dirt recreational trail next to river.

Balancing recreational access with stream bank naturalization in the park may help reduce erosion.

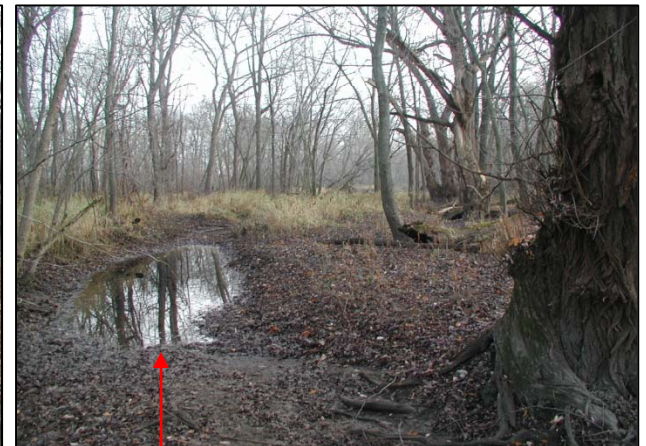
Downstream of sampling point on south bank is ephemeral pool habitat created after flood water recession.

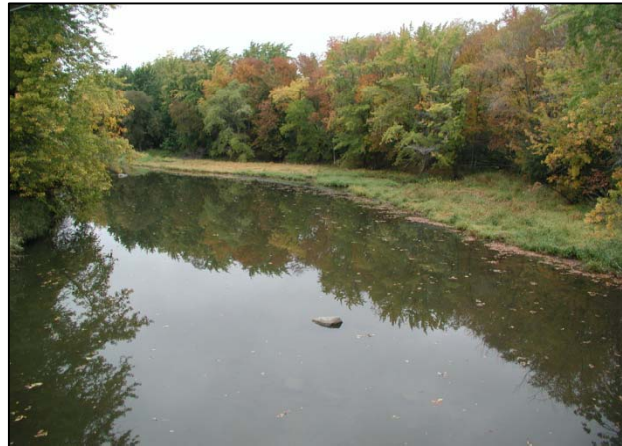
Looking upstream during normal flow conditions from sampling point in fall.

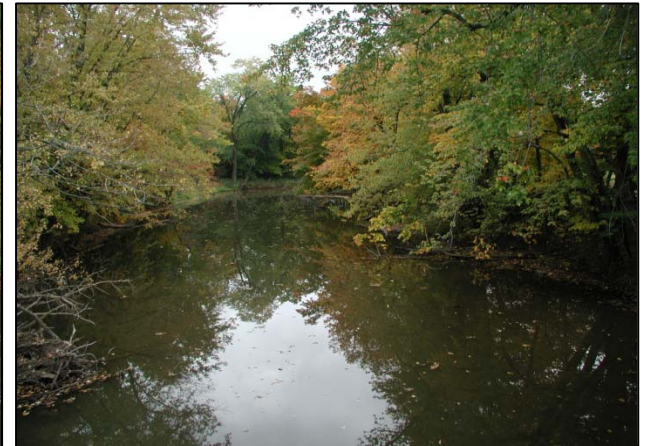
Looking downstream during normal flow conditions from sampling point in fall.

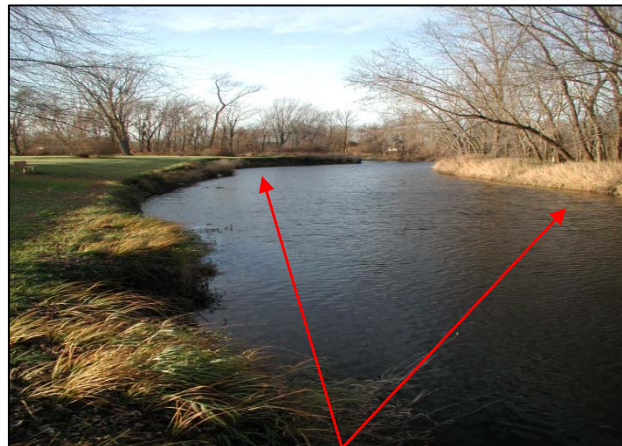
Steep eroded bank next to open parkland (left arrow) and shallow slope leading to woodland area (right arrow).

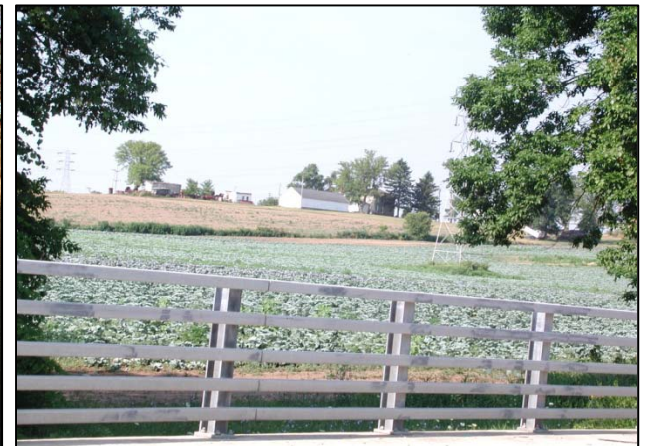
Cabbage field on west bank side of river downstream of sampling point.

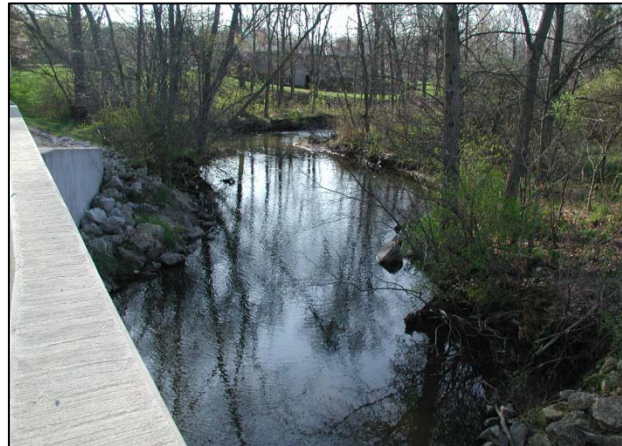
Looking upstream during normal flow conditions from sampling point in spring.

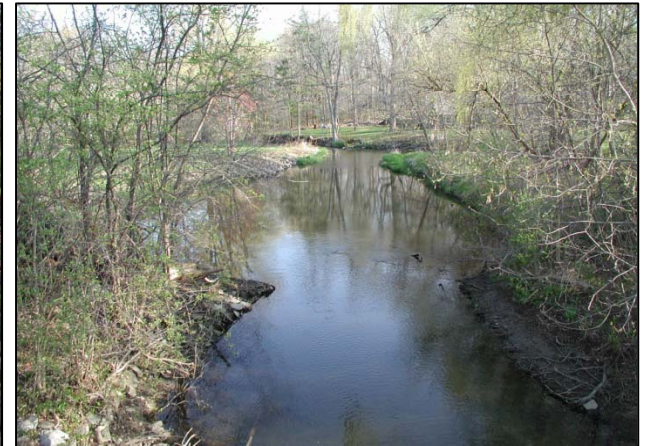
Looking downstream during normal flow conditions from sampling point in spring.

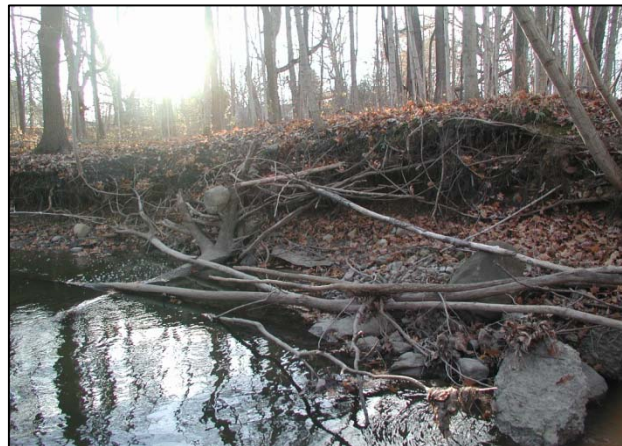
Steep eroded bank upstream of sampling point. Woody debris and various substrate sizes are evident in this habitat.

This tributary section is classified as Limited Forage Fish. Nutrient loading from the upstream WWTP and agricultural production is likely. Stream bank stabilization may help with erosion in high cut areas. Removal of crumbling infrastructure associated with the railway is recommended.

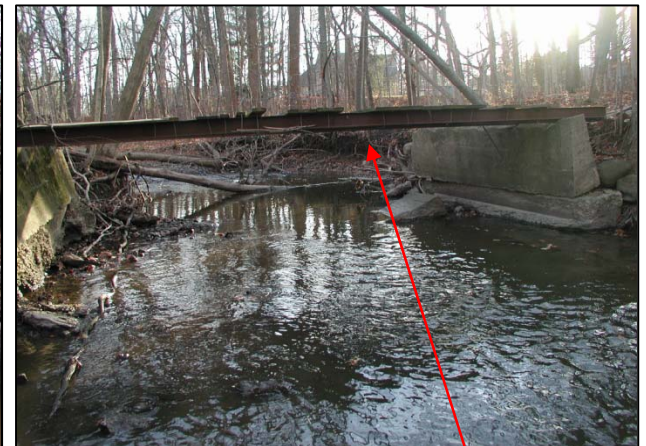
Upstream is an old abandoned rail bridge with crumbling infrastructure.

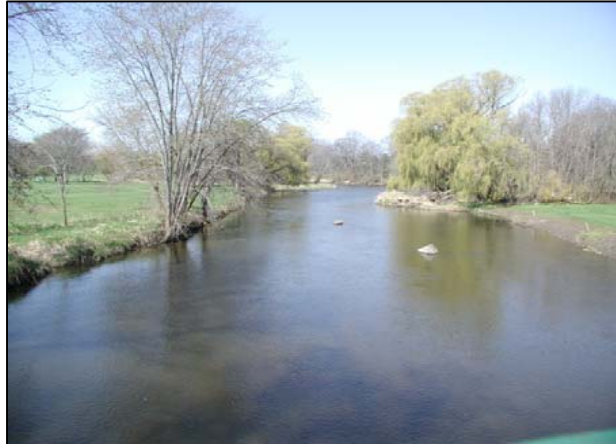
Algal and goose feces were commonly observed upstream of the sampling location in the summer. The planting of additional trees and an improved native plant buffer strip may reduce algal growth and prevent nutrients and feces on the grassy banks from reaching the river.

Looking upstream from sampling location in spring. Note open grassy areas on right north bank, where geese would reside.

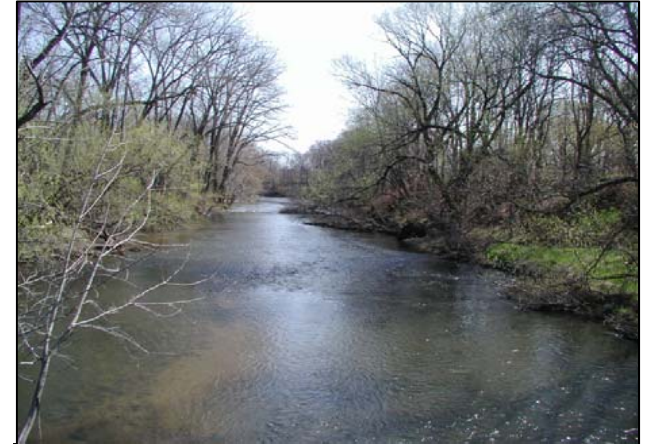
Looking downstream from sampling location in spring. Banks are fully vegetated and shaded in this location.

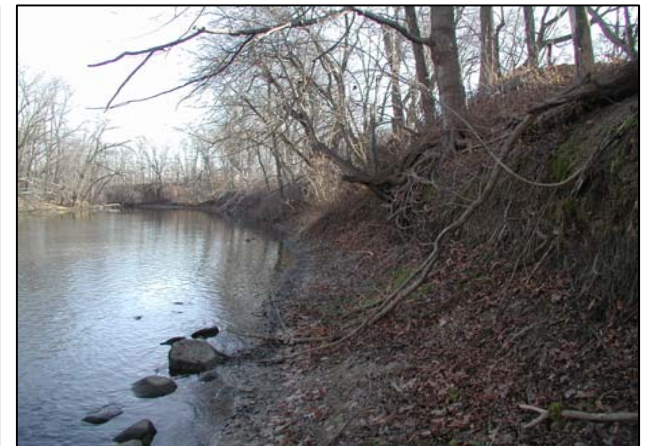
Banks are highly eroded in some locations 100 meters downstream.

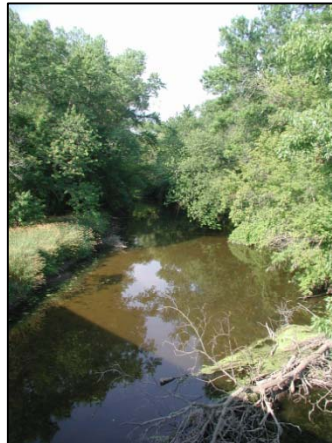
Looking upstream from sampling location in summer.

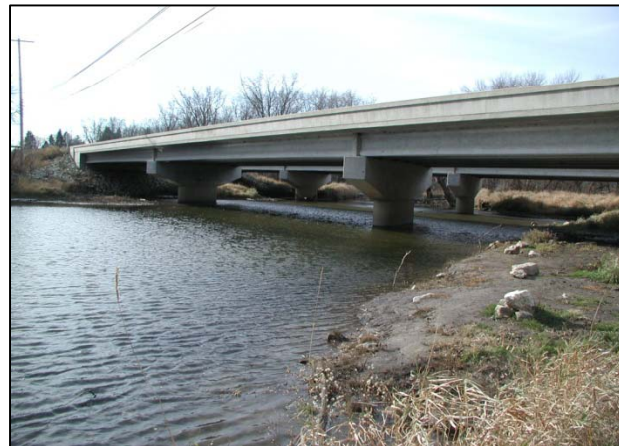
View of sampling point and large double bridge infrastructure which facilitates widening and reduces the tree canopy.

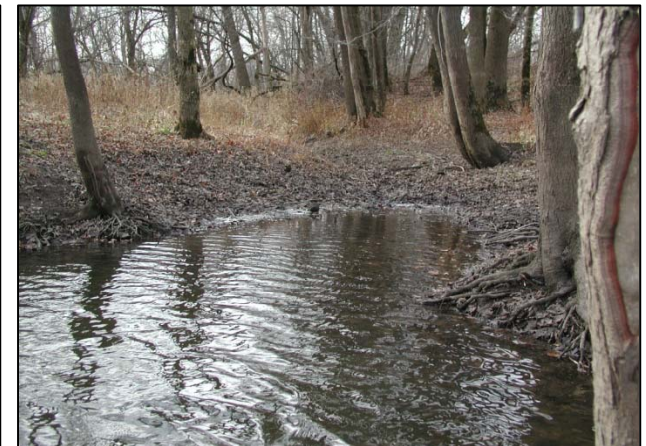
In the downstream section, connection with the flood plain allows for creation of pool habitats.

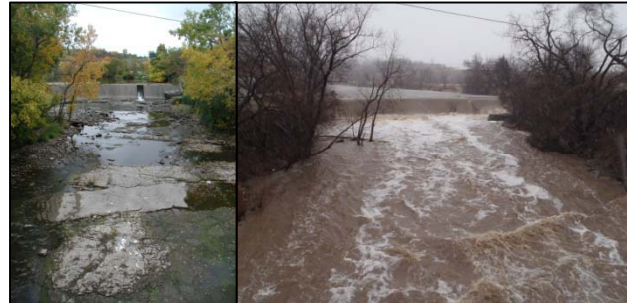
Looking upstream at the dam from the sampling point in fall during low flow (left) and a flooding episode in the winter of 2012 (right).

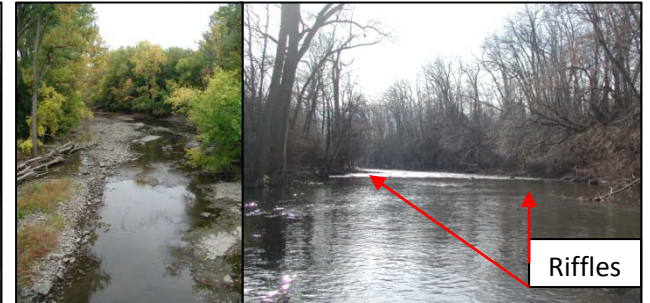
Looking downstream from the sampling point in the fall under low flow conditions (left) and with typical flow during the spring (right).

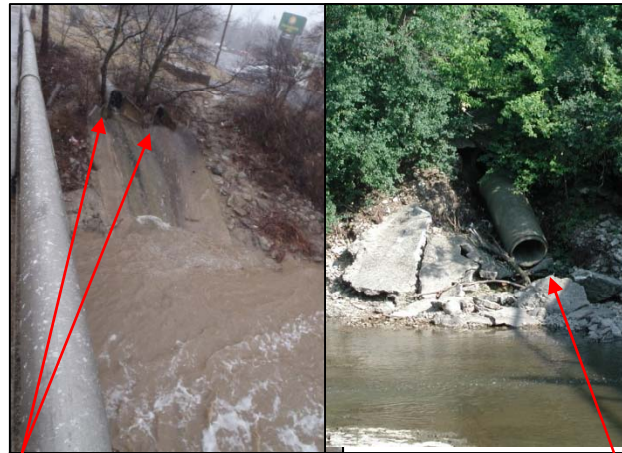
Horlick Dam Northwest (left, both discharge points) and East outfalls (right). East outfall end pipe has disconnected from discharge point.

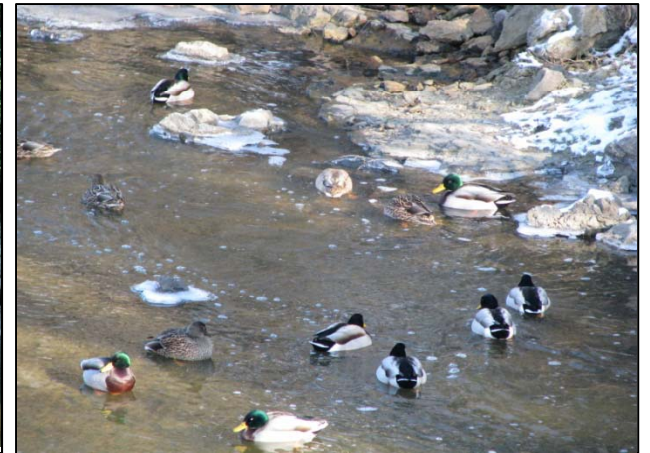
There is a near year-round duck population near this site.

Year-round resident duck population living below the dam ranges from five to 75 ducks.

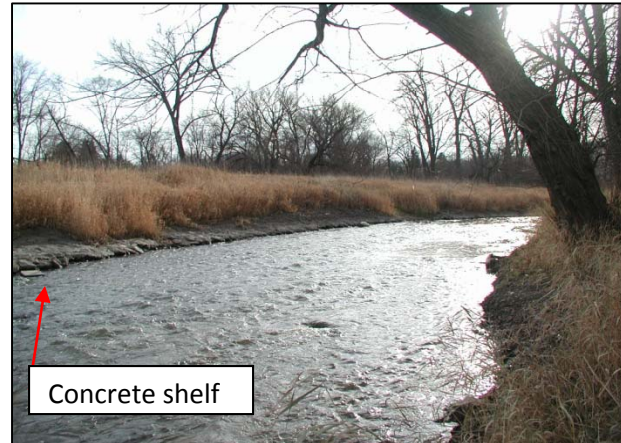
Looking upstream from the sampling location in winter. Note concrete shelf and grass island on south (left) bank and grassed area on north bank

Buffers in park are adequate but may contain invasive species. These should be identified and eradicated.

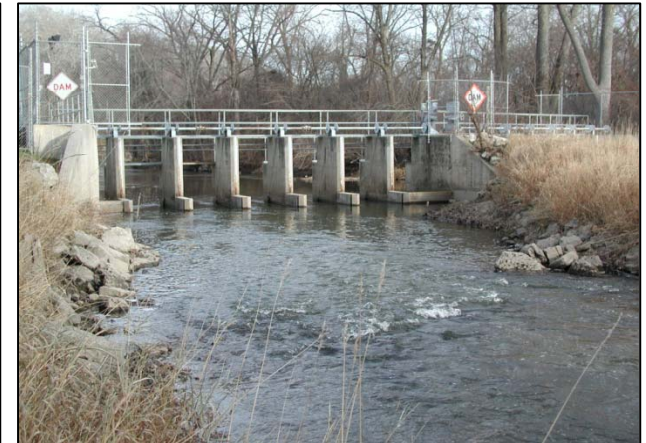
Looking downstream from sampling location in winter. Fish weir runs across stream width and free-standing rocks stabilize nearby banks.

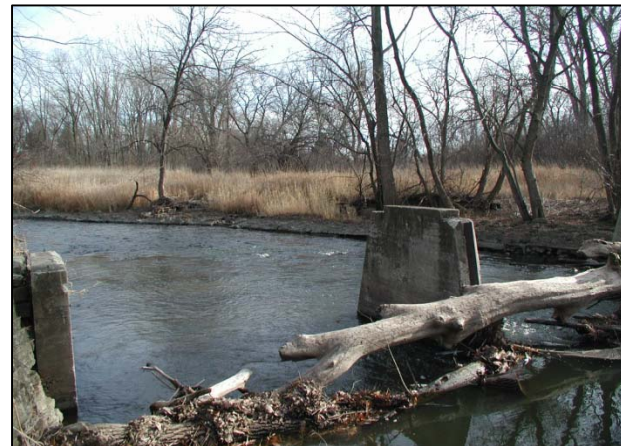
Deteriorated concrete pillars do not appear to be functional , are collecting large debris and should be investigated for removal.

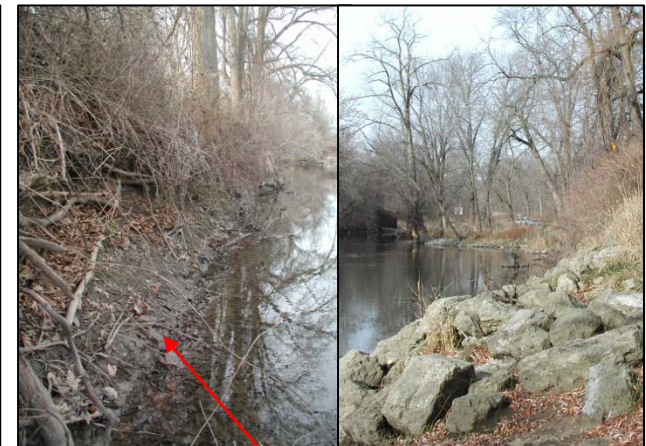
Steep eroded banks (left) at the foot of a bluff with residences on west bank and free-standing rock pilings on east bank next to park (right).

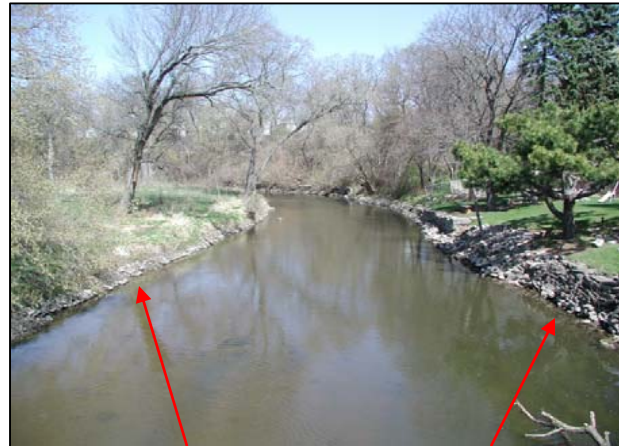
Looking upstream from sampling point in spring. Moderate rock support on west (left) bank and established rock walls on east (right) bank.

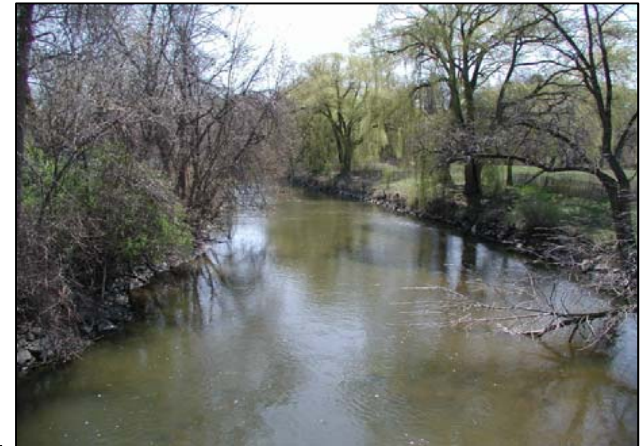
Looking downstream from sampling location on bridge in spring. Note continuation of rock wall support on both stream banks.

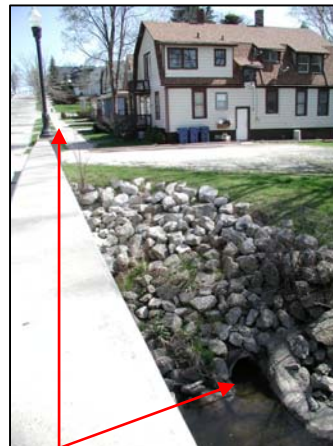
The southeast outfall samples were high for human markers, phosphorus, and detergents. A sanitary sewer line from an uphill house was disconnected from the storm sewer and dry weather flow from the outfall ceased. The large upstream outfall was tested four times and may also be a source of fecal pollution loading to the Root River; testing should continue. The southwest outfall was always dry.

Uphill sanitary sewage source (left arrow) and southeast outfall (right arrow).

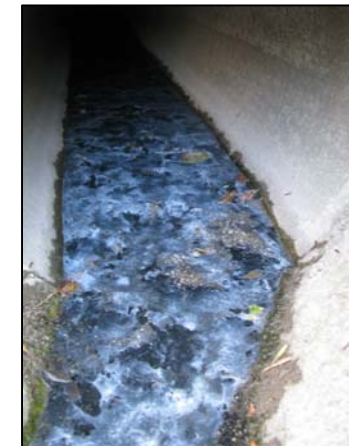
High levels of detergents found in southeast outfall (note foaming present in storm water discharge).

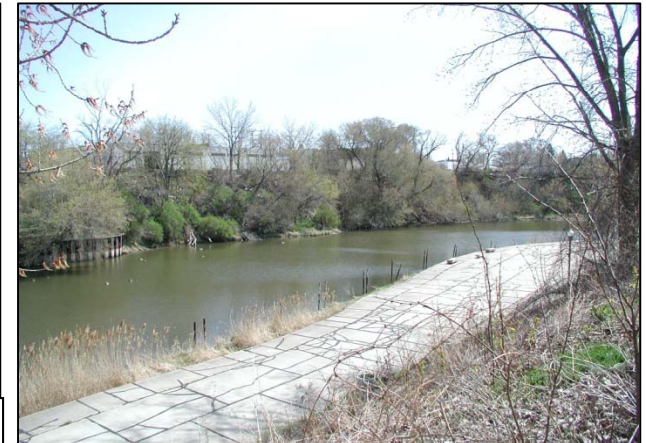
View looking downstream from the sampling point from the REC parking lot. This is the beginning of channelized section of the river.

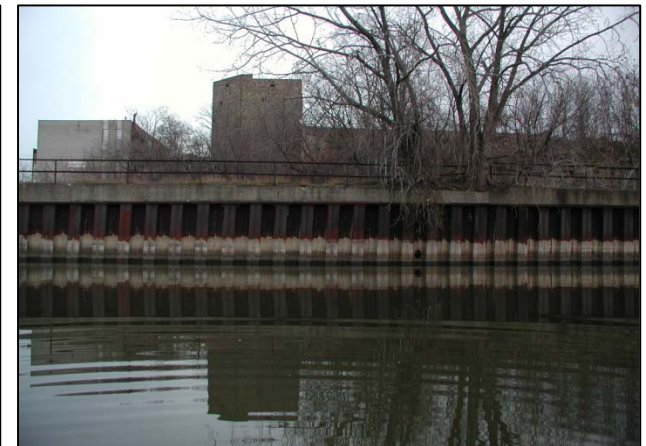
East bank of channelized river portion with industrial/commercial land use visible in the background .

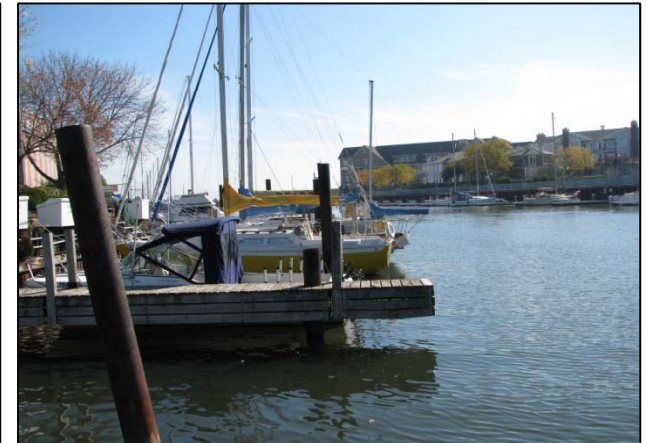
Looking upstream from sampling point in summer. Area is channelized through the harbor until the mouth of the river at Lake Michigan.

The river is controlled by steel and concrete-reinforced walls comprising the channel leading out from the Root River mouth to the harbor. No erosion was noted. Substrate could not be assessed due to deep river conditions. No to very little tree canopy exists.

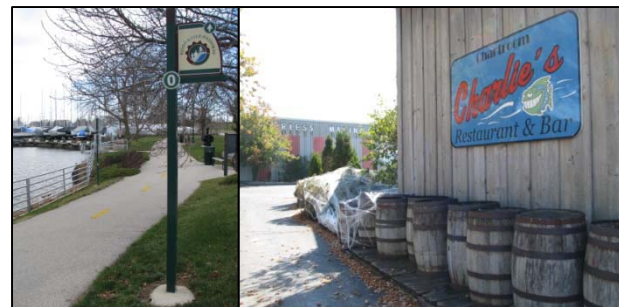
Looking downstream from sampling point in summer.
