COMMUNITY ASSISTANCE
PLANNING REPORT NO. 58
(3RD EDITION)

A LAKE MANAGEMENT PLAN FOR PEWAUKEE LAKE WAUKESHA COUNTY, WISCONSIN

Prepared by the
Southeastern Wisconsin Regional Planning Commission
W239 N1812 Rockwood Drive
P.O. Box 1607
Waukesha, Wisconsin 53187-1607
www.sewrpc.org

June 2020

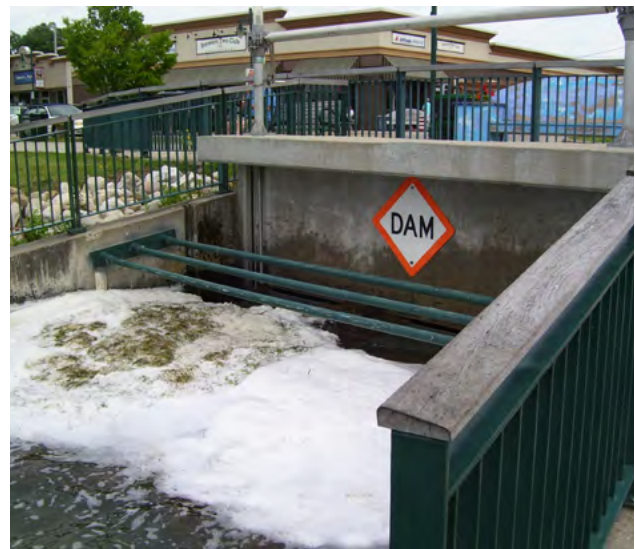
Pewaukee Lake's water level has been artificially elevated by a dam for nearly 180 years. The dam considerably increased water depth, changing the former marshy eastern basin into a shallow lake and submerging marshy areas around the Lake's shoreline. The former weir-type dams had very limited capacity to vary water discharge rates. The dam was rebuilt in 2010, incorporating a bottom draw gate that now allows the dam operator a high degree of control over dam discharge rates and Lake water levels. This modification enhances capacity to diminish the duration of slow-no-wake periods, retain excessive runoff, augment downstream dry weather flow, and influence a number of other factors of interest to the community and/or that affect waterbody ecology. It is important to note that the dam is not designated as a flood control structure.

The Lake outlet dam was modified in 2010.

The Lake’s outlet elevation was artificially raised about 180 years ago when a dam was built at the point where the Pewaukee River exits the Lake. Today’s dam is not the same dam constructed in 1842. Several structures have been erected over the years, most of which relied primarily on a fixed weir elevation to pass water downstream. In such a structure, the amount of water passed by the dam increases as lake elevation increases. The relationship between lake elevation and flow over the recently replaced dam is shown in Figure 2.19. The current dam, built in 2010 and owned and operated by the Village of Pewaukee, uses subsurface gates to release water from the Lake. The outflow rate for the current dam depends upon both gate position and lake level elevation. The outlet dam raises the Lake’s water elevation roughly eight feet.

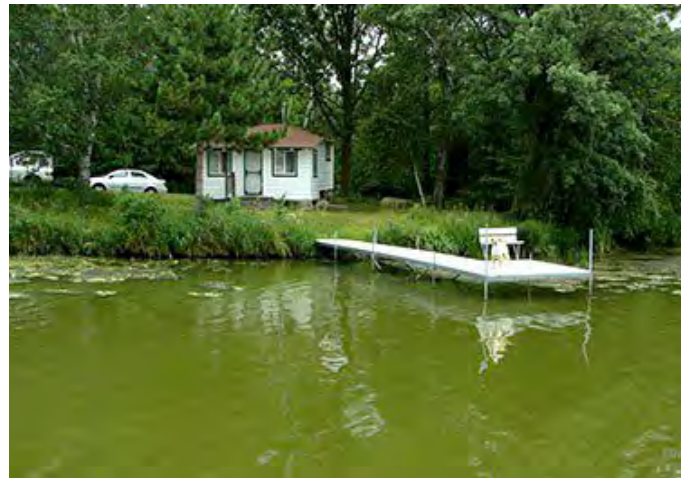
Figure 2.26
Potential Appearance of a Hyper-Eutrophic Lake

4. **The lake's current and past trophic status**—Lakes are commonly classified according to their degree of nutrient enrichment, or trophic status. The ability of lakes to support a variety of recreational activities and healthy fish and other aquatic life communities is often correlated with the lake's degree of nutrient enrichment. Three terms are generally used to describe the trophic status of a lake: oligotrophic (nutrient poor), mesotrophic (moderately fertile), and eutrophic (nutrient rich) (see Figure 2.24). Each of these states can happen naturally. Lakes tend to naturally shift to a more nutrient-rich state, a progression sometimes referred to as "aging" (see Figure 2.25). However, if a lake rapidly shifts to a more eutrophic state, human-induced pollution may be responsible for this change. An indicator of severe human pollution is when a lake displays "hyper-eutrophic" nutrient levels, a condition indicating highly enriched water (see Figure 2.26). Hyper-eutrophic conditions do not commonly occur under natural conditions, and are nearly always related to human pollutant sources.

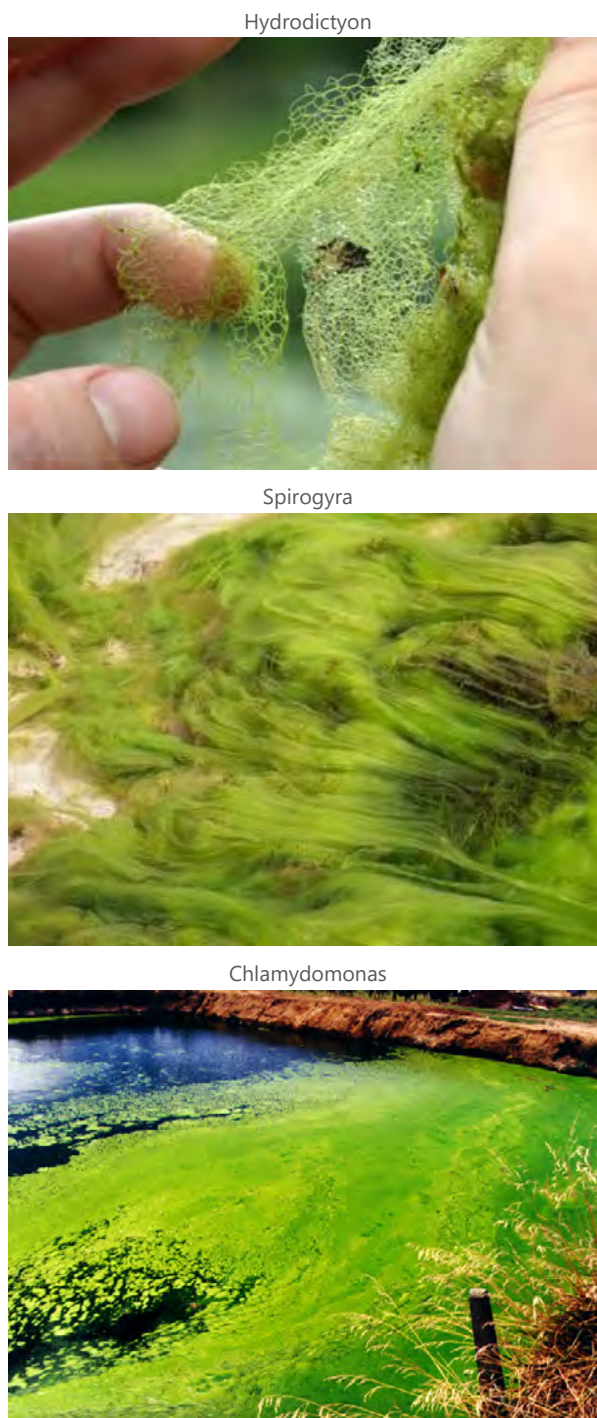
Figure 2.43
Common Types of Non-Toxic Algae

Chlorophyll-a, a photosynthetic pigment whose abundance is used to indicate algal biomass, is the most reliable metric of a lake’s trophic status. Algae is an important and healthy part of lake ecosystems. Algae is a foundational component of lake food chains and produces oxygen in the same way as rooted plants. Many kinds of algae exist, from single-cell, colonial, and filamentous algae to cyanobacteria (see Figure 2.43).

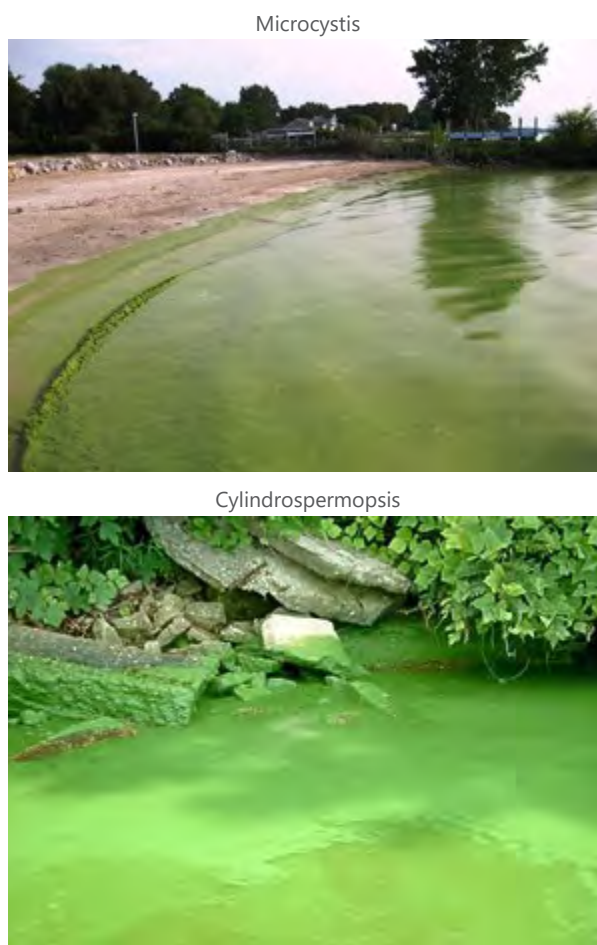
Figure 2.44
Appearance of Toxic Algae Blooms

Most algae strains are beneficial to lakes when present in moderate levels. However, the presence of toxic strains (see Figure 2.44), as well as excessive growth patterns, should be considered issues of concern. As with aquatic plants, algae grows faster in the presence of abundant phosphorus (particularly in stagnant areas). Consequently, when toxic or high volumes of algae begin to grow in a lake, it often is a sign of phosphorus enrichment or pollution.

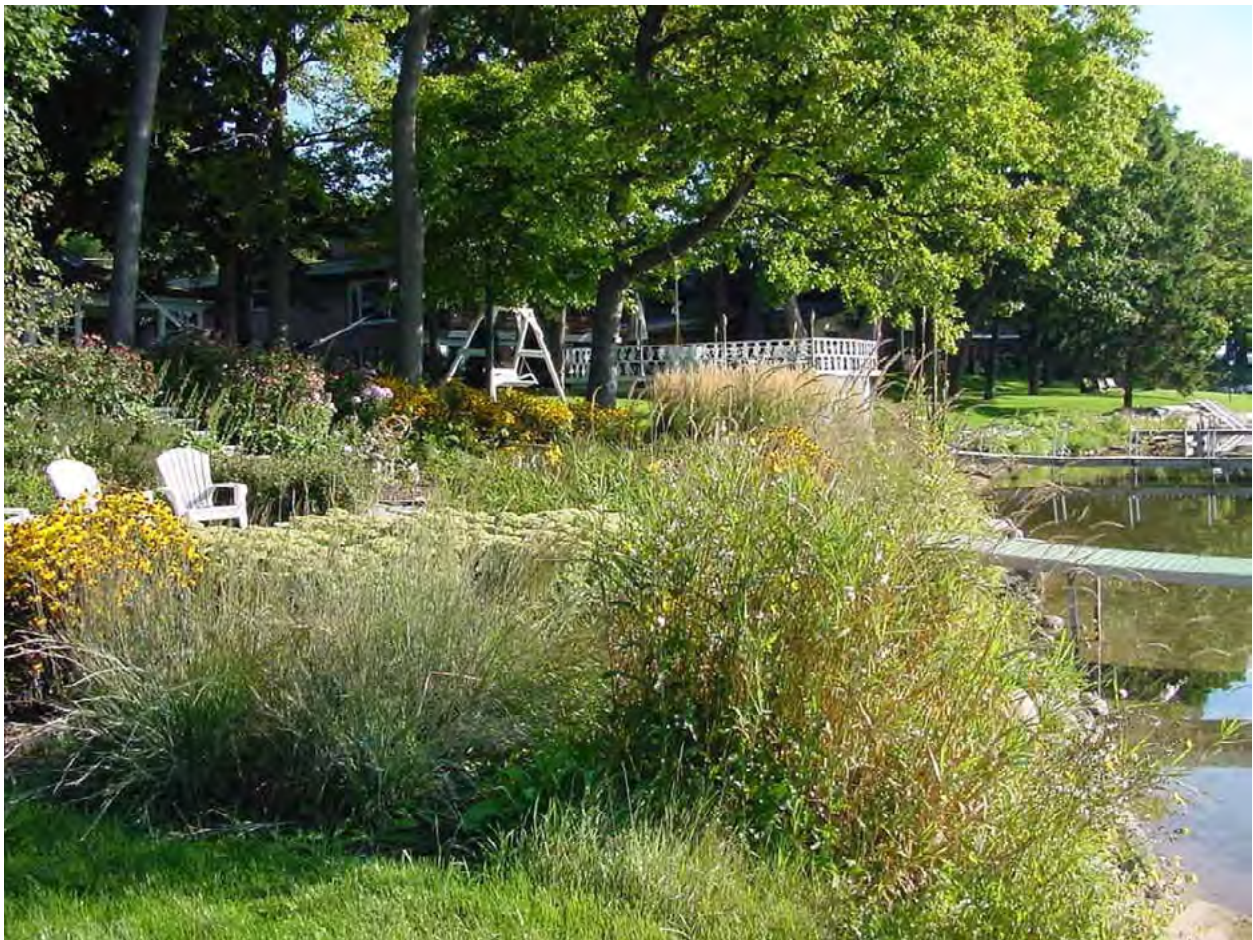
Figure 2.60
Natural Shoreline Buffers

“Soft” shoreline protection techniques, such as vegetated shoreline protection, are increasingly required pursuant to Chapter NR 328, “Shore Erosion Control Structures In Navigable Waterways,” of the *Wisconsin Administrative Code*. These techniques include natural shoreline, native planting, maintenance of aquatic plants along shorelines, and “fish sticks” (see Figure 2.58). Vegetative shoreline protection is becoming more popular as people living along lakes and streams become increasingly aware of the value of protecting their shorelines, improving overall aesthetic appeal of their shoreline, and promoting natural and nature-like habitat for both terrestrial and aquatic wildlife. Additionally, shorelines protected with vegetation help shield a lake from both land-based and shoreline pollution and sediment deposition. These “soft” techniques can be incorporated with “hard” shoreline protection in order to reduce erosion, mitigate pollutant loading, and improve aquatic habitat (see Figure 2.60). Examples of techniques that incorporate “hard” and “soft” techniques into “living” shorelines are presented in Appendix B on page 313.¹³⁵

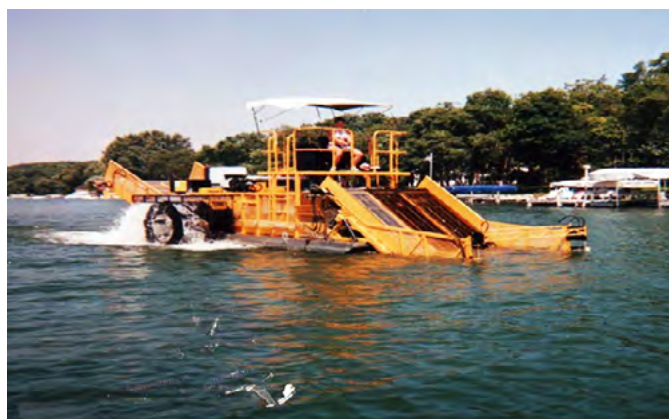
Figure 2.75
Lake Pewaukee Sanitary District
Aquatic Plant Harvester

Currently, the LPSD operates three harvesters (Figure 2.75) that are used for cutting from the ends of the piers to about two hundred feet from shore. These harvesters cut to a depth of five feet and cut a nine-foot wide path. In 2014, two new harvesters were added; one of the older machines was converted into a “shallow water harvester” and the other reserved as a back-up.

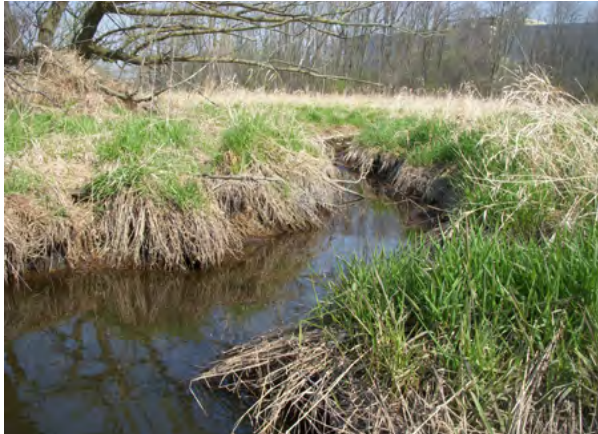
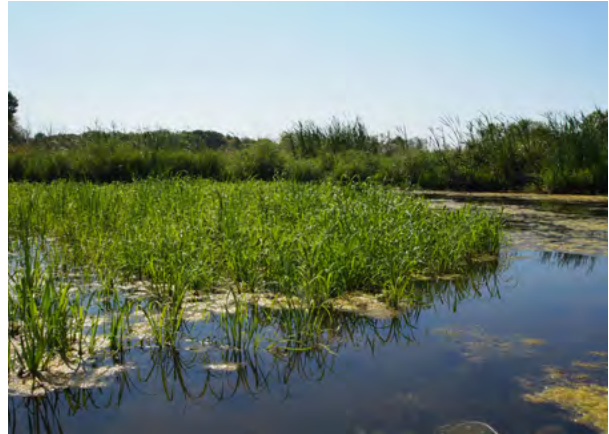
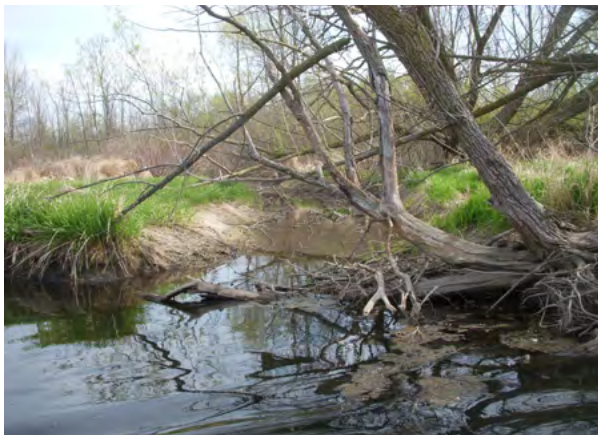
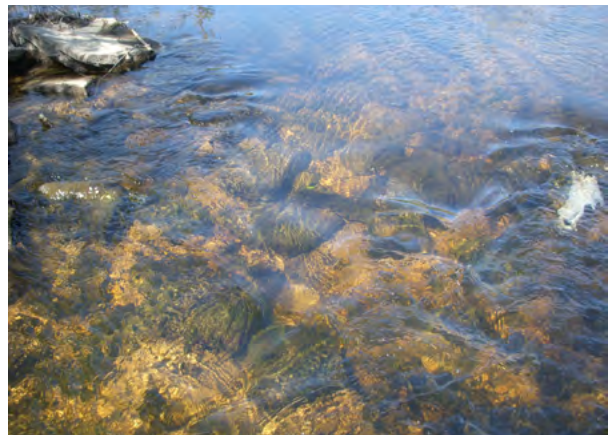
Figure 2.82
Example of Instream Cover Within the Pewaukee Lake Watershed

Overhanging Vegetation

Emergent Vegetation

Wood Debris

Boulders and Cobble

Instream cover is an essential component of a healthy stream ecosystem. It provides shelter for aquatic organisms, prevents excessively high water temperatures, and inhibits eutrophication. The type and amounts of riparian vegetation are significant drivers of the types and amounts of instream cover. Examples of instream cover are shown in Figure 2.82. Instream woody structures are an important component of stream ecosystems, providing essential food and habitat for aquatic organisms. Woody structures can affect

channel morphology forming pools; retain organic matter, gravel, and sediment; influence invertebrate abundance; and provide cover and velocity refuge for fish.¹⁹³

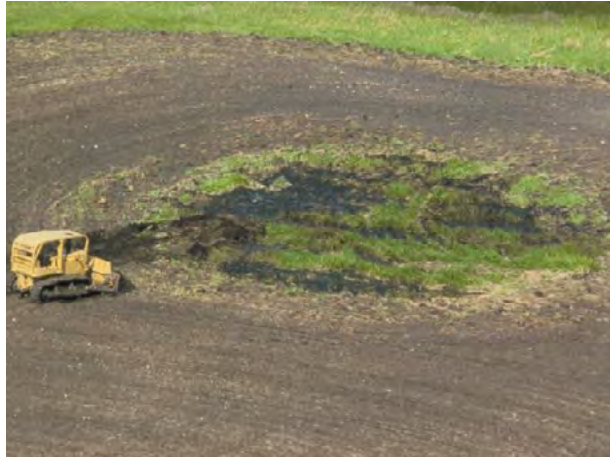
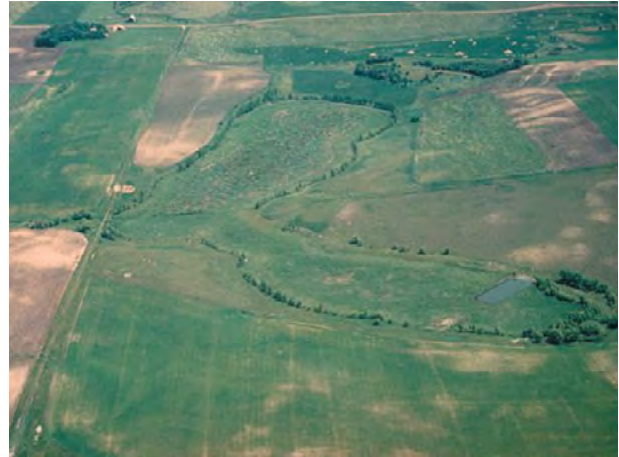
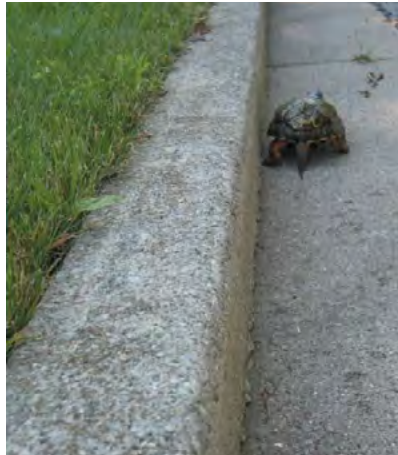
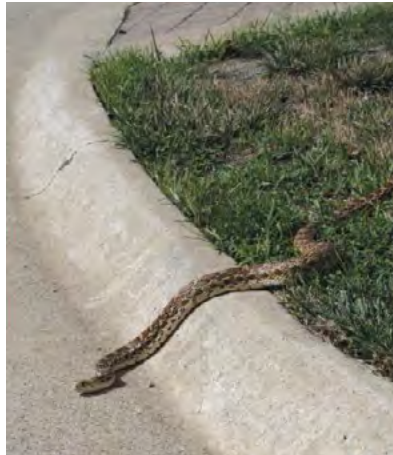
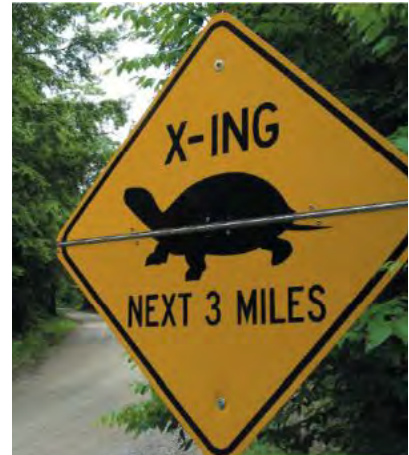
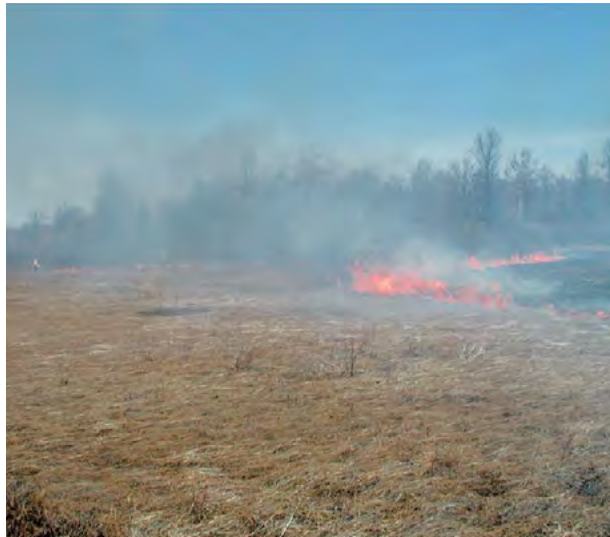
Figure 3.8
Examples of Habitat Improvement Projects in Agricultural and Urban Landscapes for Amphibians and Reptiles

Recreation or Reconnection of Wetland and Upland Habitats

Removing Obstacles and/or Placing Signage Can Improve Safety and Effectiveness of Travel Between Habitats

Burning Can Be an Effective Management Tool

Roadside Fences Can Reduce Mortality

This should be a medium priority, although this should increase to a higher priority if wildlife populations decline. The acceptance and employment of BMPs can be fostered through voluntary, educational, or incentive-based programs for properties adjacent to the shoreline, and by directly implementing these practices on public and protected lands. Special interest non-governmental organizations ("NGOs", e.g., Pheasants Forever, Ducks Unlimited, Trout Unlimited, Walleyes for Tomorrow, etc.) exist to foster habitat improvement projects, some of which collaborate with land owners to install beneficial projects. If this recommendation is implemented, a complete list of BMPs and relevant NGOs should be compiled and provided to landowners (see Figure 3.8 for examples of enhancing herptile habitats).

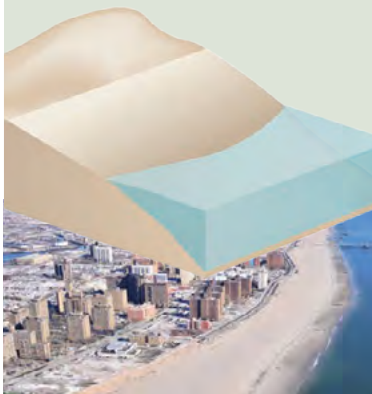
BEACH NOURISHMENT ONLY

Large volume of sand added from outside source to an eroding beach. Widens the beach and moves the shoreline seaward.

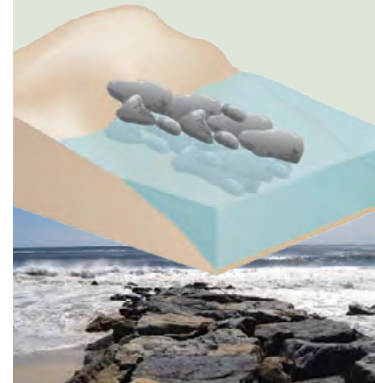
GROIN

Perpendicular, projecting from shoreline. Intercept water flow and sand moving parallel to the shoreline to prevent beach erosion and break waves. Retain sand placed on beach.

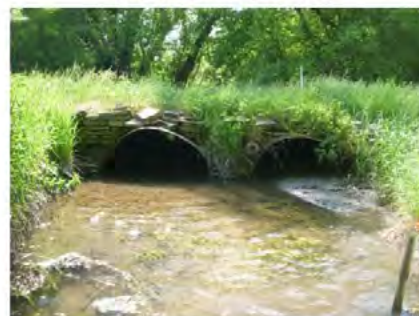
6- YENCH ROAD
COCO CREEK (RM 1.00)

6	One 5.6-foot-wide, 3.2-foot-high; one 5.6-foot-wide, two-foot-high corrugated metal pipe arch culverts	Yench Road	1.00	34.0	Stable	Lannon stone wall surrounding culvert is failing	1.0	0.5	Passable	General maintenance on structure headwall	N/A	2012	
7	Four 3.0-foot-diameter concrete round projecting culverts	City of Pewaukee Private crossing	1.13	17.0	Moderate	Poor	0.9	0.0	Restricted Passage	Remove. All flow directed in culvert 2. Culverts 1, 3, and 4 are perched at inlet and outlet	N/A	2015	
8	Span wood foot bridge	City of Pewaukee Private crossing	1.86	5.0	Moderate	Fair	--	--	Passable	Replace	N/A	2015	
9	One eight-foot-wide, four-foot-high concrete box culvert	CTH KE Primary culvert	2.43	48.0	Stable	Good	1.0	1.5	Passable	None	N/A	2012	
10	One eight-foot-wide, four-foot-high concrete box culvert	CTH KE Secondary culvert	2.43	48.0	Stable	Good	1.0	1.5	Passable	None	N/A	2015	
12	Wood foot bridge with abutment on one side	Abandoned private crossing	2.69	8.0	Moderate	Fair	--	--	Passable	Remove, not necessary	N/A	2015

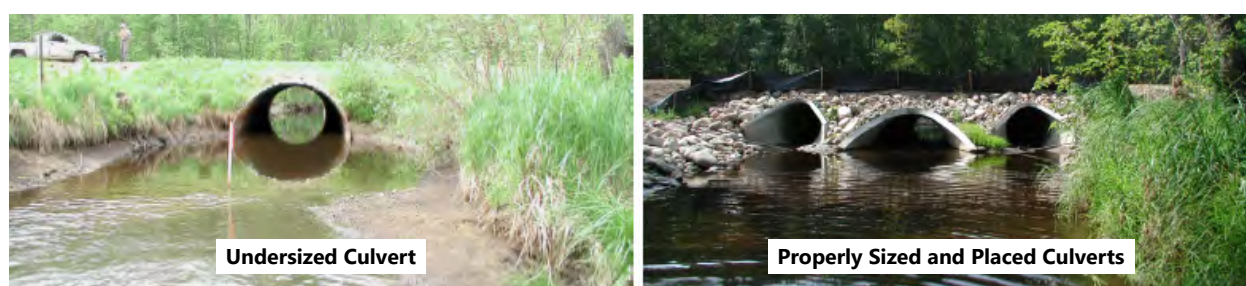
Figure E.2
Considerations for Culvert Design and Placement

- Offsetting Multiple Culverts—If multiple culverts are necessary, it is recommended that the culvert inverts be offset vertically and only one culvert be designed to provide passage during low flow conditions and the additional culverts be used to pass the higher flow events (see Figure E.2). Therefore, the low flow culvert will be the only culvert, in a series of two or more culverts, designed to provide fish passage during low flows and shall meet the physical requirements of passage above.

It is understood that it may not be possible to achieve some of the minimum passage criteria below based upon specific on-site conditions or constraints, however, the closer the designed and completed culvert can meet these criteria the better the long-term passage and overall sustainability of the fishery will be achieved in this region.

- Slope—Culvert should be installed with a slope that matches the riffle slope as measured in the thalweg⁵ (see Minnesota DNR guidelines)⁶
- Water Depth and Velocity—Water depths and velocities should be comparable to those found in the natural channel at a variety of flows. Depths should maintain the determined thalweg depth at any point within the culvert during low flow periods (see Minnesota DNR guidelines).

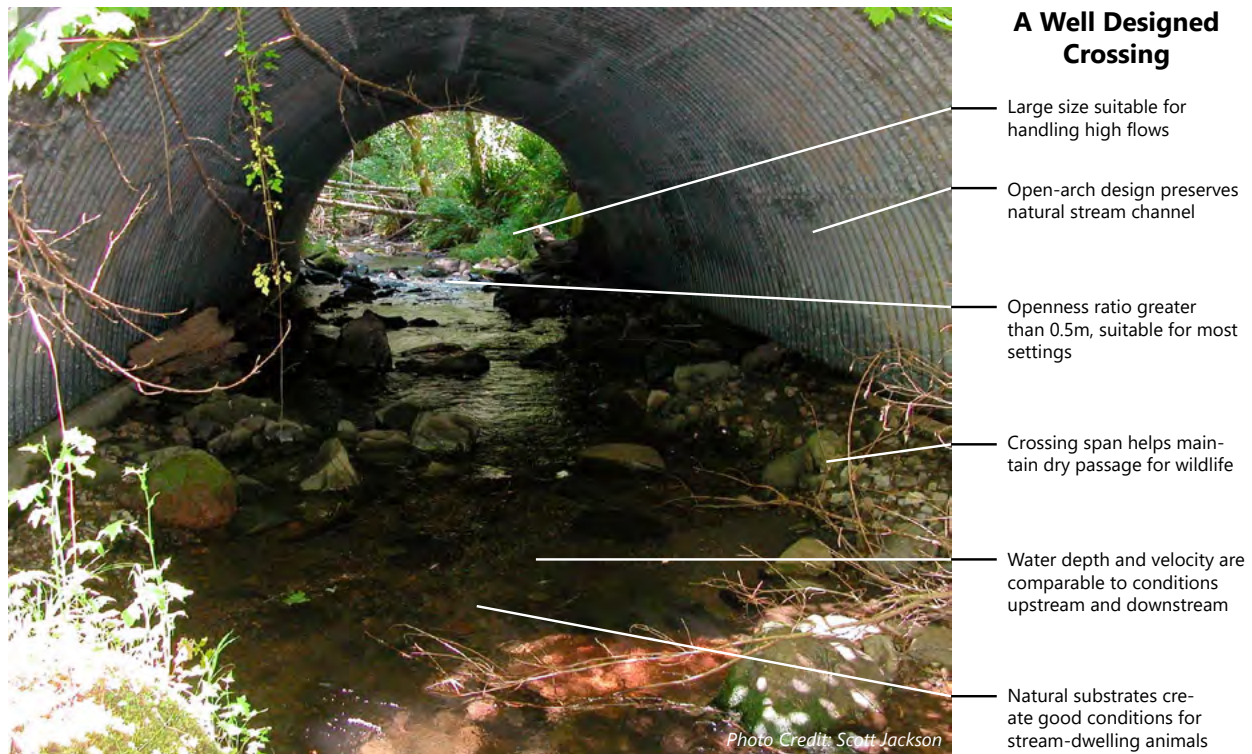
Figure E.3
Key Features that Promote Fish and Wildlife Passage

- Align the culvert with the existing stream alignment (e.g., 90 degree bends at the inlet or outlet should be avoided, even though this will increase culvert length, see Minnesota DNR guidelines).¹⁰
- The low flow culvert should be centered on the thalweg of the channel to ensure adequate depths inside the culvert.
- Provide grade control where there is potential for head-cuts that could degrade the channel.
- It may be necessary to install riprap protection on the outside bank below the outlet to reduce bank erosion during high flow events.
