SOUTHEASTERN WISCONSIN REGIONAL PLANNING COMMISSION

TECHNICAL REPORT NUMBER 61

FIELD MONITORING AND DATA COLLECTION FOR THE CHLORIDE IMPACT STUDY

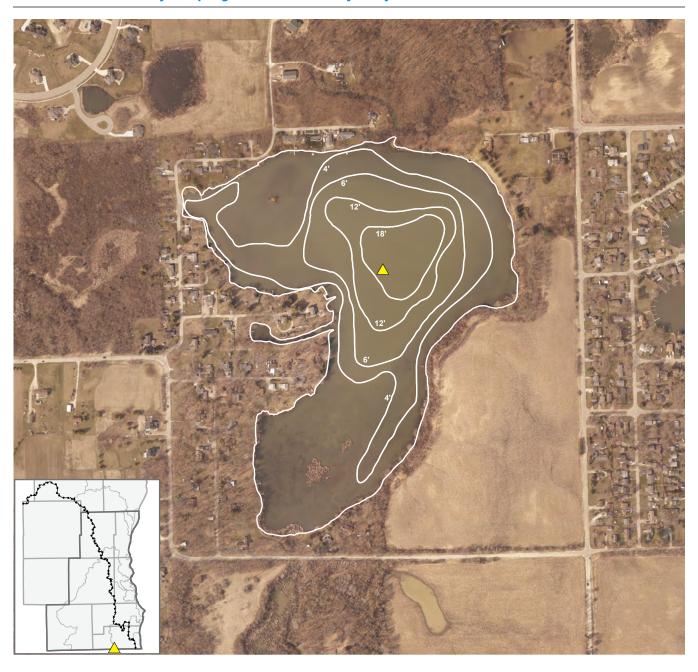
Map 2.18 Voltz Lake Water Quality Sampling Location and Bathymetry

WATER QUALITY SAMPLING LOCATION

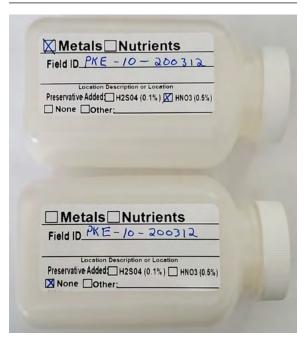
Sample Bottles for Water Quality Sampling

When collecting water quality samples during periods Figure 3.10 of low streamflow and safe conditions, Commission staff entered the water downstream of the monitoring site and walked upstream toward the CTD-10 sensor. Water samples were collected as close to the CTD-10 sensor as practical. Once at the sampling location, extra care was taken to avoid disturbing streambed sediments. Samples were always collected facing upstream to avoid capturing any sediment or debris that may have been disturbed while walking through the stream. Samples were collected in two separate 250 ml plastic bottles, labeled with sample identification and analysis information (see Figure 3.10). With the caps removed, the two sample bottles were submerged at the same time about six inches below the water surface to allow the bottles to fill with stream water. The Commission staff were careful to avoid collecting any surface water that could be contaminated with floating debris. The caps were placed back onto the bottles and the bottles were lightly shaken before the water was poured out. This process was repeated a total of three times to clean any contaminants on the interior of each bottle and bottle cap. The bottles were submerged a final time to collect the sample. The nitric acid preservative was added to one of the sample bottles that was marked to

be analyzed for metals such as calcium, magnesium, potassium, and sodium. The preservative lot number sticker was removed from the acid vile and adhered to the WSLH datasheet for documentation. Additional information such as sample ID, sample date, and sample time were recorded on the WSLH datasheet as presented in Appendix D. The WSLH datasheet and both sample bottles were promptly placed into a onegallon resealable plastic bag, labeled with the site identification and sample date, and placed in a cooler filled with ice. Samples were stored in a refrigerator at the Commission offices at the end of the sampling day until they were transported to the WSLH for analysis. Samples were analyzed for chloride, calcium, magnesium, hardness, potassium, sodium, and sulfate as described in the Laboratory Analysis section.

- Sample bottles 250 ml plastic sample bottles with screw-on caps were provided by the WSLH and were used to hold the collected lake water quality samples. Each bottle had a label to hand-write information such as site identification, date and time of sample, and the type of laboratory analysis to be conducted (Figure 3.10).
