# **LAKE PARK BLUFF STABILITY AND PLANT COMMUNITY ASSESSMENT: 2003**

## **MILWAUKEE COUNTY WISCONSIN**

**SOUTHEASTERN WISCONSIN  
REGIONAL PLANNING COMMISSION**

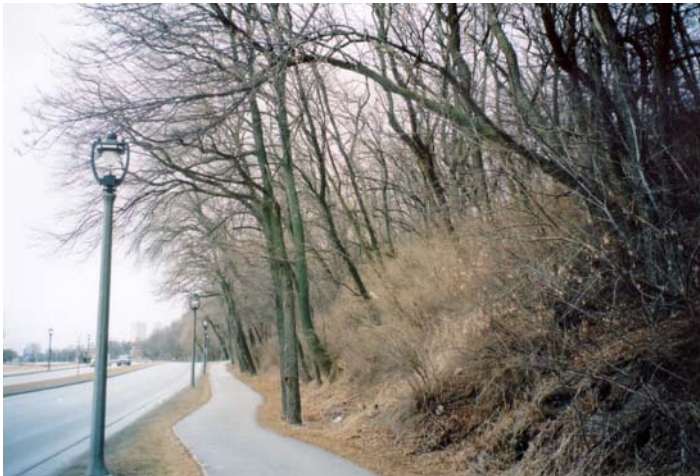
DISTINCTIVE TIPPED AND CURVED TREES WITHIN THE SOUTHERN BLUFFS OF LAKE PARK. PHOTO WAS TAKEN NEAR THE BOTTOM OF PROFILE 3 (SEE MAP 1 FOR LOCATION) LOOKING SOUTH FEBRUARY 11, 2003.

On sites with shallow soils and steep slopes, this may indicate mechanical shifting of materials and signal the potential for a slope failure. There were many observations of tipped trunk trees, as shown in Figure 8, among the southern slopes of Lake Park, specifically Profiles 1 through 3. There were no observations of tipped trees in other bluffs of Lake Park.

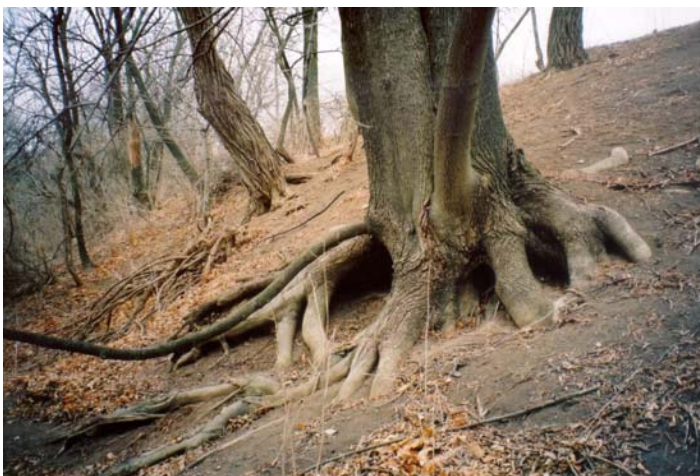
DISTINCTIVE BARE ROOTS UNDER TREES WITHIN THE SOUTHERN BLUFFS OF LAKE PARK. PHOTO WAS TAKEN NEAR THE BOTTOM OF PROFILE 2 (SEE MAP 1 FOR LOCATION) LOOKING SOUTH FEBRUARY 11, 2003.

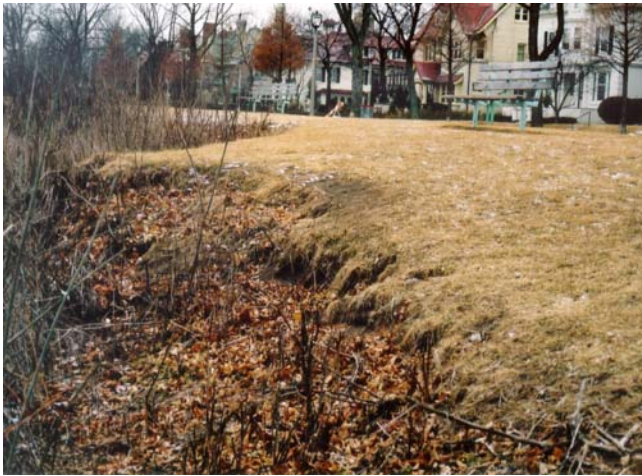
**TOP BLUFF EROSION WITHIN LAKE PARK**

DISTINCTIVE MOWED GRASS AND BLUFF EROSION WITHIN THE SOUTHERN BLUFFS OF LAKE PARK. PHOTO WAS TAKEN NEAR THE TOP OF PROFILE 1 (SEE MAP 1 FOR LOCATION) LOOKING SOUTH, FEBRUARY 11, 2003.

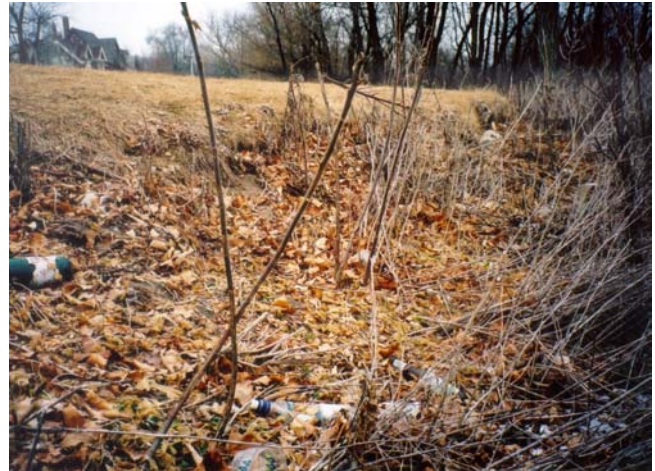
DISTINCTIVE MOWED GRASS, BLUFF EROSION, AND TRASH DEBRIS WITHIN THE SOUTHERN BLUFFS OF LAKE PARK. PHOTO WAS TAKEN NEAR THE TOP OF PROFILE 1 (SEE MAP 1 FOR LOCATION) LOOKING NORTH, FEBRUARY 11, 2003.

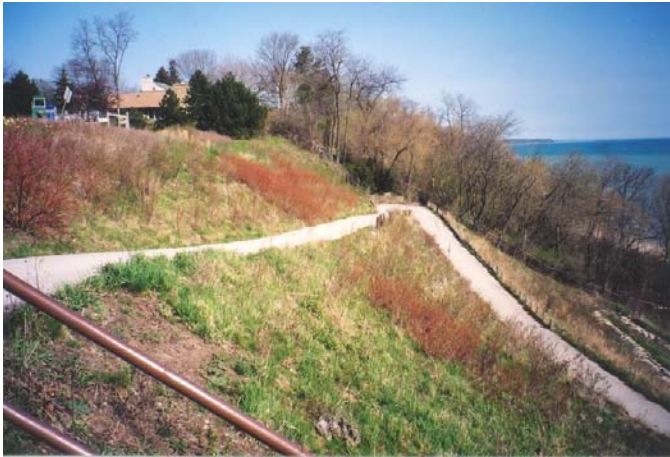
**VIEW A**

Northern top bluff of Atwater Park indicates the first sections to be restored as part of the Atwater Park Bluff Planting Project dated April 23, 2004. Note the various grass and shrub layers established.

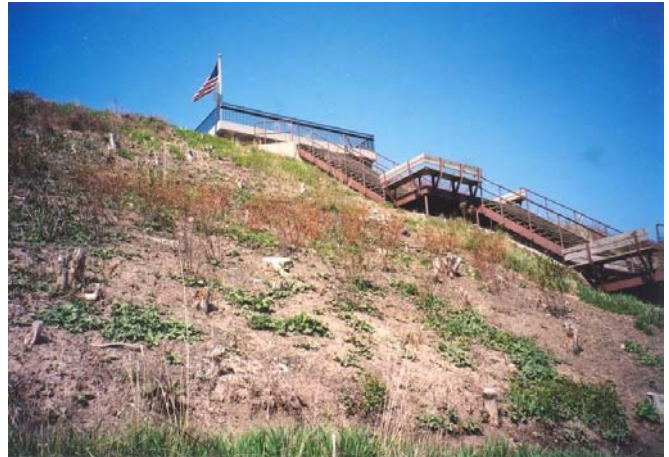
**VIEW B**

Middle portion of the top bluff of Atwater Park indicates the most recently restored areas on the bluffs dated April 23, 2004. Note the exposed soil with limited germination success, due to drought conditions during the critical establishment of the newly seeded and planted area. These areas are more susceptible to erosion as well as to invasion of exotic invasive species such as garlic mustard, which has established itself (dark green leafy areas) in clumps on these barren slopes.

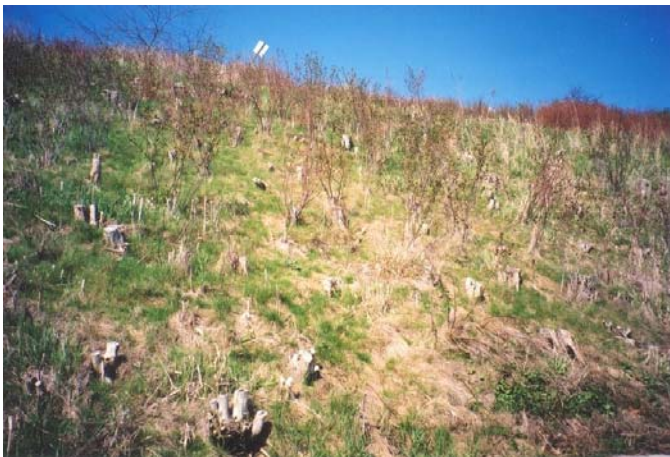
**VIEW C**

Southern to central portion of Atwater Park Bluff's that indicates the preservation of stumps, which help to stabilize the bluff, amongst the native shrub and grass plantings as part of the Atwater Park Bluff Planting Project dated April 23, 2004.

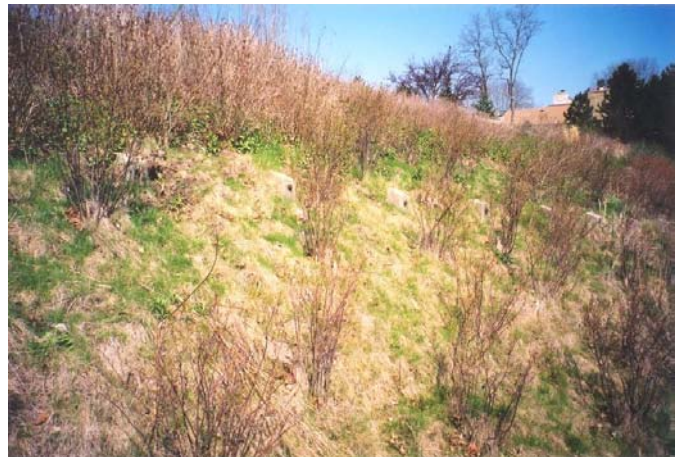
**VIEW D**

Northern portion of the top bluff of Atwater Park that indicates the spacing of newly planted shrubs and grasses as part of the Atwater Park Bluff Planting Project dated April 23, 2004. Note the dark green leafy areas associated with many of the upper tier shrubs in the photo, which are the exotic invasive plants of garlic mustard that need to be eradicated or it will come to dominate the site.
