AQUATIC PLANT MANAGEMENT PLAN FOR NAGAWICKA LAKE

WAUKESHA COUNTY, WISCONSIN

SOUTHEASTERN WISCONSIN REGIONAL PLANNING COMMISSION

February 2025

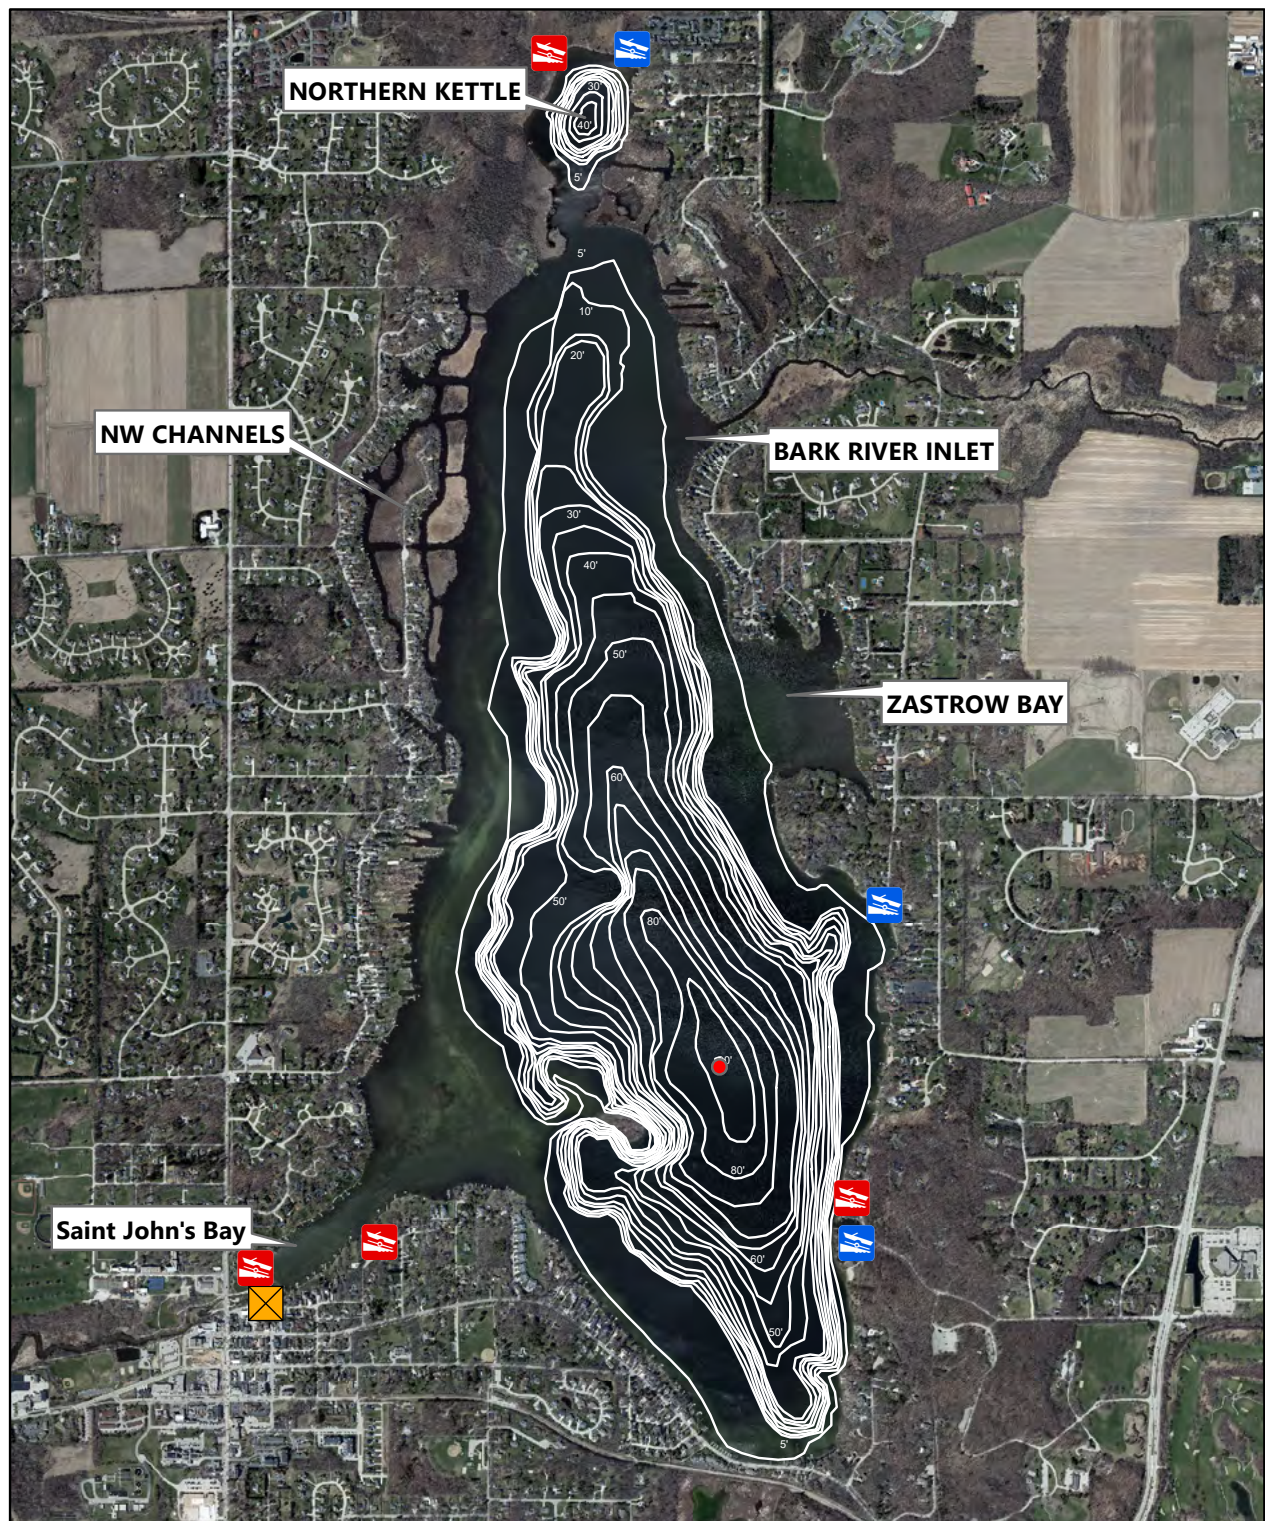
Map 1.1
Bathymetry and Local Location Names of Nagawicka Lake

- 5' — 5 FOOT WATER DEPTH CONTOUR
- DEEP HOLE MONITORING SITE
-

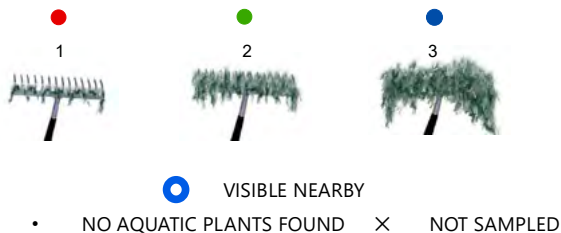
Figure 2.3
Total Rake Fullness in Nagawicka Lake: July 2024

NOTE: Survey was conducted on Nagawicka Lake from July 8th-11th, 2024.

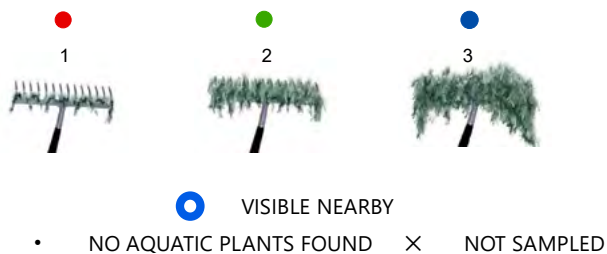
Figure A.1
Muskgrass Rake Fullness in Nagawicka Lake: July 2024

NOTE: Survey was conducted on Nagawicka Lake from July 8th-11th, 2024.

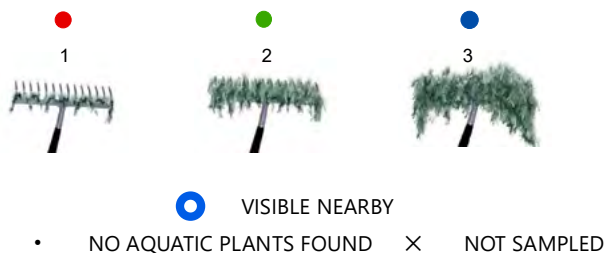
Figure A.5
Elodea Rake Fullness in Nagawicka Lake: July 2024

NOTE: Survey was conducted on Nagawicka Lake from July 8th-11th, 2024.

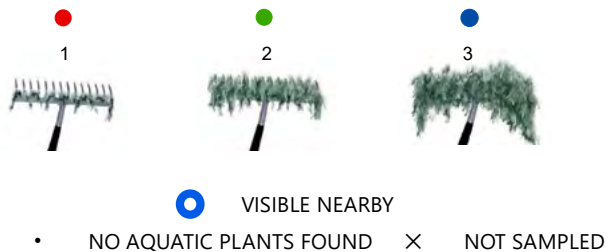
Figure A.8
Spiny Naiad Rake Fullness in Nagawicka Lake: July 2024

NOTE: Survey was conducted on Nagawicka Lake from July 8th-11th, 2024.

In 2016, spiny naiad was found at 44 points but was only found at 4 points in 2024 (see Figure 2.9). Additionally, there were 3 visual sightings in 2016 and 2 sightings in 2024. In 2024, 5 of the 6 points where spiny naiad was found were located near the entrance to Saint John's Bay (see Map A.8 in Appendix A). The remaining point was located near Sylvester Drive south of Price Road.
