# UPPER OCONOMOWOC RIVER NUTRIENT AND SEDIMENT STUDY

**SOUTHEASTERN WISCONSIN  
REGIONAL PLANNING COMMISSION**

## EXECUTIVE SUMMARY

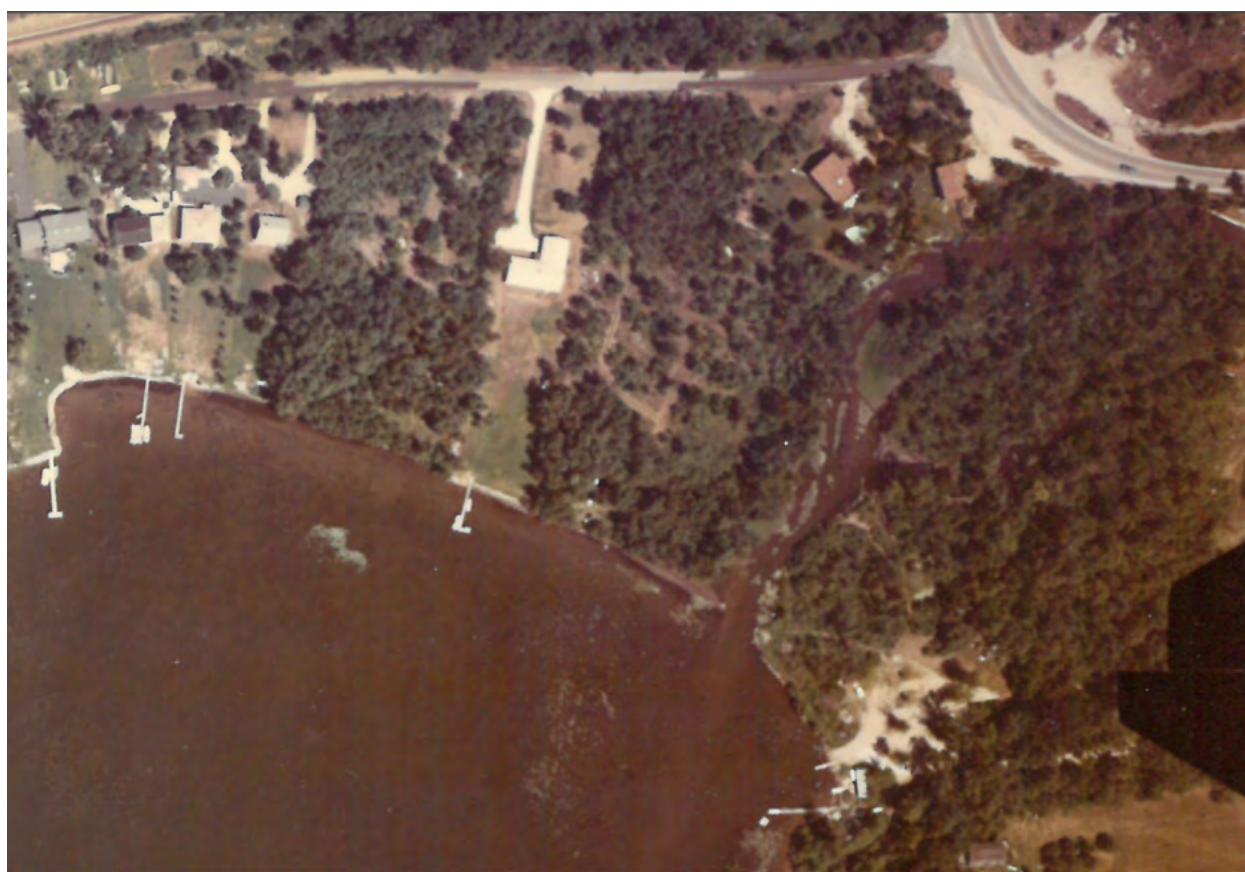
**Figure 1.1**  
**Upper Oconomowoc River Confluence with North Lake: August 2, 1976**

Note: Sediment bars can be seen forming a braided channel condition within the River before it enters North Lake confluence.

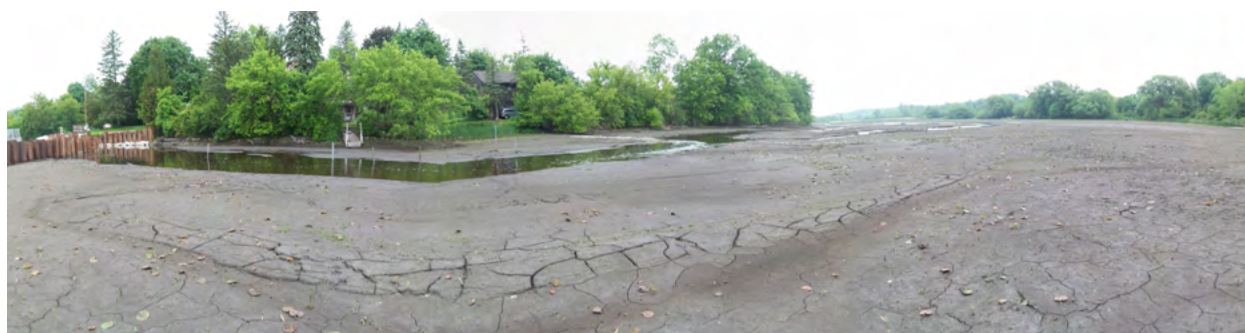
**Figure 2.18**  
**Monches Dam Millpond Drawdown Condition: June 2013**

Note: Panoramic view/composite of several photos showing the southern outlet (left) under construction and entire basin to the northeast (right).

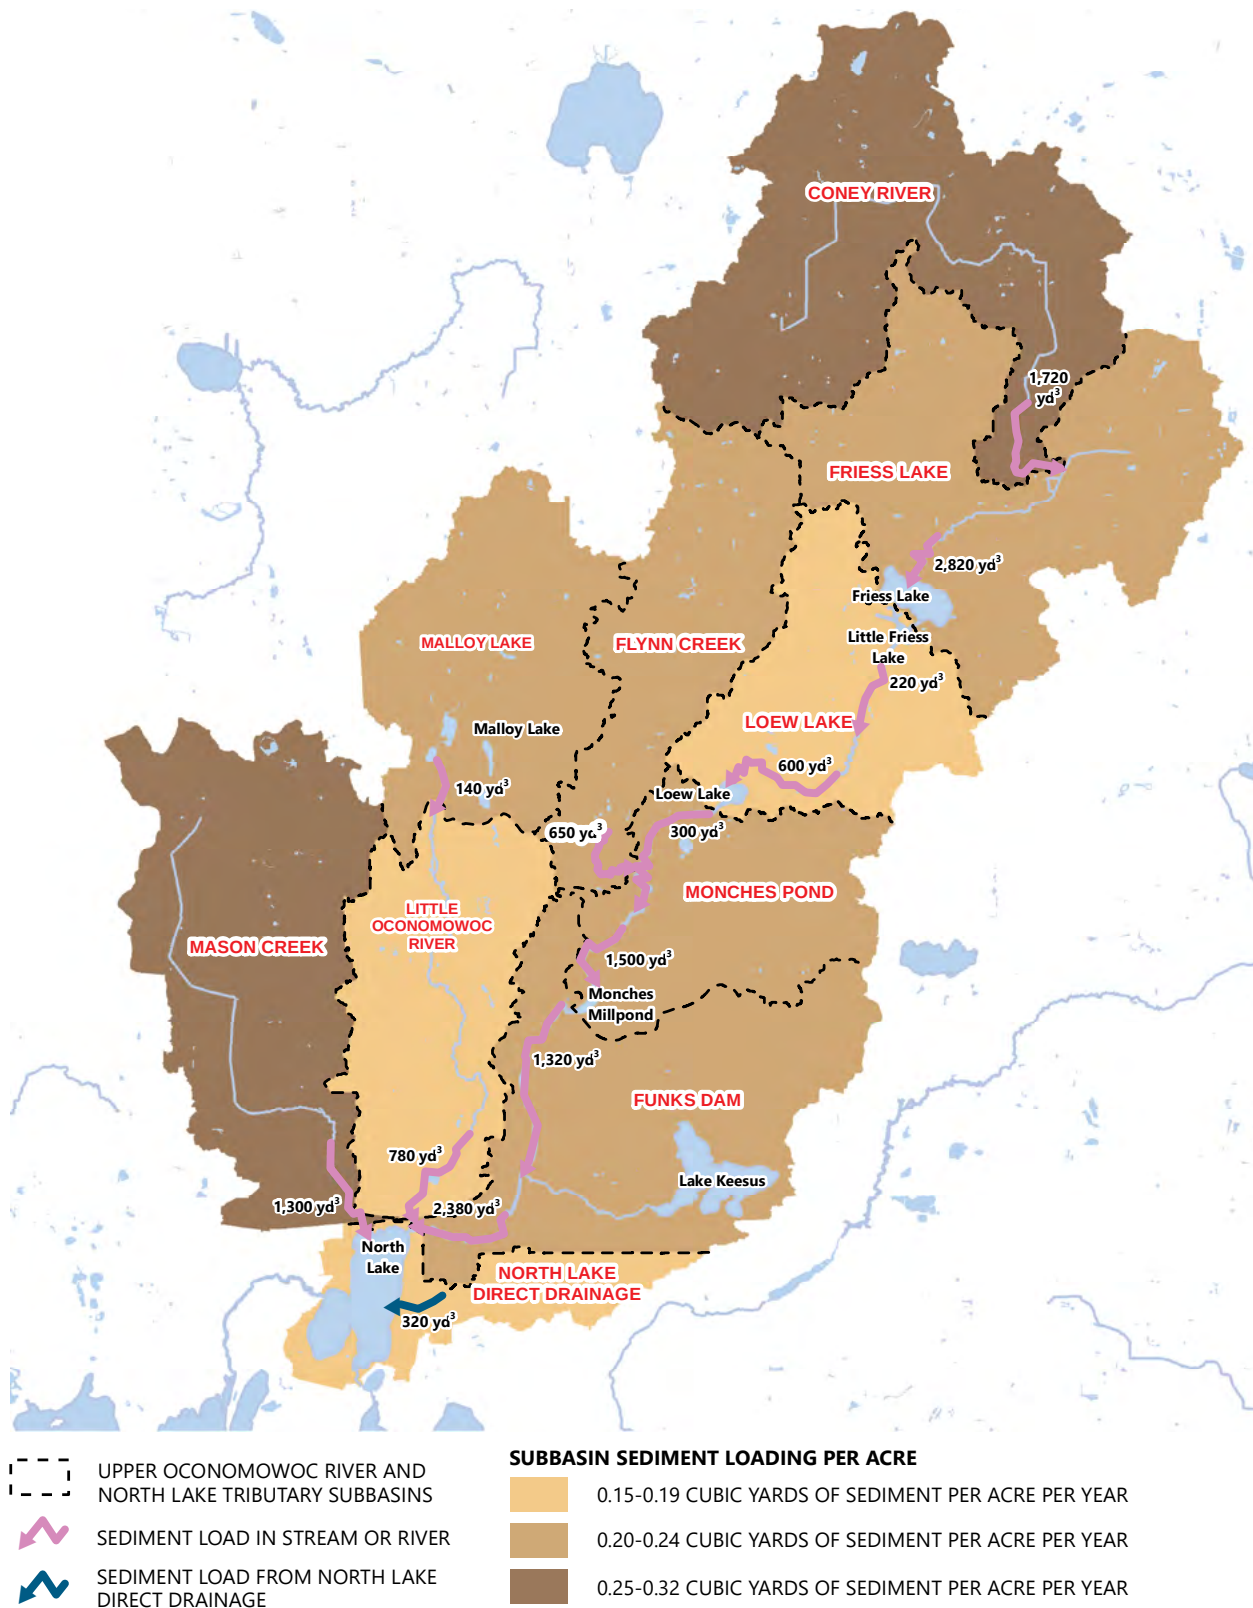
**Figure 2.35**  
**Modeled Annual Sediment Transport in the Upper**  
**Oconomowoc River and North Lake Tributary Subbasins**

Note: Sediment transport estimates have been rounded to the nearest 10 cubic yards per year.

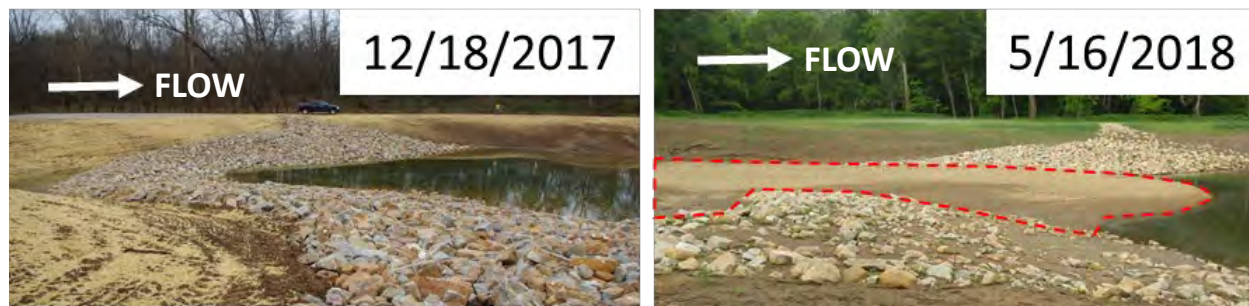
**Figure 5.** Deposition of coarse sediment at the upstream entrance to trap; during low water (Pics: J.Collum)

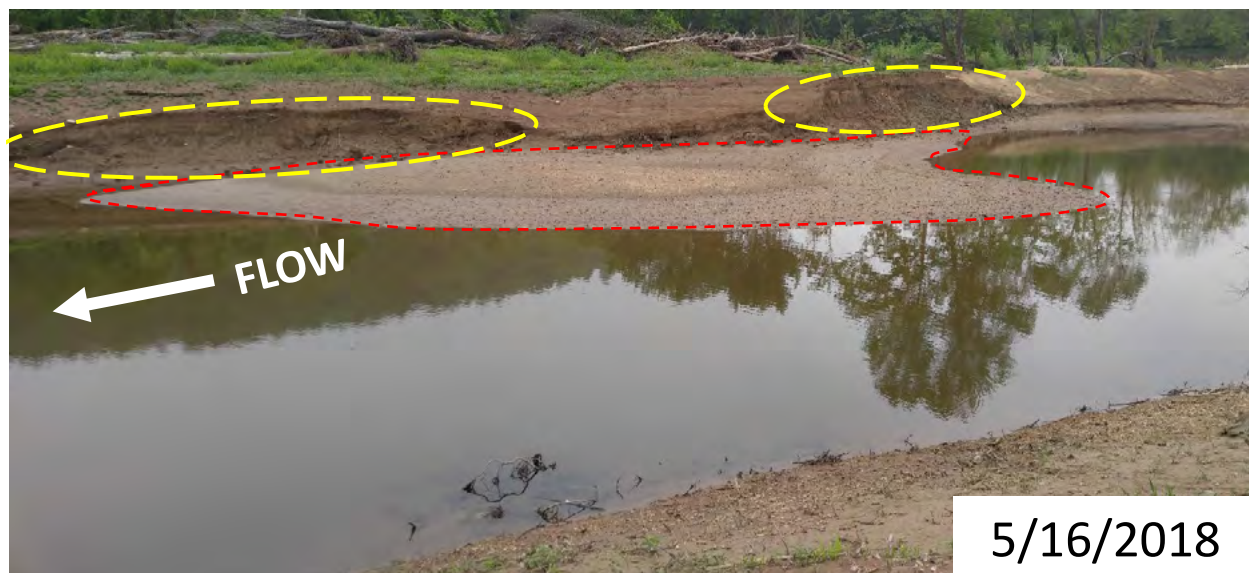
**Figure 6.** Deposition of fine sediment within trap; during low water (Pic: J.Collum)
