AQUATIC PLANT MANAGEMENT PLAN FOR CRAVATH AND TRIPPE LAKES

WALWORTH COUNTY, WISCONSIN

MEMORANDUM REPORT
NUMBER 275

Prepared by the
Southeastern Wisconsin Regional Planning Commission
W239 N1812 Rockwood Drive
P.O. Box 1607
Waukesha, Wisconsin 53187-1607
www.sewrpc.org

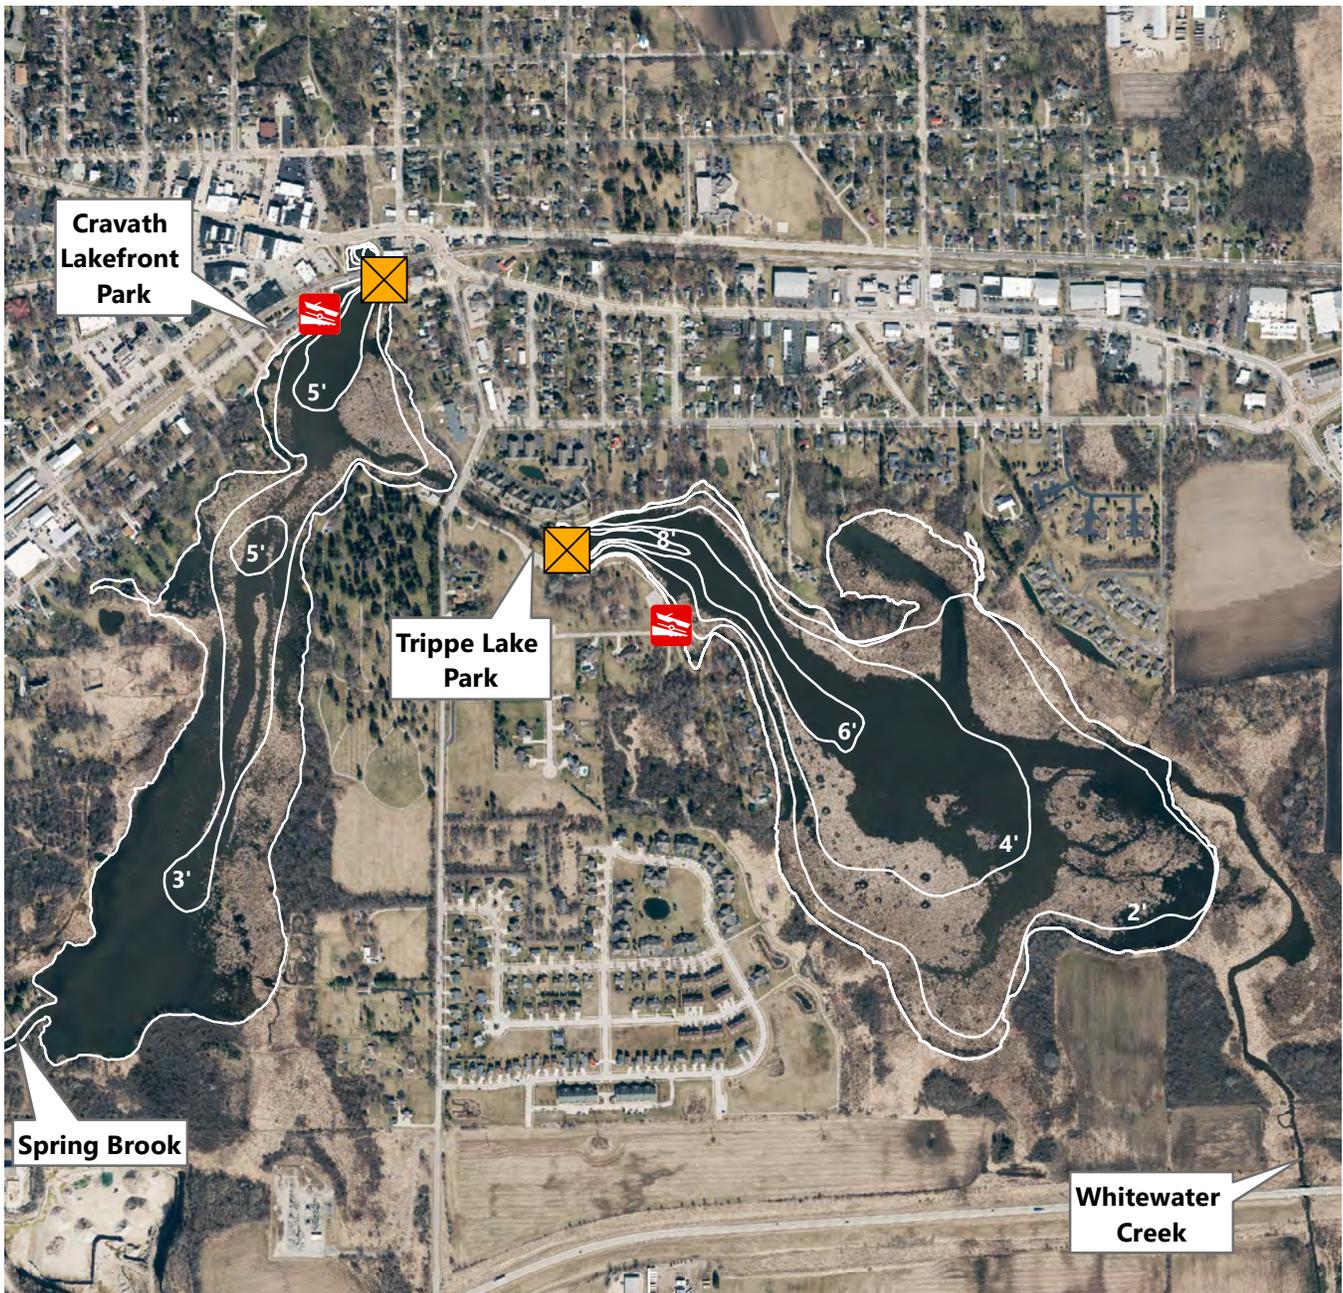
Map 1.1
Location, Public Access, and Bathymetry of Cravath and Trippe Lakes

Note: Aerial imagery from 2024; Bathymetry depths are from WDNR, Trippe Lake's contours are from 1961 and Cravath Lake's contours are from 1966 and thus may not reflect the current depth of the lakes.

Cravath Lake is a 70-acre impounded drainage lake located in the City of Whitewater in Walworth County. It is fed by both Spring Brook and Trippe Lake, and outflows to the Whitewater Creek, to the Bark River, and then to the Rock River (see Map 1.1).¹ Attaining a maximum depth of 10 feet, the Lake can support aquatic plant growth throughout most of its surface area. A 2017 survey performed by Lake and Pond Solutions observed 12 aquatic plant species in the Lake which included several beneficial native species such as Sago pondweed (*Stuckenia pectinata*), Illinois pondweed (*Potamogeton illinoensis*), and American lotus (*Nelumbo lutea*). Invasive aquatic plant species, including Eurasian watermilfoil (*Myriophyllum spicatum*) and curly-leaf pondweed (*Potamogeton crispus*) were also observed during the survey.

Trippe Lake is a 212-acre drainage lake also located in the City of Whitewater. It is fed by Whitewater Creek, and outflows into Cravath Lake (see Map 1.1). It has a maximum depth of 8 feet and was previously surveyed by Lake and Pond Solutions in 2017. A total of 16 species were reported, with similar beneficial native species (*Stuckenia pectinata*) as well as non-native invasives (*Potamogeton crispus* and *Myriophyllum spicatum*). Cravath and Trippe lakes underwent a drawdown from 2019 to 2021, followed by dredging and controlled burns in 2022 for management of aquatic plants. The aquatic plant survey conducted for this update was performed in July of 2024 where Commission staff utilized the recommended baseline monitoring protocol employed by the WDNR.²

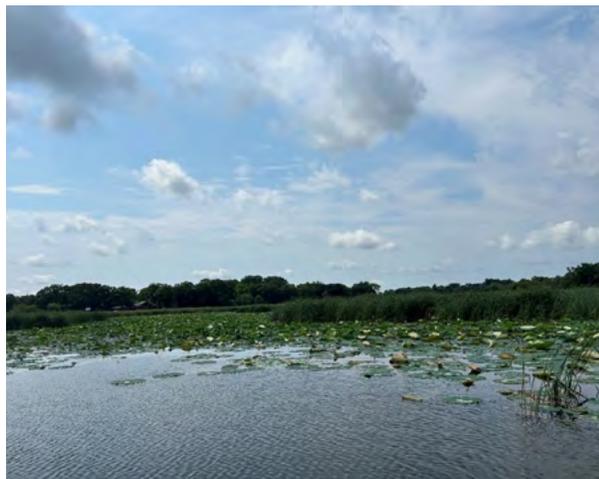
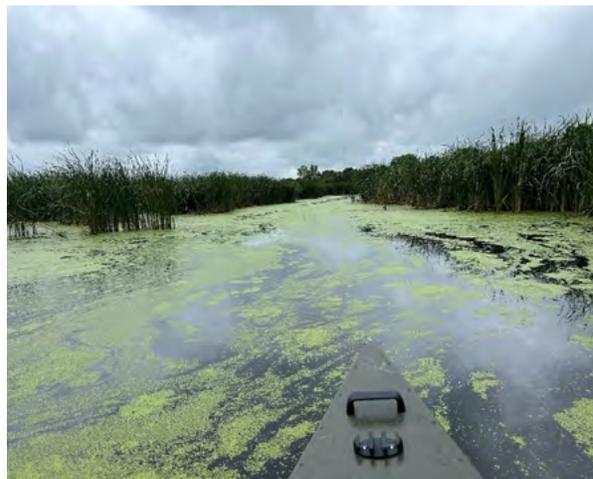
Figure 2.12
Hybrid Cattails in Cravath and Trippe Lakes: July 2024

Trippe Lake Cattails

Cravath Lake Cattails

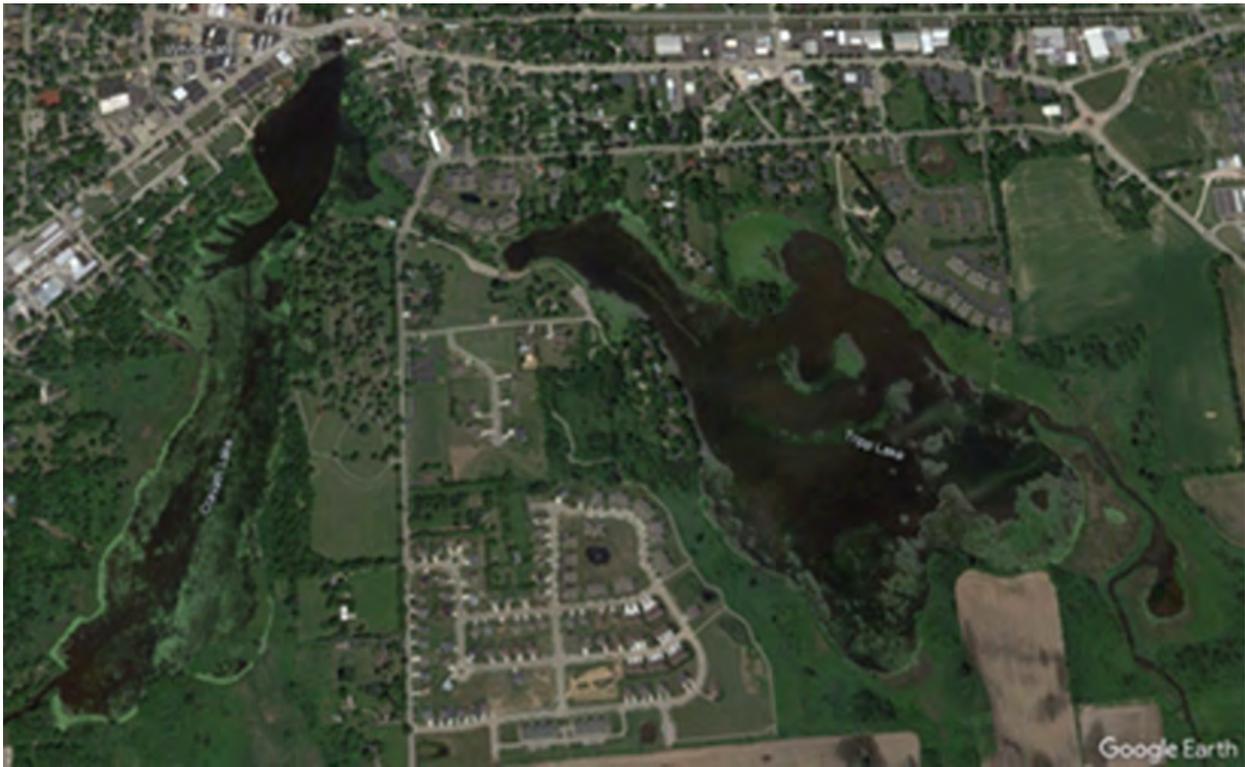
Figure 2.13
Hybrid Cattail Extent in Cravath and Trippe Lakes

June 2015 Cattails

May 2023 Cattails

Commission staff were unable to sample large portions of the lake due to the dense growth of hybrid cattails (see Figure 2.10 and Figure 2.11). Much of the shoreline was unable to be seen or accessed from the Lakes' open water due to the dense growth (see Figure 2.12). Commission staff used aerial imagery to estimate the increase of cattail growth in the Lakes from pre draw-down conditions in 2015 as well as recent cattail conditions in 2023 (see Figure 2.13)²⁷. The cattail coverage on Trippe Lake in June 2015 was estimated to be 27 acres, or 22 percent. Comparatively, the cattail coverage in May 2023 was estimated to be 50 acres, or 41 percent of the lake acreage. Cravath Lake's cattail coverage in June 2015 was estimated to be 3 acres, or 5 percent. Comparatively, the cattail coverage in May 2023 was estimated to be 33 acres, or 47 percent.
