SEWRPC Staff Memorandum

AQUATIC PLANT SURVEY OF SWIFT LAKE AND INVASIVE SPECIES SURVEYS OF PELL LAKE AND COMO LAKE, WALWORTH COUNTY, WISCONSIN

December 2025

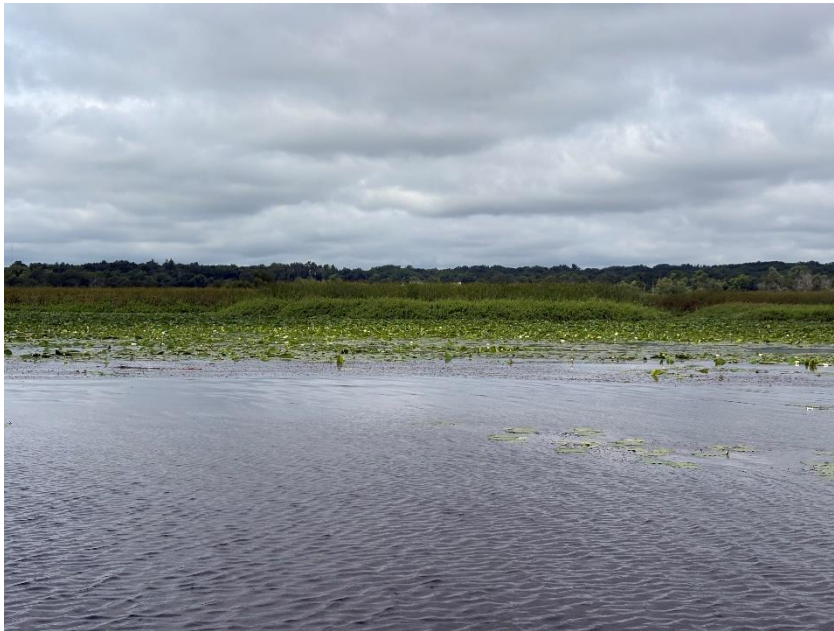
Figure 2
Photos of Como Lake: August 11th, 2025

Como Lake

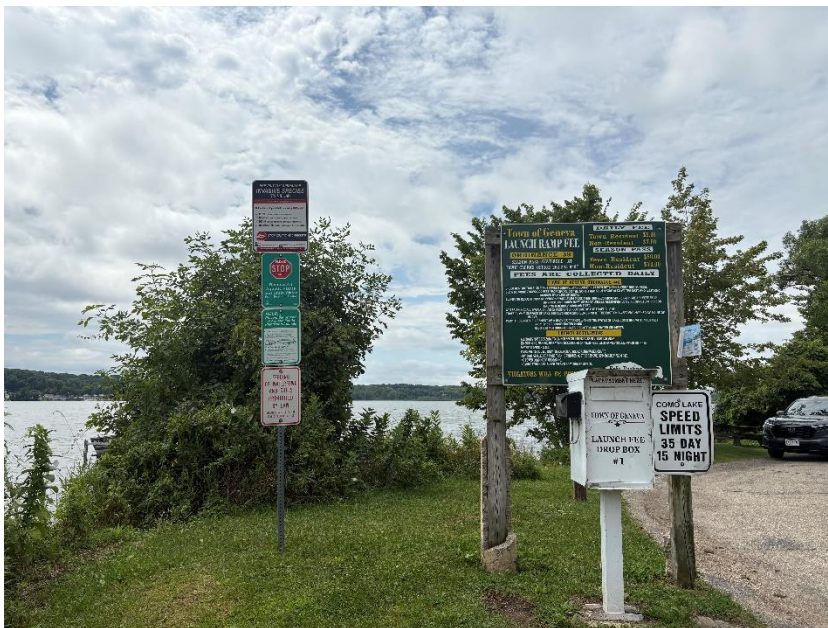
Signage at Como Lake boat launch

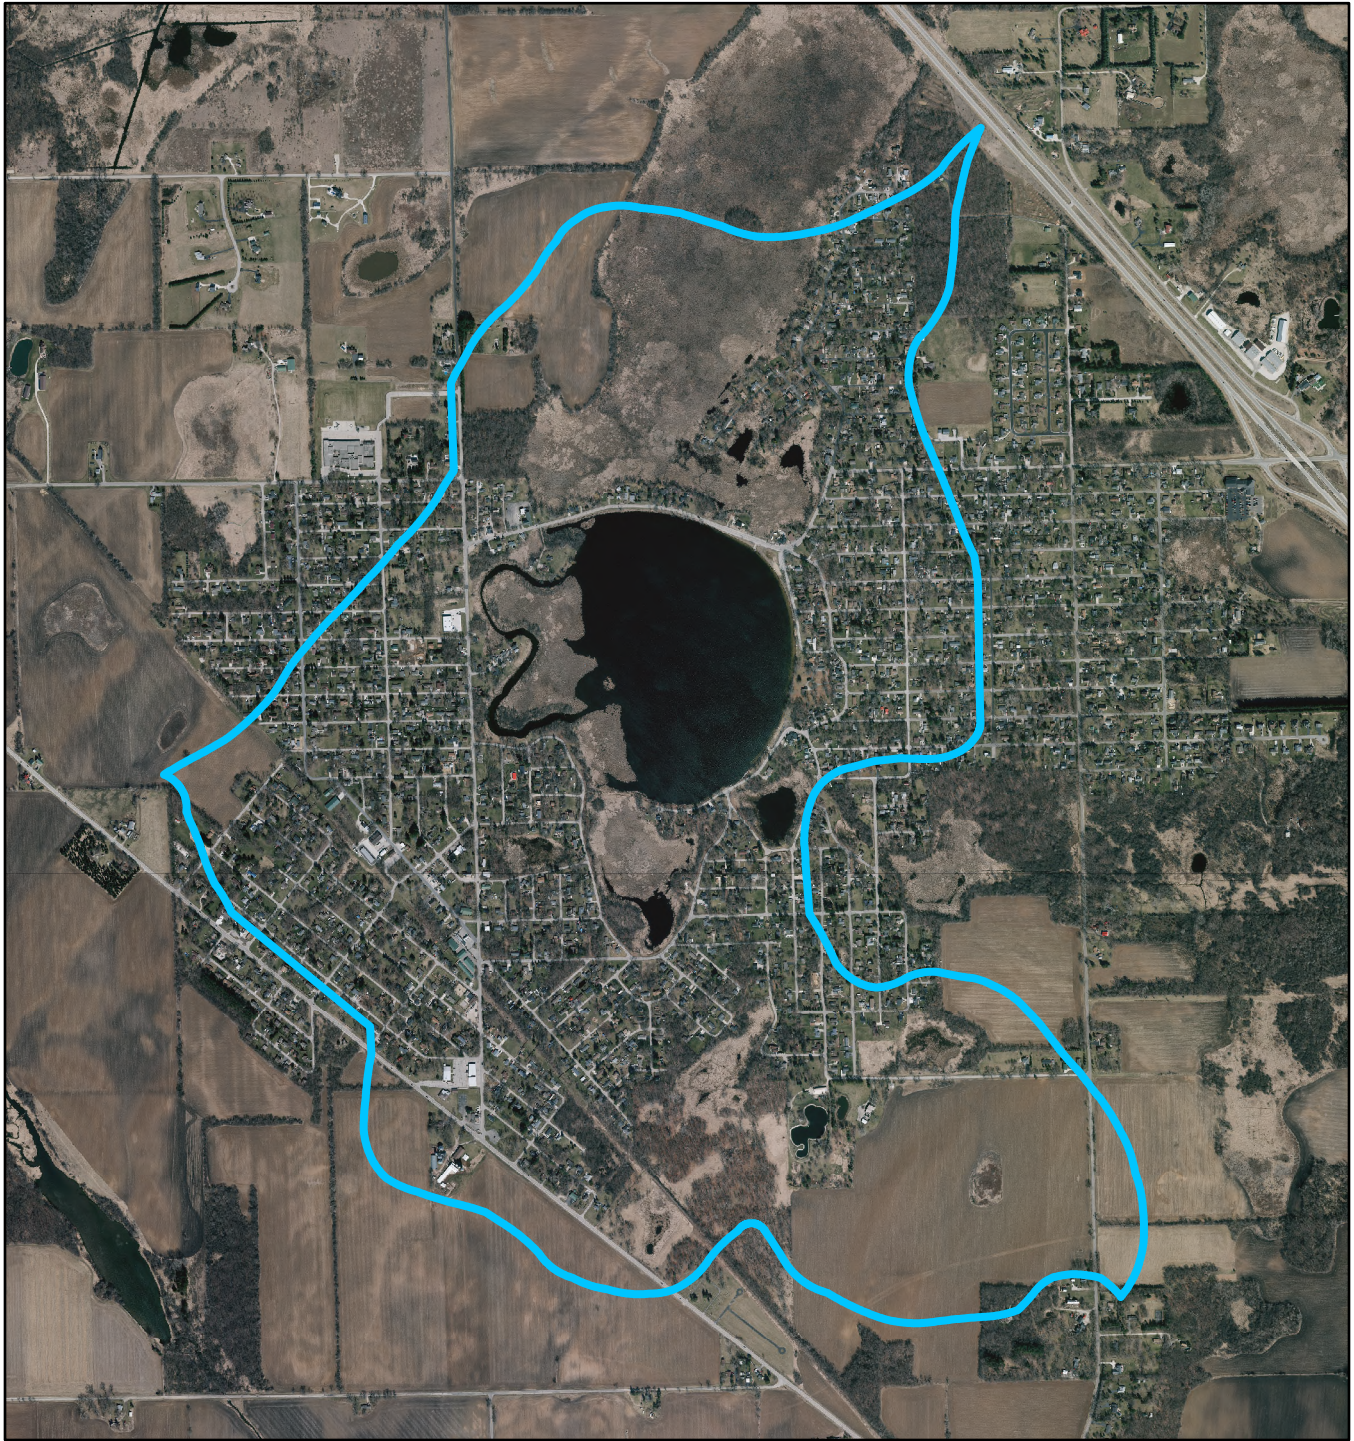
Figure 4
Pell Lake Watershed

WATERSHED BOUNDARY

Pell Lake is an 86-acre seepage lake located in the Town of Bloomfield within Walworth County, Wisconsin. The lake is reported to have a maximum depth of 13 feet with a mean depth of four feet, although as a seepage lake these water levels are likely to fluctuate significantly between years with especially low and high precipitation. The lake is accessible through a public boat launch on the north shore of the lake which is suitable for launching both motorized and non-motorized watercraft. The lake has a watershed area of 1,100 acres (see Figure 4). The Commission completed a lake management plan for Pell Lake in 2006.⁵ In that plan, phosphorus loads to the lake were estimated to be 425 pounds per year. Pell Lake has previously been the subject of two aquatic plant surveys: one in 2013 by Stantec and a second in 2018 by WI Lake & Pond Resource, LLC. Through 2022 the Pell Lake - Lake Association Inc. monitored the lake's beach for *E. coli*.

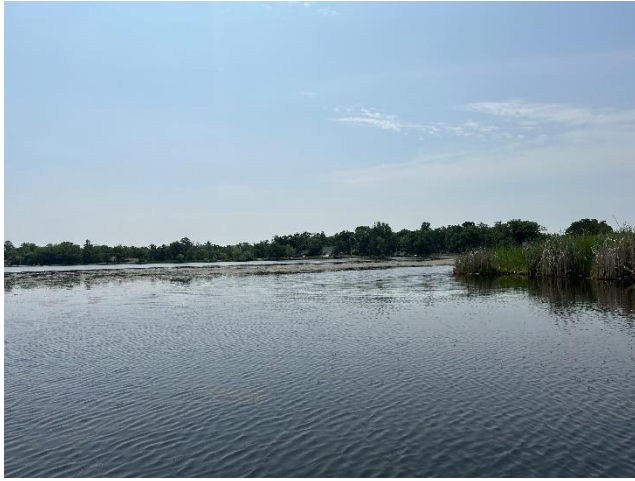
Figure 5
Photos of Pell Lake: June 16th, 2025

Pell Lake

Commission staff worked with Walworth County staff to complete the meander survey of Pell Lake on June 16th, 2025, following the protocol established by the WDNR (see Figure 5). Staff surveyed eight target site locations including the boat launches (see Figure 6). The weather conditions during the survey were warm with clear skies and minimal winds. During the survey, several nonnative species were found including EWM and CLP. Both EWM and CLP were found intermixed sparingly with native populations of aquatic plants and were not found to be forming any monoculture beds. EWM was first verified and vouchered in the Lake in

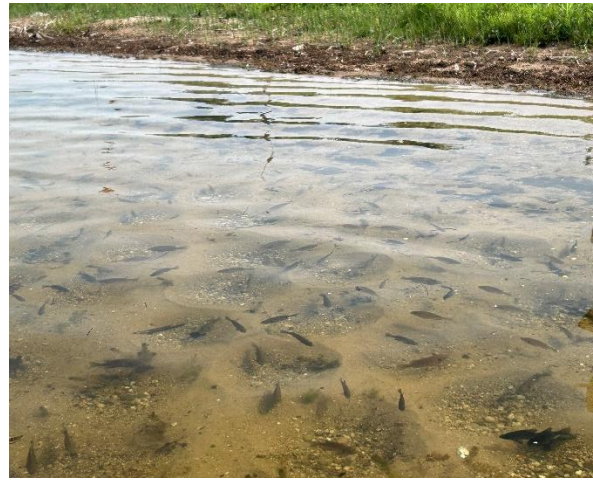
Panfish over nests in Pell Lake

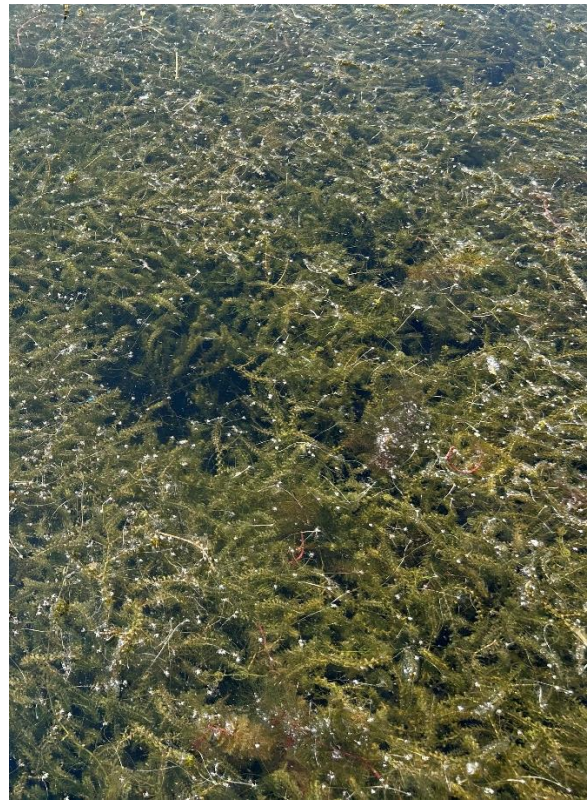
Native Elodea in Pell Lake

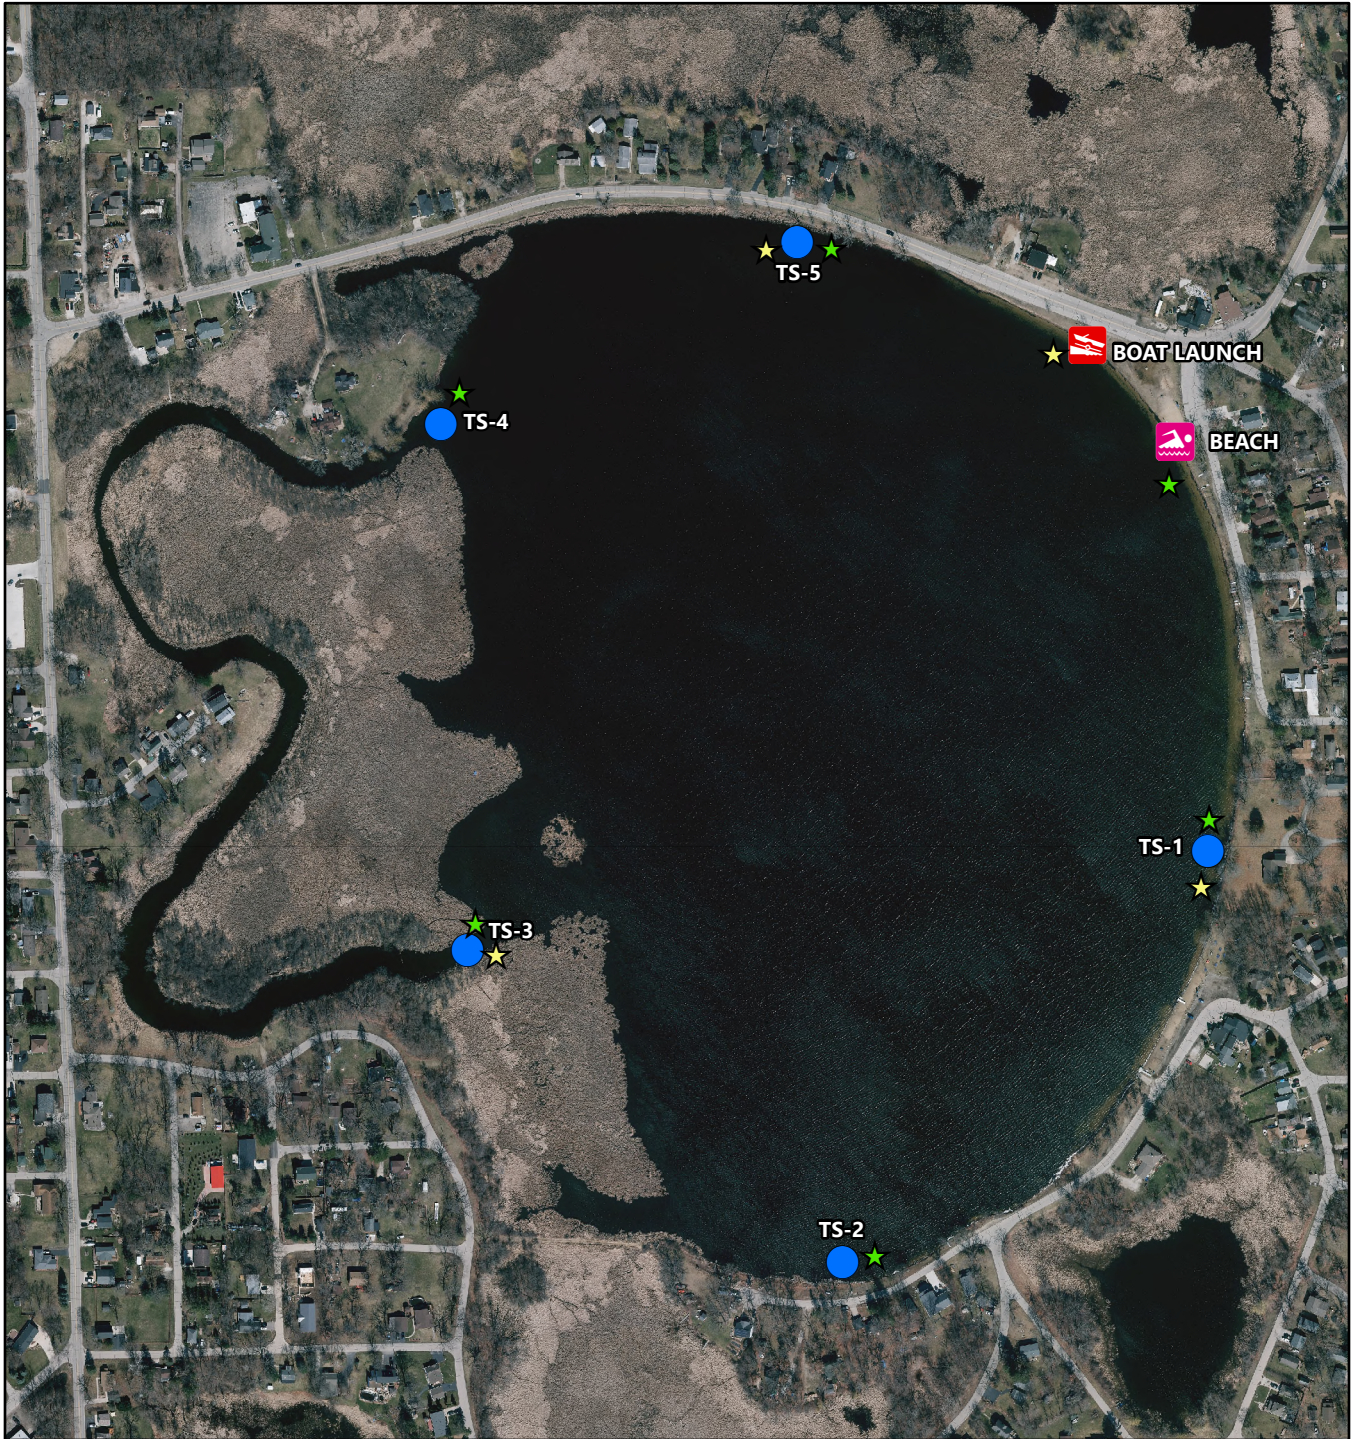
Figure 6
Aquatic Invasive Species Meander Survey on Pell Lake: June 16th, 2025

2014 according to WDNR data.⁶ CLP has been in the lake since 2000 but was not found during the 2018 or 2013 aquatic plant surveys. Hybrid cattails were seen along portions of the shoreline. No other new AIS were found in Pell Lake. Elodea, muskgrass, white water lilies (*Nymphaea odorata*) were among some of the native plants seen during the survey. Pell Lake's water was exceptionally clear and many panfish were seen around their nests in the sandy and rocky nearshore areas of the lake. Near site 2 of the meander survey, Commission and County staff observed what appeared to be blue aquarium gravel however no aquarium organisms were found.

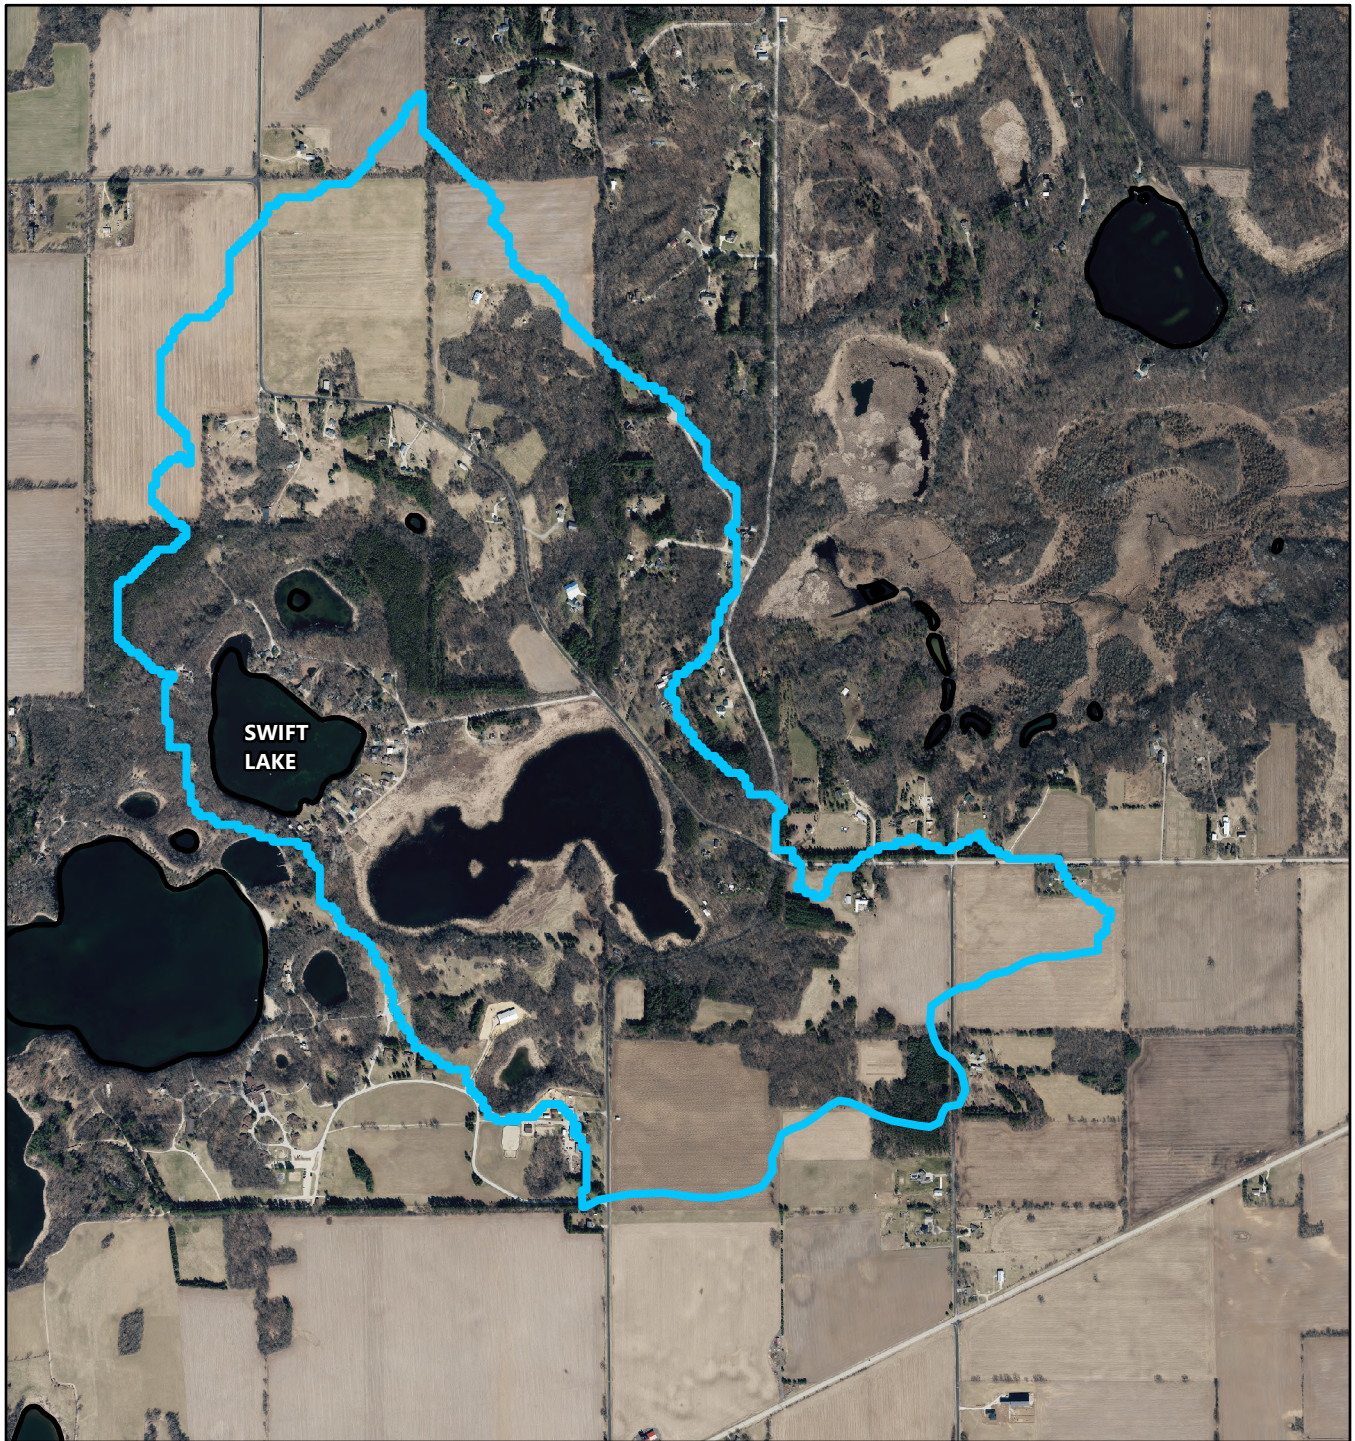
Figure 7
Swift Lake Watershed

WATERSHED BOUNDARY

Swift Lake is a 20-acre seepage lake located in East Troy in Walworth County, Wisconsin. The lake is reported to have a maximum depth of 8 feet with a mean depth of four feet, although as a seepage lake these water levels are likely to fluctuate significantly between years with especially low and high precipitation.⁷ The lake has no public access and is surrounded by private property.⁸ The WDNR WiLMS model estimates that the lake has watershed size of 672 acres, of which 49 percent is wooded, with agriculture (22 percent) and low intensity development (6 percent) making up the remaining major land uses (see Figure 7). The WDNR Presto-Lite modeled total phosphorus loads to the lake are 8 pounds per year with an 80 percent confidence interval of 4-17 pounds. There is currently no active lake organization managing the lake.

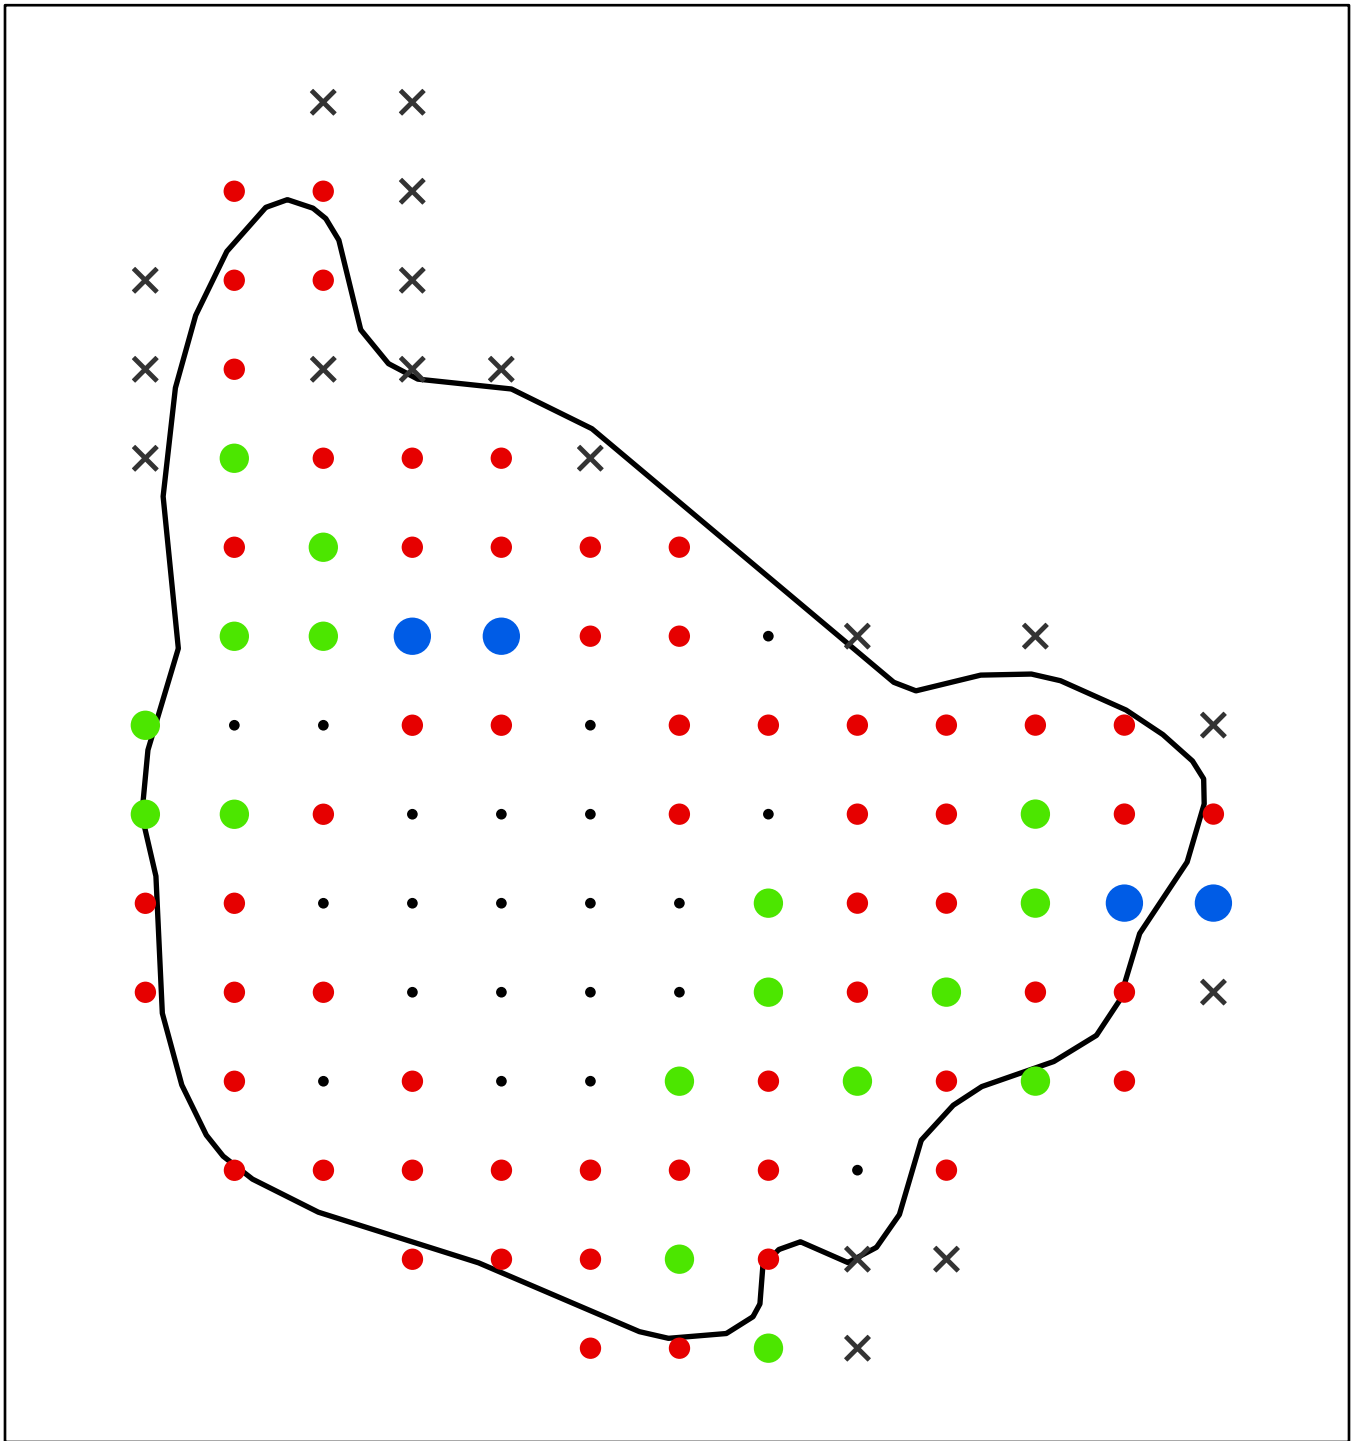
Figure 10
Swift Lake Total Rake Fullness: September 2025

Commission staff recorded the water depth, sediment type, the qualitative abundance of all aquatic plants combined, and the qualitative abundance of each species. A total of 100 sites were sampled during the survey, 77 of which had aquatic vegetation present. The maximum depth of colonization, which is the deepest water depth aquatic plants were observed to grow at, was nine feet. This depth is only one foot lower than the maximum water depth recorded during the survey, which along with the 77.8 percent littoral frequency of occurrence indicates the entirety of the Lake has enough light to support aquatic plant growth. The average rake fullness was 1.04 (see Figure 10) with the vast majority of sites visited having a rake fullness of one, indicative of relatively low aquatic plants abundance, and only four points having a rake fullness of 3, which is indicative of high aquatic plant abundance. A total of thirteen species of aquatic plants were found with the three most common being: yellow bullhead lily also known as spatterdock (*Nuphar variegata*, found at 48 sites), common bladderwort (*Utricularia vulgaris*, found at 32 sites), and floating-leaf pondweed (*Potamogeton natans*, found at 22 sites) (see Table 1). Figure 8 shows some of the extent to which white water lilies were growing on the lake, which provide excellent habitat for fishes in the lake. Two sites had more than five species present (see Figure 11). Two sensitive aquatic plant species were found in the lake, variable pondweed (*Potamogeton gramineus*) which was found at 13 sites and small bladderwort (*Utricularia minor*), found at 24 sites (see Figure 12). The floristic quality index of Swift Lake was 19.9 and the mean coefficient of conservatism value was 6, which indicates an aquatic plant community composed of relatively few but predominantly sensitive species. No invasive aquatic plant species were found in Swift lake during the survey. However, the lake has had a history of EWM being present in the lake since 2004.¹⁰ The aquatic plant data recorded during the survey was submitted to the WDNR and will likely be presented on the WDNR Aquatic Plant Explorer tool following the publication of this report.¹¹

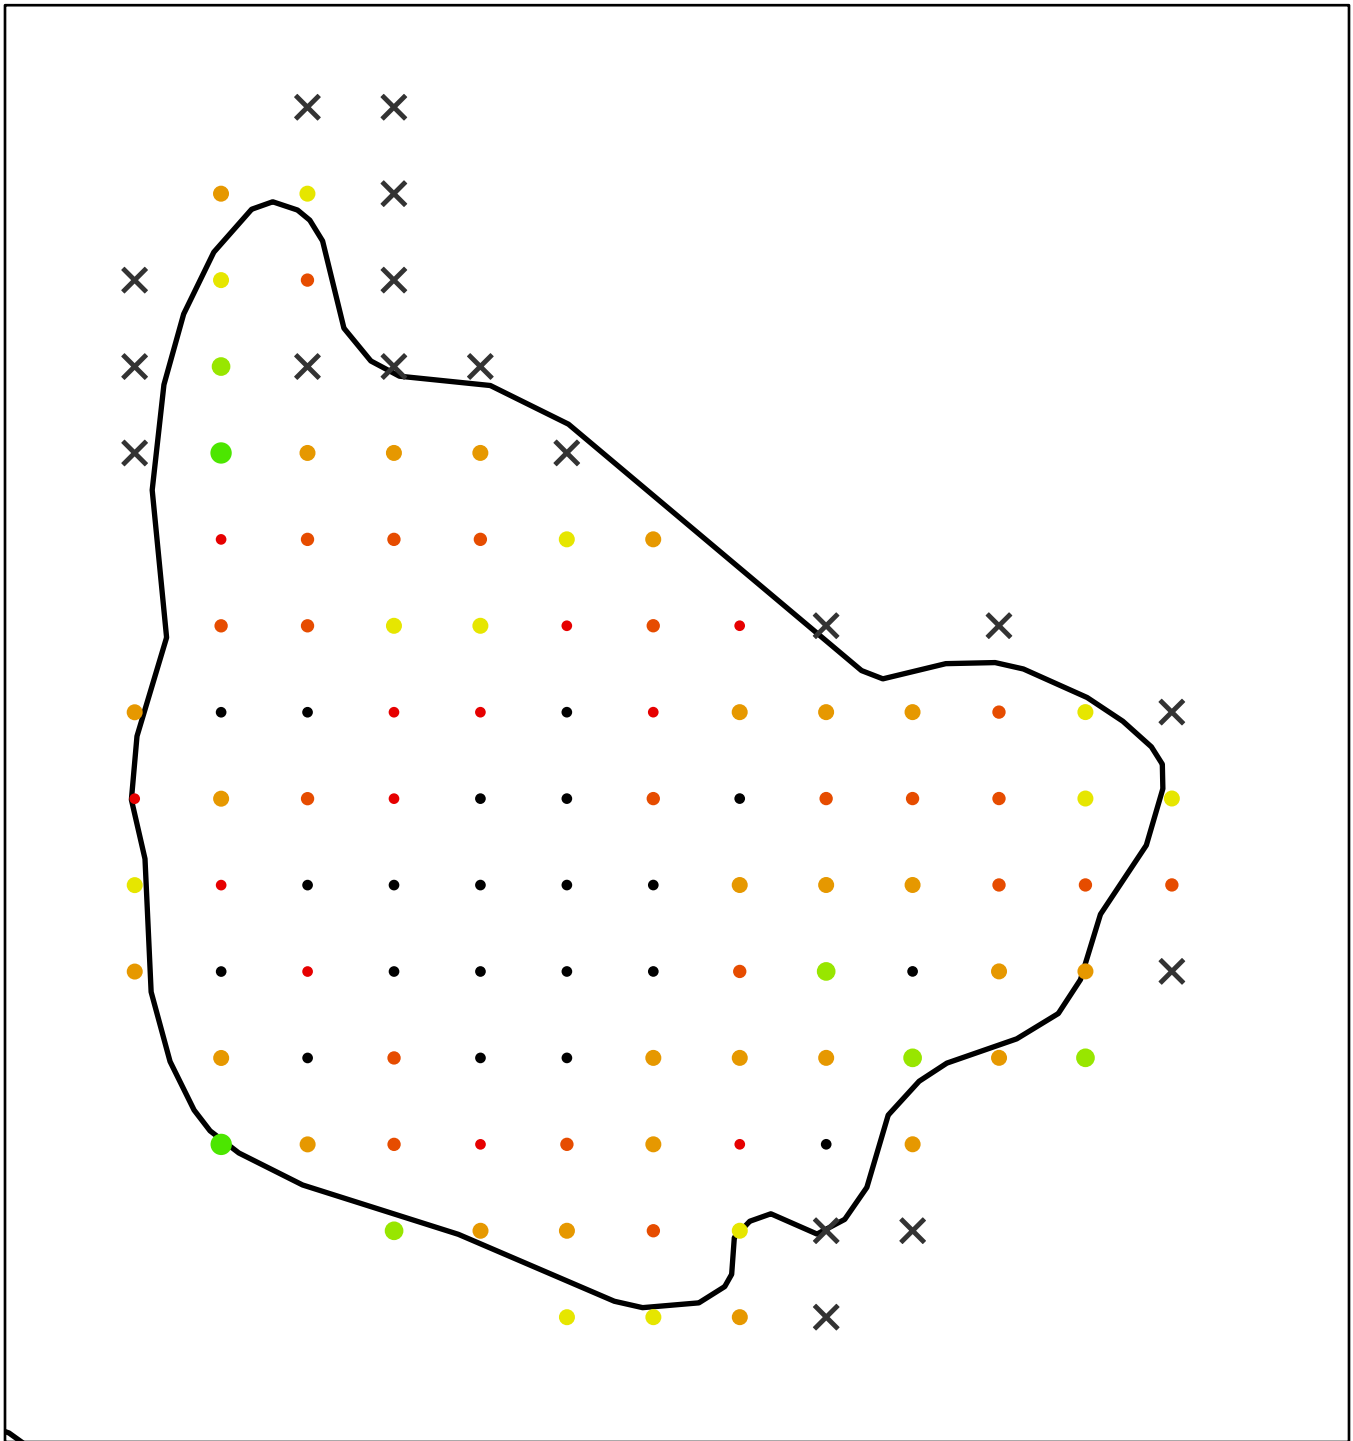
Figure 11
Species Richness in Swift Lake: September 2025

NOTE: Survey was on September 5th, 2025. Species Richness values include nearby visual sightings of aquatic plants and nonnative aquatic plant species.

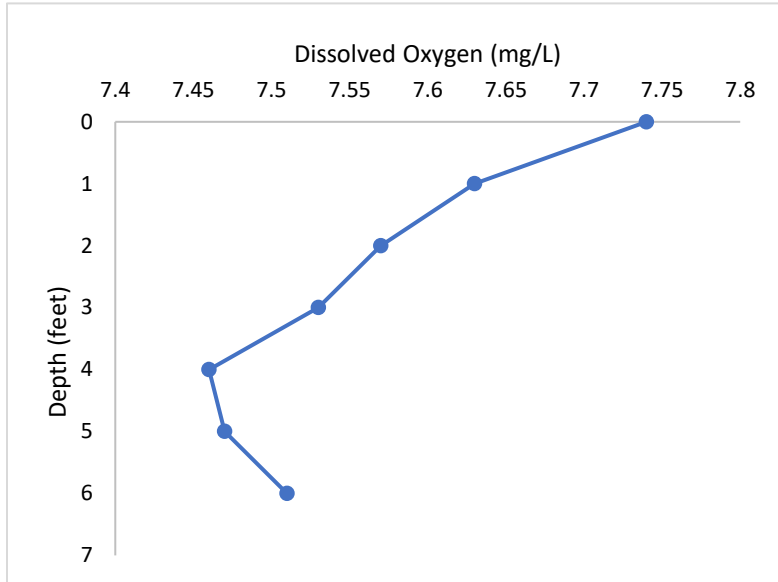
Figure 14
Dissolved Oxygen Profile for Swift Lake: September 5th, 2025

Dissolved oxygen (DO) levels are one of the most critical factors affecting the living organisms of a lake ecosystem. DO is generally higher at the surface of a lake where there is an interchange between the water and atmosphere, stirring by wind action (which aids in atmospheric oxygen diffusion into the surface waters at the air-water interface), and oxygen production by plant and algae photosynthesis. Metabolic processes, such as bacterial decomposition and respiration by aquatic organisms, consume oxygen and decrease DO concentrations. A minimum DO concentration of 5 mg/l is considered necessary for survival of most species of fish. Although Commission staff only measured dissolved oxygen concentrations down to six feet, these concentrations ranged from 7.74 to 7.46 mg/L (see Figure 14). As the lake was mixed at the time of sampling, there was no evident thermal stratification nor a large change in DO concentrations. The Lake's waters have DO concentrations that are supportive of all Southeastern Wisconsin fish species.
