Staff Memorandum

JACKSON PARK POND SURVEY, MILWAUKEE COUNTY, WISCONSIN

April 2, 2026

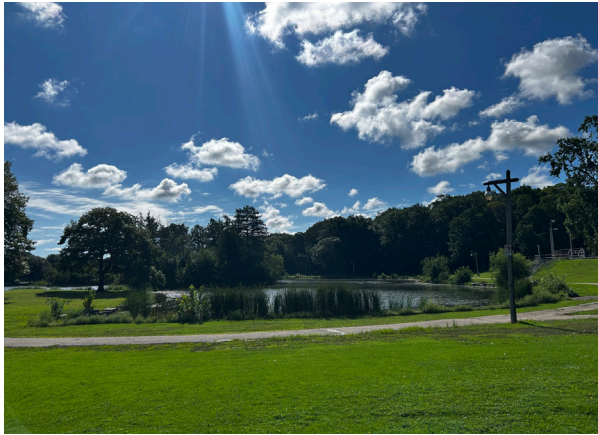
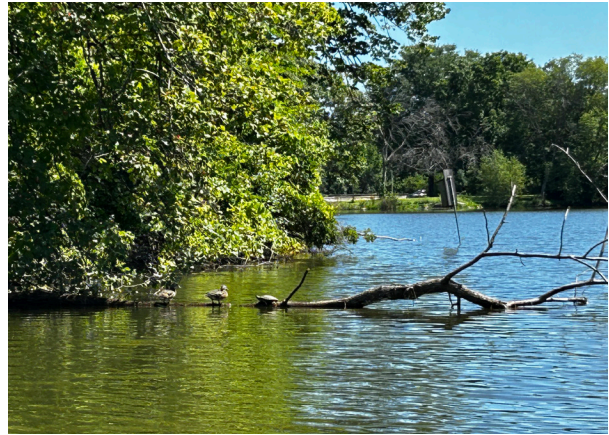
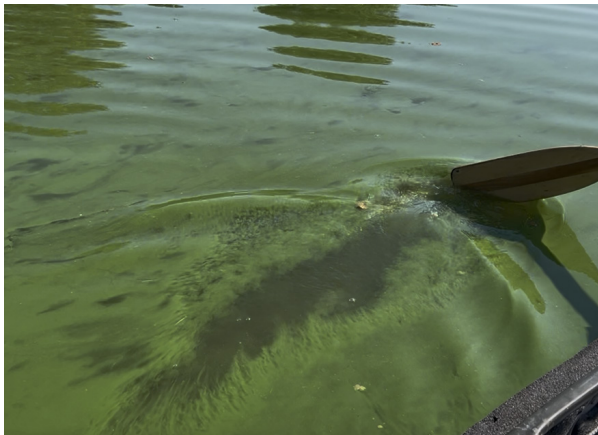
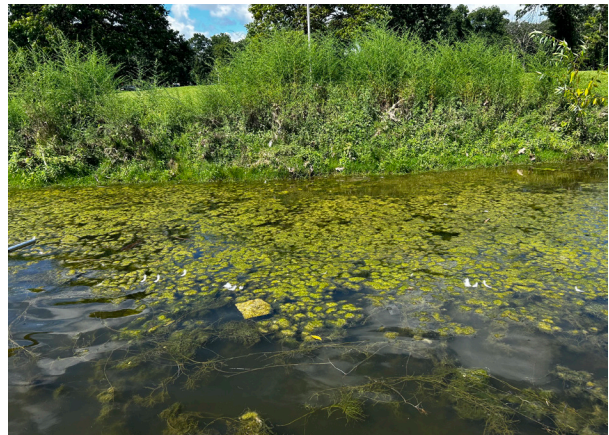
Figure 3
Images from Jackson Park Pond

Commission staff surveyed Jackson Park Pond's aquatic plant community on August 21st, 2025, then returning to collect sediment depths and water quality data on September 19th, 2025. These efforts included identification of aquatic invasive species (AIS). The weather conditions were warm and sunny with mild wind. The Pond's water clarity was poor, as the Pond appeared to have an active algal bloom on the date surveyed (see Figure 3). The Pond's shoreline was varied, with some areas having vegetative buffers, others large rocks, and some areas with turf grass up to the edge with visible shoreline erosion. Commission staff accessed the Pond on the southwest end via a carry-in ramp. Wood ducks and a turtle were observed during the survey (see Figure 3) as well as muskrat and native birds.

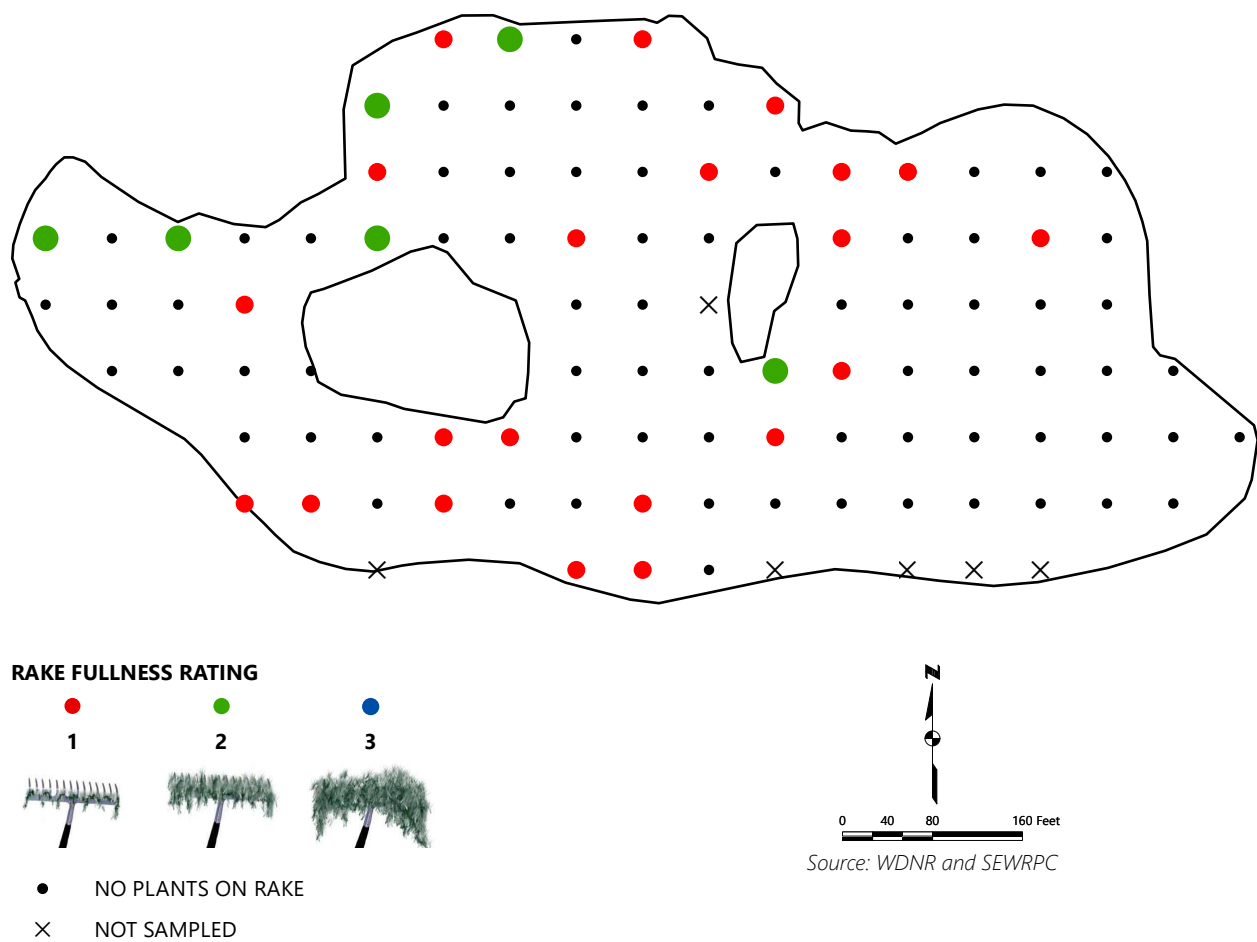
Figure 5
Total Rake Fullness in Jackson Park Pond: August 2025

Note: Survey was conducted on Jackson Park Pond on August 21st, 2025.
