SEWRPC Staff Memorandum

MALLARD LAKE SURVEY, MILWAUKEE COUNTY, WISCONSIN

December 23, 2025

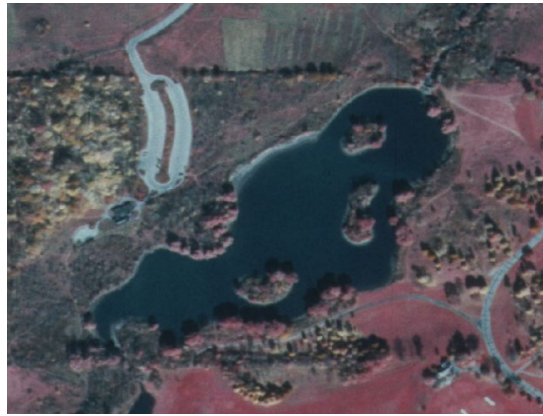
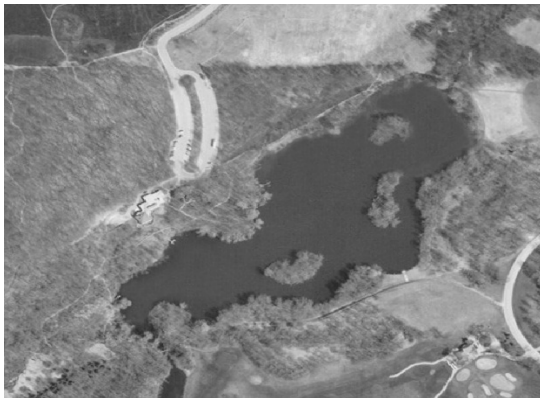
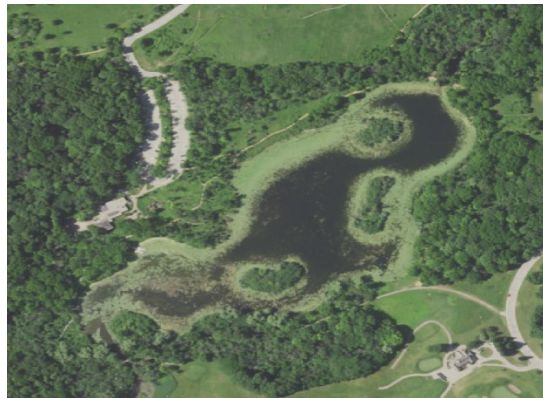
Figure 1
Aerial Imagery of Mallard Lake: 1937, 1980, 2000, and 2022

1937 Aerial

1980 Aerial

2000 Aerial

2022 Aerial

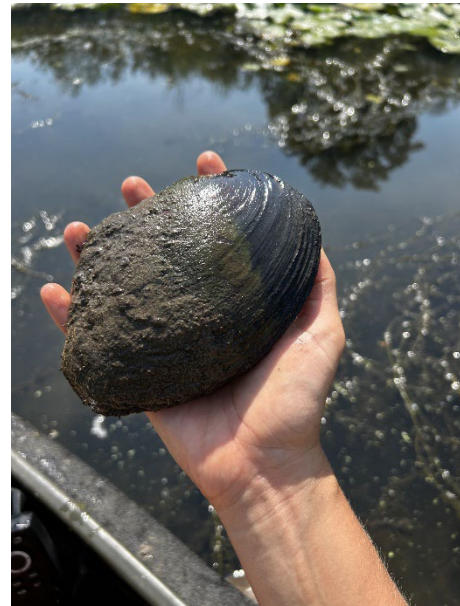
Native Mussel Found on Southern End of Lake

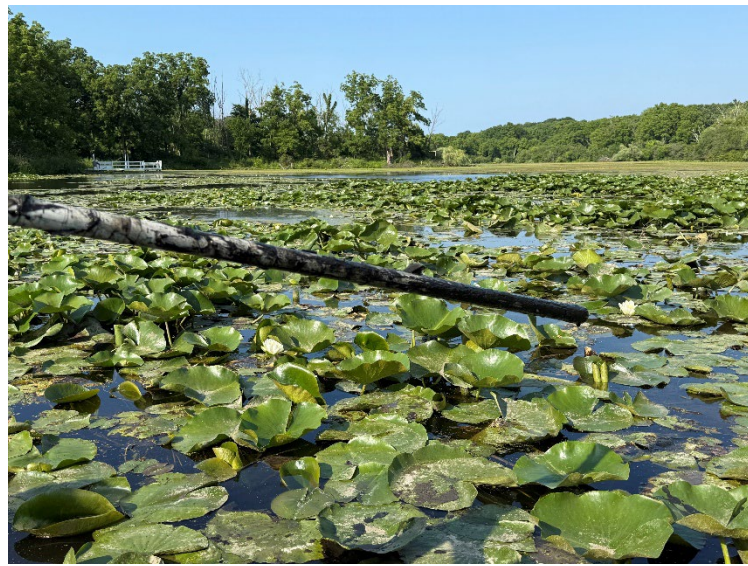
Flocculent Sediment Depth in South End

Out of the 34 sediment depths collected, accumulated sediment depths ranged from zero to 4.3 feet (see Map 4). The highest amount of accumulated sediment was seen in the southern end on the lake near the inlet tributary; some of this area was too shallow to navigate using the Commission's canoe due to the accumulation of flocculent sediment. This area was marked as being between 3 and 5 feet deep in 1970 but

was less than a half-foot deep during the Commission's visit in 2025. This tributary has been previously identified as a significant source of sediment into the Lake and is an area of ongoing study and restoration planning (see Figure 6). Other high accumulation areas were on the western side of the Lake, which may correspond with the primary flow of water through the impoundment.

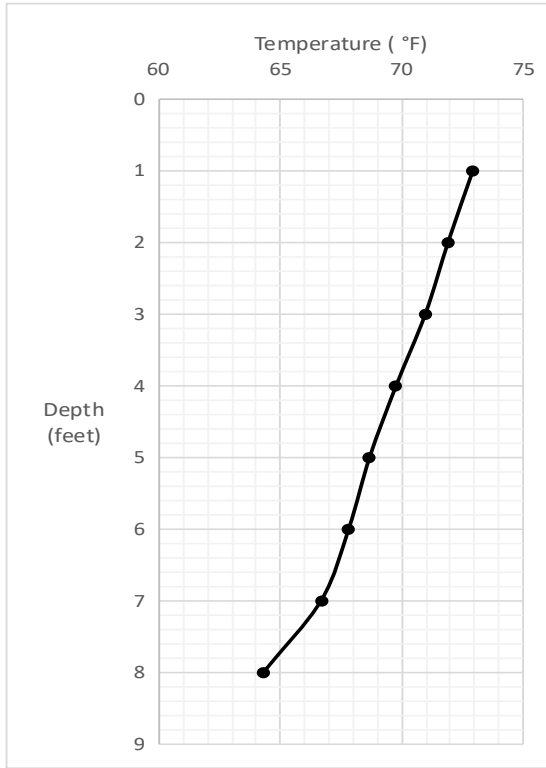
Figure 5
Water Quality Profiles for Mallard Lake

A minimum DO concentration of 5 mg/l is considered necessary for survival of most species of fish. Commission staff measured dissolved oxygen concentrations ranging from 1.04 to 11.44 mg/l¹⁴ (see Figure 5), generally decreasing with depth. Percent saturation of DO showed similar data patterns, ranging from 11.5 to 130.4 percent throughout the water column. The lowest depths of the lake were nearly anoxic and would not be supportive of fish or other aquatic life. The anoxic levels recorded are likely a result of the respiration of sediments at bottom of the lake consuming (reducing) the dissolved oxygen concentrations. Oxygen supersaturation, recorded at a depth of three feet, is probably caused by high intensities of photosynthesis of both algae and aquatic plant growth. As 140 percent saturation and higher can cause fish

The pH of Mallard Lake ranged from 7.03 to 8.37 and was more alkaline near the surface before subtly decreasing with depth (see Figure 5). This pattern is most likely due to higher concentrations of carbonic acid that forms in the anoxic waters in the bottom of the waterbody. Like most lakes in southeastern Wisconsin (mean pH of 8.1), Mallard Lake is a slightly basic waterbody.¹⁷

Commission and nature center staff recorded PSI and mVORP values as detected in the suite of the Hanna Instruments meter (see Figure 5). PSI refers to 'pound-force per square inch' or the amount of pressure in the water. These values typically increase with depth due to hydrostatic pressure. PSI was fairly consistent through the water column, slightly increasing with depth.

mVORP refers to the oxidation-reduction potential (ORP), measured in millivolts (mV), which reports the electron transfer capacity by measuring oxidizing or reducing agents. The unique combination of dissolved solutes in the water (i.e. chlorine, decaying matter, hydrogen, oxygen) swing the redox value to be positive or negative. A high ORP typically signifies higher oxygen content that can support biochemical processes in a lake ecosystem. Lower ORP values can indicate eutrophication, high nutrient content that consumes the oxygen to lead to anoxic conditions. The mVORP values of Mallard Lake remained relatively positive until seven feet of depth, correlating to observed anoxic conditions at those depths.

kills, the recorded supersaturation conditions are also likely stressful to fishes at the opposite extreme. Anoxia and oxygen supersaturation within the water column of the Lake have two implications. First, because these dissolved oxygen samples were only collected during the day, the dissolved oxygen concentrations data presented here may be less representative of average concentrations and more typical of maximum concentrations achieved during diurnal periods. More samples should be taken at different times of the day to quantify the fluctuations in DO levels and determine more average conditions. Second, respiration by the same algae and aquatic plants may cause steep declines in dissolved oxygen concentration at night when photosynthesis cannot occur due to lack of light that may cause dissolved oxygen to drop to near zero. Anoxia and oxygen supersaturation, along with daily rapid fluctuations in oxygen levels are all stressful to fish. These conditions are a likely indicator of an enriched nutrient status within the Lake, likely contributing to the presence of the most tolerant fish species. Incoming sediment and nutrient loading may exacerbate present supersaturation and anoxic conditions, decreasing habitat viability for fishes and other aquatic macroinvertebrates within the Lake.
