Staff Memorandum

MCGOVERN PARK POND SURVEY, MILWAUKEE COUNTY, WISCONSIN

April 2, 2026

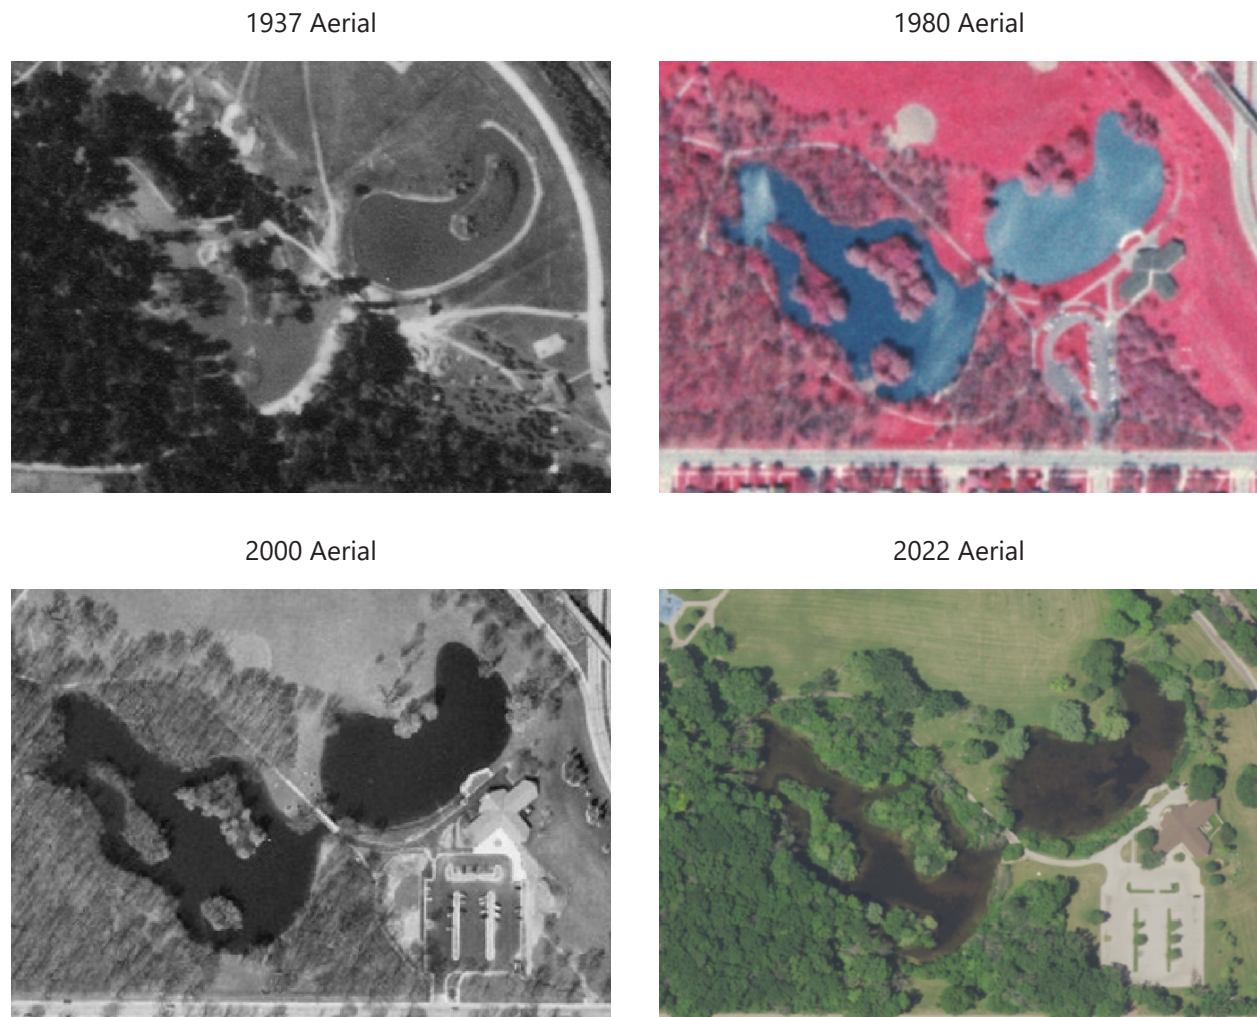
Figure 1
Aerial Imagery of McGovern Park Pond: 1937, 1980, 2000, and 2022

Note: The red color seen in the 1980s aerial image of McGovern Park Pond was due to infrared imaging processes used that year.

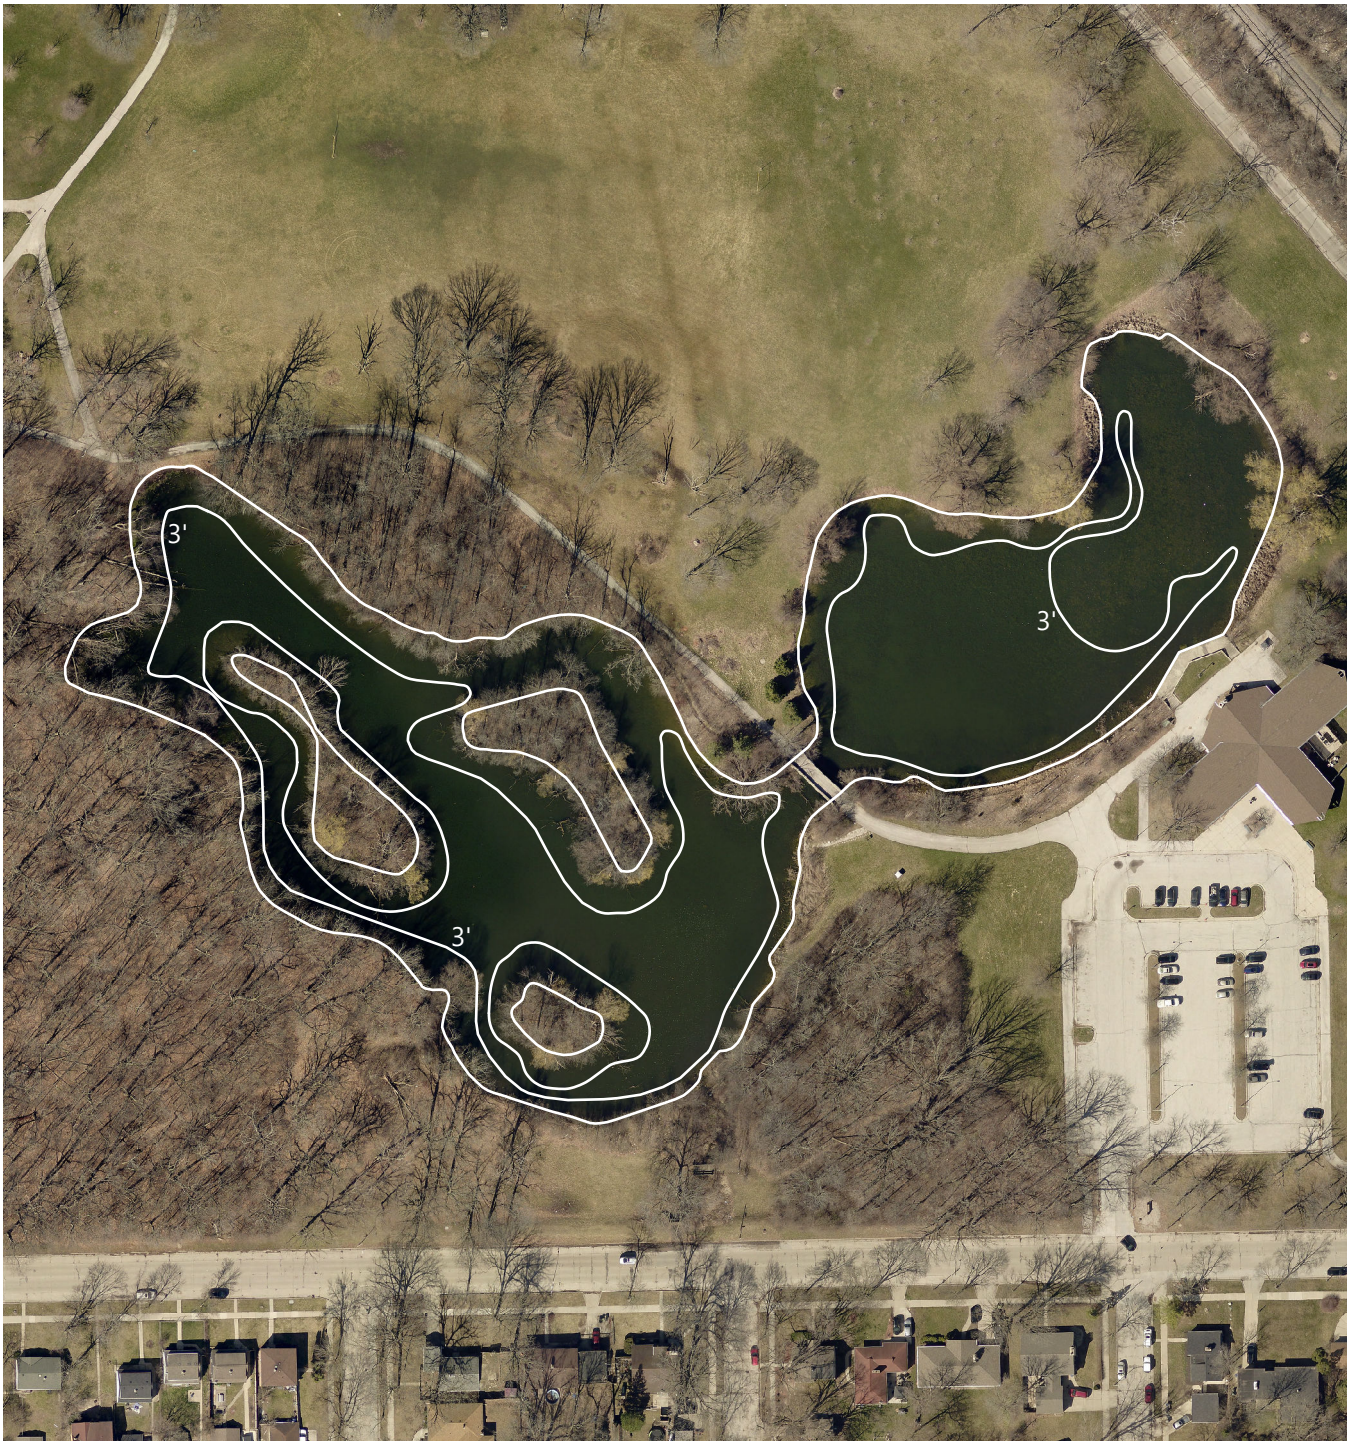
Map 1
Bathymetric Contour Lines of McGovern Park Pond: 1970

Note: Bathymetric contour lines of McGovern Park Pond in 1970 may not reflect the current the current contours. Contour lines are drawn in intervals of 3 feet.

A historic 1970 WDNR survey indicated a maximum depth of 4.5 feet in McGovern Park Pond, whereas the 2025 survey found a maximum depth of 7 feet (see Map 2). This change in depth may have been due to changes in water levels at the time of the surveys or dredging of the Pond, as the northernmost island in the top lobe of the Pond was present in 1970 but no longer seen in 1980 aerial photography (see Figure 1). This suggests that the Pond was manipulated in that timeframe, though the exact cause of change and the time of occurrence is unknown. All but one surveyed point in the 2025 survey was recorded to be organic,

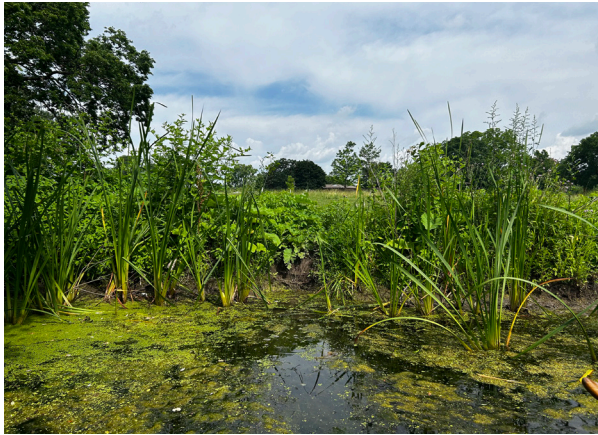
Erosion on Shoreline

A 2003 assessment of McGovern Park Pond determined that an estimated 950 linear feet of shoreline exhibited erosion. This assessment was part of the larger Lagoon Shoreline Assessment that surveyed over 30 Milwaukee County Park ponds/lagoons.²² Erosion not only contributes nutrients and pollutants in the eroded sediment but also decreases future stormwater infiltration capacity. As precipitation events occur, stormwater more readily flows directly over eroded sites and into the waterbody instead of being stored and filtered for contaminants by vegetation.

- McGovern Park Pond likely suffers from eutrophic or hypereutrophic conditions, which is contributed by waterfowl, turf management, and/or shoreline erosion. These pollution sources can be managed through methods such as native shoreline plantings, which deter geese and reduce nutrient erosion, as well as reducing fertilizer use on Park turf grass near the Pond.

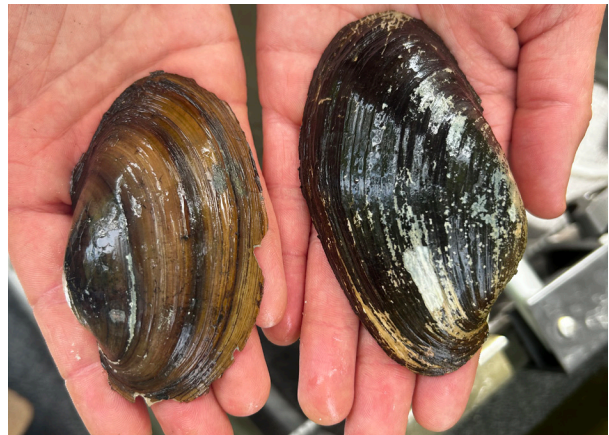
Native Mussel Shells

Commission staff surveyed McGovern Park Pond’s aquatic plant community on July 16th, 2025. These efforts included identification of aquatic invasive species (AIS). The weather conditions were warm and sunny with mild wind. The Pond’s water clarity was poor, most likely due to suspended solids in the water. The Pond’s shoreline was varied, with some areas having vegetative buffers and naturalized shoreline, and some areas with turf grass up to the edge and visible shoreline erosion (see Figure 2). Commission staff accessed the Pond on the northwest end and launched off the shoreline. Several native birds and mussels were observed during the survey (see Figure 2).

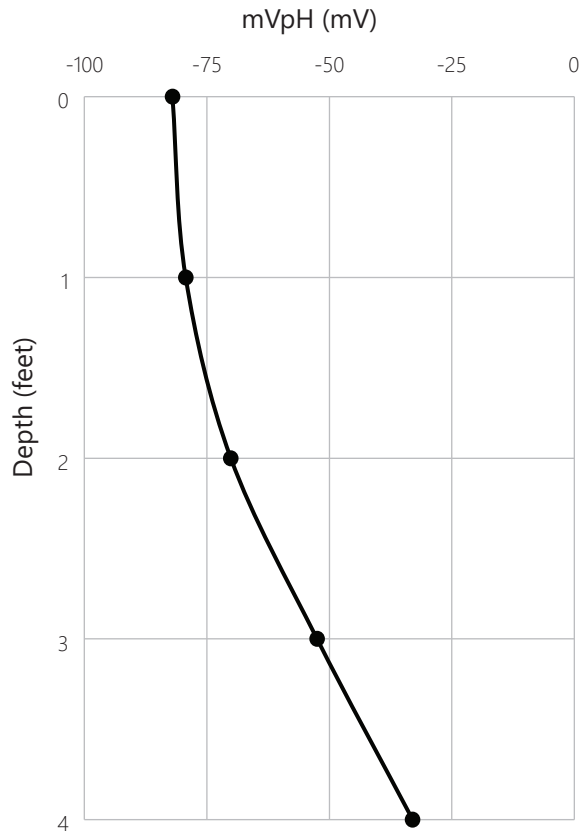
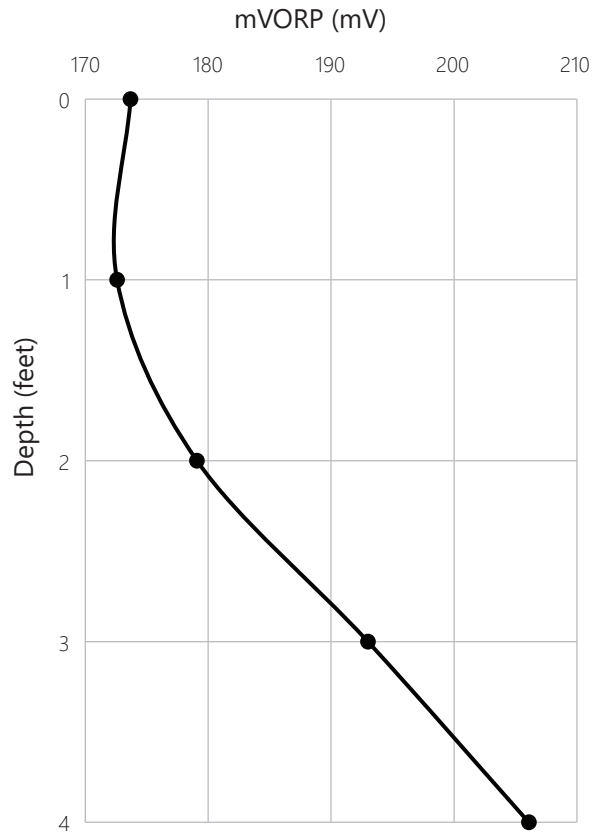
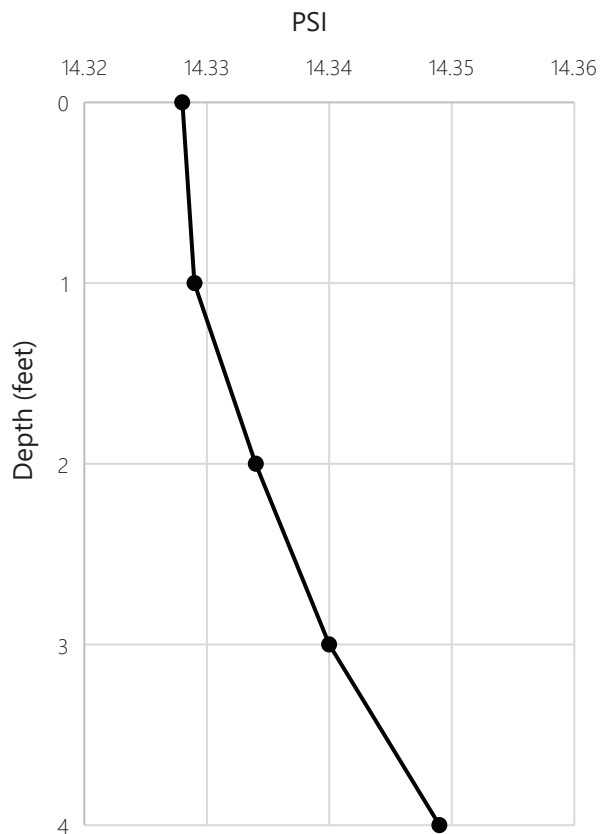
Figure 4
Water Quality Profiles for McGovern Park Pond

A minimum DO concentration of 5 mg/L is considered necessary for survival of most species of fish. Commission staff measured dissolved oxygen concentrations ranging from 3.4 to 9.6 mg/L (see Figure 4) decreasing with depth.¹⁷ The DO percent saturation of the Pond ranged from 43.8 to 125.4 percent. The surface waters down to three feet of depth met dissolved oxygen criteria for fish habitat, while the bottom foot of the water column was unsuitable. Oxygen supersaturation, recorded at the water's surface down to two feet in the water column, is likely caused by high intensities of photosynthesis from the duckweeds, algae, and watermeal that covered the surface waters. As 140 percent saturation can cause fish kills, the recorded supersaturation conditions are likely stressful to fish. The anoxic levels recorded are likely a result of the respiration of sediments at bottom of the lake consuming (reducing) the dissolved oxygen concentrations. These conditions are a likely indicator of an enriched nutrient status within the Pond. Incoming sediment and nutrient loading may exacerbate present supersaturation conditions, decreasing habitat quality for aquatic organisms. As fishing is an important recreational activity to the Pond, maintaining dissolved oxygen levels through aquatic plant management, regular monitoring of water quality conditions, and reducing nutrient loads to the Pond (see discussion below) can aid in creating a thriving environment for fish. Other methods to alleviate dissolved oxygen conditions, such as operating an aerator or circulator, could also be considered to alleviate conditions during particularly stressful mid-summer periods.

With an average pH of 8.2, McGovern Park Pond is a slightly basic waterbody.³¹ The pH of the Pond ranged from 7.6 to 8.5 and was more alkaline near the surface (see Figure 4). These measurements are consistent with past findings from 2010 to 2024 (pH between 7.7 and 8.6) and indicate no long-term change in the Pond pH. A waterbody's pH can be affected by acids released by decomposition of organic material, underlying soil and bedrock type, and photosynthesis of aquatic plants, phytoplankton, and algae. Additionally, external factors such as pollutants contained in discharges from point sources and in stormwater runoff can also affect the waterbody's pH.

fish species.¹⁶ Surpassing sublethal criteria can increase fish stress and decrease the vitality and longevity of stocked species. The drop in water temperature past the surface waters and into the first foot of water may have been due to the presence of duckweeds and watermeal shielding waters from the Sun. As the temperature profile was taken before aquatic plant treatment, more extensive monitoring and depth profiles should be conducted to evaluate water fluctuations in temperatures for fish species.

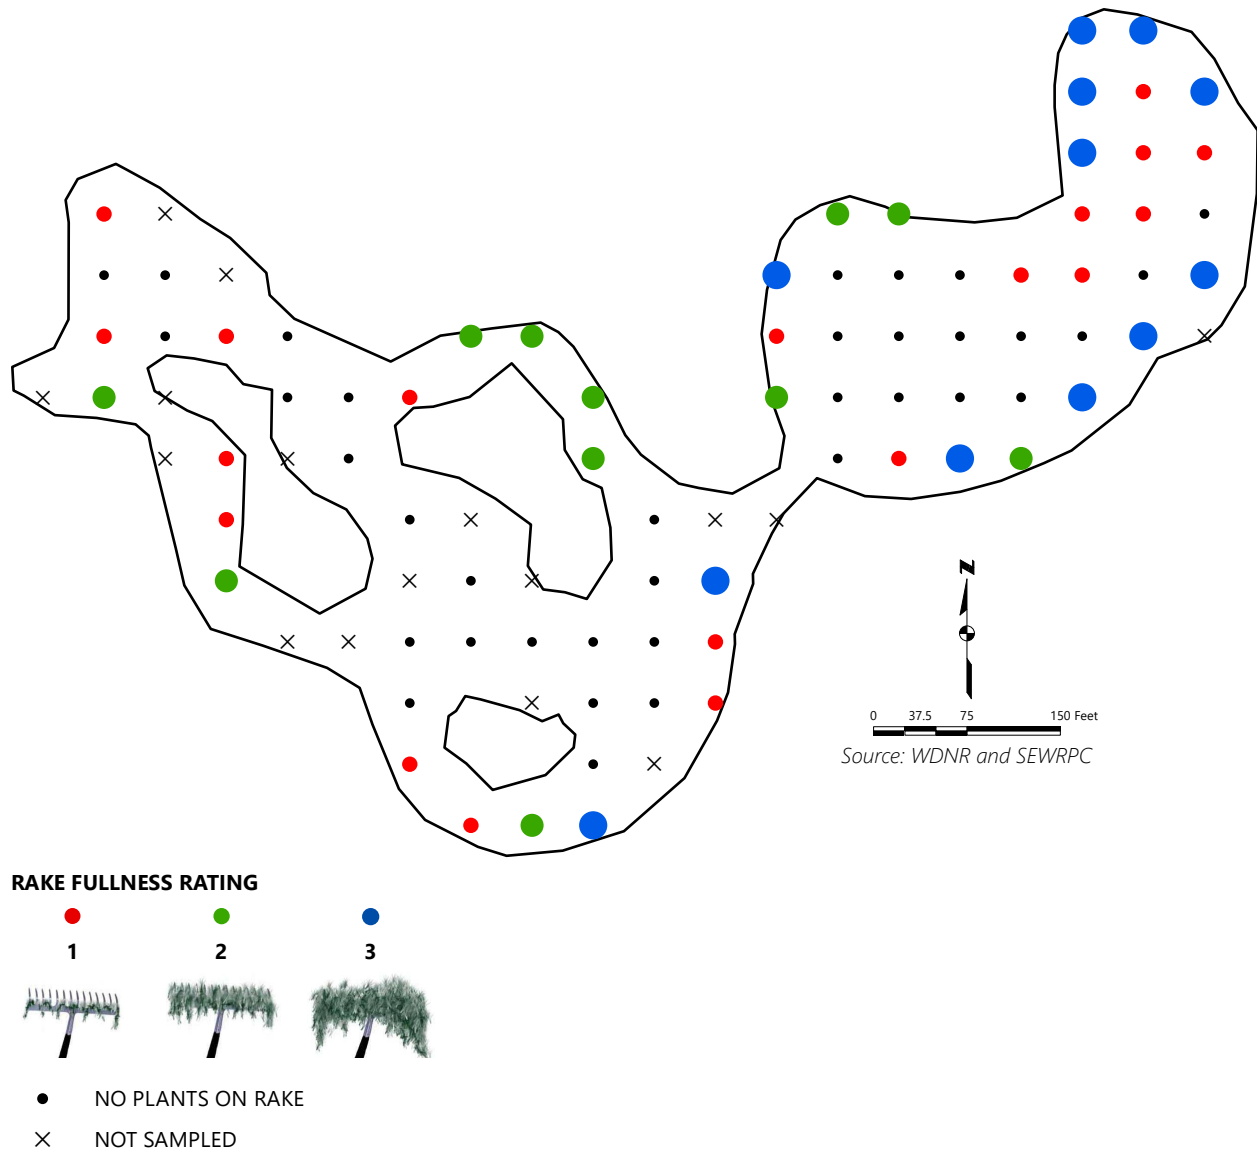
Figure 5
Total Rake Fullness in McGovern Park Pond: Summer 2025

Commission staff observed ten aquatic plant species during the point-intercept survey (see Table 2 for a subset of the benefits of observed species).¹⁰ The total littoral vegetation coverage, or the percentage of aquatic plant occurrence in depths that were shallower than the maximum depth of plants, was 61.5 percent. The maximum depth of colonization by plants was five-and-a-half feet. The average rake fullness was one (see Figure 5). Nine total species were identified by rake sampling, while one plant was seen visually by staff (*Typha* sp., cattail) and not collected on the rake. For the littoral points, the species ranked in order of abundance were: coontail (*Ceratophyllum demersum*, 67.5 percent), common waterweed (*Elodea canadensis*, 60.0 percent), Eurasian watermilfoil (*Myriophyllum spicatum*, 50.0 percent), large duckweed (*Spirodela polyrhiza*, 45.0 percent), and forked duckweed (*Lemna trisulca*, 42.5 percent). Eurasian watermilfoil and curly-leaf pondweed were the only aquatic invasive plant species seen in the Pond. Commission staff observed the invasive Chinese mystery snail (see Figure 2). Common reed (*Phragmites australis*) has been reported near the Pond but was not recorded directly by staff.¹¹

Note: Survey was conducted on McGovern Park Pond on July 16th, 2025.

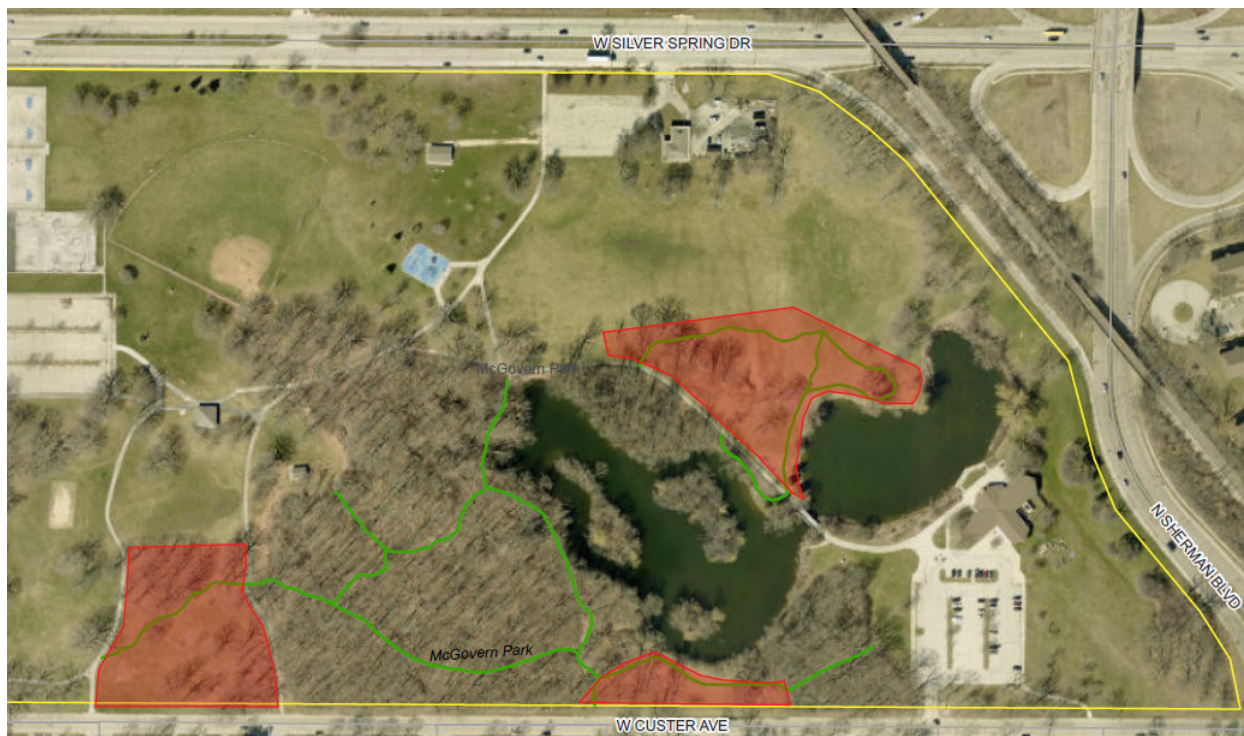
Figure 6
Reforestation Project in McGovern Park: 2024-2025

The surrounding woods of the Pond were reforested in 2024-2025 (see Figure 6), providing assistance in stormwater runoff, enhancing biodiversity, and reducing nutrient loading into the Pond. Other future nutrient reduction methods can include dredging the Pond, applying an alum treatment, reducing the geese population, and/or enhancing native shoreline vegetation could help to reduce phosphorus and chlorophyll-*a* concentrations and enhance water clarity. While these additional management options can be costly, grants are available through the WDNR for implementation of best management practices.^{27,28} Implementing a variety of improvements could allow for synergistic outcomes for improved Pond quality. Particularly, native shoreline plantings can decrease soil erosion, increase pollinator visitation, and discourage direct access of geese into and out of the Pond to deter nuisance populations.²⁹

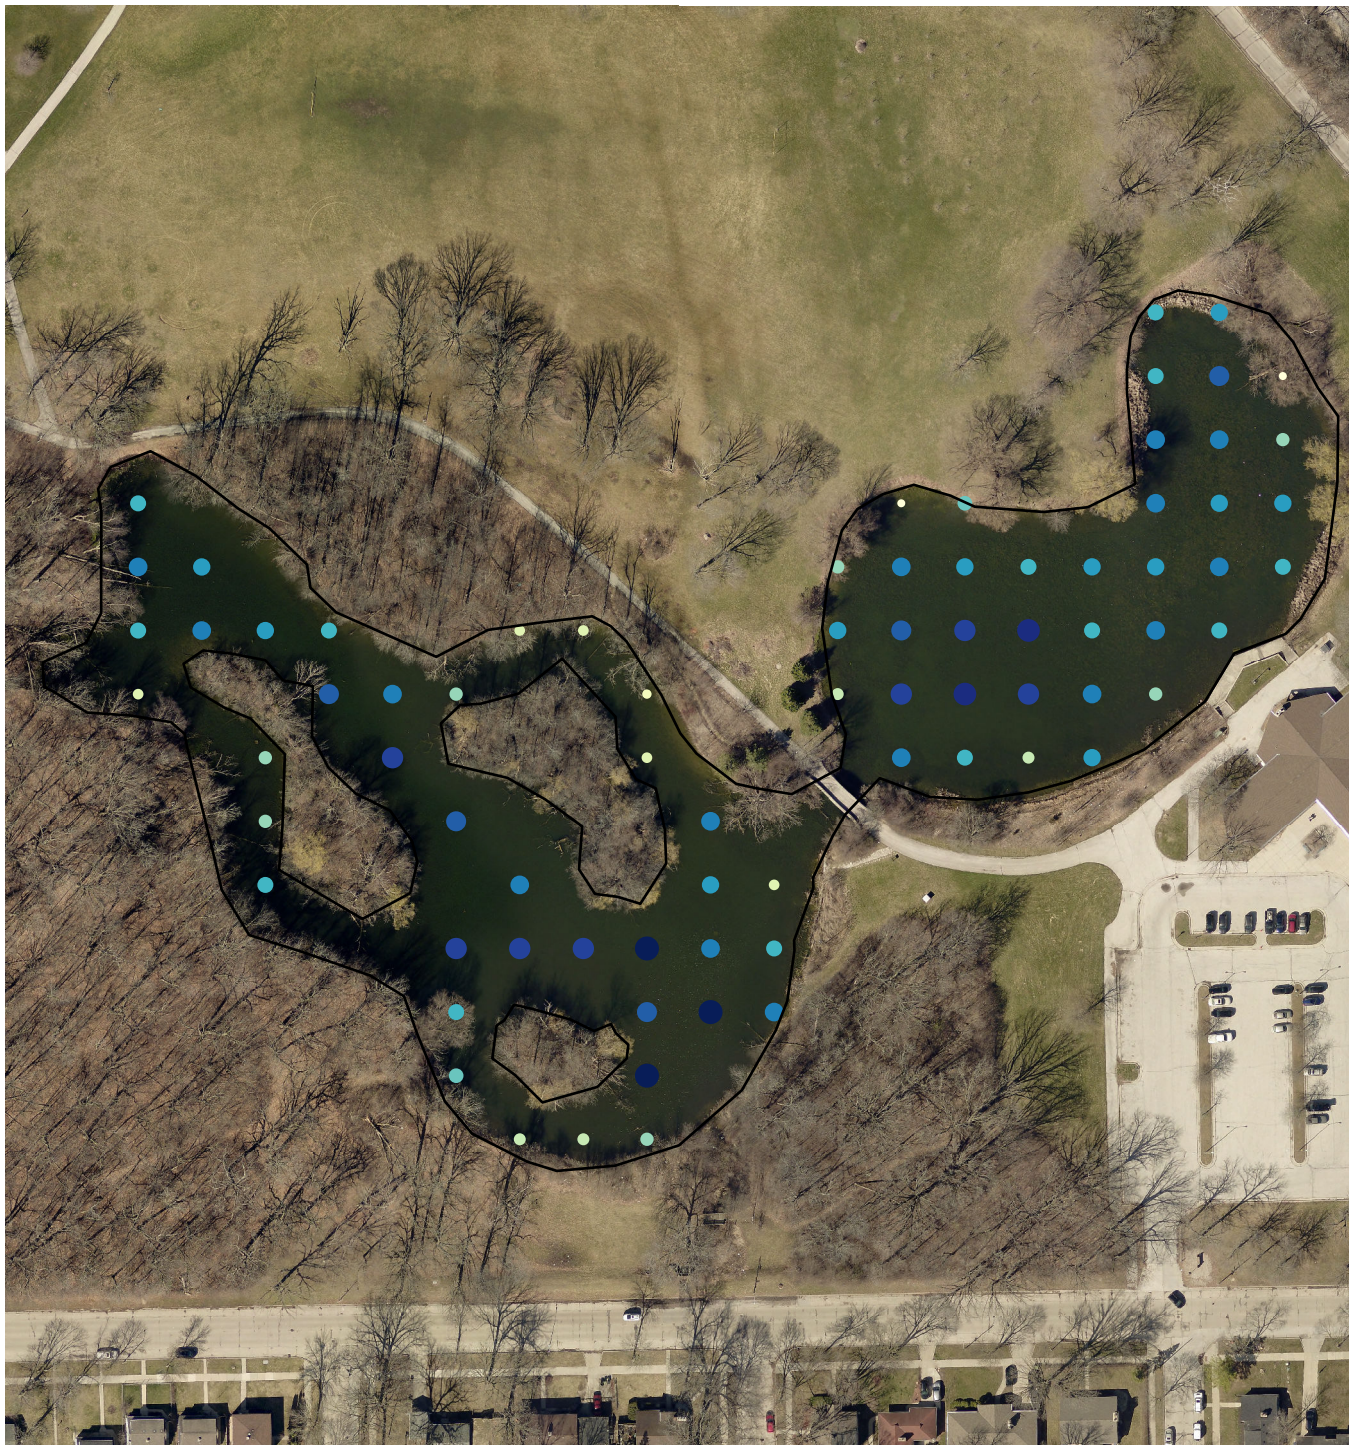
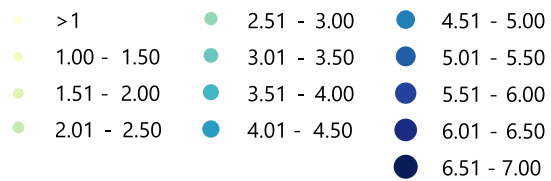
Map 2
Water Depths in McGovern Park Pond: Summer 2025

Note: Water depths were collected on July 16th, 2025.

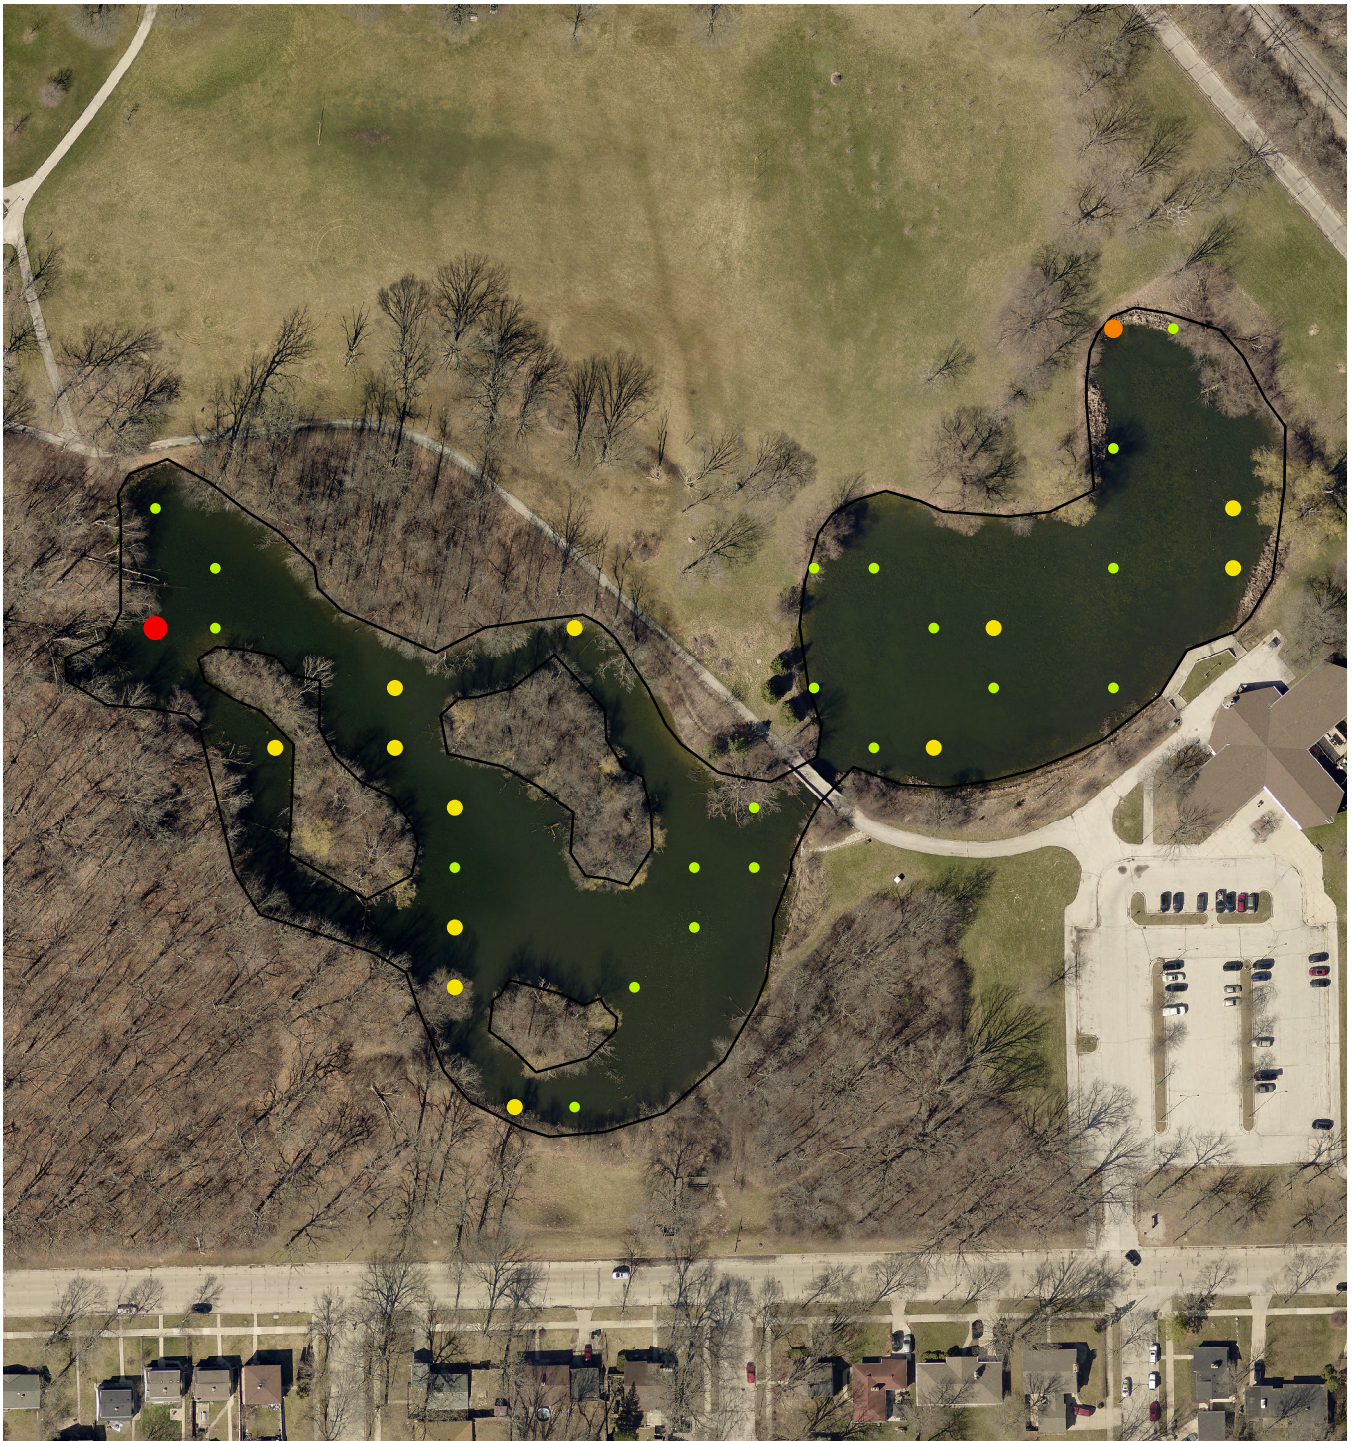
Map 3
Sediment Depths in McGovern Park Pond: Summer 2025

Commission staff surveyed flocculent sediment depths in McGovern Park Pond using a seven-foot-long hollow plastic tube marked in inches to the top. At selected points from the point-intercept survey, the pole was lowered until it hit the current Pond bottom, and a depth measurement was recorded. The pole was then pushed down once more to break through accumulated sediment until it could not be pushed further, called the point of refusal, and another measurement was made. Accumulated sediment was calculated by subtracting the point of refusal measurement from the current Lake bottom depth.

Out of the 35 sediment depths collected, accumulated sediment depths ranged from zero to 1.8 feet (see Map 3). The highest amount of accumulated sediment was seen on the shorelines. Areas deeper than 7 feet were unable to be quantified for sediment accumulation. As only a limited number of sediment depths were taken, the total flocculent sediment volume within the Pond is unable to be confidently quantified.
