Inventory and Assessment of Culverts, Bridges, and Stormwater Outfalls

Oak Creek Watershed Restoration Plan

Instream Survey Progress Update-Fall 2017

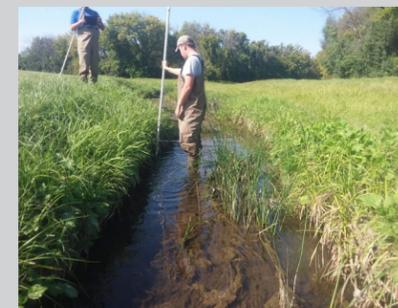
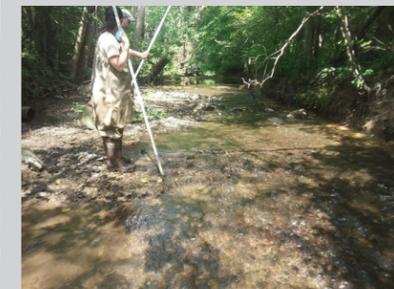
Instream Habitat Assessment

Cross-section surveys were conducted at 163 sites along Oak Creek's mainstem, the North Branch of Oak Creek, and the Mitchell Field Drainage Ditch. An additional 467 pool habitats and 342 riffle habitats were recorded to assess the overall distribution of instream habitat types. Pools are deep water areas with slower water velocities that serve as critical habitat for resting fish. Riffles are shallow water areas with higher water velocities and larger substrates that serve as critical spawning habitat for fish and important habitat for macroinvertebrates.
