SEWRPC Staff Memorandum

**EVALUATION OF THE POTENTIAL IMPACT OF THE
REMOVAL OF THE MONTEREY DAM
ON WATER QUALITY AND WATER QUANTITY IN ASHIPUN LAKE**

January 26, 2012

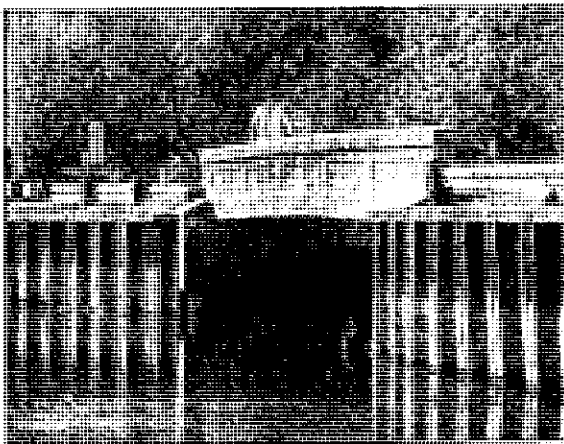
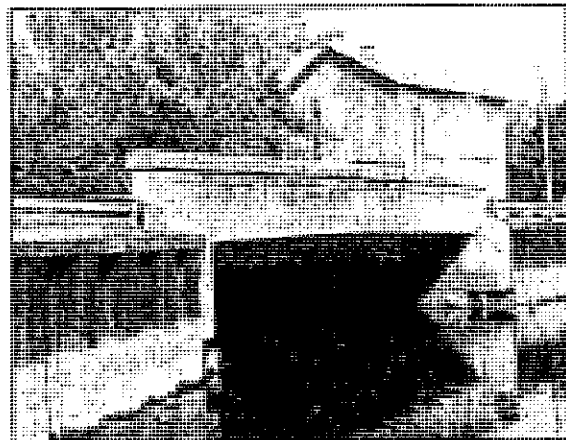
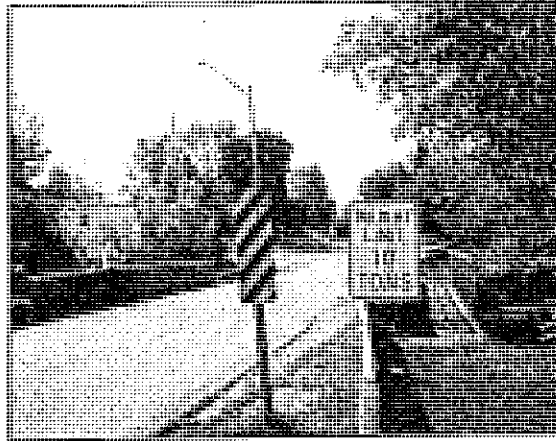
The existing bridge is a 38 foot span concrete deck girder bridge constructed in 1923, as documented in past WISDOT inspection reports. The bridge is posted for a 10 ton load limit and is adjacent to and integral with the Monterey Dam. There are no plans available for the existing bridge or dam.

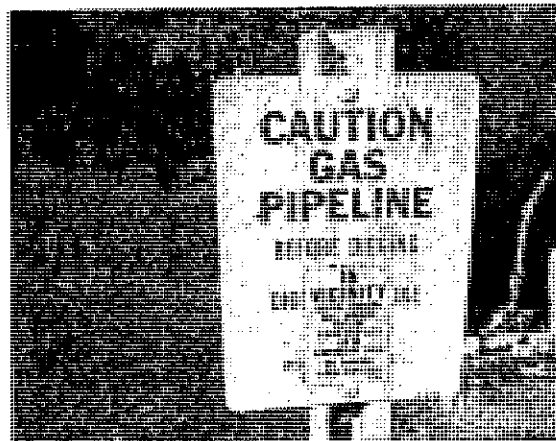
The wingwalls on the east side of the bridge are constructed of driven steel sheet piles. The reinforced concrete parapets probably serve as upturned exterior concrete deck girders. There is a 6-inch diameter gas pipeline on the west side of the bridge adjacent to the parapet and between the bridge deck and the steel walkway over the dam.

The bridge is in generally poor condition with the major deficiencies listed below:

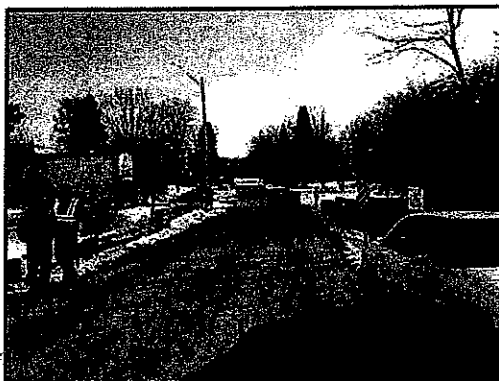
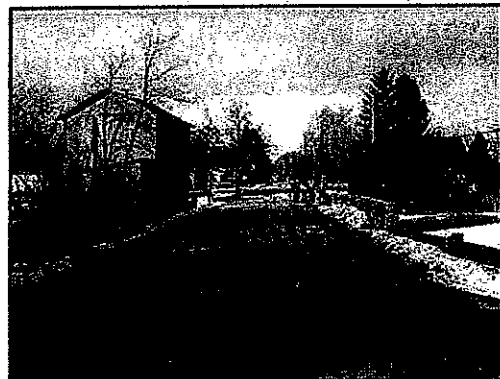
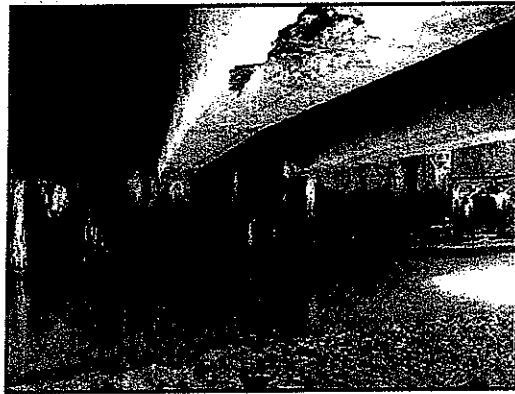
The existing bridge is a 38 foot span concrete deck girder bridge constructed in 1923, as documented in past WISDOT inspection reports. The bridge is still posted for a 10 ton load limit and is adjacent to and integral with the Monterey Dam. There are no plans available for the existing bridge or dam.

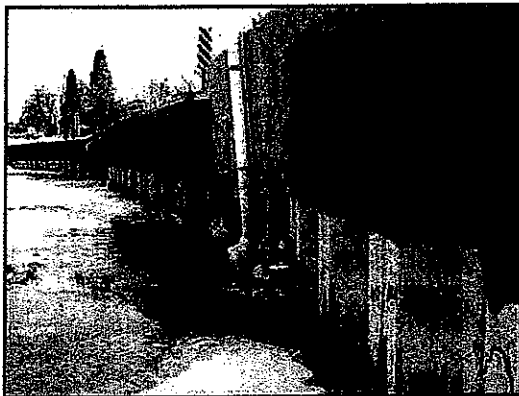
The wingwalls on the east side of the bridge are constructed of driven steel sheet piles. An old fire department standpipe remains on the east side. It appears as though the retaining wall above the mill race by the standpipe is tipping to the east. There is a 6-inch diameter gas pipeline on the west side of the bridge adjacent to the parapet and between the bridge deck and the steel walkway over the dam.

The bridge is in generally poor condition with the major deficiencies listed below:

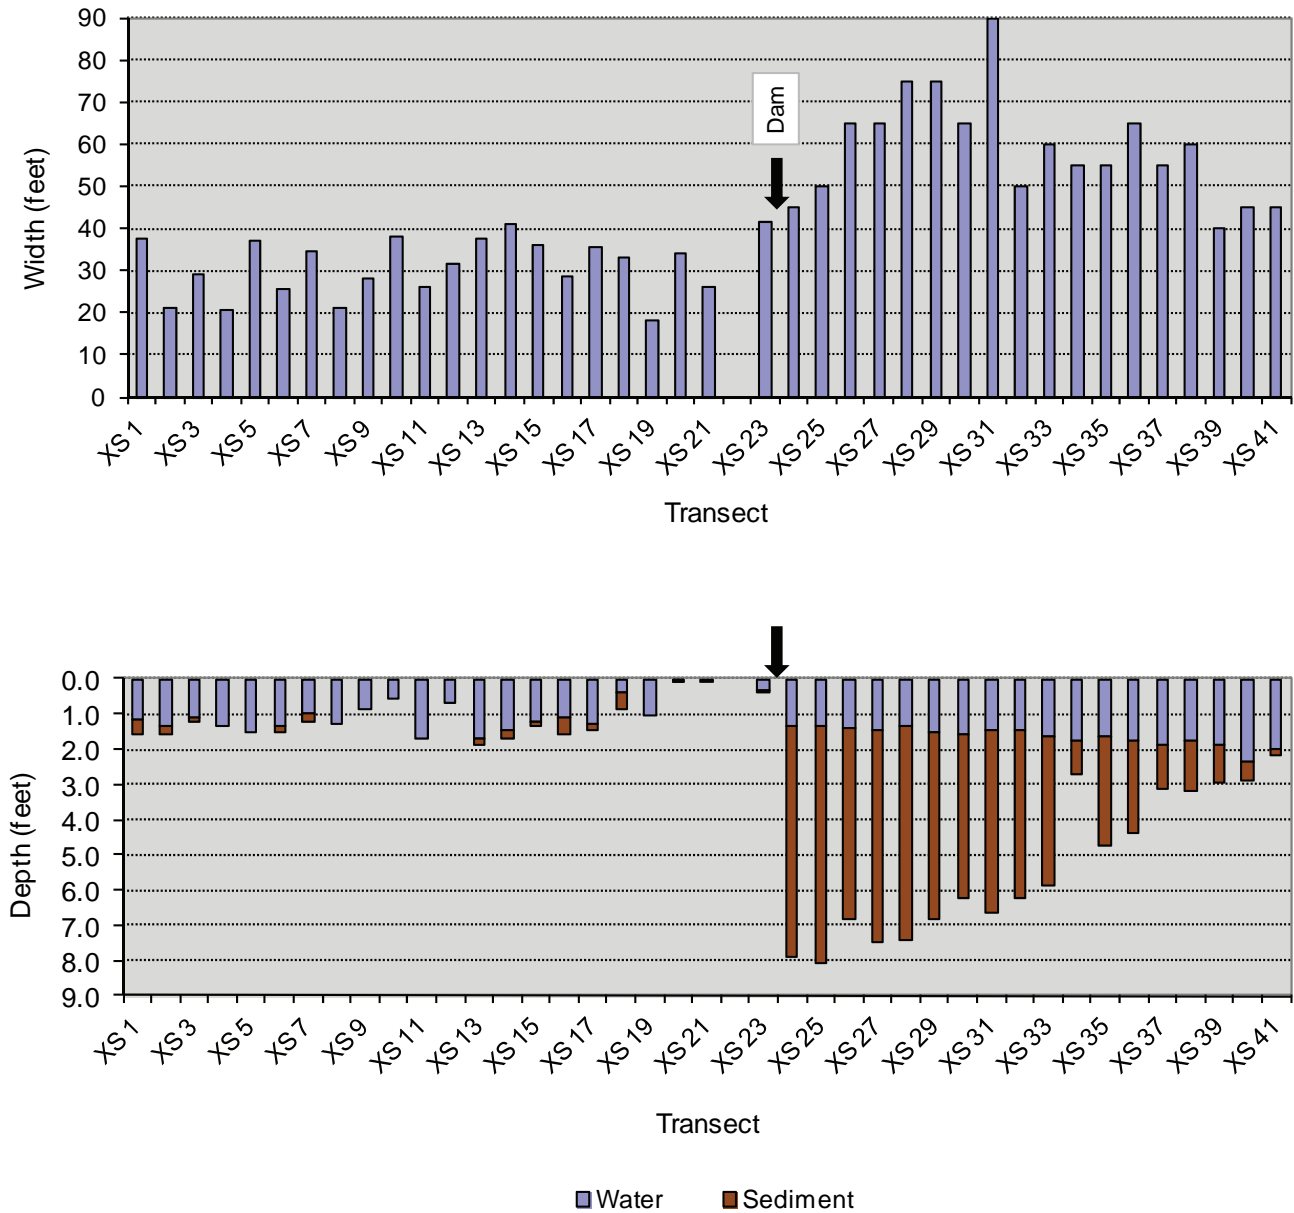
Exhibit 14

NOTE: Due to the diversion of water from the Monterey Dam spillway to the mill race, water depths in transects 20 through 23 were low in this area because water was not flowing through this section of channel at the time of this survey.

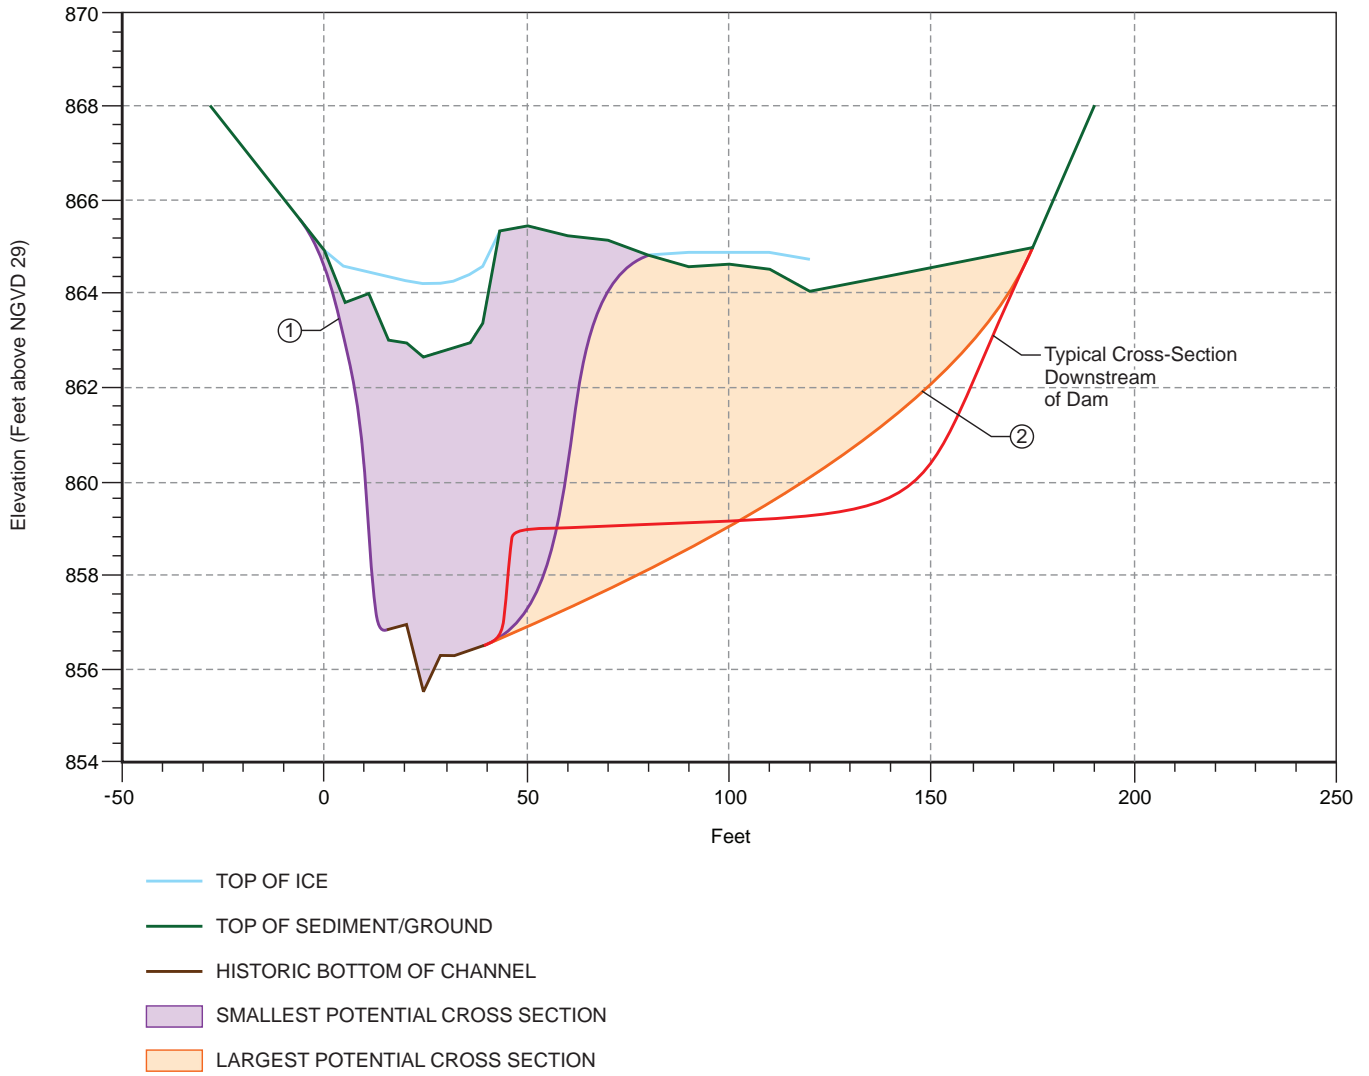
Exhibit 16

NOTE: The top of ice and top of sediment/ground cross sections are approximately 200 feet upstream of Monterey dam, looking upstream.
