# TRAFFIC CONTROL STUDY FOR THE VILLAGE OF FOX POINT

## MILWAUKEE COUNTY WISCONSIN

**MEMORANDUM REPORT  
NUMBER 114**

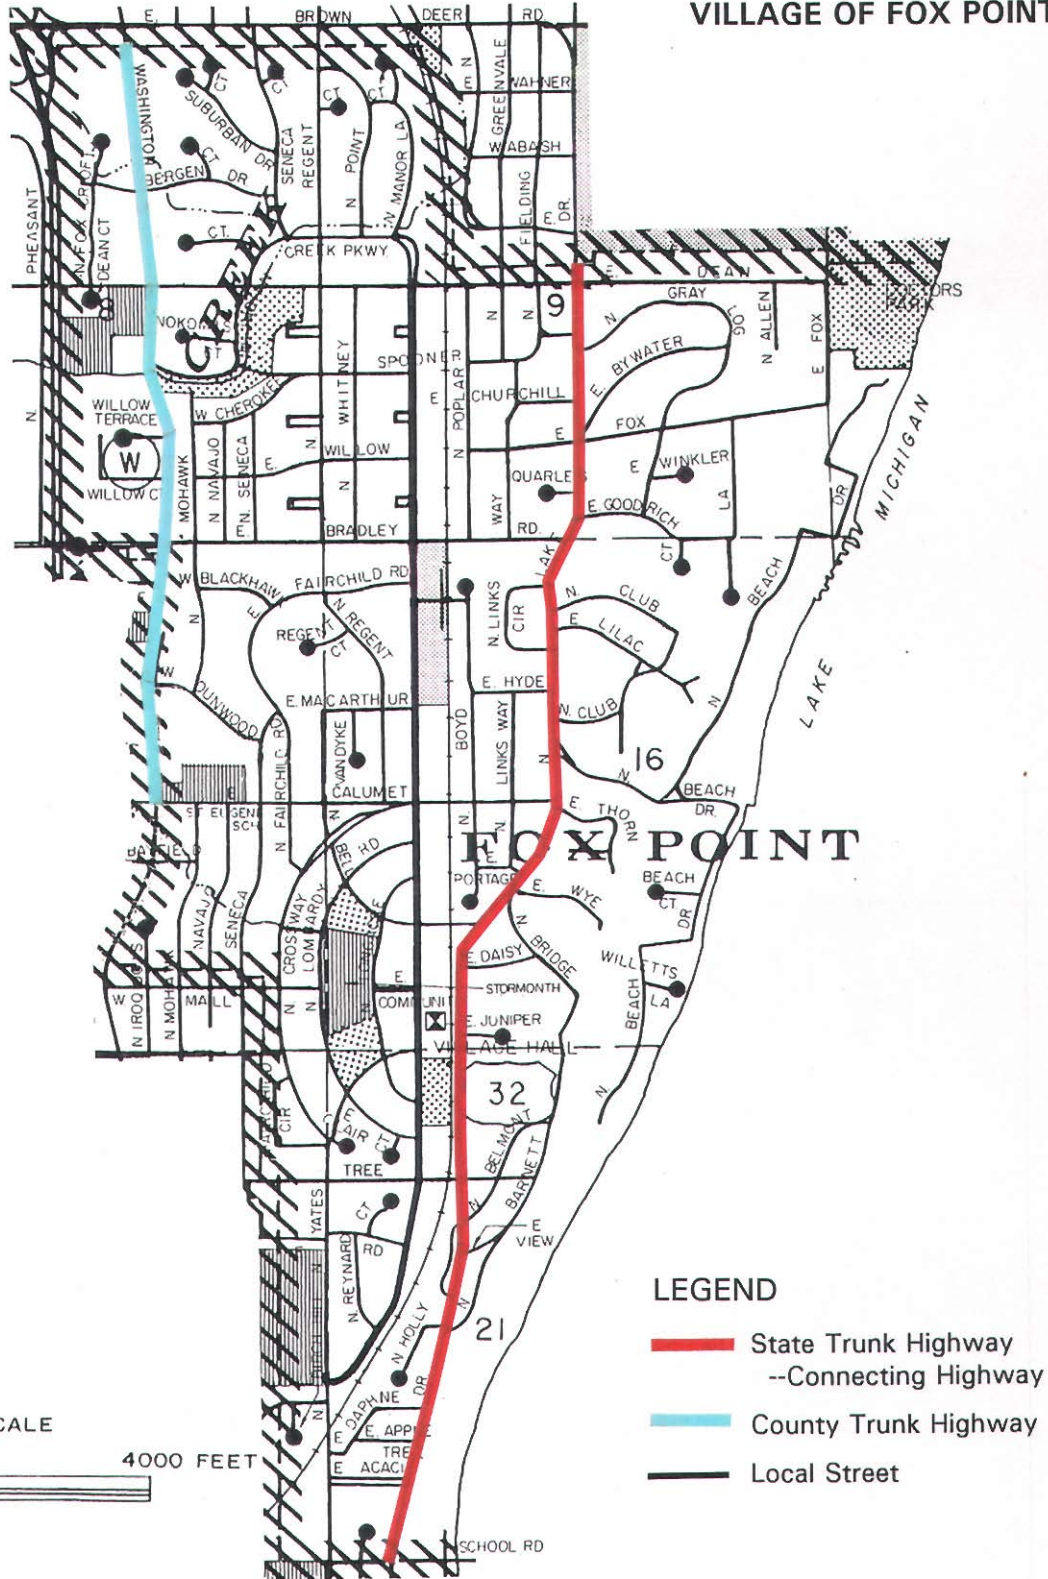
All of the streets and highways in the Village have one through traffic lane in each direction except N. Lake Drive (STH 32) which has three lanes delineated by pavement markings. Two different pavement marking schemes are utilized to delineate the lanes as shown in Figure 1. Alternative pavement marking scheme 1 shown in Figure 1 is utilized to delineate the three lanes on N. Lake Drive from the south corporate limit to approximately N. Holly Court; from a point about 400 feet north of E. Green Tree Road to E. Juniper Lane; from approximately E. Beach Drive to approximately E. Hyde Way; and from E. Fox Lane to the north corporate limit. Alternative pavement marking scheme 2 shown in Figure 1 is utilized to delineate the three lanes on the intervening segments of N. Lake Drive from approximately N. Holly Court to a point about 400 feet north of E. Green Tree Road; from E. Juniper Lane to approximately E. Beach Drive; and

THE EXISTING LONGITUDINAL PAVEMENT MARKING SCHEMES  
ON N. LAKE DRIVE IN THE VILLAGE OF FOX POINT: 1993

As noted in the inventory, N. Lake Drive (STH 32) through the Village has three lanes delineated by pavement markings. Two different pavement marking schemes are utilized to delineate the lanes as shown in Figure 1. Alternative pavement marking scheme 1 shown in Figure 1 is utilized to delineate the three lanes on N. Lake Drive from the south corporate limit to approximately N. Holly Court; from a point about 400 feet north of E. Green Tree Road to E. Juniper Lane; from approximately E. Beach Drive to approximately E. Hyde Way; and from E. Fox Lane to the north corporate limit. Alternative pavement marking scheme 2 shown in Figure 1 is utilized to delineate the three lanes in the intervening segments of N. Lake Drive from approximately N. Holly Court to a point about 400 feet north of E. Green Tree Road; from E. Juniper Lane to approximately E. Beach Drive; and from a point between E. Hyde Way and N. Links Circle on the south to a point between E. Goodrich Lane and E. Fox Lane.

Each of the pavement marking schemes conveys different information to motorists utilizing the roadway. The broken yellow longitudinal pavement marking lines shown by alternative pavement marking scheme 1 in Figure 1 delineate the left edge of a lane where travel on the other side of the line is in the opposite direction. Motorists may cross a broken yellow line to overtake and pass a vehicle traveling the same direction.

A double longitudinal line consisting of a normal, broken yellow line and a normal, solid yellow line as shown by alternative pavement marking scheme 2 in Figure 1 delineates a separation between travel paths in opposite directions where overtaking and passing is permitted with care for traffic adjacent to the broken line and is prohibited for traffic adjacent to the solid line. This is a one direction, no-passing marking and is used on two-way, two- and three-lane roadways to regulate passing. It is also used to delineate the edges of a lane in which travel in either direction is permitted (but only as part of a left-turn maneuver). In the latter application, the markings are to be placed with the solid lines on the outside and the dashed lines to the inside of the lane as shown by alternative pavement marking scheme 2 in Figure 1. Traffic adjacent to

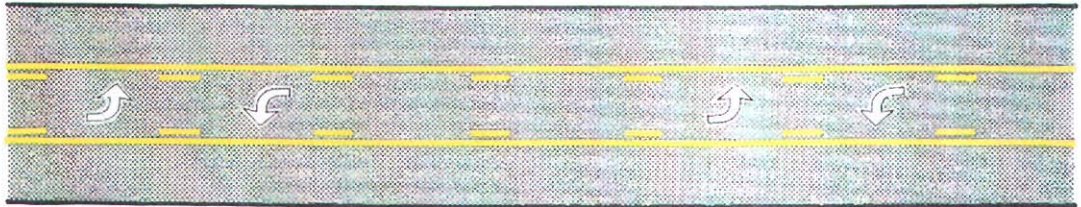
Figure 6

It should be noted that, while not required, pavement marking arrows, as shown in Figure 6, are recommended in the Manual on Uniform Traffic Control Devices to supplement the longitudinal pavement marking pattern and regulatory signing required for operation of the center lane as a two-way left-turn lane. Because the requisite regulatory signing is not provided, it may be concluded that all travel, including left turns, should be excluded from the center lane on those segments of N. Lake Drive where alternative pavement marking scheme 2 exists.

REQUIRED LONGITUDINAL AND RECOMMENDED ARROW PAVEMENT MARKINGS  
FOR THE OPERATION OF A THREE LANE ROADWAY WITH TWO THROUGH TRAFFIC LANES  
AND A CONTINUOUS TWO-WAY LEFT-TURN LANE IN THE CENTER LANE<sup>a</sup>

<sup>a</sup> In addition to the pavement markings shown in this Figure, the use of regulatory signing with the message "TWO-WAY LEFT-TURN ONLY" is required for the operation of a continuous two-way center left-turn lane, by the Wisconsin Manual on Uniform Traffic Control Devices.

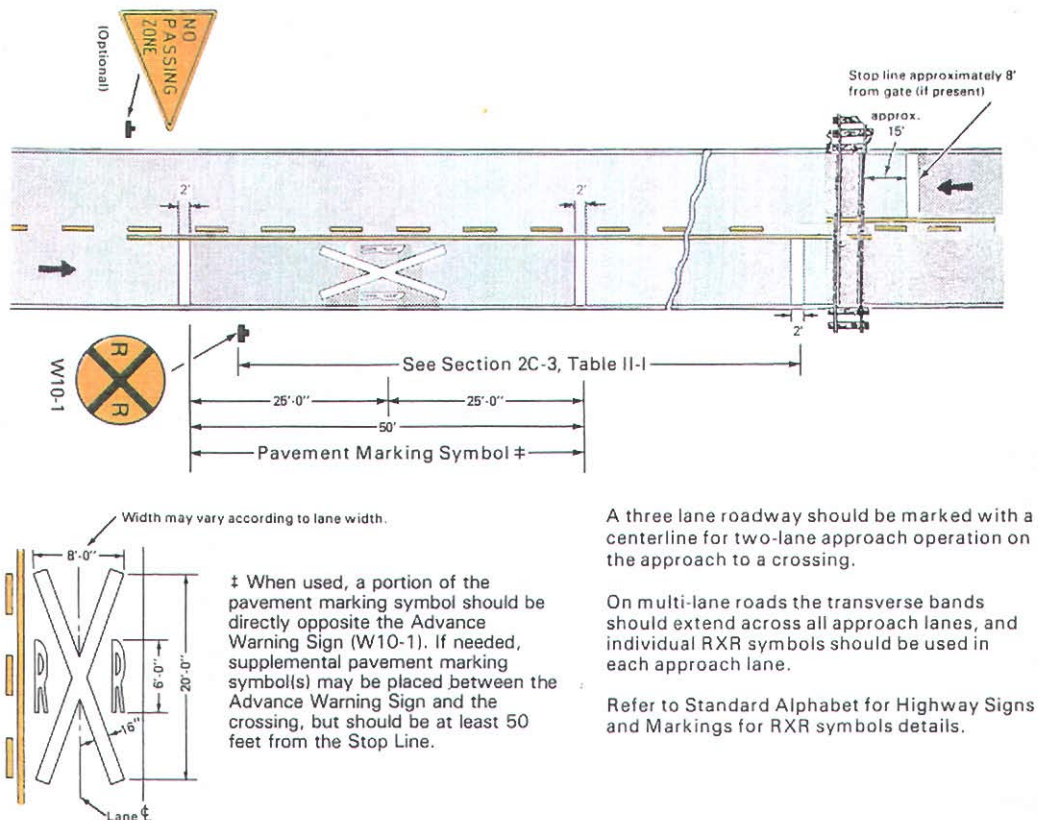
The inventory of traffic control devices at the railway-highway grade crossing indicated that there are no existing pavement markings. The Manual on Uniform Traffic Control Devices does require the use of pavement markings essentially as illustrated in Figure 7 on all paved approaches where grade crossing signals are provided. The Wisconsin Supplement to the Manual on Uniform Traffic Control Devices, however, permits the omission of such pavement markings where the approach distance is less than 100 feet as is the case on the westbound E. Green Tree Road approach to the railway crossing. Thus, with respect to the prescribed pavement markings, none of the street approaches complies with the Manual on Uniform Traffic Control Devices except the westbound E. Green Tree Road approach.

**TYPICAL PLACEMENT OF WARNING SIGNS AND PAVEMENT MARKINGS  
AT RAILROAD-HIGHWAY GRADE CROSSINGS**

It is recommended that pavement markings be installed on all street approaches to the railway-highway grade crossings within the Village except the westbound E. Green Tree Road approach as illustrated in Figure 7. The estimated cost to the Village to implement this action is \$7,000.
