# A LAKE MICHIGAN SHORELINE EROSION MANAGEMENT PLAN FOR MILWAUKEE COUNTY WISCONSIN

**SOUTHEASTERN WISCONSIN  
REGIONAL PLANNING COMMISSION**

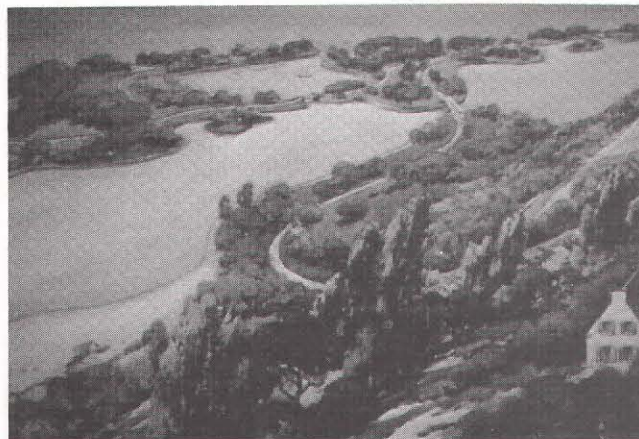
Figure 2

### PROPOSED EXTENSION OF LINCOLN MEMORIAL DRIVE: 1934

The Milwaukee County Regional Planning Department recommended in 1934 that a series of islands be constructed which would allow the extension of Lincoln Memorial Drive from Lake Park in the City of Milwaukee to E. Green Tree Road in the Village of Fox Point. This recommendation was reaffirmed by Milwaukee County in 1945, and by the U. S. Army Corps of Engineers in 1945 and in 1975. Funds were never provided to implement the recommendation.

This 1934 study by the Milwaukee County Regional Planning Department recommended that a series of offshore islands be constructed from Lake Park in the City of Milwaukee to E. Green Tree Road in the Village of Fox Point, as shown in Figure 2. The proposed islands were to be designed to provide protection against wave erosion, create additional public lake frontage, allow extension of Lincoln Memorial Drive to E. Green Tree Road, and provide protection for small boating activities. The study found that construction of offshore islands within the study area would be technically feasible. The study recommendation was not implemented.

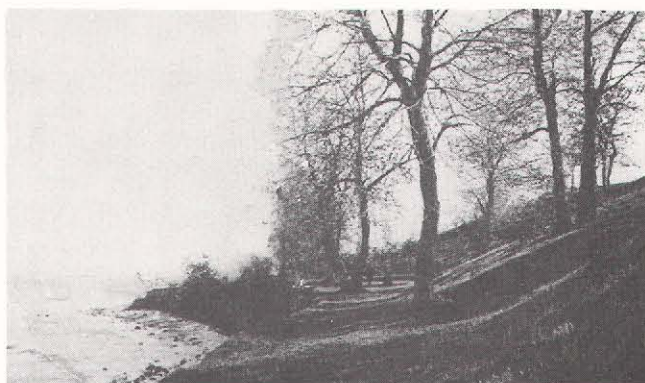
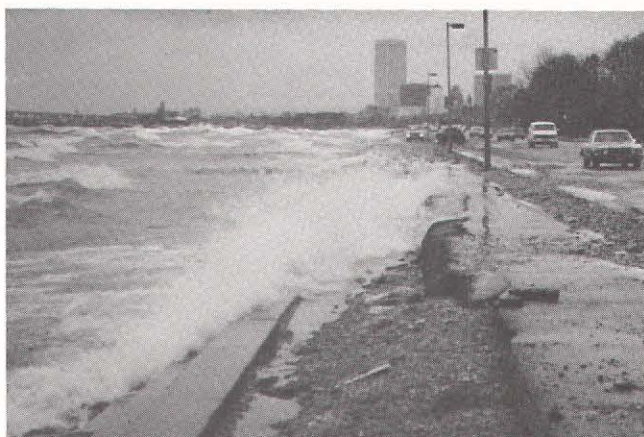
LAKE MICHIGAN SHORELINE  
NEAR LAKE PARK: 1908 AND 1986

The 1908 photograph (top view) shows the stable, well-vegetated bluffs of Lake Park at the Lake Michigan shoreline. Fill was later placed in the lake to create additional land, and Lincoln Memorial Drive was constructed on the fill. The land lakeward of Lincoln Memorial Drive eroded, allowing wave action during intense storms to wash debris onto the roadway, as shown in the December 1986 photograph (bottom view). The McKinley Beach Restoration Project, begun in 1987, is intended to protect this roadway (see Figure 9).

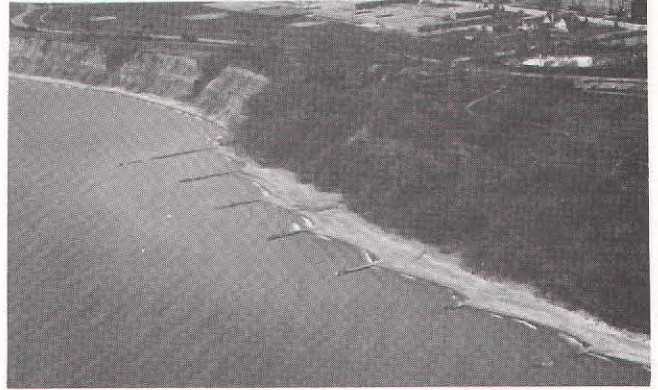
**SHERIDAN PARK GROINS: 1945 AND 1987**

The Sheridan Park groins, constructed in 1933, have built a beach which has protected the bluff slopes for over 50 years. The accretion of the beach occurred rapidly; within 10 years after construction, over three acres of beach had been formed. The 11 permeable groins are constructed of precast concrete beams and sills arranged in an overlapping criss-cross fashion with a cover of solid concrete slabs. Because of a lack of maintenance, however, the groins have deteriorated and are now subject to overtopping and material loss. Increased erosion of the beach threatens the stability of the bluff slopes.

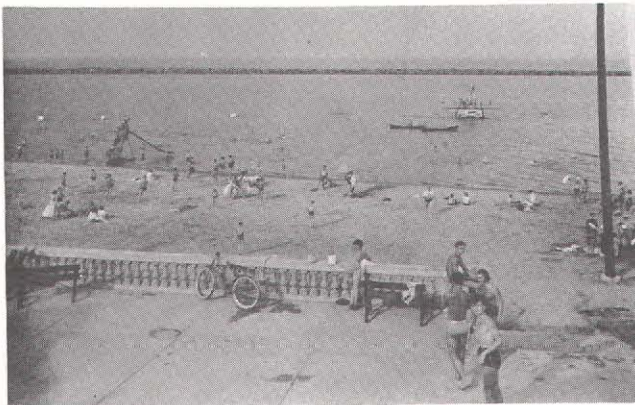
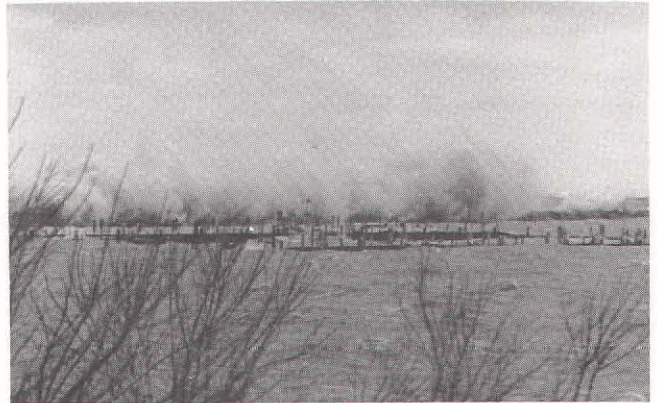
**MILWAUKEE SOUTH SHORE BREAKWATER**

The 12,500-foot-long Milwaukee South Shore breakwater was constructed in segments between 1913 and 1931. Most of the segments were constructed by the City of Milwaukee, although the southernmost 600 feet of the breakwater was built by The Milwaukee Electric Railway & Light Company, the predecessor company to the Wisconsin Electric Power Company. As shown in the early photograph, the breakwater, located about 1,000 feet offshore in an approximate water depth of 20 feet, provided substantial protection of the shoreline from the Milwaukee Harbor southward to the City of St. Francis. In 1950, Milwaukee County assumed responsibility for maintaining the breakwater, but little maintenance has actually been performed. As shown in the 1987 photograph taken near the South Shore Marina, the breakwater has deteriorated and is overtopped by waves during storms.

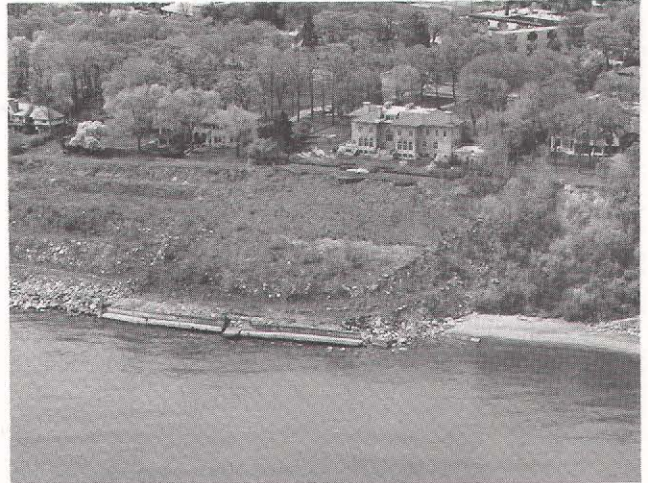
BLUFF SLOPE FILL PROJECT AT 5270 N. LAKE DRIVE, VILLAGE OF WHITEFISH BAY: 1976 AND 1986

A major bluff slippage occurred at 5270 N. Lake Drive in April 1973, following a severe rainfall. Later that year, concrete rubble and soil were placed on the bluff slope to increase its stability. The fill material has effectively stabilized the slope, although erosion at the toe of the bluff is occurring, as shown in the 1986 photograph.

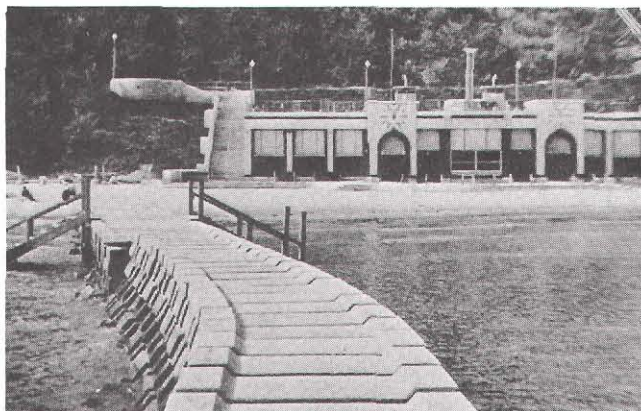
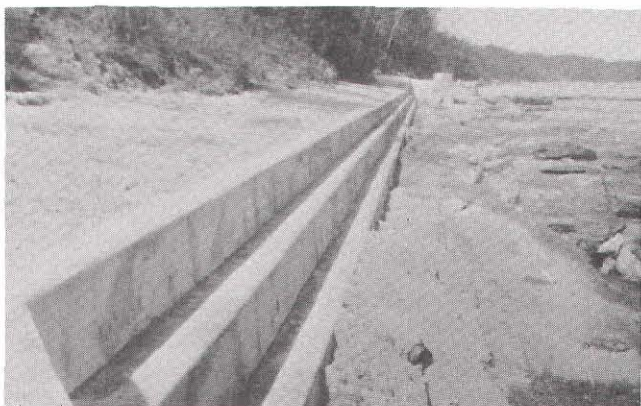
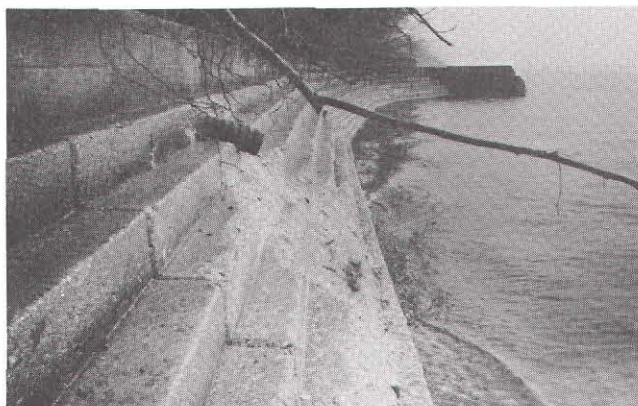
### ATWATER PARK, VILLAGE OF SHOREWOOD

### BIG BAY PARK, VILLAGE OF WHITEFISH BAY

These parks in northern Milwaukee County, which have been protected by shore protection structures since the 1930's, all were damaged by shoreline erosion during the high-water period of 1985 through 1987. The 400- to 500-foot-long permeable groins at Atwater Park, built in 1932, have deteriorated, resulting in severe erosion of the beach. The Atwater Park beach house was demolished in 1987. Concrete bulkheads at Buckley Park, Big Bay Park, and Klode Park, all built in 1943, were damaged by scouring and overtopping. The Big Bay Park bulkhead is subject to overtopping during high-lake-level periods, and the 1986 photograph shows the scouring effects frequently caused by waves deflecting off bulkheads. The scouring at the base of the structure has exposed at least three additional concrete steps which were previously buried by sand.

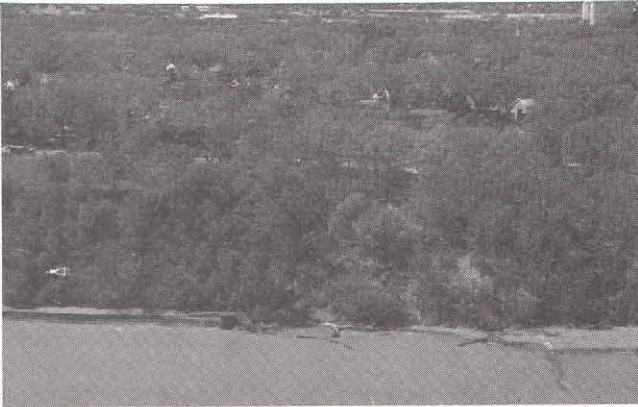
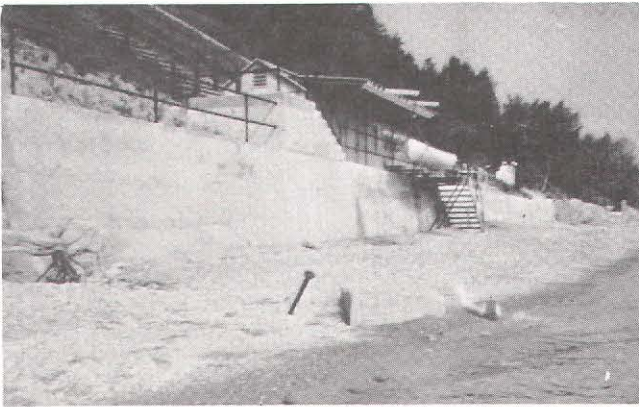
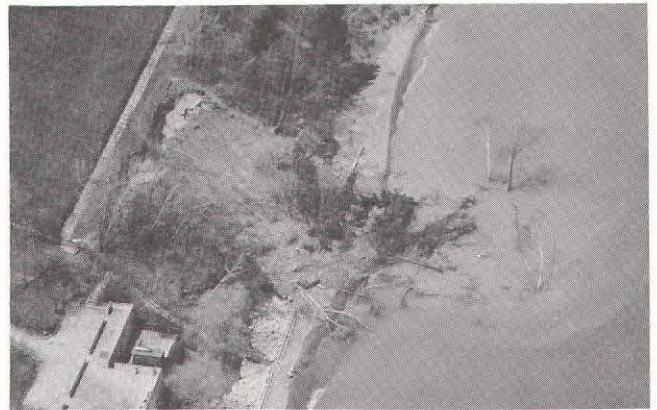
BUCKLEY PARK, VILLAGE OF WHITEFISH BAY

KLODE PARK, VILLAGE OF WHITEFISH BAY

The Buckley Park bulkhead collapsed in November 1986, as the bluff slope above the bulkhead failed. A portion of the Klude Park bulkhead collapsed in December 1986, and the bluff behind the bulkhead then failed in April 1987, as shown in the May 1987 photograph.

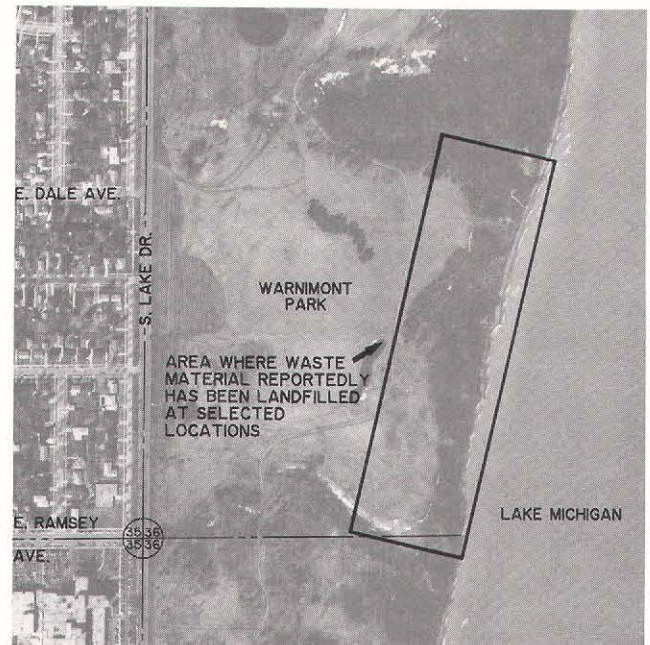
Figure 20

KNOWN DEPOSITS OF WASTE MATERIAL WHICH MAY CONTAIN TOXIC SUBSTANCES NEAR THE SHORELINE OF SECTION 36, TOWNSHIP 6 NORTH, RANGE 22 EAST, CITY OF CUDAHY

Avenue extended, in Warnimont Park, in the northwest one quarter of U. S. Public Land Survey Section 36, Township 6 North, Range 22 East, in the City of Cudahy. That landfill was in operation from at least 1950 until about 1963.<sup>13</sup> In some portions of the landfill, about 50 feet of waste material is covered by about 20 feet of soil. The landfill reportedly contains paints, dyes, resins, lacquers, foundry sand, castings, automobile bodies, empty barrels, broken concrete, vegetation, and construction debris. As shown in Figures 18 and 20, the bluff near the location of the former Manke Dump is actively eroding. There has been no evidence that the waste material at this site has actually eroded into the lake.

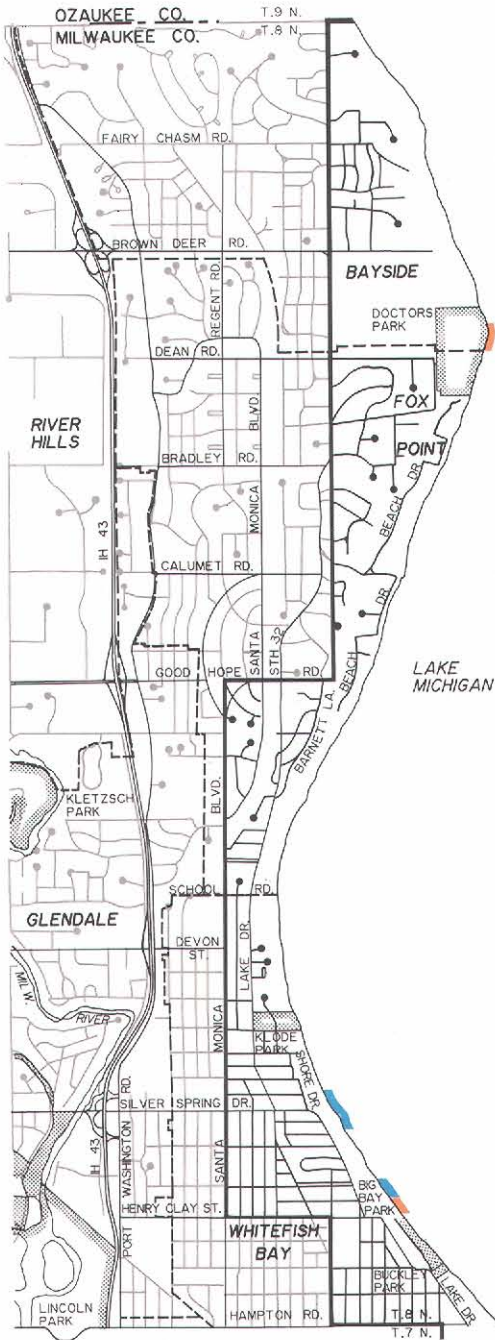
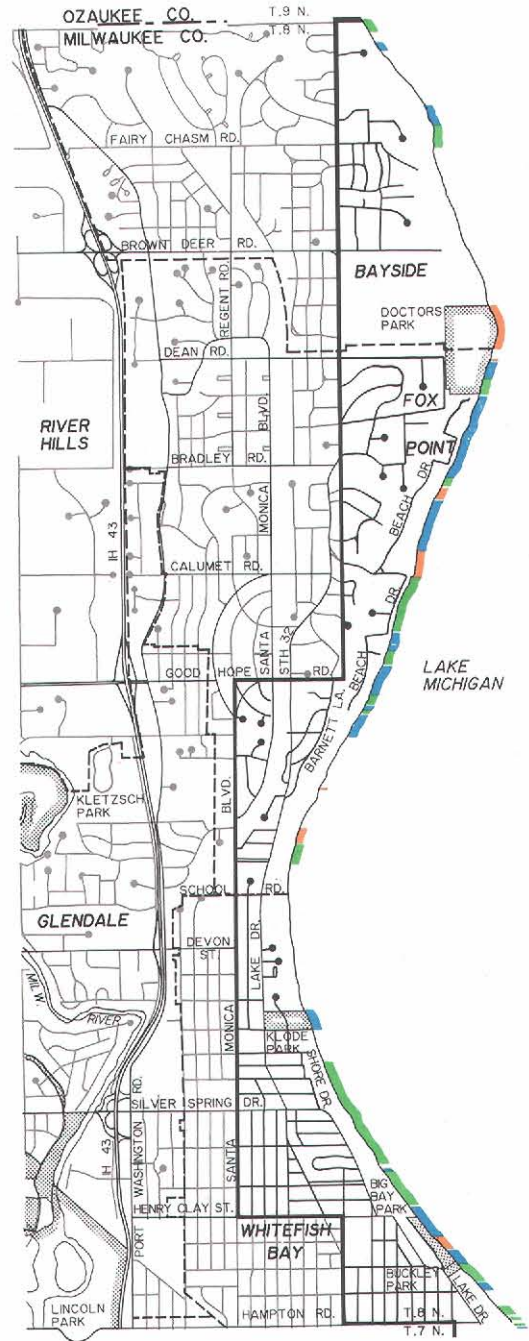
## HISTORIC EVOLUTION OF SHORE PROTECTION STRUCTURES ALONG THE LAKE MICHIGAN SHORELINE OF MILWAUKEE COUNTY: 1920, 1945, 1975, AND 1987

A review of the construction of shore protection measures over nearly the past 70 years helps ascertain the extent of protection provided, and the types of structures used. Shore protection structures that were in existence in 1920, 1945, 1975, and 1987 are shown on Map 22. The structures are identified on the maps as revetments, bulkheads, breakwaters, or groins. The lineal extent of each structure type at each time period is presented in Table 24 and illustrated in Figure 25.

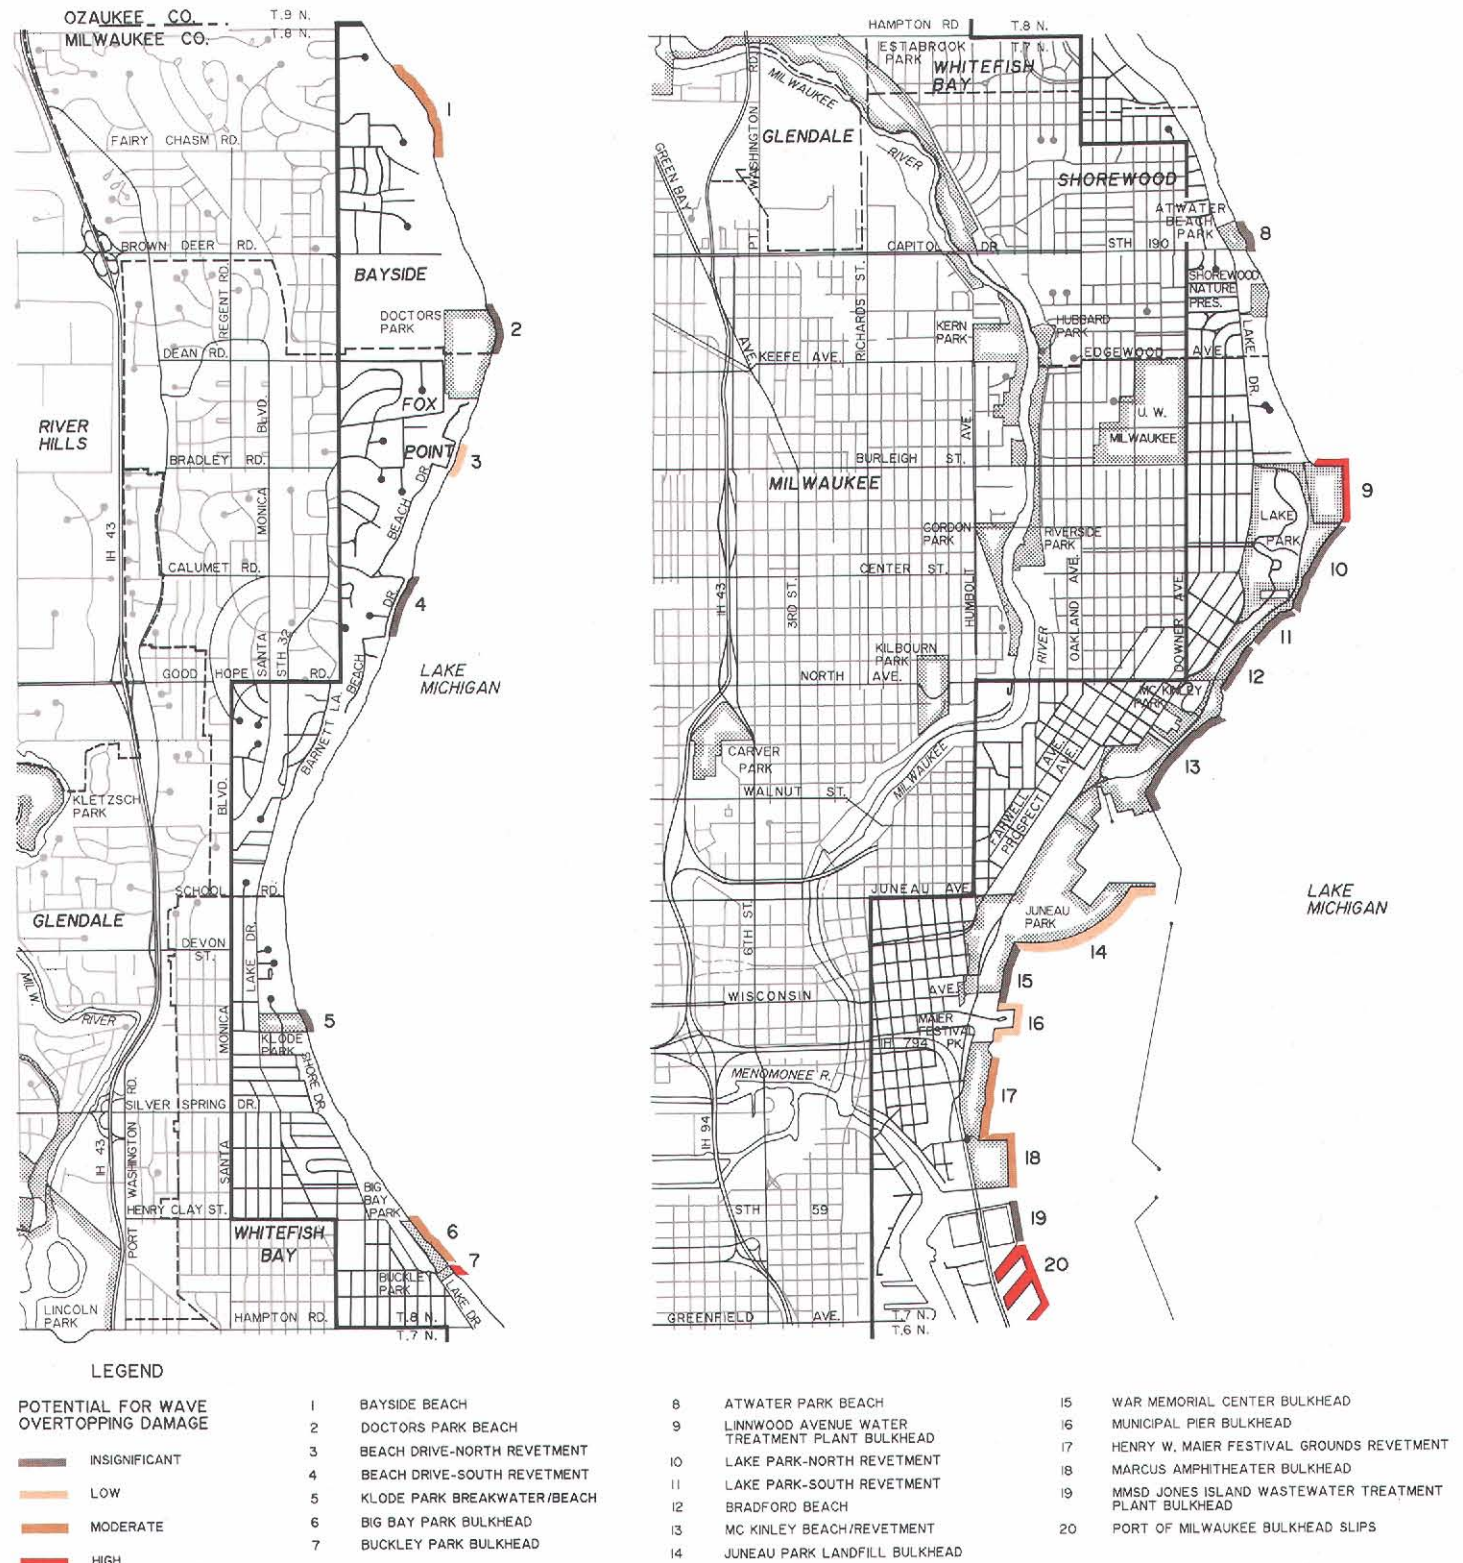
Map 27

POTENTIAL FOR WAVE OVERTOPPING DAMAGE TO MAJOR STRUCTURES AND BEACHES WITH A 10-YEAR LAKE MICHIGAN WATER LEVEL OF 582.8 FEET NGVD AND A 20-YEAR STORM WAVE

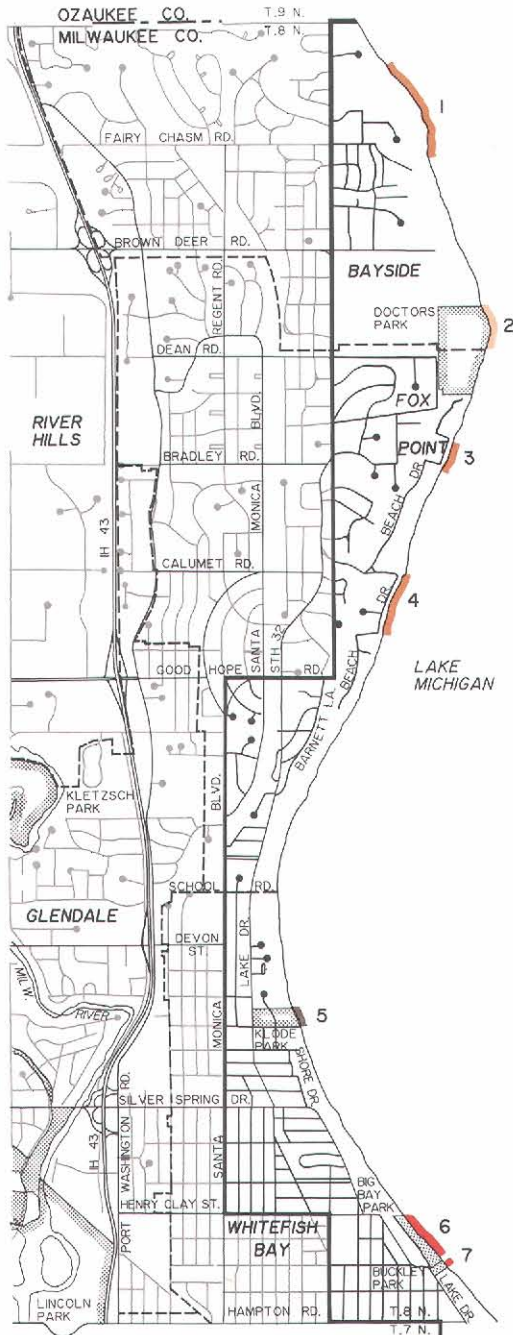
Map 28

POTENTIAL FOR WAVE OVERTOPPING DAMAGE TO MAJOR STRUCTURES AND BEACHES WITH A 100-YEAR LAKE MICHIGAN WATER LEVEL OF 584.3 FEET NGVD AND A 20-YEAR STORM WAVE

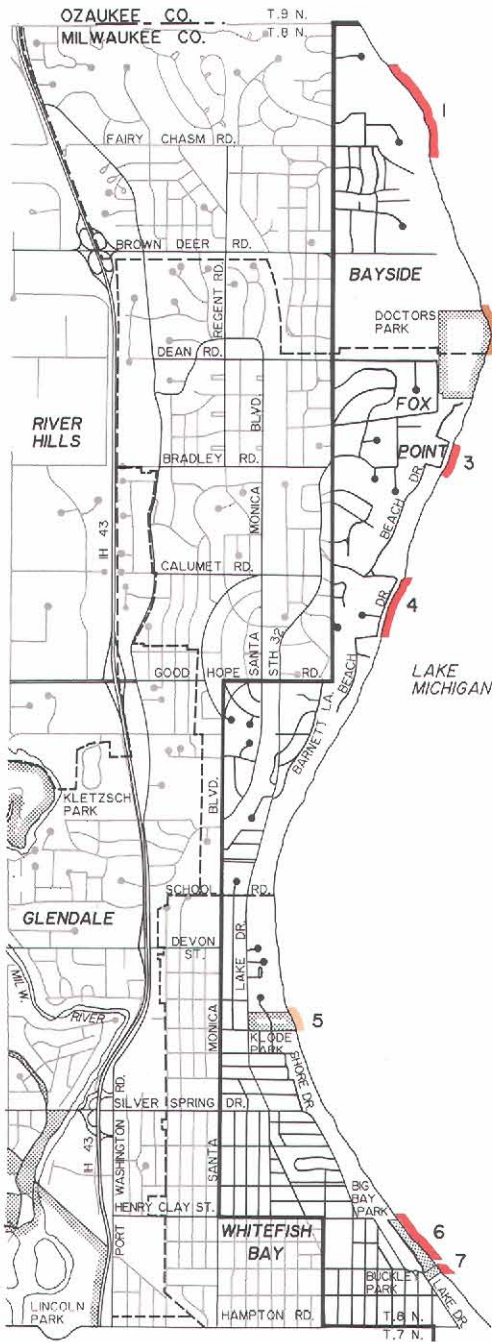
Map 32

POTENTIAL FOR WAVE OVERTOPPING DAMAGE TO MAJOR STRUCTURES AND BEACHES WITH A 500-YEAR LAKE MICHIGAN WATER LEVEL OF 585.9 FEET NGVD AND A 50-YEAR STORM WAVE

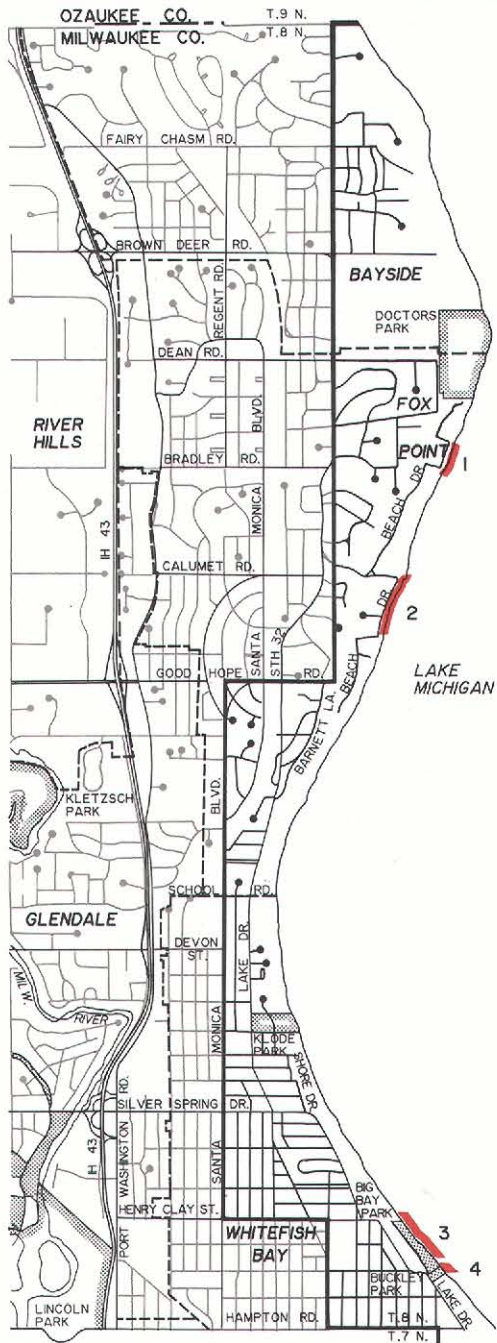
Map 33

**SHORE PROTECTION STRUCTURES WHICH MAY BE DAMAGED  
UNDER EXTREMELY LOW LAKE MICHIGAN WATER LEVELS**

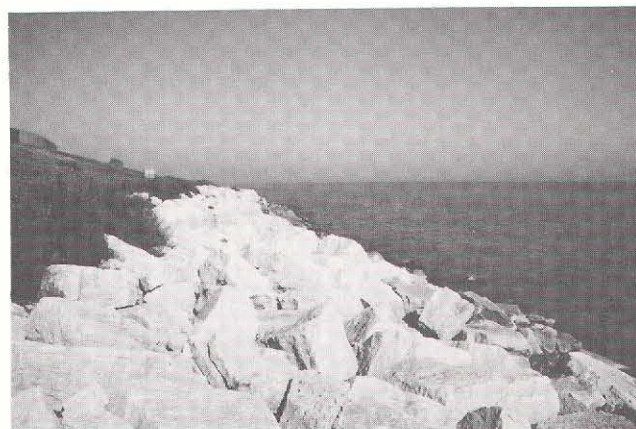
Figure 80

# TYPICAL RIPRAP REVETMENT

**Riprap:** As shown in Figure 80, a riprap revetment utilizes rock or quarry stone as its armor layer. To be durable, the armor stone should be free of laminations and cracks. The stone should be angular, with the greatest dimension no greater than three times the least dimension. Slab-shaped stones are not desirable for an armor layer. Riprap revetments providing three levels of protection are illustrated in Figure 80. A light revetment may require two to three tons of stone per lineal foot of shoreline; a medium revetment, three to five tons of stone per foot; and a heavy revetment, five to 10 tons of stone per foot. The size of the armor stones needed to provide adequate protection is dependent on the wave height, the specific gravity and quality of the stone, the slope of the structure, and the degree of interlocking of the individual stones. An alternative riprap revetment design, known as a berm revetment, utilizes a thick layer of variable-size armor stone with an average weight typically less than one-half the weight of the stone required by conventional design methods. Wave action shapes the thick armor layer into a berm which dissipates the wave energy.

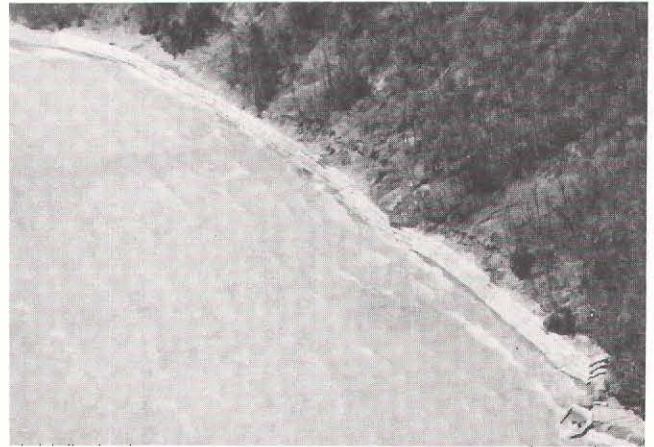
Figure 81

# TYPICAL GROUT-FILLED BAG REVETMENT

**Grout-Filled Bags:** Large grout-filled bags have been placed at the toe of bluffs to form revetments within the study area. These bags are typically six feet deep by two and one-half feet high, and up to 20 feet long. The 20-foot-long bags weigh about 14 tons each. As shown in Figure 81, the bags should be placed parallel to the shore, with reinforcing bars installed both

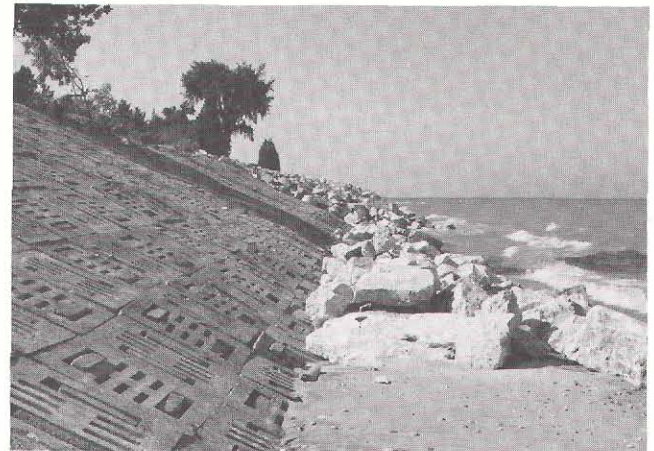
Figure 82

# TYPICAL INTERLOCKING CONCRETE BLOCK REVETMENT

cially available. The interlocking concrete blocks or slabs fit together to form a revetment. These blocks or slabs typically weigh up to 1,000 pounds each. As shown in Figure 82, the blocks or slabs are usually perforated with holes or slots to neutralize pressure from changing water levels and to absorb energy from wave action. A filter cloth should be placed beneath the concrete units to prevent the underlying soil from being washed away by waves or groundwater seepage, and stone should be placed at the toe of the revetment to prevent scouring.

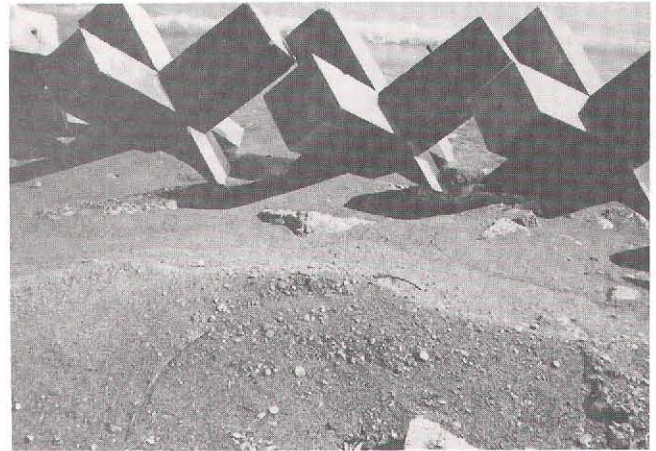
Figure 83

# TYPICAL CAST-IN-PLACE CONCRETE UNITS

TYPICAL CONCRETE UNIT

Larger concrete units, usually cast in place, which do not specifically interlock are also commercially available. These units can be placed along the shoreline to create a revetment. The units, an example of which is shown in Figure 83, vary in size, often ranging from two to three tons each. Heavy construction equipment is usually required to install the structures. These structures are most appropriate for relatively low-wave-energy environments. The capital cost of a revetment constructed of larger cast-in-place concrete units ranges from \$100 to \$200

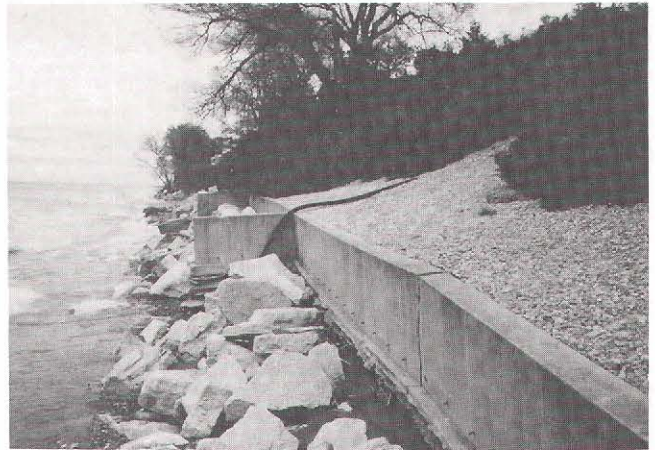
Figure 85

# TYPICAL CONCRETE CANTILEVERED BULKHEAD

**Concrete Cantilevered Bulkhead:** A cantilevered, cast-in-place, reinforced concrete bulkhead, as illustrated in Figure 85, consists of a concrete base with a cantilevered wall. The wall is constructed with weep holes and backfilled with coarse granular material to prevent hydrostatic pressure buildup and frost heave. Riprap toe protection should be provided. A cantilevered bulkhead derives its support solely from ground penetration, so sufficient embedment is required.

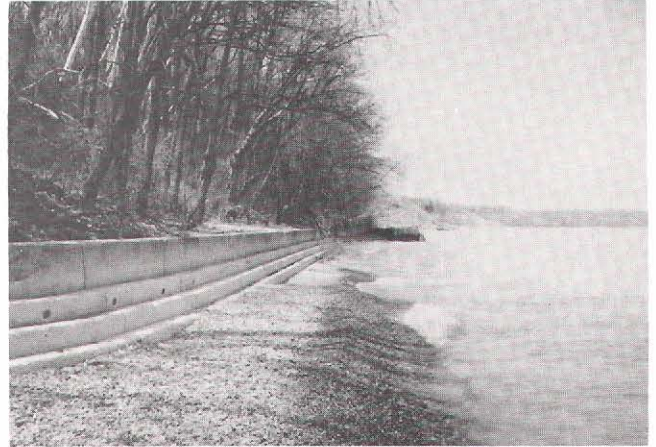
Figure 87

# TYPICAL CONCRETE-STEPPED BULKHEAD

**Concrete-Stepped Bulkhead:** A third type of bulkhead is a cast-in-place, concrete-stepped bulkhead, as shown in Figure 87. The bulkhead, cast as a massive, gravity-held structure to resist overturning by wave action or soil pressures, should include a splash apron along its crest to prevent erosion caused by wave action overtopping the structure. As shown in the figure, the face of the bulkhead is stepped toward the lake. The concrete-stepped bulkhead does not require deep embedment or piles beneath the beach, and the steps provide access to the lake water. The structure is, therefore, more suitable for uses such as swimming and wading than most revetments or other types of bulkheads.

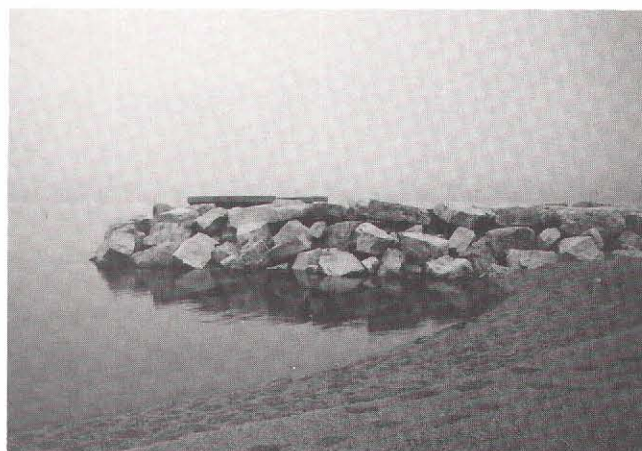
Figure 88

# TYPICAL QUARRY STONE GROIN SYSTEM WITH ARTIFICIALLY NOURISHED GRAVEL BEACH

## PROFILE B-B'

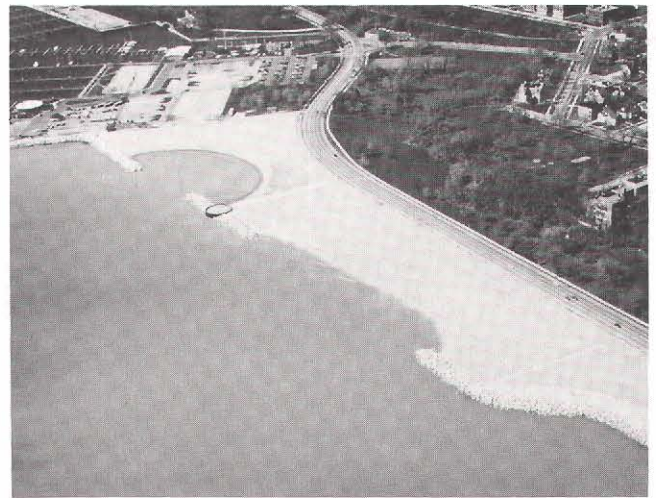
Figure 90

# TYPICAL ARMORED HEADLAND AND POCKET BEACH SYSTEM

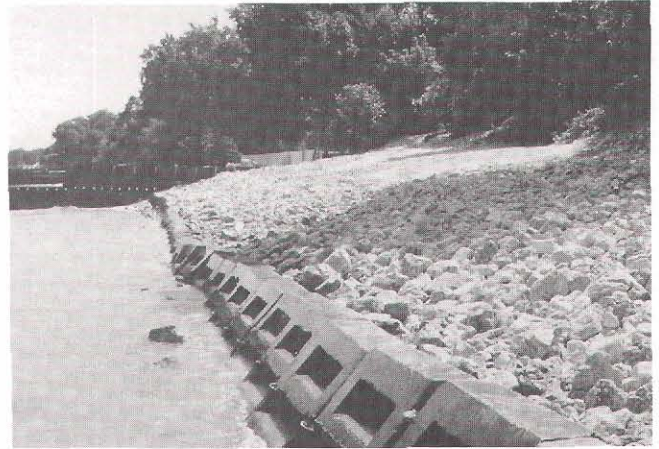
Figure 92

# TYPICAL PERCHED COBBLE BEACH SYSTEM

absorbing structures, particularly suitable where the shoreline water is deep. A beach constructed of cobble stones ranging from 3 to 12 inches in diameter, as shown in Figure 92, would be able to absorb considerable wave energy, while staying intact better than do beaches composed of sand and gravel. The reduced wave reflection would help prevent scouring of the lakebed. The

To increase the effectiveness of the cobble beach and prevent the migration of the cobbles, a sill would be placed lakeward of the original shoreline to create a perched beach and a new shoreline. The sills could be constructed of precast concrete units, quarry stone, or steel sheet pile. As shown in Figure 92, the permeable, precast, steel fiber-reinforced concrete units typically weigh two tons each, and measure approximately four feet high, four feet wide, and six feet deep. They are usually set adjacent to each other in water typically three to six feet deep. The structures are secured to each other with steel cables. The manufacturers of concrete units report that the sloped front and back profile and tapered openings temper wave energy but allow enough energy transmission to avoid scouring of the lakebed from wave reflection. Accretion of beach material has been reported both lakeward and landward of some pervious sills. Heavy construction equipment is required to install the structures. The capital cost of precast concrete units is approximately \$250 per lineal foot of shoreline. A sill constructed of quarry stone would have a capital cost of about \$250 per lineal foot of shoreline, and a sill constructed of sheet pile would have a capital cost of about \$600 per lineal foot of shoreline.

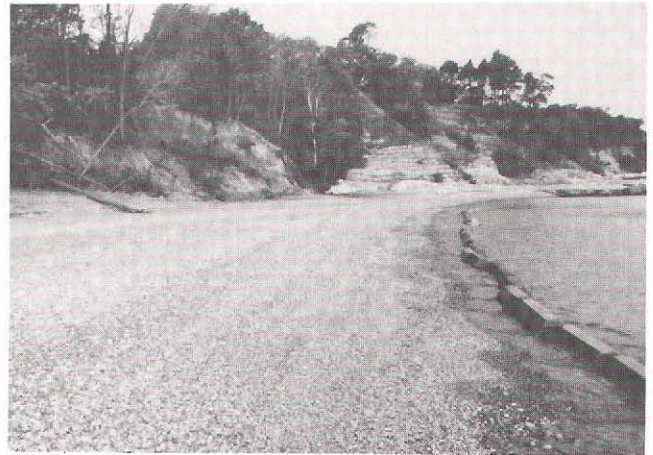
Figure 93

# TYPICAL PERVIOUS CONCRETE SILL

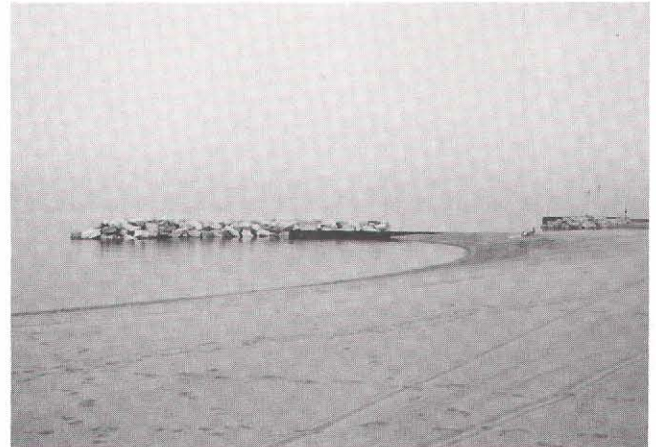
Figure 95

# TYPICAL SEGMENTED RUBBLEMOUND BREAKWATER SYSTEM

NOTE: PROFILE DRAWN THREE TIMES LARGER THAN PLAN.

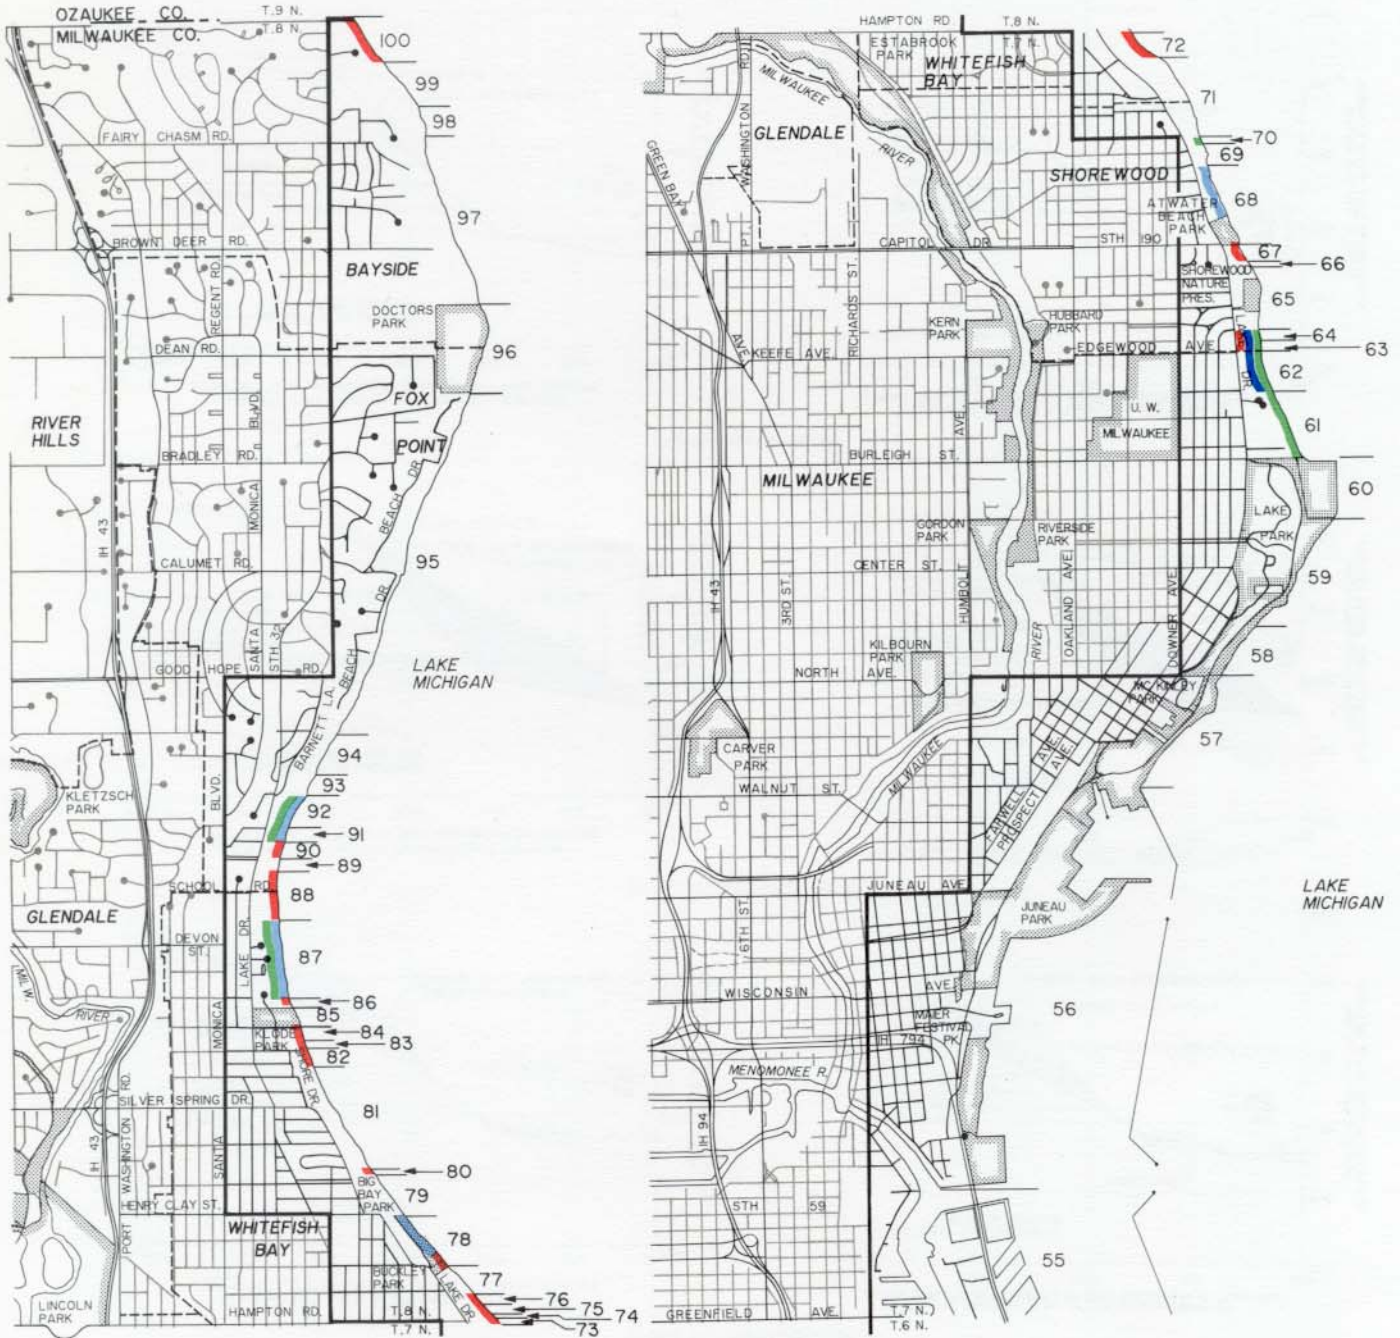
Map 38

PRELIMINARY BLUFF STABILIZATION PLAN ELEMENT FOR MILWAUKEE COUNTY

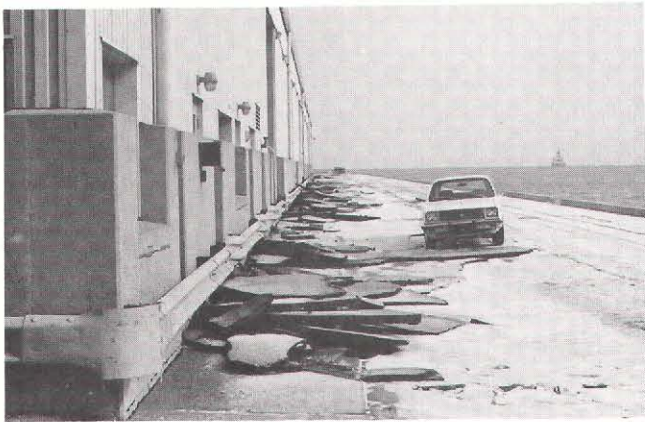
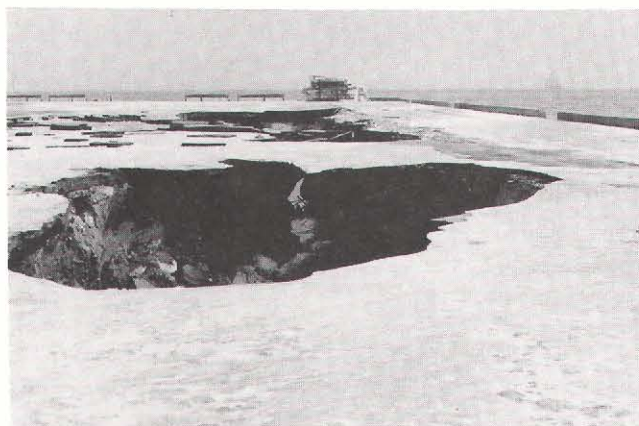
Figure 106

**DAMAGES TO THE HARBOR SHORELINE AND PORT OF MILWAUKEE  
FACILITIES CAUSED BY THE MARCH 9, 1987, STORM EVENT**

The large standing waves generated by storms from the northeast and occurring at the dock walls of the municipal piers not only create hazardous berthing conditions in the slips, but also have caused flooding on Jones Island. Crests of these waves can peak higher than the top of the dock walls. Strong onshore winds cause these waves to break over the top of the walls and into adjacent buildings. The storm of April 9, 1973, which overtopped the north breakwater, caused standing waves which overtopped the dock wall and crashed into adjacent buildings, staving in doors and creating standing water and water damage. Flooding also occurred during the March 9, 1987, storm event.

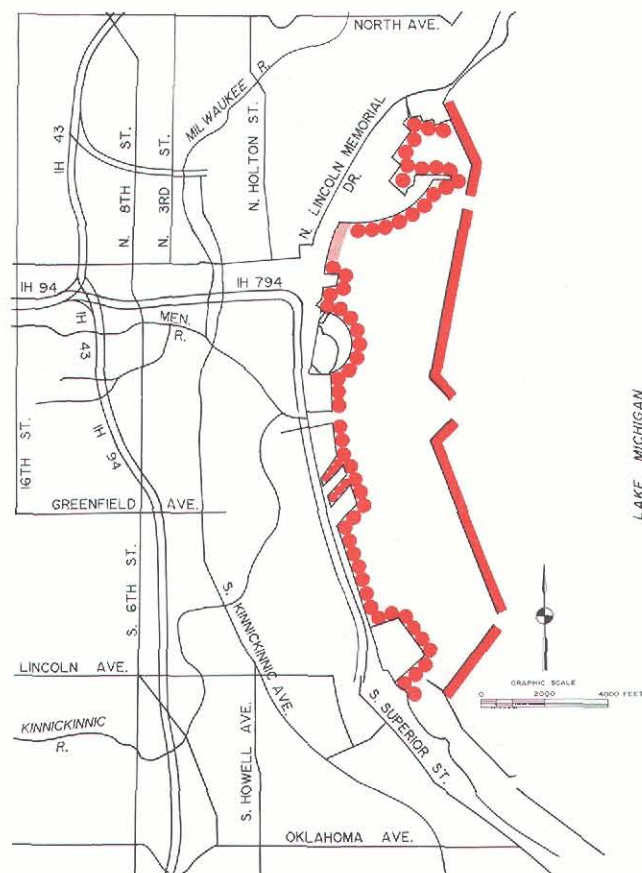
**MILWAUKEE OUTER HARBOR  
BREAKWATER ALTERNATIVE NO. 2  
RECONSTRUCT TO RAISE ELEVATION BY  
8.7 FEET WITH POURED CONCRETE WALL**

Alternative No. 2—Reconstruct Outer Harbor Breakwater to Raise Elevation by 8.7 Feet with Construction of Poured Concrete Wall: Alternative No. 2, shown on Map 45, would include construction of an eight-foot-wide, 8.7-foot-high poured concrete wall to enhance offshore protection, as shown in Figure 107. Wave energy would continue to enter the harbor through the breakwater openings. A structural engineering analysis would be required to determine whether the existing breakwater would be able to support the new wall. The only onshore measure that would need to be reconstructed is the bulkhead protecting the Milwaukee County War Memorial Center, which has a toe scouring problem. Onshore storm damages could be reduced by as much as 80 percent.<sup>18</sup> Waves would reflect off the new breakwater wall, which could increase wave oscillation within the harbor and make navigation difficult close to the wall and in the harbor openings. Waves reflecting off vertical waves can create standing waves twice the height of the incoming waves. Such standing waves generate strong horizontal currents, which, combined with the violent vertical motion of the water surface, make navigation hazardous. This alternative would severely restrict the view of the open lake from the shoreline. Alternative No. 2 would entail a capital cost of approximately \$30.3 million, an annual maintenance cost of about \$1.1 million, and an equivalent annual cost of about \$3.0 million.

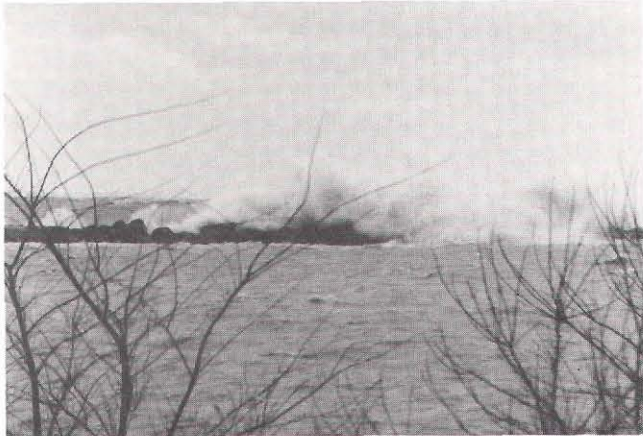
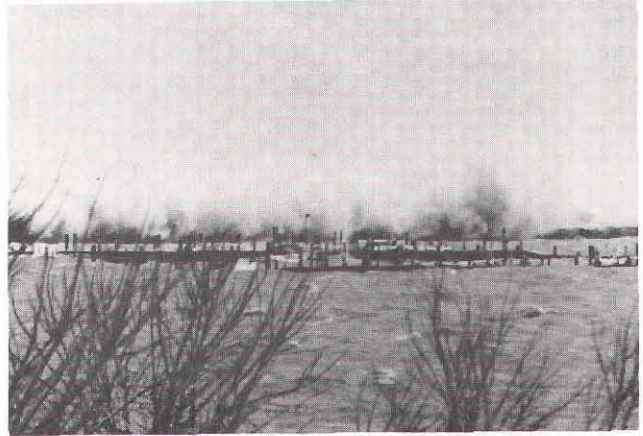
WAVES OVERTOPPING THE SOUTH SHORE BREAKWATER ON MARCH 9, 1987

Furthermore, as the breakwater deteriorates, more wave energy is transmitted over the breakwater. During a 100-year recurrence interval lake level with a 20-year recurrence interval storm wave, as much as 60 percent of the incoming storm wave height is estimated to be transmitted over the breakwater. Figure 109 shows waves overtopping the breakwater near the South Shore Marina during the March 9, 1987, storm event, when a 100-year recurrence interval maximum instantaneous water level was recorded. The portion of the breakwater shown in the figure is the highest breakwater section. Other breakwater sections were totally submerged during that storm. Wave transmission, and the resulting shoreline erosion behind the breakwater, may be expected to increase as the breakwater further deteriorates. Proper rehabilitation or reconstruction of the breakwater would require rebuilding the side slopes to a stable angle and increasing the elevation, and sometimes the width, of the breakwater crest. In 1979, Milwaukee County estimated that reconstructing the South Shore breakwater to a crest elevation of 588.6 feet NGVD—or eight feet above City of Milwaukee datum—would entail a capital cost of about \$8,250,000.<sup>23</sup> Funds for the reconstruction were never allocated by the County.

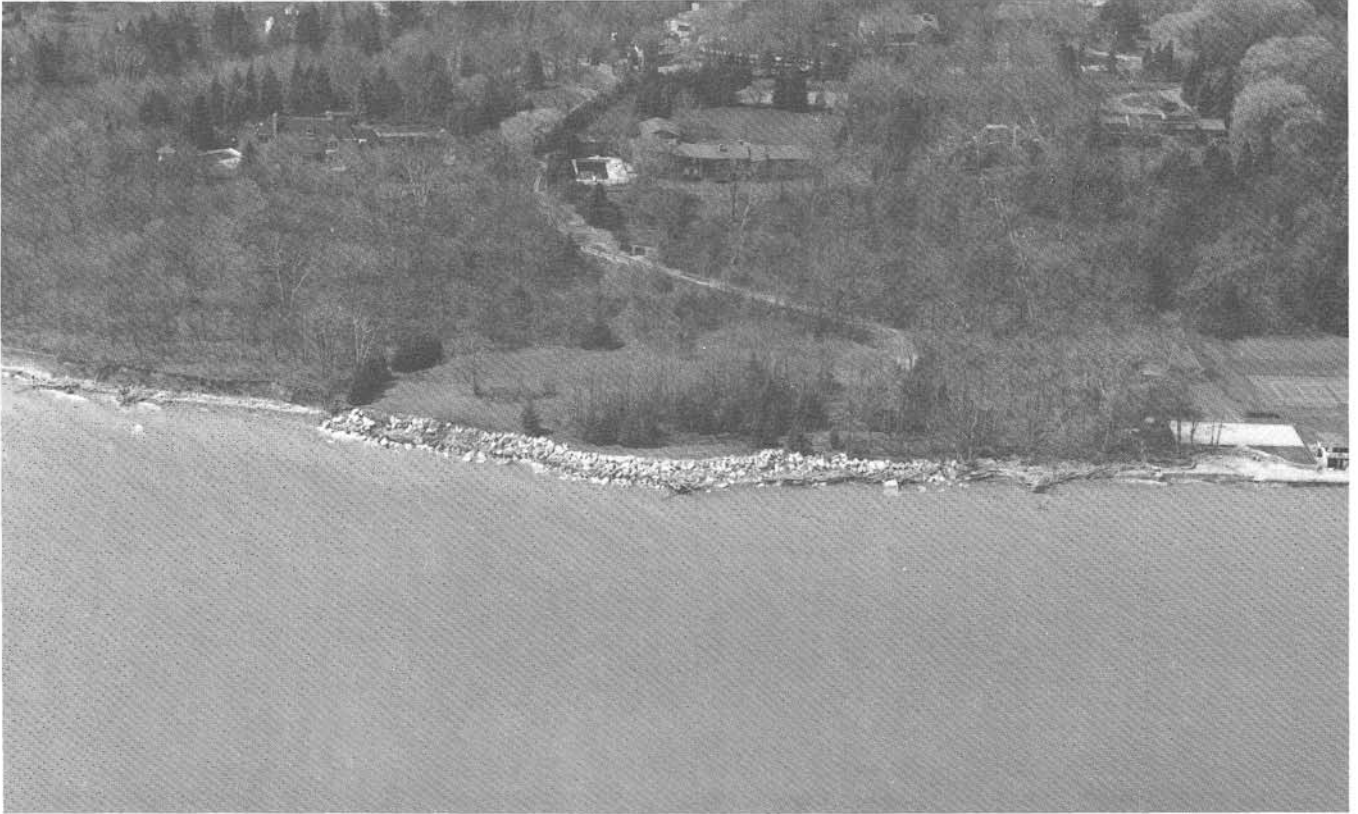
**Figure A-147**

**1476-1434 E. BAY POINT ROAD, VILLAGE OF BAYSIDE**
