# A LAKE MICHIGAN SHORELINE EROSION MANAGEMENT PLAN FOR MILWAUKEE COUNTY WISCONSIN

**SOUTHEASTERN WISCONSIN  
REGIONAL PLANNING COMMISSION**

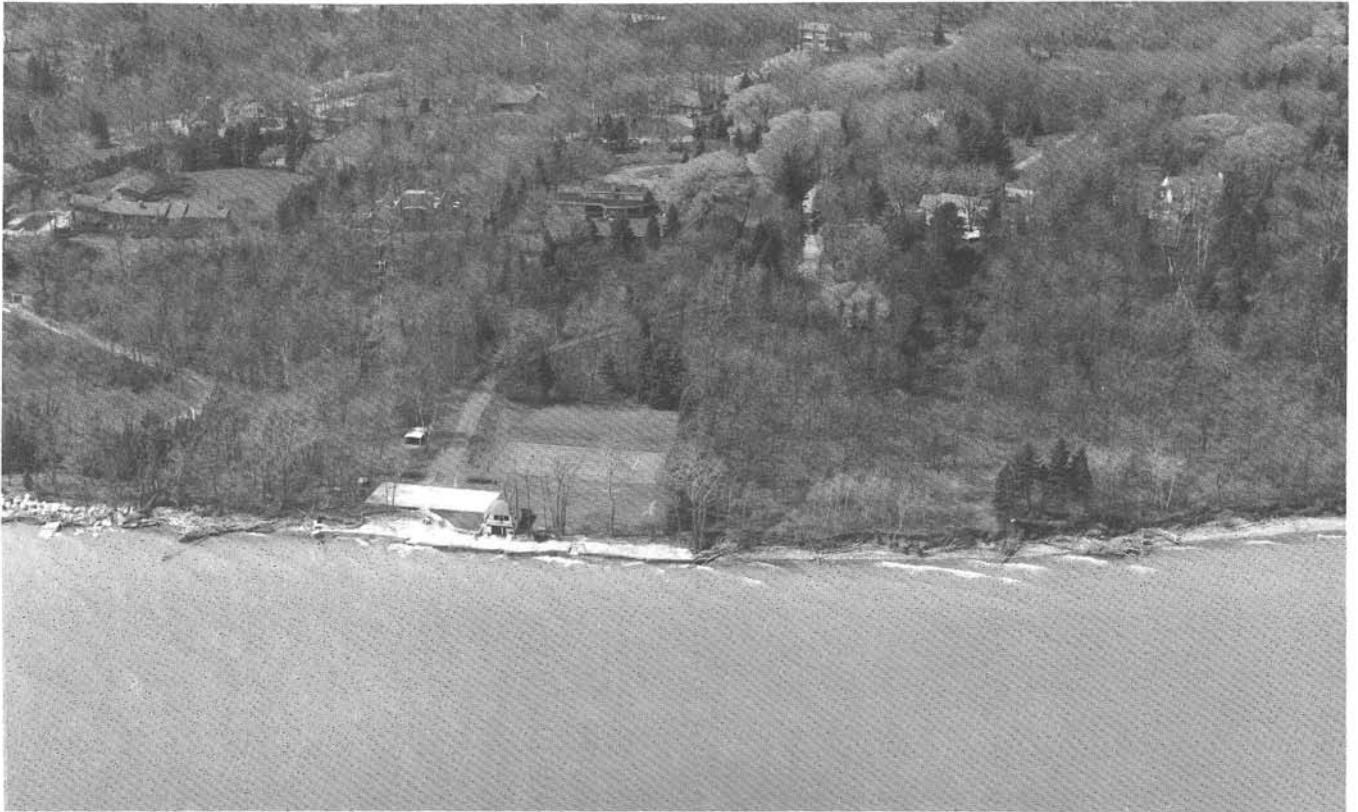
**Figure A-148**

**1470-1400 E. BAY POINT ROAD, VILLAGE OF BAYSIDE**

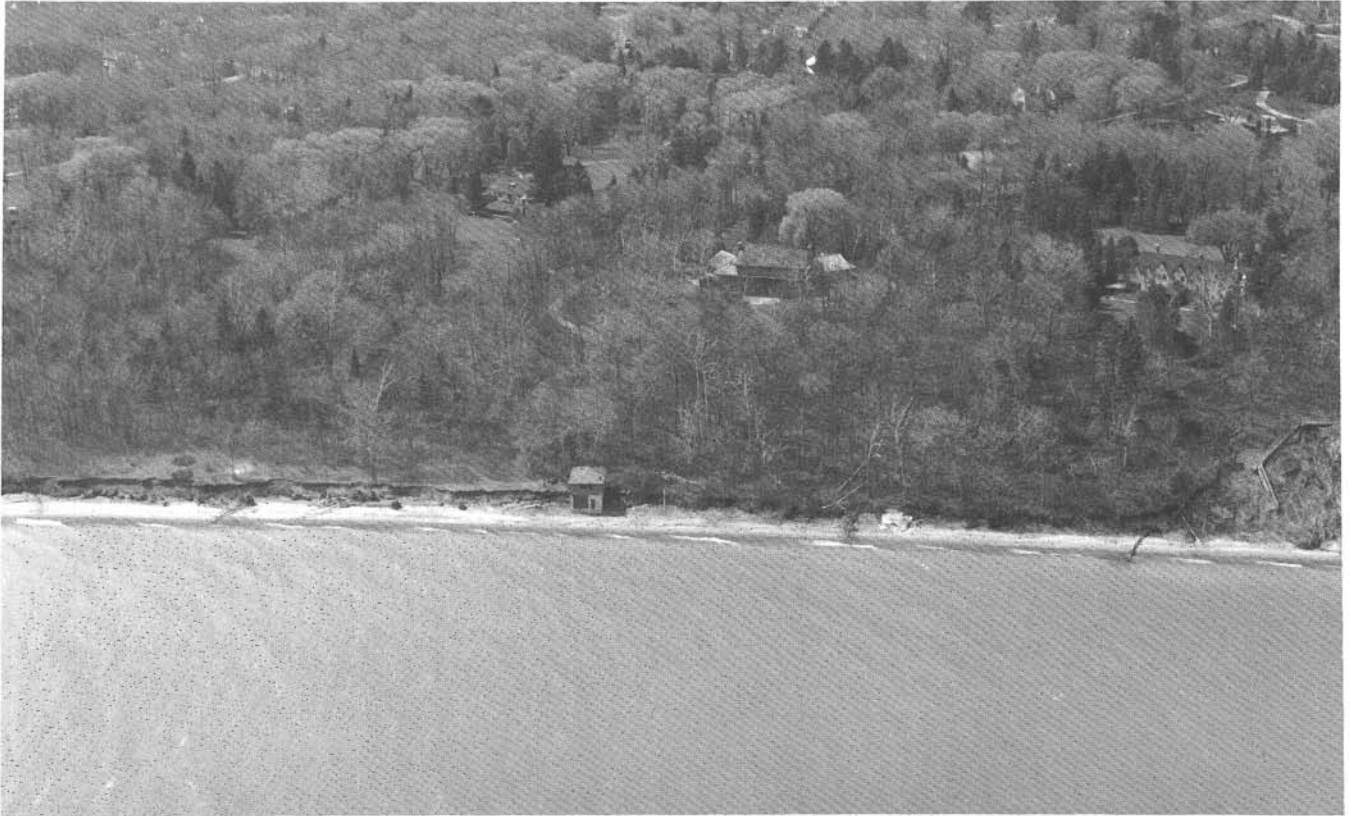
**Figure A-149**

**9364-9400 N. LAKE DRIVE-EXTENDED, VILLAGE OF BAYSIDE**

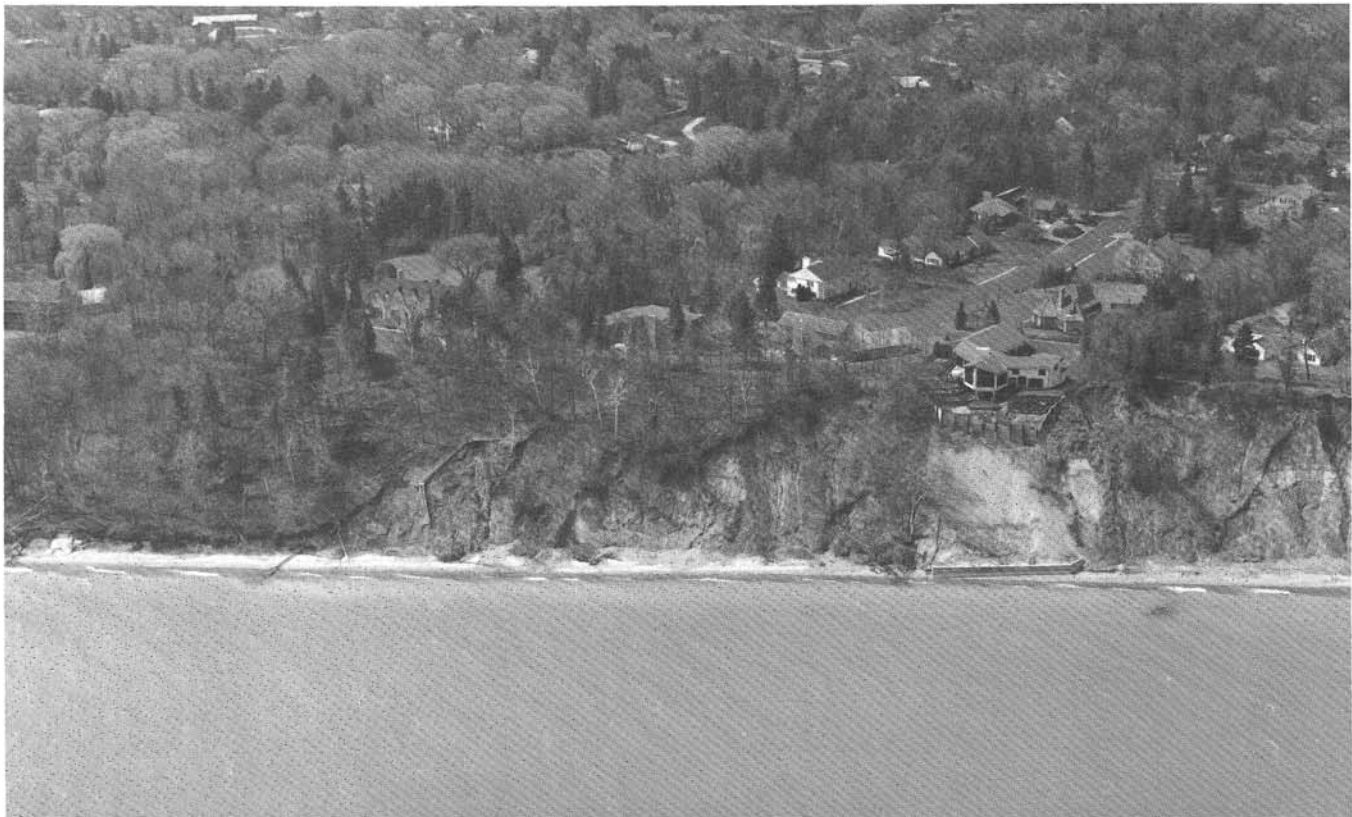
**Figure A-150**

**9364 N. LAKE DRIVE-EXTENDED-9550 N. LAKE DRIVE, VILLAGE OF BAYSIDE**

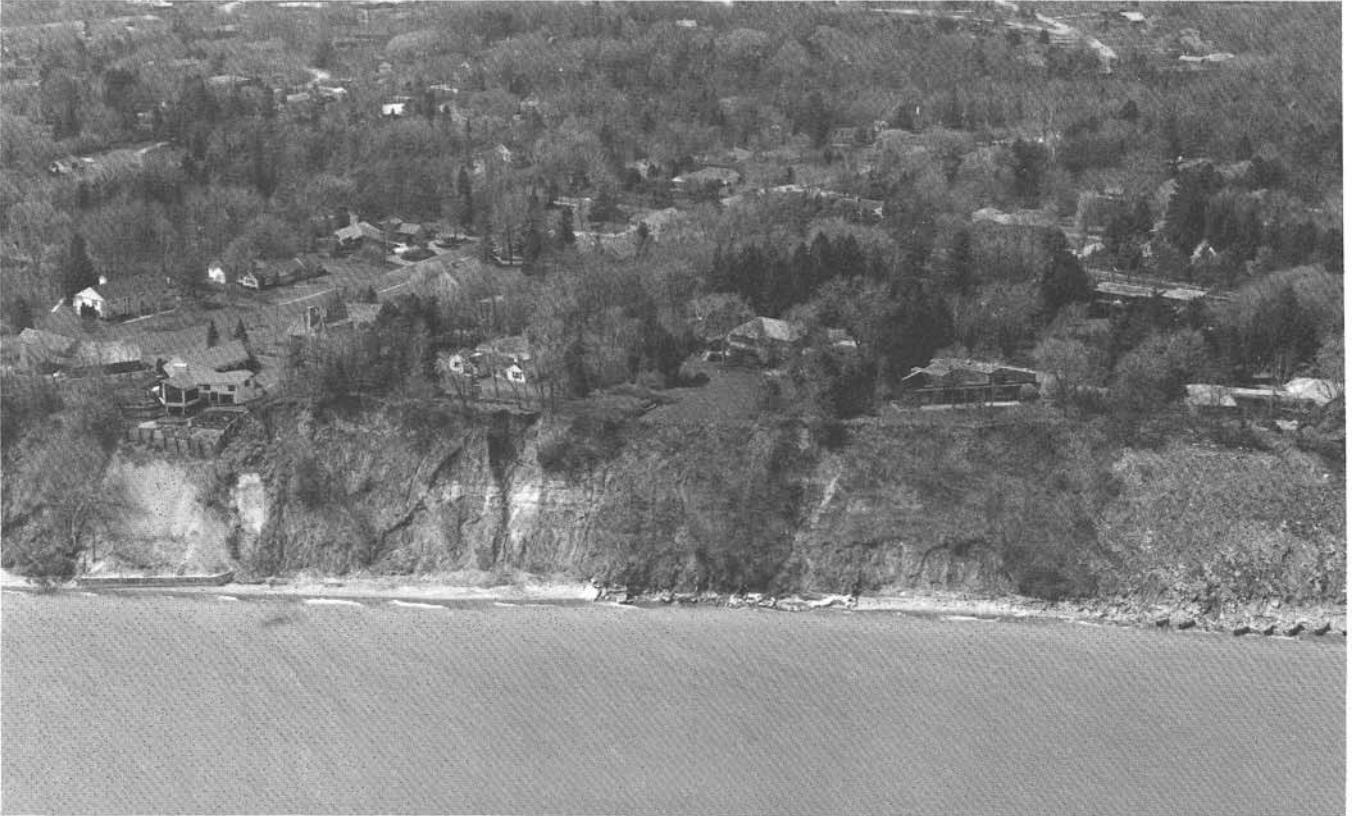
Figure A-151

1260 E. DONGES COURT-9578 N. LAKE DRIVE (COUNTY LINE), VILLAGE OF BAYSIDE
