**TRAFFIC STUDY OF  
THE INTERSECTIONS OF  
N. BERKELEY BOULEVARD  
AND E. SILVER SPRING  
DRIVE AND N. DIVERSEY  
BOULEVARD, N. CONSAUL  
PLACE AND E. SILVER SPRING  
DRIVE IN THE VILLAGE OF  
WHITEFISH BAY**

**MILWAUKEE COUNTY  
WISCONSIN**

**SOUTHEASTERN WISCONSIN  
REGIONAL PLANNING COMMISSION**

**MEMORANDUM REPORT  
NUMBER 118**

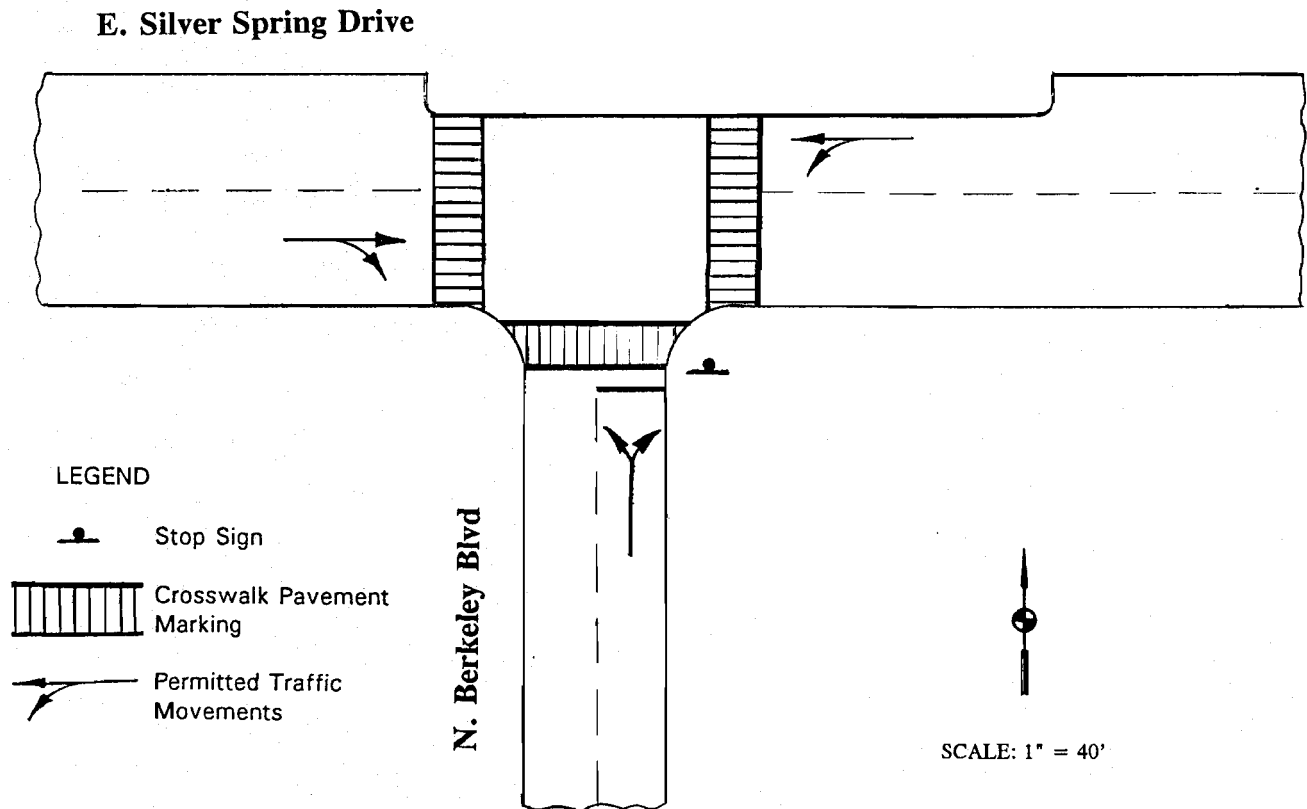
Figure 1

EXISTING N. BERKELEY BLVD AND E. SILVER SPRING DRIVE INTERSECTION: 1996

The intersection of E. Silver Spring Drive and N. Berkeley Boulevard is a "three-legged, tee" intersection as shown on Figure 1. Both intersecting roadways are constructed to urban cross-sections. North Berkeley Boulevard has an existing pavement width of 30 feet from curb face to curb face and a posted speed limit of 25 miles per hour. Parking is allowed on both the east and west sides of N. Berkeley Boulevard but not in the immediate vicinity of the intersection. An alley is located approximately 120 feet south of the intersection on both the east and west sides of the roadway.

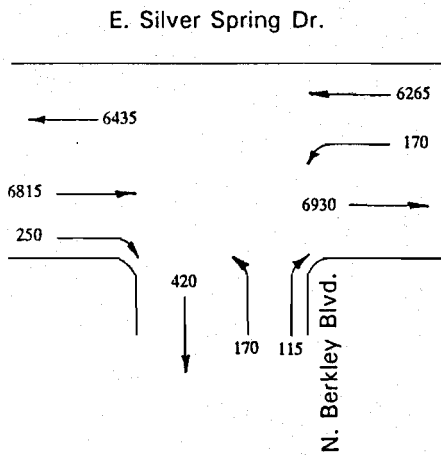
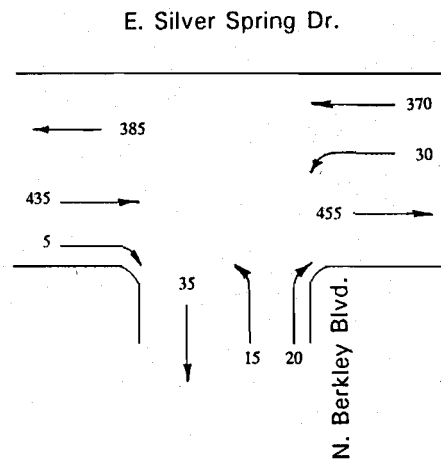
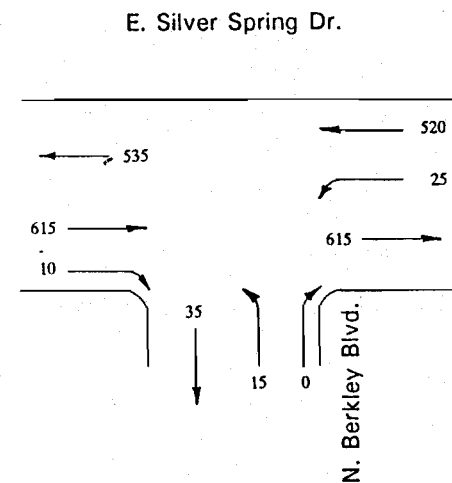
TURNING MOVEMENT TRAFFIC VOLUMES AT  
N. BERKELEY BOULEVARD AND E. SILVER SPRING DRIVE: 1996

In order to evaluate the potential need for traffic control signals at this intersection under current operating conditions, the Commission staff conducted manual turning movement counts and 24 hour machine traffic counts in June, 1996. The manual turning movement volume data was collected from 6:00 a.m. to 6:00 p.m. This time period included both the morning and evening peak hours of traffic flow. Based upon the 24 hour machine traffic counts approximately 13,785 vehicles entered the intersection on an average weekday in 1996. Based upon the 12 hour manual turning movement counts, approximately 10,580 vehicles entered the intersection between 6:00 a.m. and 6:00 p.m. on an average weekday in 1996. The morning and evening peak hour manual turning movement counts are shown on Figure 2 along with the estimated 1996 average weekday turning movement volumes.

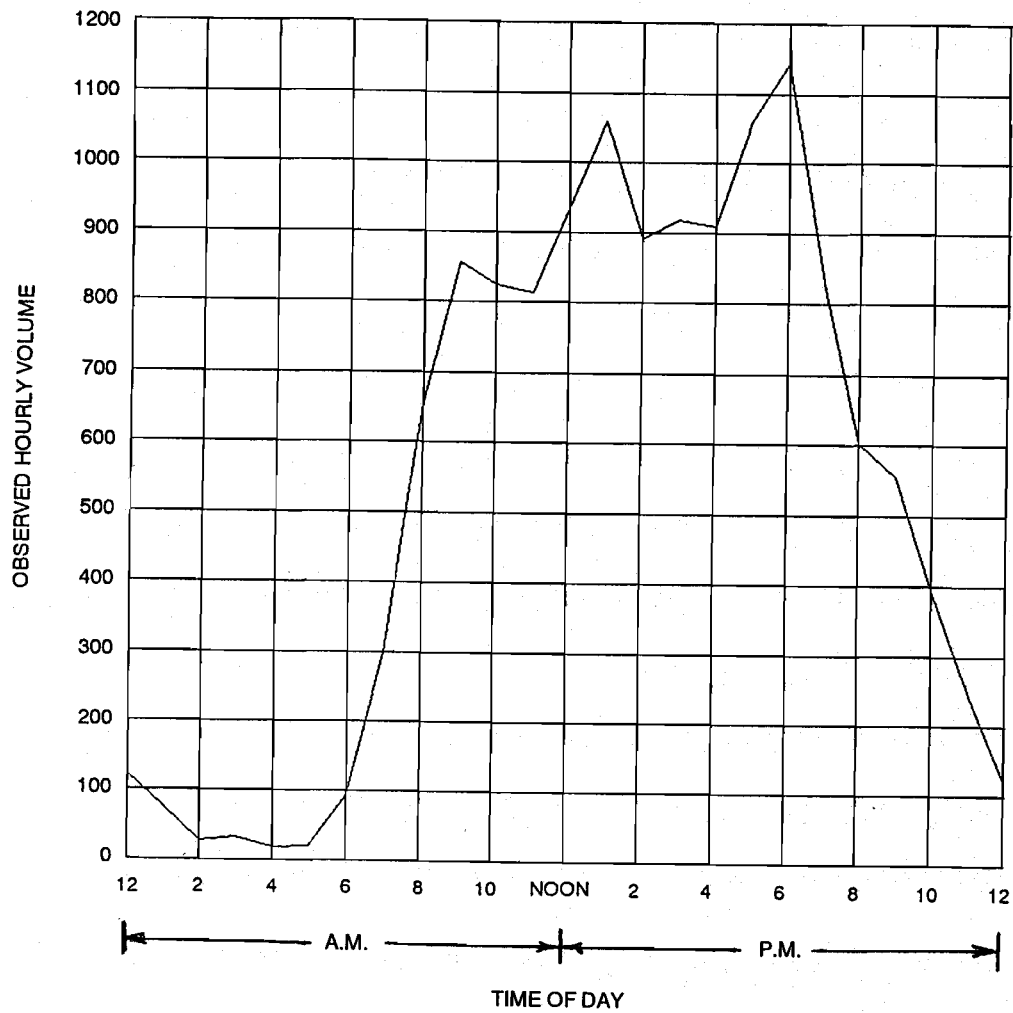
Figure 3

HOURLY VARIATION IN AVERAGE WEEKDAY TRAFFIC  
OBSERVED ON E. SILVER SPRING DRIVE EAST OF  
N. BERKELEY BOULEVARD: JUNE, 1996

The hourly traffic volumes observed during an average weekday on E. Silver Spring Drive between N. Berkeley Boulevard and N. Diversey Boulevard is shown on Figure 3. Unlike many arterials in the Southeastern Wisconsin Region on which traffic typically experiences two very distinct peak hours, one in the morning and one in the evening, there are three peak hours on this segment of E. Silver Spring Drive: morning, midday, and evening peak hours. On an average weekday, traffic on this segment of E. Silver Spring Drive decreases only moderately after the morning peak hour. Traffic then increases significantly to another peak in the midday and then decreases moderately again in the midafternoon before increasing to another peak in the evening peak hour. While commuter traffic is largely responsible for the morning and evening peaks, the midday peak reflects the trip generation characteristics of shopping trips to and from the Village central business district and the Bay Shore Shopping Center.

The hourly traffic volumes observed during an average weekday on E. Silver Spring Drive between N. Berkeley Boulevard and N. Diversey Boulevard, as previously noted, is shown on Figure 3. As previously mentioned, unlike many arterials in the Southeastern Wisconsin Region on which traffic typically experiences two very distinct peak hours, one in the morning and one in the evening, there are three peak hours on this segment of E. Silver Spring Drive: morning, midday and evening peak hours. On an average weekday, traffic on this segment of E. Silver Spring Drive decreases only moderately after the morning peak hour. Traffic then increases significantly to another peak in the midday and then decreases moderately again in the midafternoon before increasing to another peak in the evening peak hour. While commuter traffic is largely responsible for the morning and evening peaks, the midday peak reflects the trip generation characteristics of shopping trips to and from the Village central business district and the Bay Shore Shopping Center.

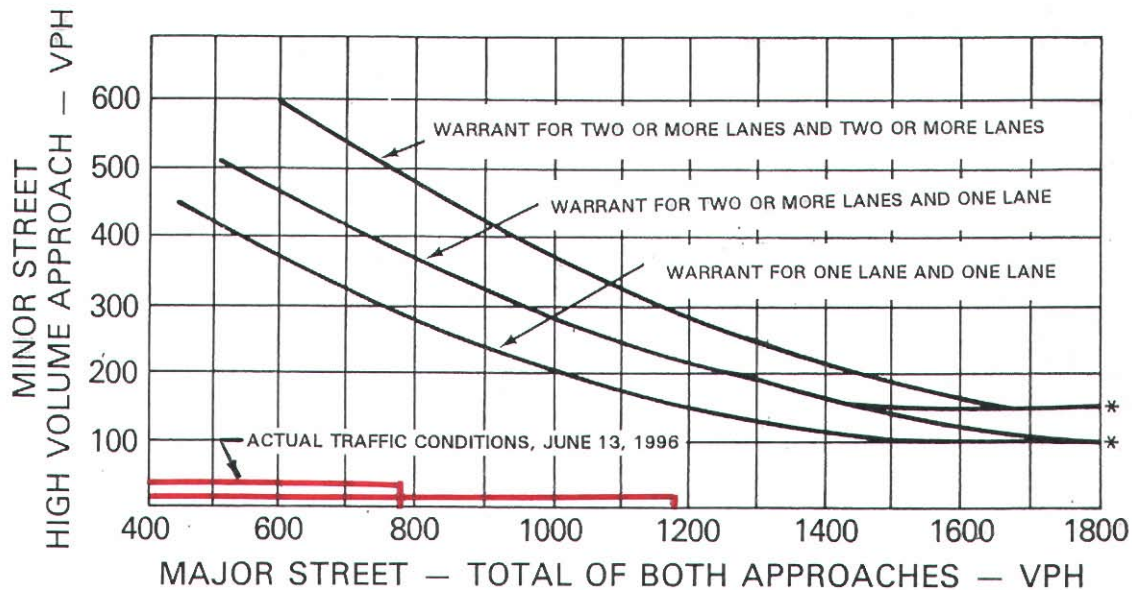
Figure 4

PEAK HOUR VOLUME WARRANT ANALYSIS OF THE INTERSECTION OF  
N. BERKELEY BLVD and E. SILVER SPRING DRIVE IN THE VILLAGE OF WHITEFISH BAY

The third warrant considered--the peak hour volume warrant--is satisfied when the number of vehicles per hour on E. Silver Spring Drive--measured as the total on both approaches--and the corresponding vehicles per hour on N. Berkeley Boulevard for any one hour--or any four consecutive 15-minute periods--of an average day are above the applicable curve on Figure 4. As shown on Figure 4, this warrant is not met, as the point of intersection of the corresponding traffic volumes falls below the single lane/single lane warrant curve in both of the morning and evening peak hours.

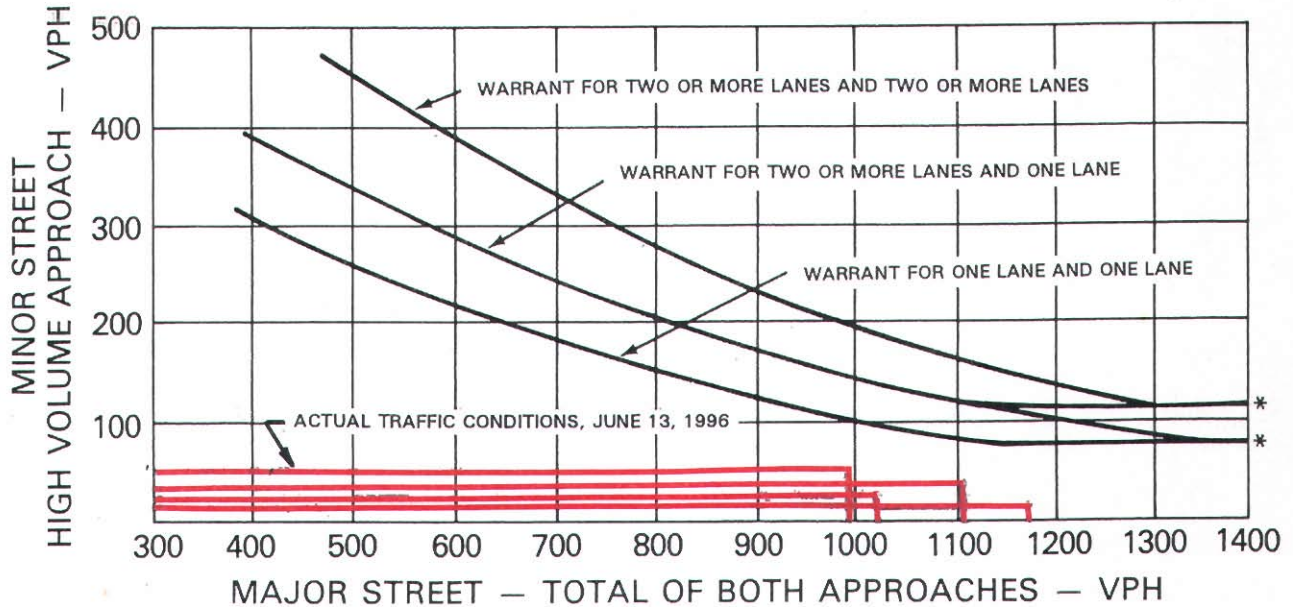
FOUR HOUR VOLUME WARRANT ANALYSIS OF THE INTERSECTION OF  
N. BERKELEY BLVD AND E. SILVER SPRING DRIVE IN THE VILLAGE OF WHITEFISH BAY

The fourth warrant considered--the four hour volume warrant--is satisfied when during each of any four hours of an average day, the number of vehicles per hour on E. Silver Spring Drive--measured as the total on both approaches--and the corresponding number of vehicles per hour on the N. Berkeley Boulevard approach are all above the curve on Figure 5 for the existing combination of approach lanes. As shown on Figure 5 this warrant is not met, as the point of intersection

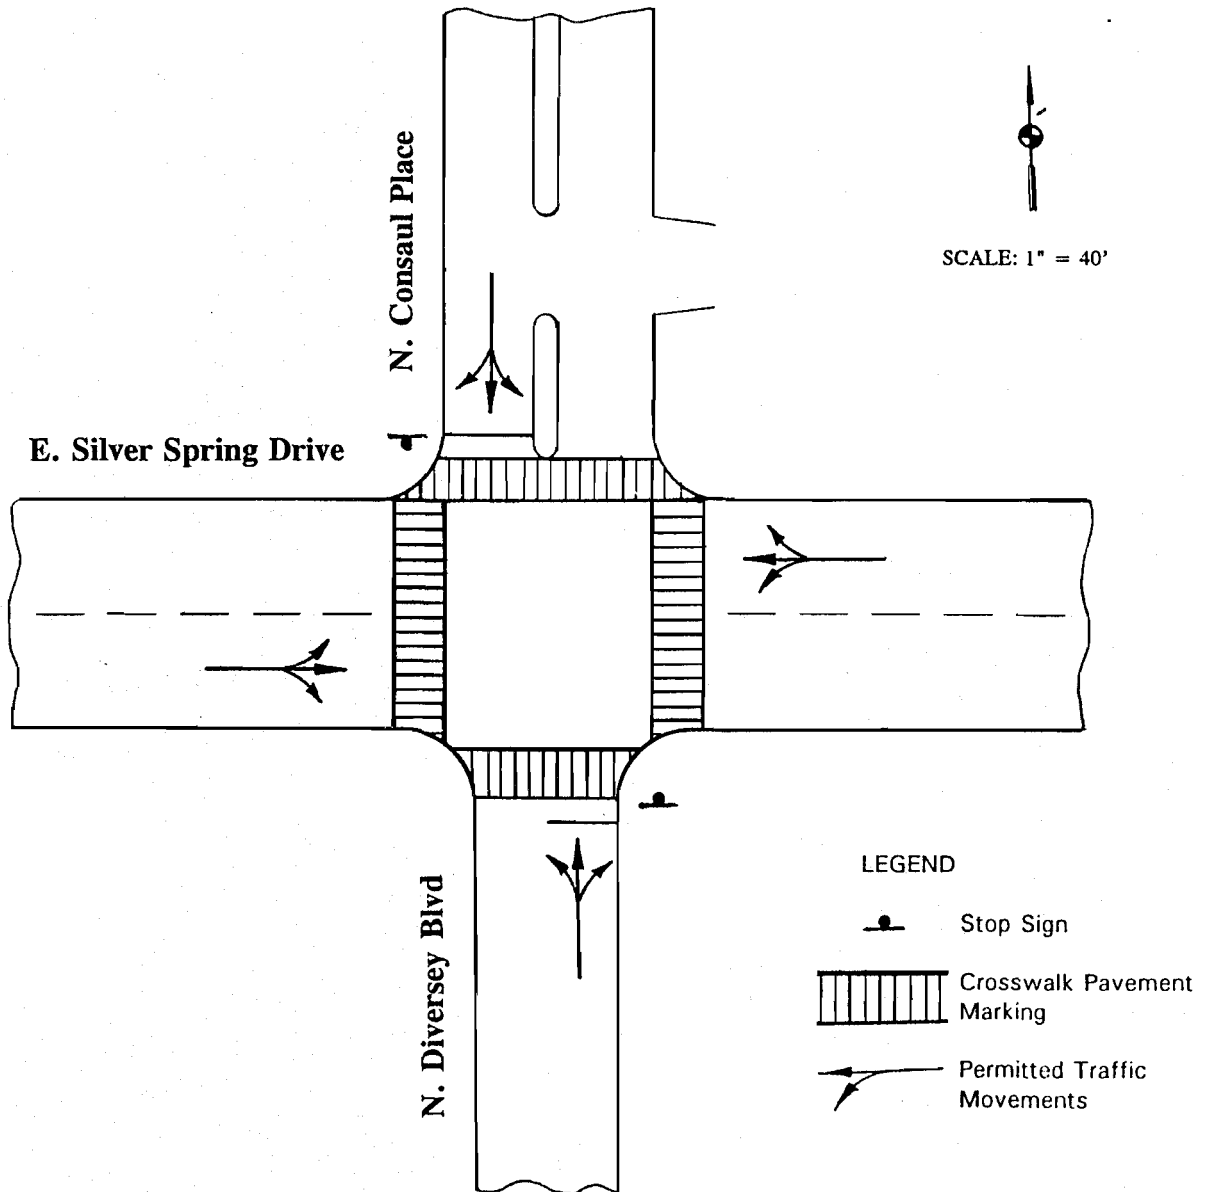
Figure 6

EXISTING E. SILVER SPRING DRIVE INTERSECTION WITH  
N. CONSAUL PLACE AND N. DIVERSEY BOULEVARD: 1996

The intersection of E. Silver Spring Drive, N. Diversey Boulevard, and N. Consaul Place is a "four-legged" intersection as shown on Figure 6. Both intersecting roadways are constructed to urban cross-sections. North Consaul Place has a posted speed limit of 25 miles per hour and twin 20 foot wide pavements separated by a four foot wide concrete median. No parking is allowed on the east side of N. Consaul Place; however, parking is permitted on the west side of N. Consaul Place, beginning about 40 feet north of the stop line, and ending approximately 100 feet north. An alley and a driveway are located approximately 160 feet and 50 feet north of the intersection, respectively, on the east side of N. Consaul

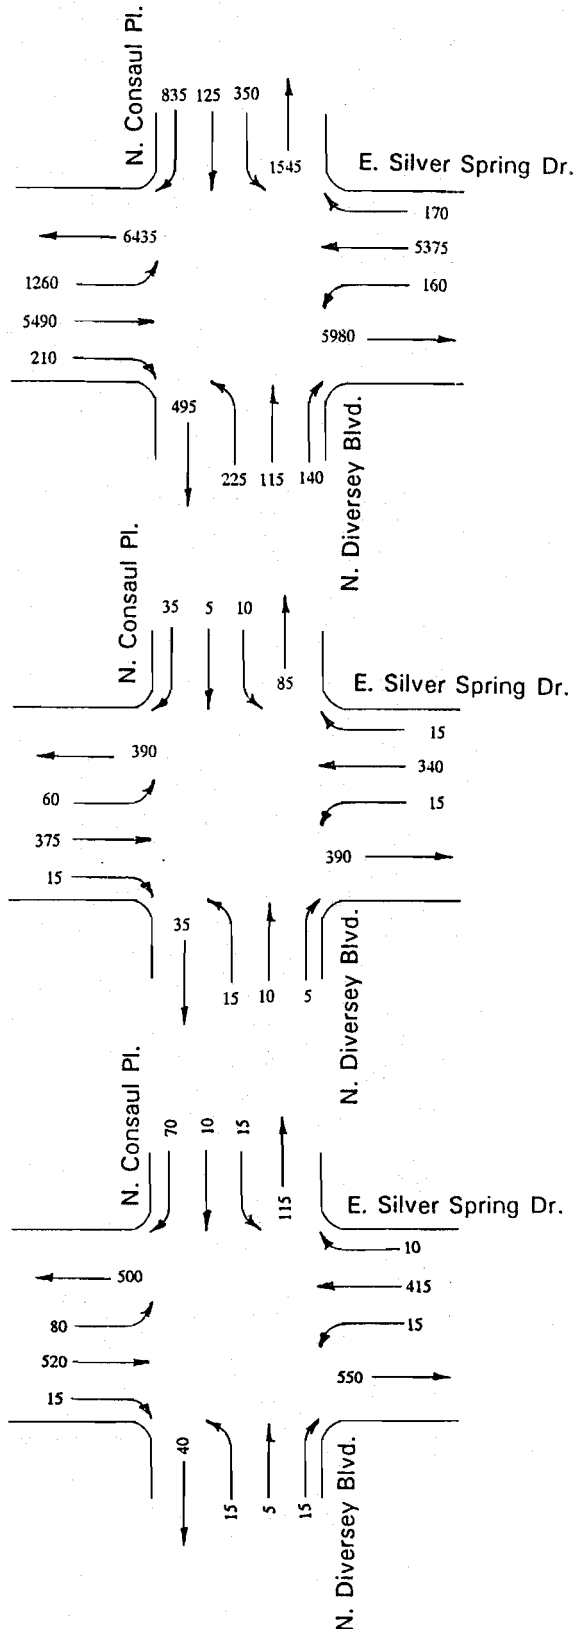
TURNING MOVEMENT TRAFFIC VOLUMES AT THE E. SILVER SPRING DRIVE  
INTERSECTION WITH N. CONSAUL PLACE AND N. DIVERSEY BOULEVARD: 1996

1996 Estimated Average Weekday  
Turning Movement Volumes

1996 Morning Peak Hour  
Turning Movement Volumes  
8:00 a.m. to 9:00 a.m.

In order to evaluate the potential need for traffic control signals at this intersection under current operating conditions, the Commission staff conducted manual turning movement counts and 24 hour machine traffic counts in June, 1996. The manual turning movement volume data was collected from 6:00 a.m. to 6:00 p.m. This time period included both the morning and evening peak hours of traffic flow. Based upon the 24 hour machine traffic counts approximately 14,455 vehicles entered the intersection on an average weekday in 1996. Based upon the 12 hour manual turning movement counts, approximately 10,810 vehicles entered the intersection between 6:00 a.m. and 6:00 p.m. on an average weekday in 1996. The morning and evening peak hour manual turning movement counts are shown on Figure 7 along with the estimated 1996 average weekday turning movement volumes.

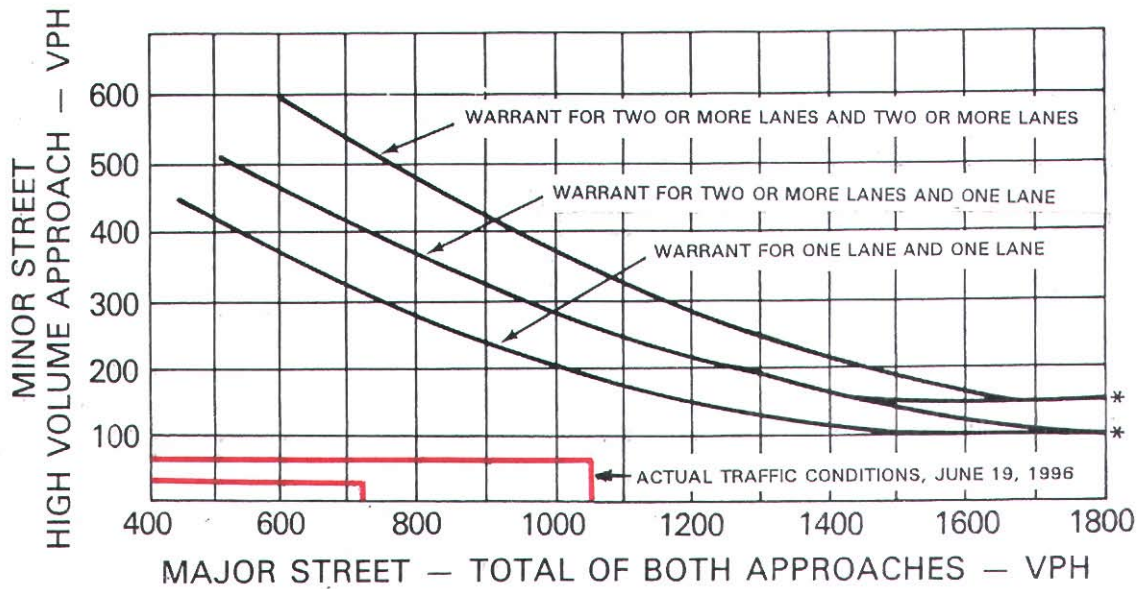
Figure 8

PEAK HOUR VOLUME WARRANT ANALYSIS OF THE INTERSECTION OF N. DIVERSEY BLVD, N. CONSAUL PLACE AND E. SILVER SPRING DRIVE IN THE VILLAGE OF WHITEFISH BAY

The third warrant considered--the peak hour volume warrant--is satisfied when the number of vehicles per hour on E. Silver Spring Drive--measured as the total on both approaches--and the corresponding vehicles per hour on either the N. Diversey Boulevard or the N. Consaul Place approach for any one hour--or any four consecutive 15-minute periods--of an average day are above the applicable curve on Figure 8. As shown on Figure 8, this warrant is not met, as the point of

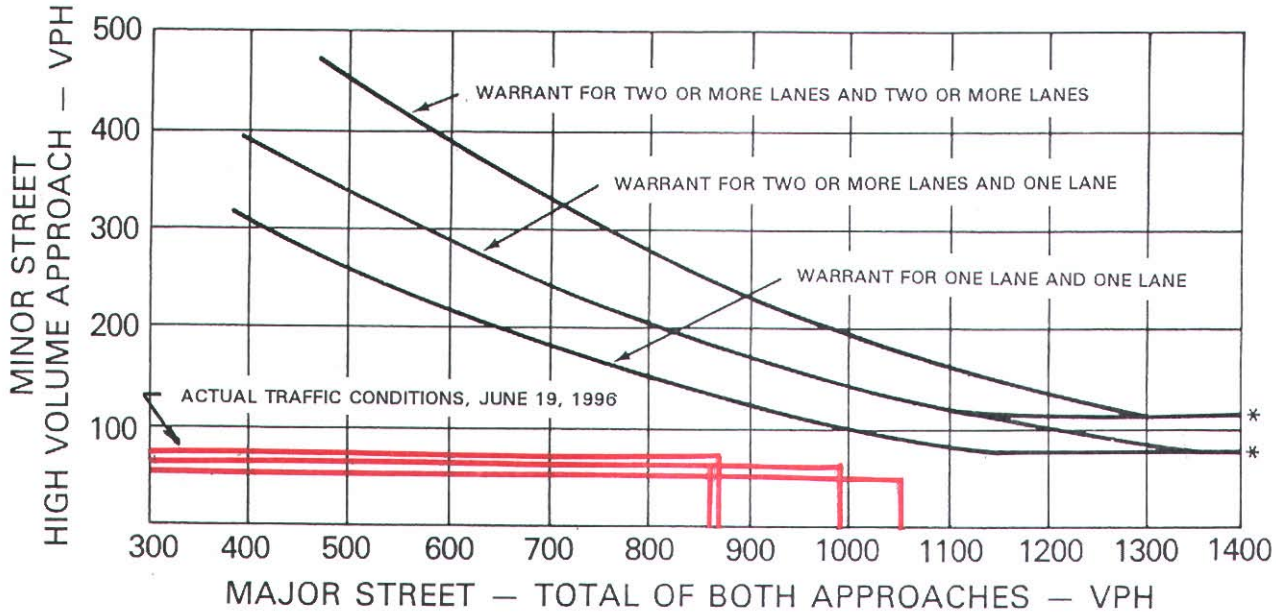
FOUR HOUR VOLUME WARRANT ANALYSIS OF THE INTERSECTION OF N. DIVERSEY BLVD, N. CONSAUL PLACE AND E. SILVER SPRING DRIVE IN THE VILLAGE OF WHITEFISH BAY

The fourth warrant considered--the four hour volume warrant--is satisfied when during each of any four hours of an average day, the number of vehicles per hour on E. Silver Spring Drive--measured as the total on both approaches--and the corresponding number of vehicles per hour on either the N. Diversey Boulevard or the N. Consaul Place approach are all above the curve on Figure 9 for the existing combination of approach lanes. As shown on Figure 9, this warrant is not met, as the point of intersection of the corresponding traffic volumes for each of four hours falls below the single lane/single lane warrant curve in each of the four highest hours.
