Community Assistance Planning Report No. 330

A RESTORATION PLAN FOR THE OAK CREEK WATERSHED

Chapter 6

6.6 ALTERNATIVES AND RECOMMENDED ACTIONS FOR THE MILL POND AND MILL POND DAM

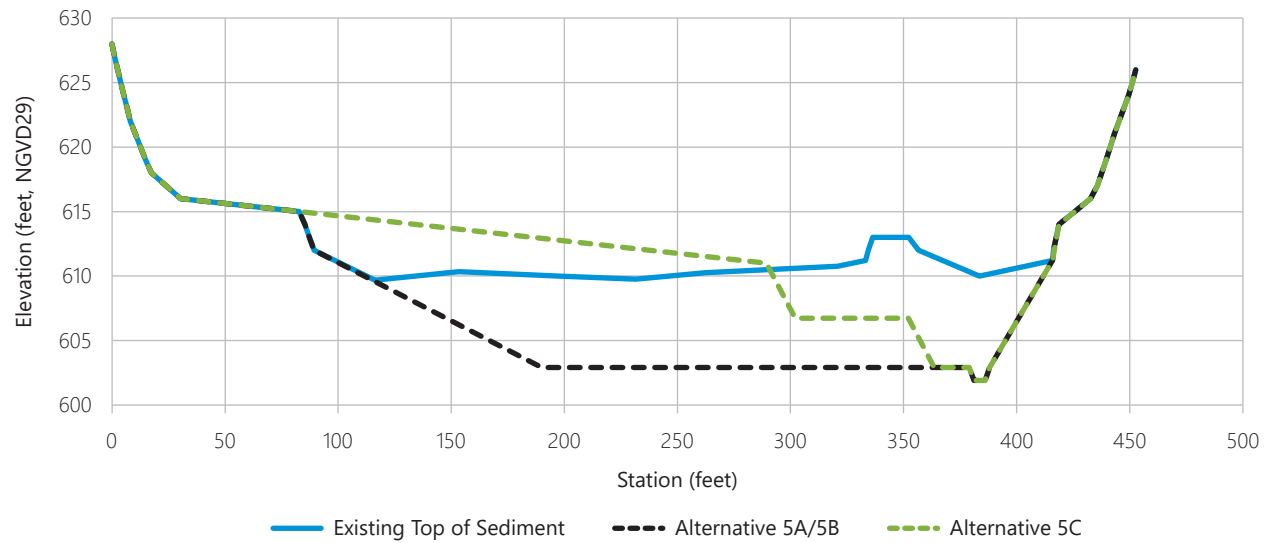
Figure 6.Mill-XS
Conceptual Cross Section for Alternative 5 Options^a

^a This figure represents the conceptual cross sections for Alternatives 5A/5B and 5C as compared to the existing top of sediment in the Mill Pond. The figure orientation is looking downstream, or to the southeast. The location of the example cross section is shown on Figure 6.Mill-Alt5AB and Figure 6.Mill-Alt5C.
