MEMORANDUM REPORT NUMBER 113

TRAFFIC STUDY OF THE INTERSECTION OF N. PORT WASHINGTON ROAD (CTH W) AND W. HIGHLAND ROAD FOR THE CITY OF MEQUON: JUNE 1995, FOLLOWING OPENING OF ST. MARY'S HOSPITAL

CITY OF MEQUON OZAUKEE COUNTY, WISCONSIN

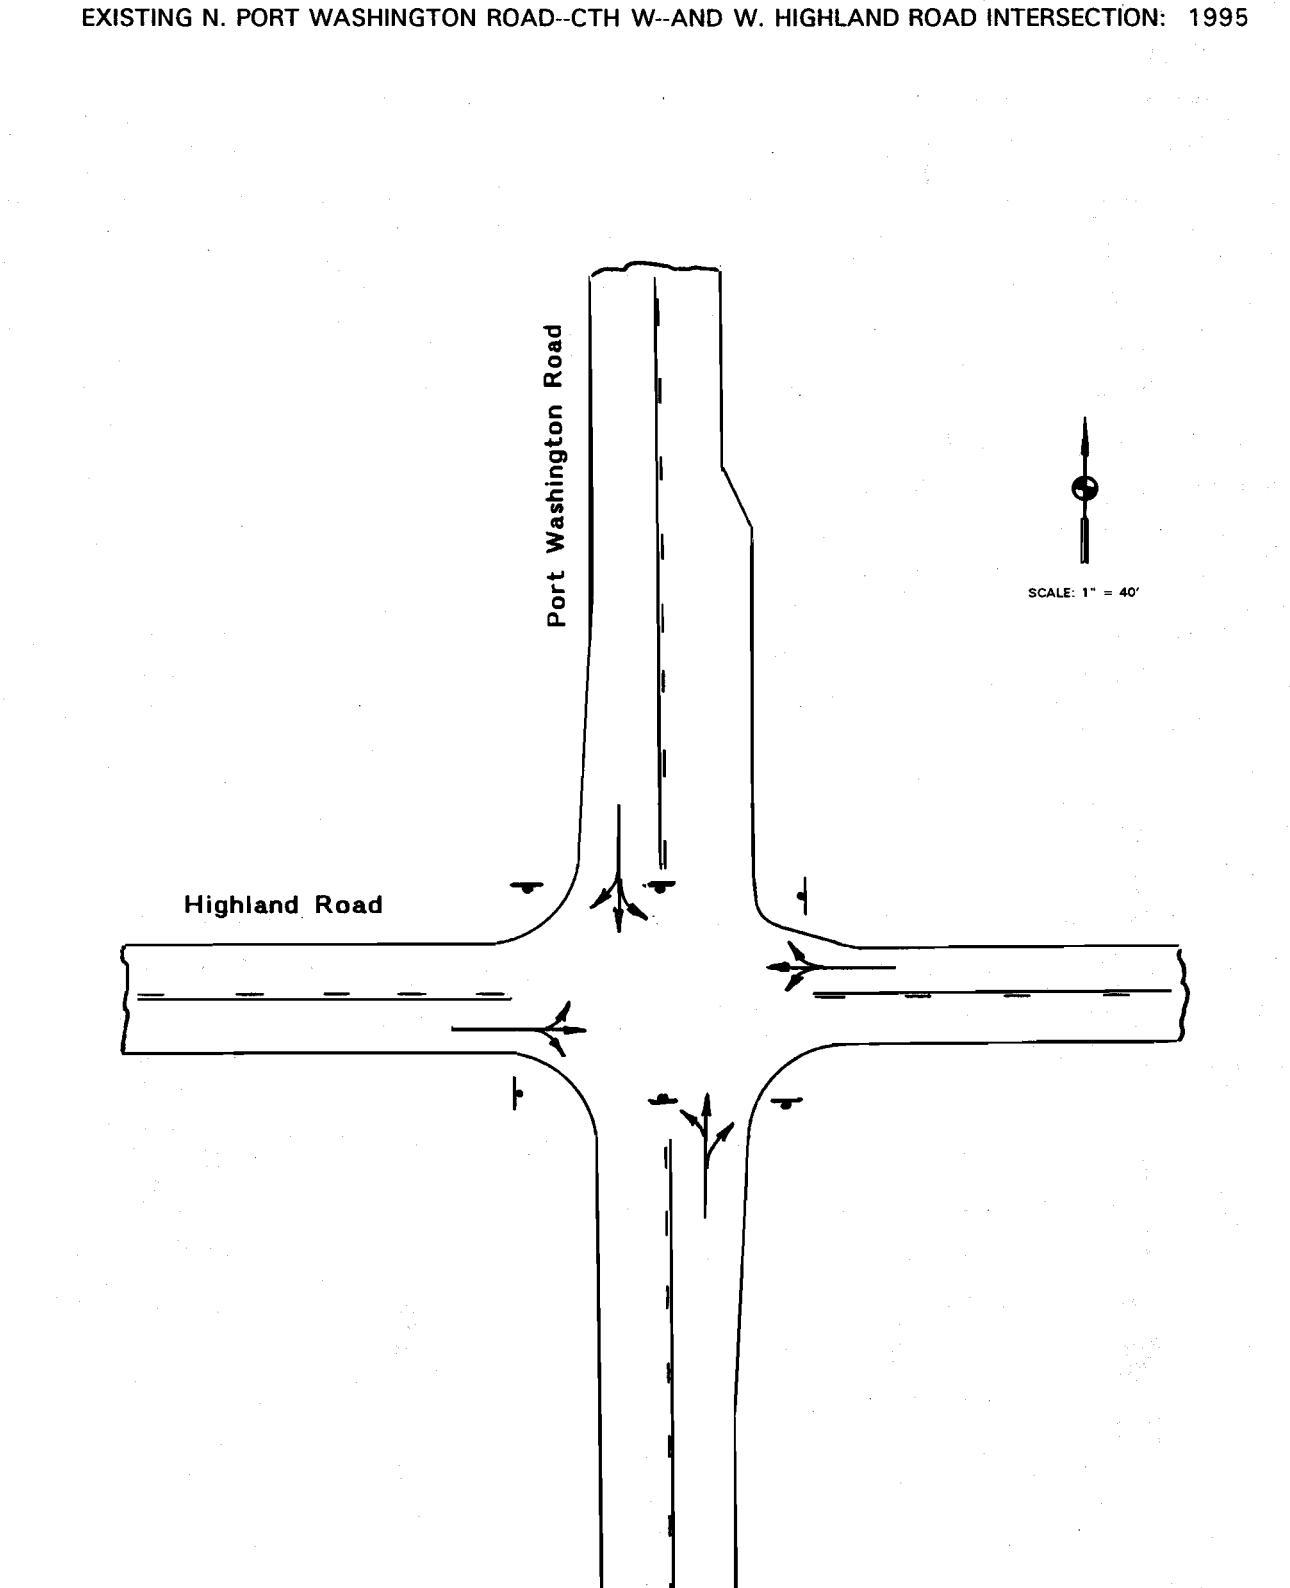
Figure 1

West Highland Road, east of N. Port Washington Road has an existing pavement width of 22 feet with 5 foot gravel shoulders and a posted speed of 35 miles per hour. There are no commercial or private driveways on W. Highland Road between N. Port Washington Road and IH 43. The configuration of the existing intersection is shown in Figure 1.

The intersection of N. Port Washington Road (CTH W) and W. Highland Road is a "four-legged" intersection. Both intersecting roadways are constructed to rural cross-sections. N. Port Washington Road north of W. Highland Road has an existing pavement width of 30 feet with 7 foot gravel shoulders and a posted speed limit of 45 miles per hour. A commercial driveway entrance is located approximately 170 feet north of the intersection on the east side of the roadway. The shoulder adjacent to the southbound lane has been paved to accommodate southbound vehicles making right turns onto W. Highland Road, and the shoulder adjacent to the northbound lane has been paved to accommodate westbound vehicles on W. Highland Road which turn right onto N. Port Washington Road.

North Port Washington Road south of W. Highland Road has an existing pavement width of 30 feet with 8 foot gravel shoulders and a posted speed limit of 45 miles per hour. A commercial driveway entrance is located approximately 225 feet south of the intersection on the west side of the roadway. The shoulder adjacent to the northbound lane has been paved to accommodate northbound vehicles making right turns onto W. Highland Road.

West Highland Road, west of N. Port Washington Road has an existing pavement width of 25 feet with 3 foot gravel shoulders and a posted speed of 35 miles per hour. A commercial driveway entrance is located approximately 95 feet west of the intersection on the south side of the roadway and a private driveway located approximately 125 feet west of the intersection on the north side of the roadway.

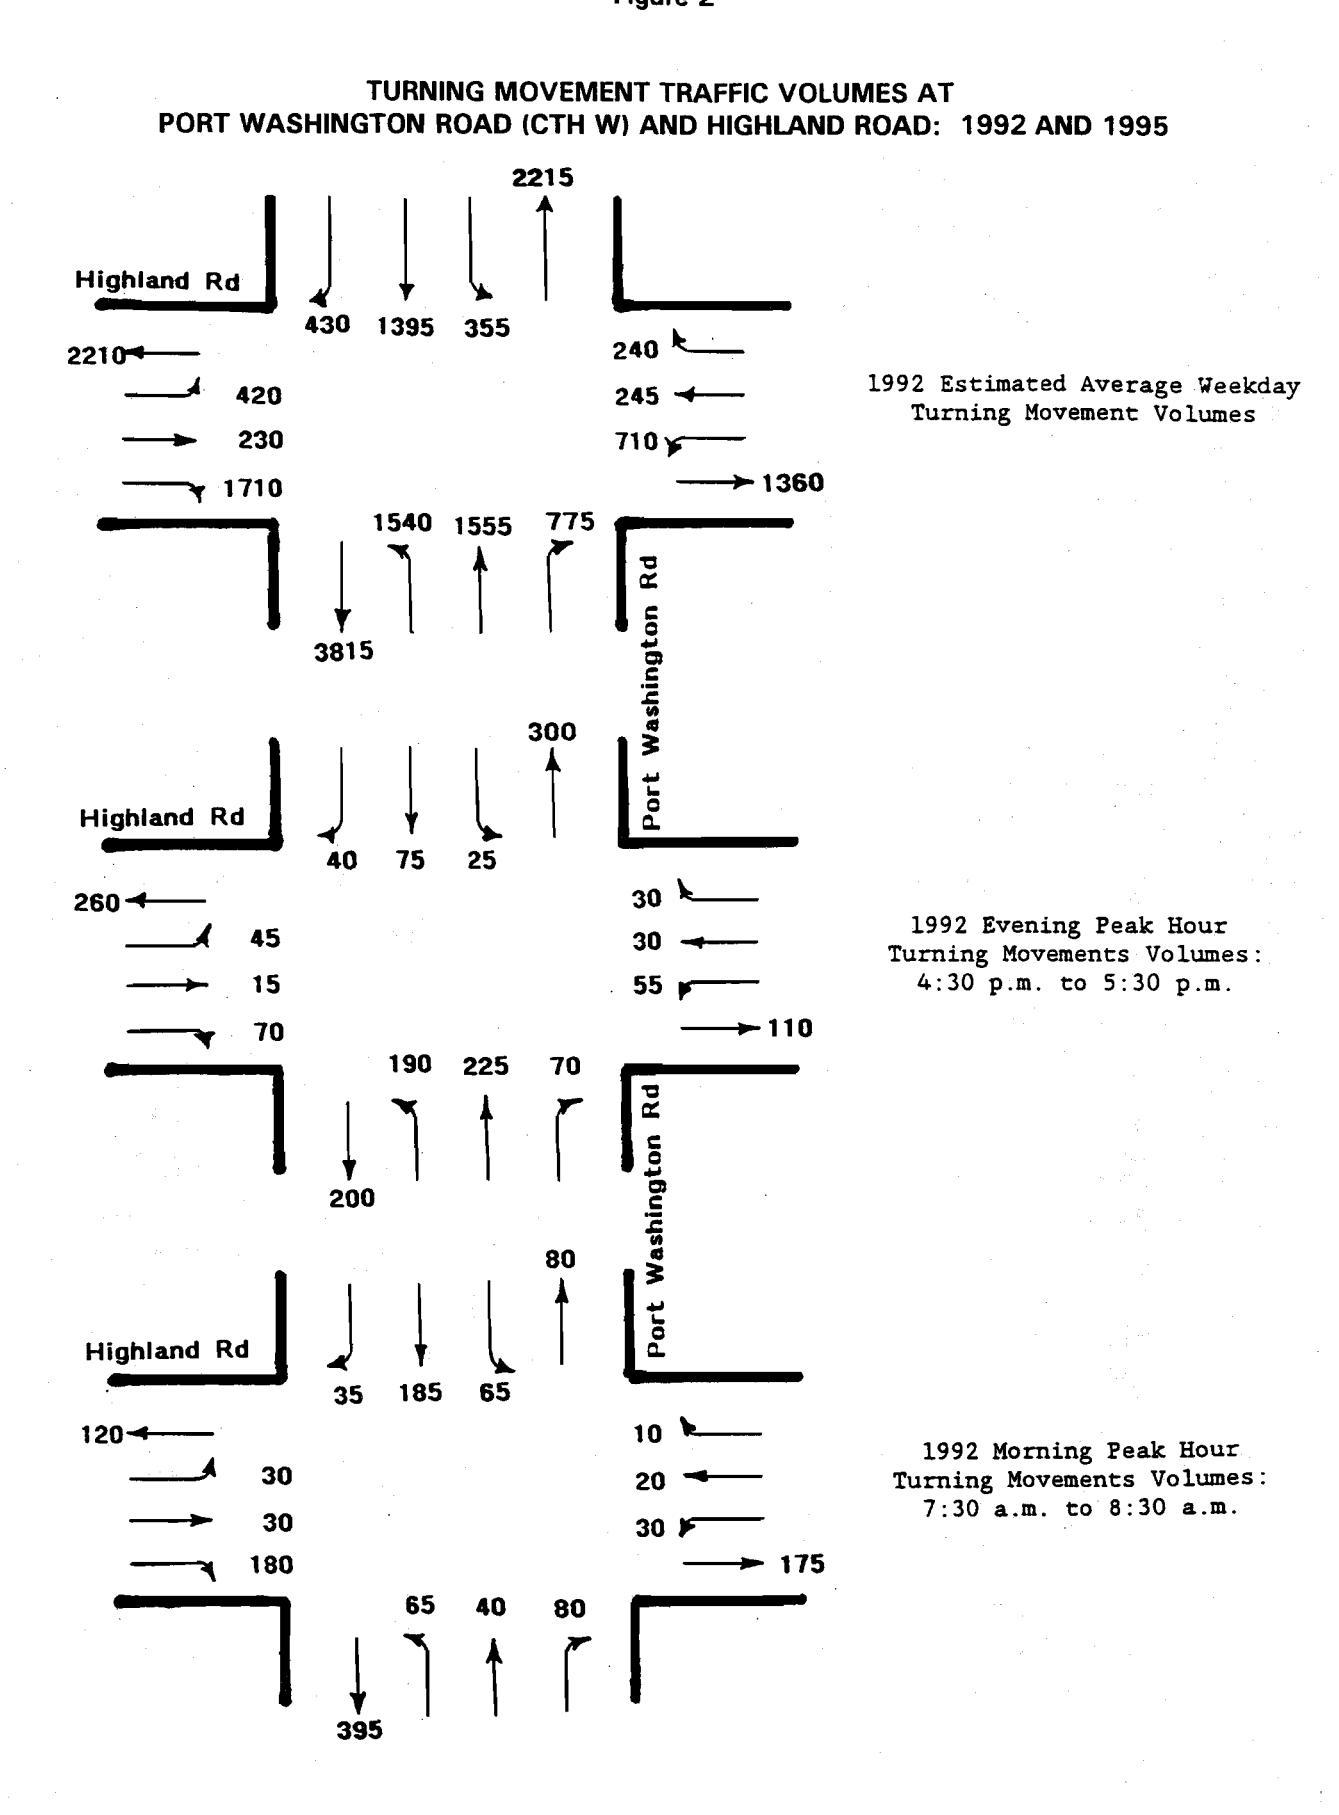
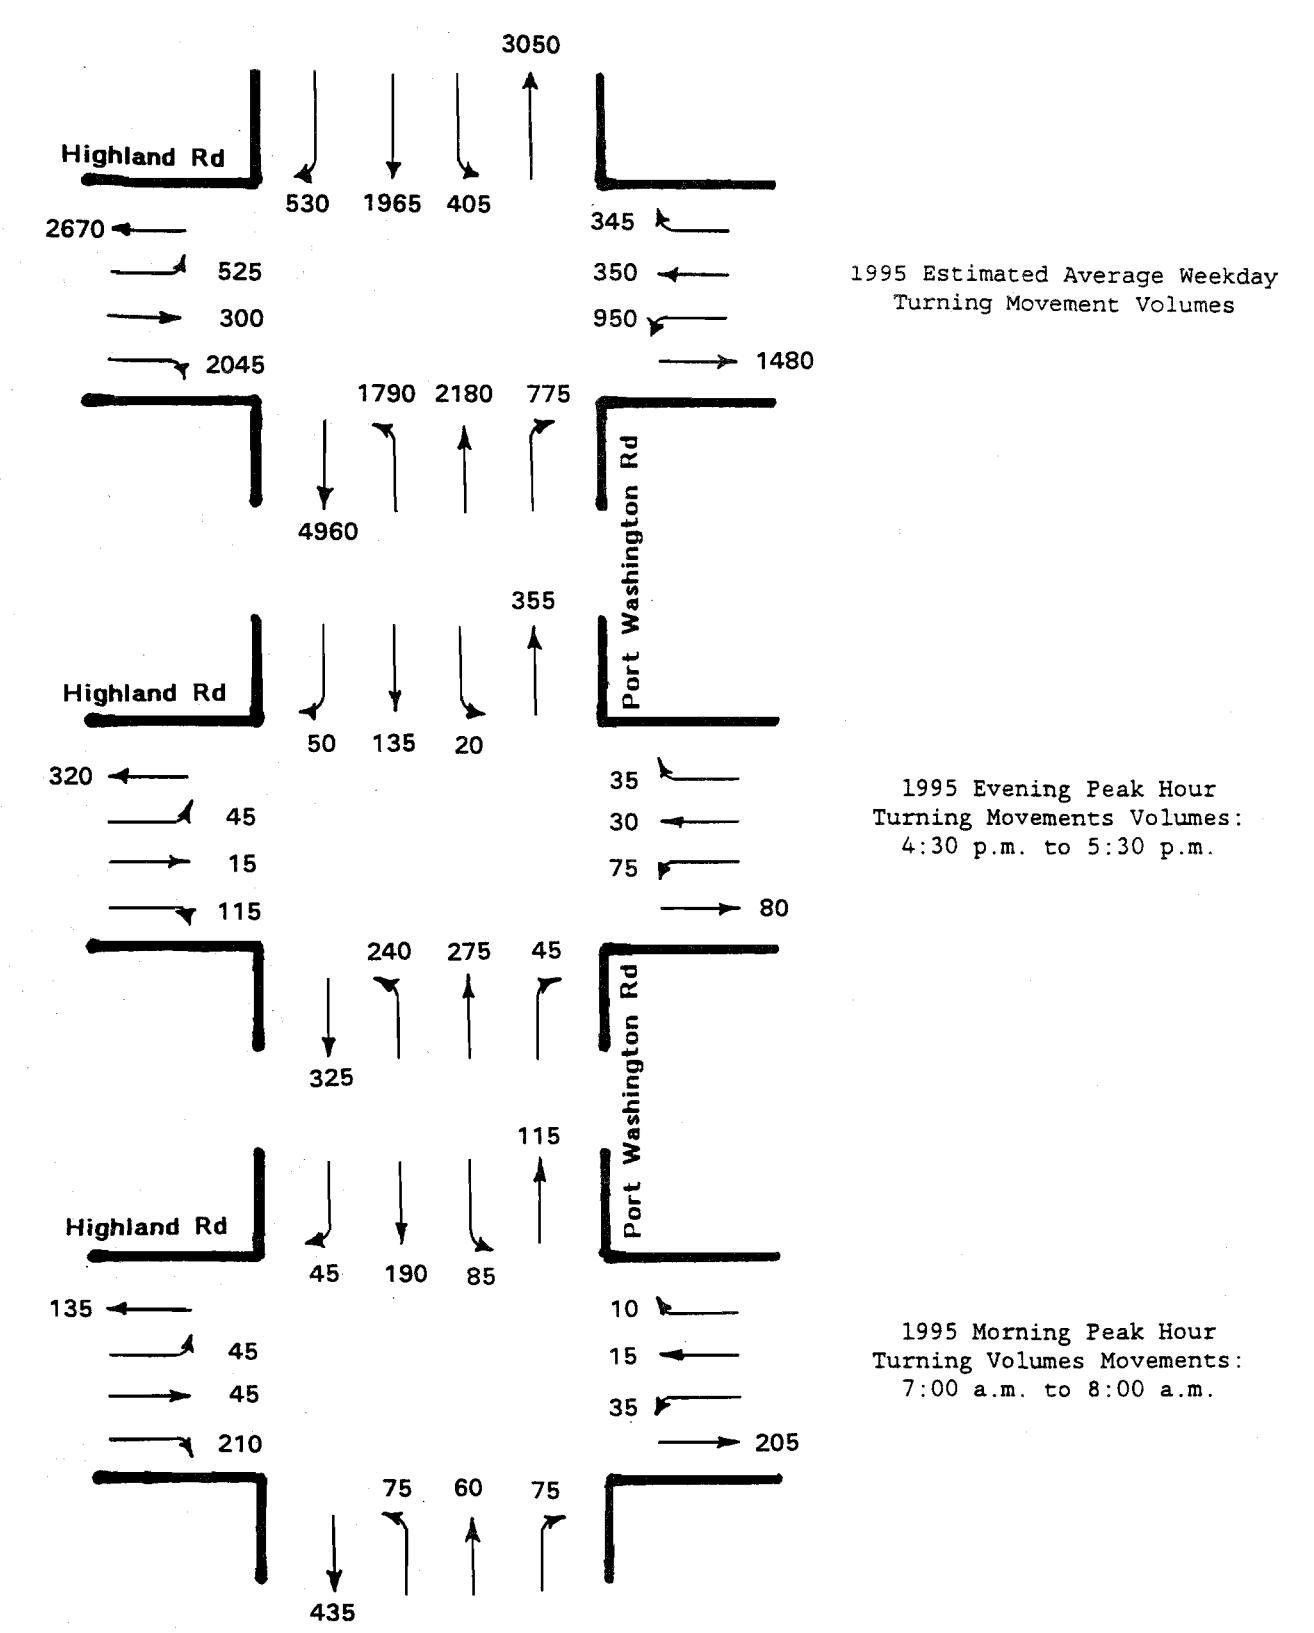
Figure 2 (continued)

March, and May and June of 1995, respectively. As in 1992, data were collected from 6:00 a.m. to 6:00 p.m. This time period included both the morning and evening peak hours of traffic flow. For comparative purposes both the 1992 and the 1995 morning and evening peak hour manual turning movement counts are shown in Figure 2 along with the estimated 1992 and 1995 average weekday turning movement volumes.

Based upon the 24-hour machine traffic counts, approximately 9,650 vehicles entered the intersection on an average weekday in 1992. By 1995, approximately 12,160 vehicles entered the intersection on an average weekday, an increase of about 26 percent compared to 1992. Based upon the 12-hour manual turning movement counts, the number of vehicles entering the intersection between 6:00 a.m. and 6:00 p.m. was 6,610 in 1992. This number had increased to approximately 9,350 in 1995, or by about 41 percent.

The 1995 manual turning movement count data indicated that turning movements accounted for about 60 percent of all movements at this intersection between 6:00 a.m. to 6:00 p.m. During the morning peak hour, more than 63 percent of all vehicles were observed turning with the north- and southbound left-turn at 75 and 85 vehicles, respectively. The eastbound right-turn represented the highest turning movement observed during the morning peak hour at 210 vehicles. During the afternoon peak hour, more than 59 percent of all vehicles were observed turning with the north- and southbound left-turn at 260 and 25 vehicles, respectively. The northbound left-turn represented the highest turning movement observed during the evening peak hour. Finally, it may be noted that the number of vehicles turning left from the northbound approach exceeded 100 vehicles per hour six times, and exceeded 200 vehicles per hour twice during the count period.

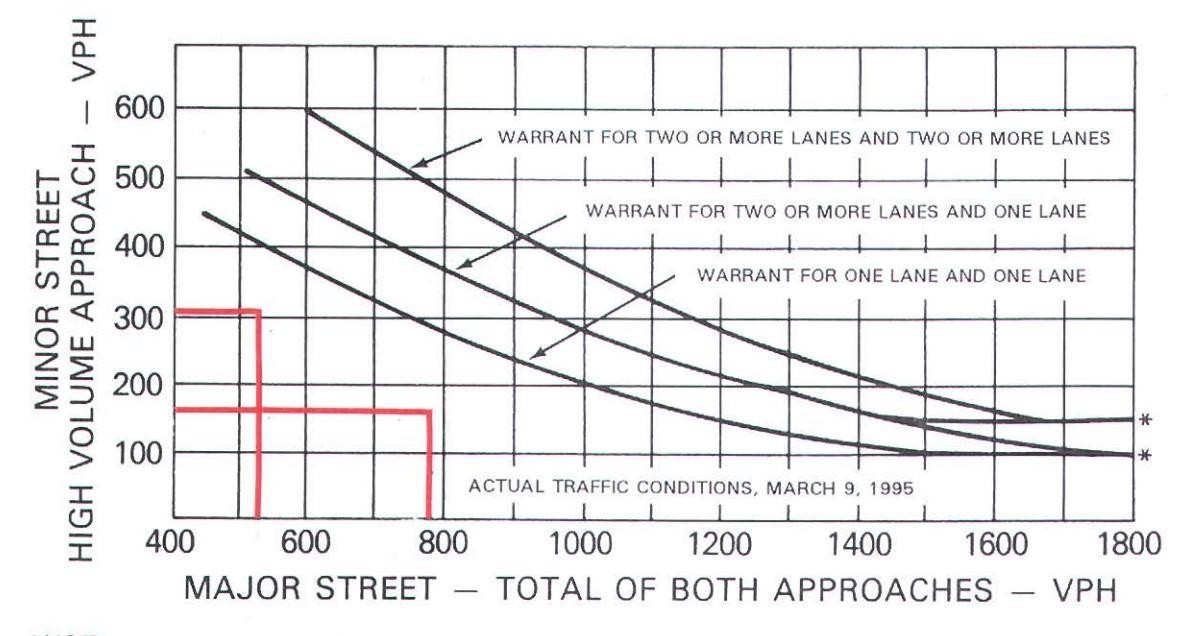
Figure 3

PEAK HOUR VOLUME WARRANT ANALYSIS OF THE INTERSECTION OF N. PORT WASHINGTON ROAD AND W. HIGHLAND ROAD IN THE CITY OF MEQUON

*NOTE: 150 VPH APPLIES AS THE LOWER THRESHOLD VOLUME FOR A MINOR STREET APPROACH WITH TWO OR MORE LANES AND 100 VPH APPLIES AS THE LOWER THRESHOLD VOLUME FOR A MINOR STREET APPROACHING WITH ONE LANE.

Vehicular	Volumes	
Peak Hour	Major Street Sum of Both Approaches	Minor Street Highest Approach	Remarks
7:00 a.m 8:00 a.m.	531	305	The warrant is not met as the point of inter- section falls below the "1 lane & 1 lane" curve.
4:30 p.m 5:30 p.m.	765	175	The warrant is not met as the point of inter- section falls below the "1 lane & 1 lane" curve.

The third warrant considered--the peak hour volume warrant--is satisfied when the number of vehicles per hour on N. Port Washington Road--measured as the total on both approaches--and the corresponding vehicles per hour on W. Highland Road-measured as the total on the highest volume approach only--for any one hour--or any four consecutive 15-minute periods--of an average day are above the applicable curve in Figure 3. As shown in Figure 3, this warrant is not met, as the point of intersection of the corresponding traffic volumes falls below the

single lane/single lane warrant curve in both of the morning and evening peak hours.

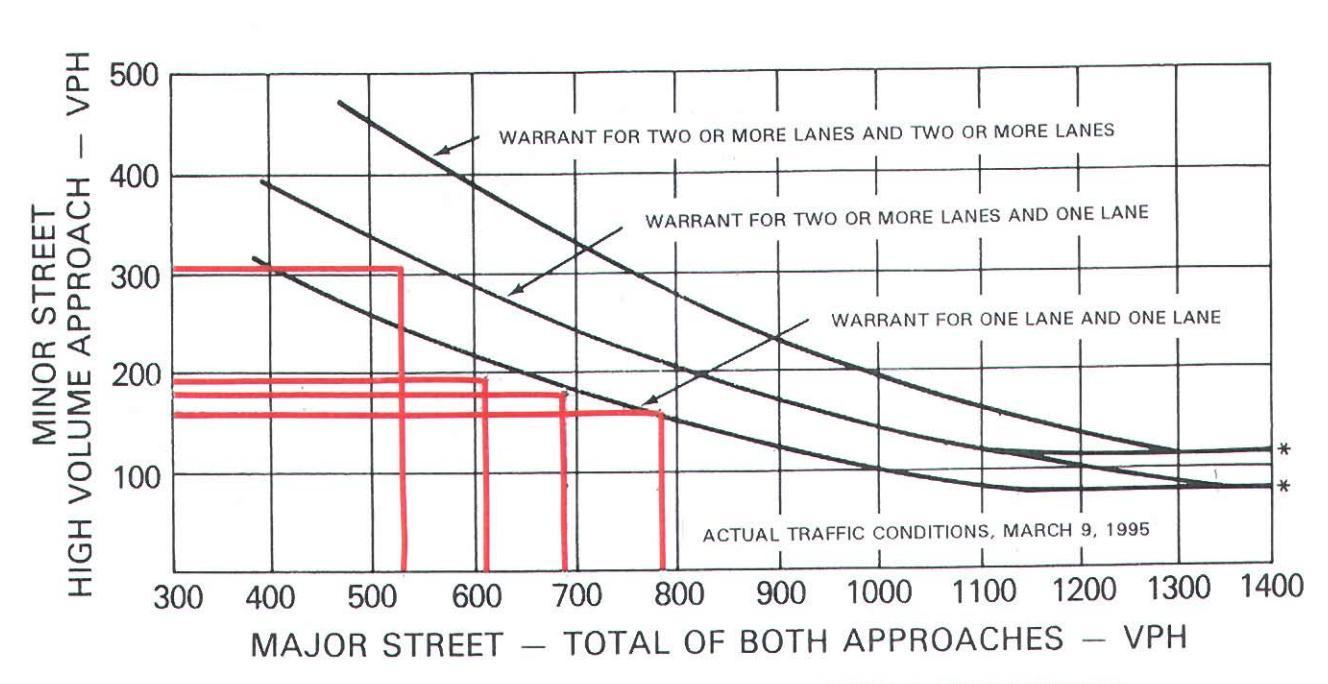
FOUR HOUR VOLUME WARRANT ANALYSIS OF THE INTERSECTION OF N. PORT WASHINGTON ROAD AND W. HIGHLAND ROAD IN THE CITY OF MEQUON

*NOTE: 115 VPH APPLIES AS THE LOWER THRESHOLD VOLUME FOR A MINOR STREET APPROACH WITH TWO OR MORE LANES AND 80 VPH APPLIES AS THE LOWER THRESHOLD VOLUME FOR A MINOR STREET APPROACHING WITH ONE LANE.

Vehicular	Volumes	
Four Highest Hours	Major Street Sum of Both Approaches	Minor Street Highest Approach	Remarks
7:00 a.m 8:00 a.m.	531	305	The warrant is met as the point of intersection falls above the "1 lane & 1 lane" curve.
3:00 p.m 4:00 p.m.	609	193	The warrant is not met as the point of inter- section falls below the "1 lane & 1 lane" curve.
4:00 p.m 5:00 p.m.	690	178	The warrant is not met as the point of inter- section falls below the "1 lane & 1 lane" curve.
5:00 p.m 6:00 p.m.	783	162	The warrant is met as the point of intersection falls above the "1 lane & 1 lane" curve.

The fourth warrant considered--the four hour volume warrant--is satisfied when, during each of any four hours of an average day, the number of vehicles per hour on N. Port Washington Road--measured as the total on both approaches--and the corresponding number of vehicles per hour on the higher volume W. Highland Road approach--measured as the total on the highest volume approach only--are all above the curve in Figure 4 for the existing combination of approach lanes. As shown in Figure 4, this warrant is not met, as the point of intersection of the corresponding traffic volumes for each of four hours falls above the single lane/single lane warrant curve in only two of the four highest hours.

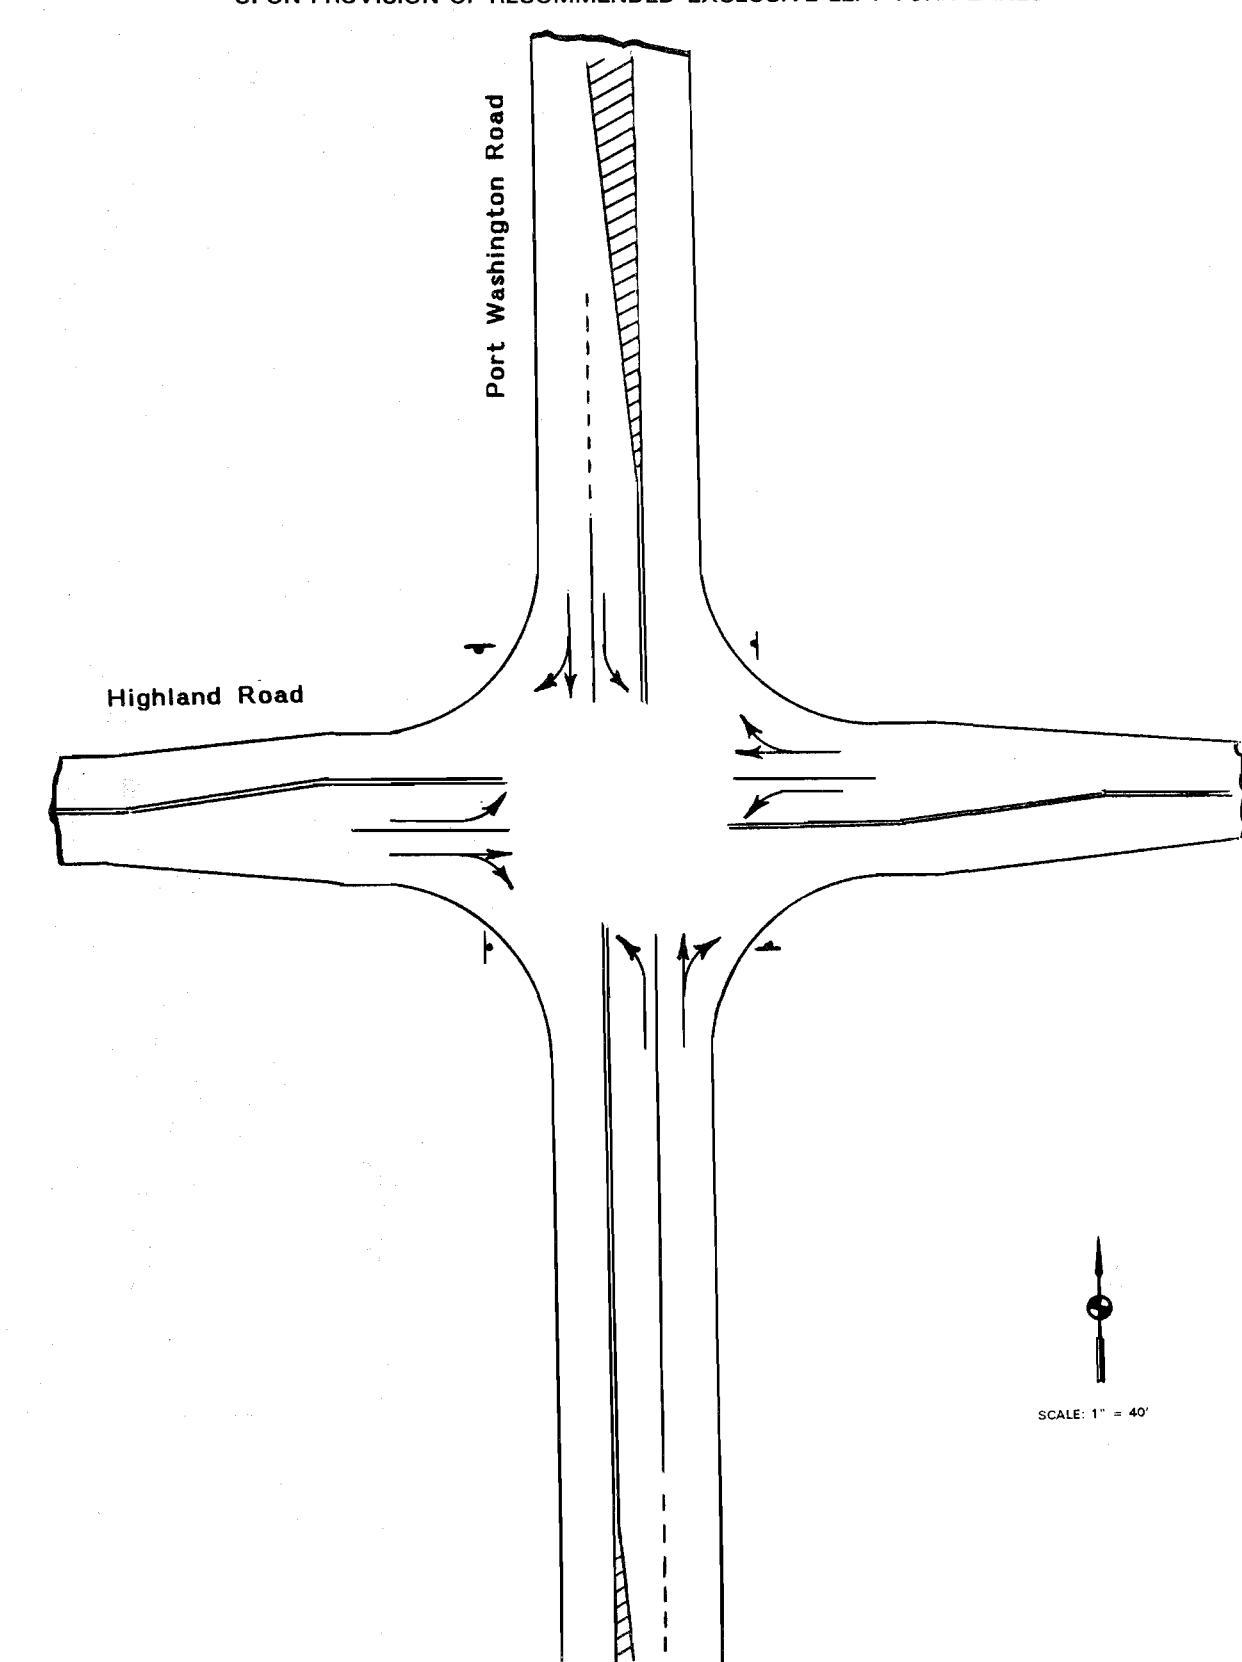
Figure 5

N. PORT WASHINGTON ROAD--CTH W--AND W. HIGHLAND ROAD INTERSECTION UPON PROVISION OF RECOMMENDED EXCLUSIVE LEFT-TURN LANES

It is recommended that provision of exclusive left-turn lanes be considered for all four approaches to the intersection of N. Port Washington Road and W. Highland Road as shown in Figure 5. Implementation of this recommendation is estimated to cost approximately \$200,000.

The provision of exclusive left-turn lanes at all four approaches to the intersection is recommended. This action is recommended because of the high percentage of the approach volumes engaging in a left-turn movement at an estimated cost of about \$200,000. This will eliminate delay for through and right-turning traffic currently caused by left-turning traffic.
